# Upper Darby High School Auditorium

## ROOM ACOUSTICS REPORT – REVISION 1

August 1, 2025

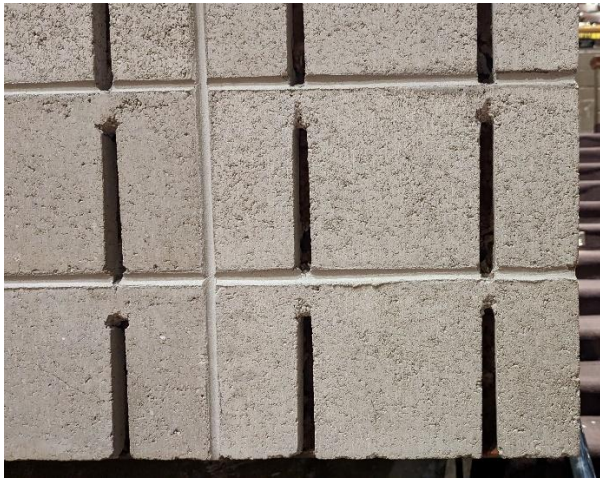
Figure 2. Pre-renovation unpainted acoustic CMU

During the design process, we discussed the painting of the acoustic CMU with the acoustic CMU manufacturer. We were informed that painting the acoustic CMU should not affect the acoustic performance, as long as the slots in the acoustic CMU are not painted over or filled in. Unpainted acoustic test data was not available for the specific type of acoustic CMU used in the auditorium; however, we reviewed acoustic test data of a similar acoustic CMU product that was both painted and unpainted, which confirmed what we were told by the manufacturer.

After reengaging with the manufacturer post renovation, we were informed that the test data provided for painted acoustic CMU uses a single light coat of spray-applied paint. It was conveyed to us that using several layers of rolled-on latex paint, as was done in this auditorium, could lower the acoustic absorption provided by the CMU. While the slots were not covered or painted over, we believe that the painting may have affected the ability of sound to pass through the CMU and into the absorptive cavities.

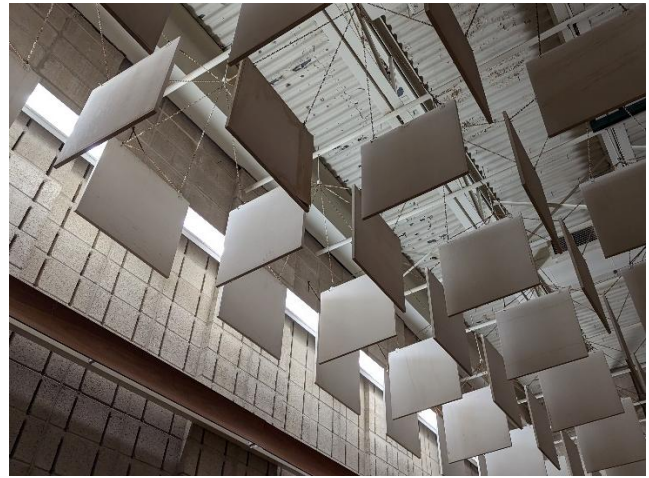
Figure 3. Pre-renovation plywood baffles

The baffles suspended from the ceiling in the pre-renovation condition were composed of plywood. Plywood does not provide much, if any, acoustical absorption in the high frequencies where the increased reverberation was observed. We do not believe the removal of the baffles caused the change in reverberation.

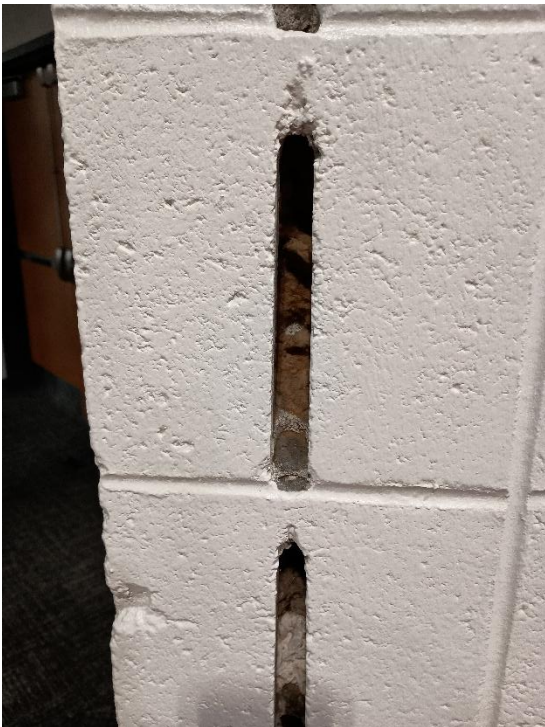
*Figure 5. Current painted acoustic CMU*

In conclusion, we believe that a combination of the painting of the acoustic CMU and the fabric selection for the seating has caused the increase in high frequency reverberation.

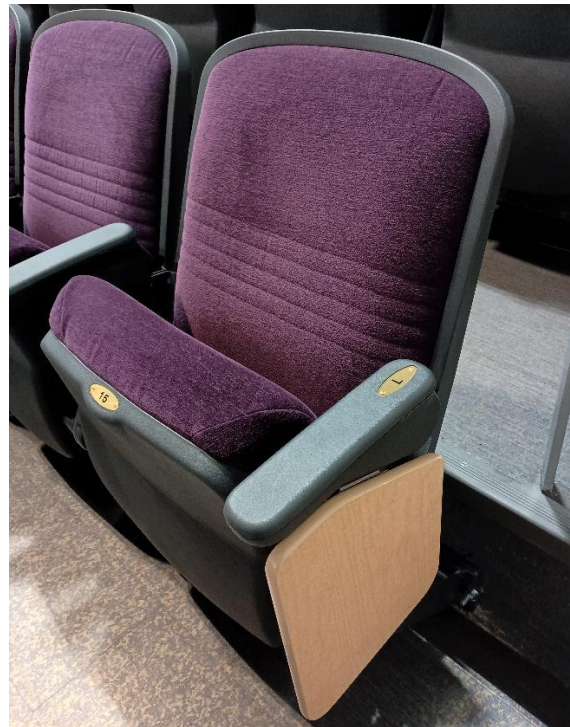
*Figure 6. Current heavily upholstered seats*

The fabric used for the new seats is Designtex Samba. We understand this fabric has a Crypton fluid barrier coating and backing, which could prevent high frequency sound from being absorbed by the seat cushions. Unfortunately, Designtex does not have acoustic test data available for this fabric; therefore, we cannot determine the acoustic impact of the fluid barrier. In our experience, we have observed that fabrics with a backing are less acoustically transparent than fabrics without a backing, with the greatest drop in performance seen in the high frequencies; therefore, this fluid barrier coating and backing could play a role in increased high frequency reverberation.

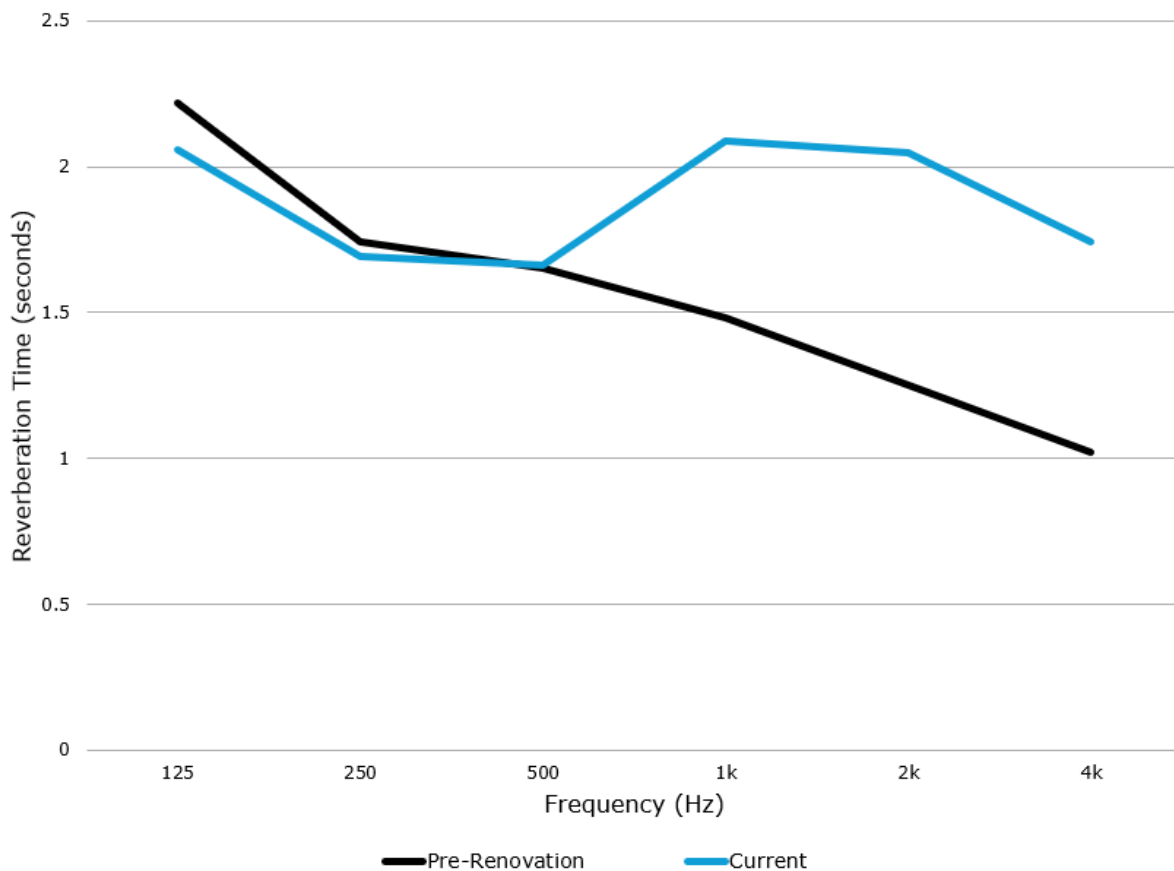
Figure 7: Comparison of pre-renovation (black) and current (blue) measured RTs

As shown in the table and figure above, the RT in the auditorium did not change much in the low to mid frequencies (500 Hz and below) after renovation. However, the current RT in the high frequencies (1,000 Hz and above) is higher than the pre-renovation condition by 0.6-0.8 seconds.

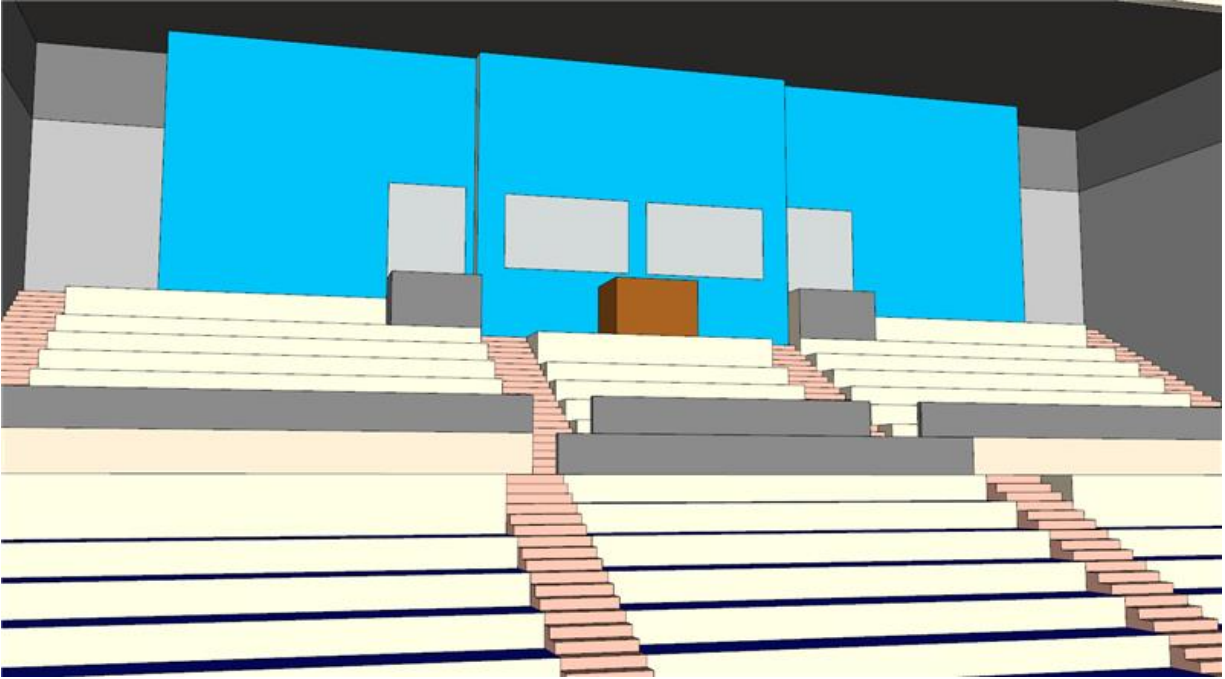
*Figure 8: Available sound booth wall acoustic panel locations*

seconds. To achieve this design goal, add 4000 SF of 1/2" fabric-wrapped fiberglass acoustical panels such as [G&S AP](#). We recommend locating these panels on the walls of the sound booth as well as the stage wall, as shown in Figure 8 and Figure 9.

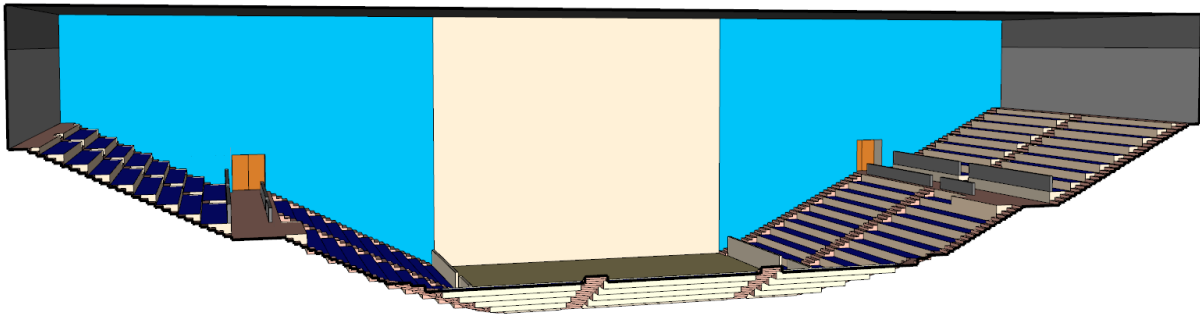
*Figure 9: Available stage wall acoustic panel locations*
