# TOWN OF SUFFIELD

## CONDITIONS ASSESSMENT & MASTER PLAN

**EXISTING CONDITIONS NARRATIVE .....C**

## FIRE DEPARTMENT 1 (HQ) - 73 MOUNTAIN RD, SUFFIELD, CT

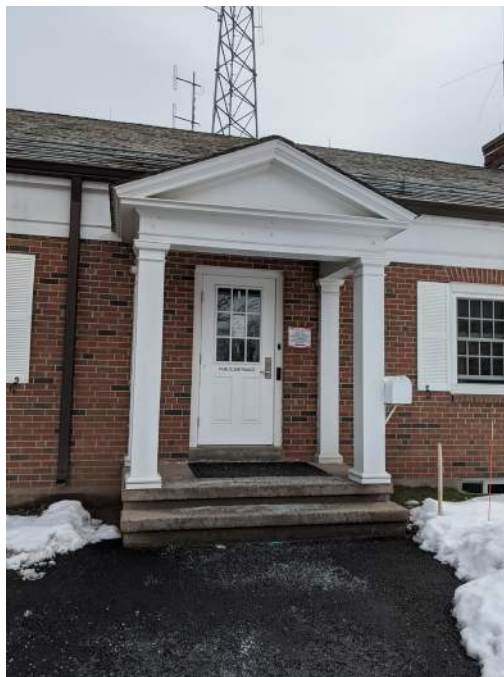
● D1. 2: Main entry is not wheel chair accessible

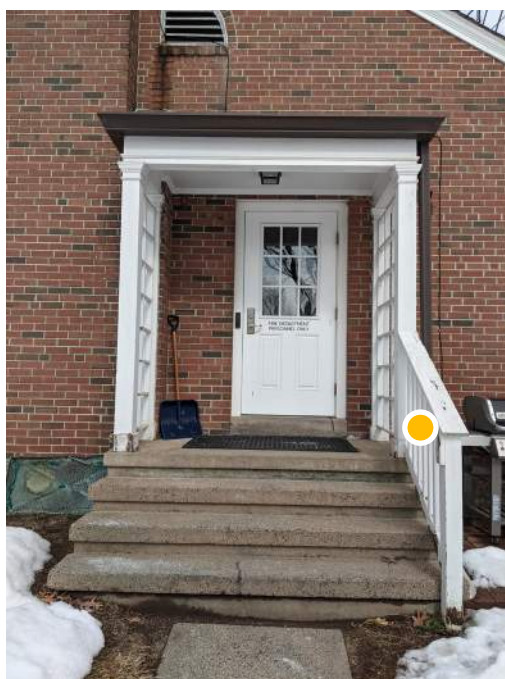
**WINDOWS/DOORS/ENTRANCES:** Doors, trim, and aluminum windows around the building are in good condition. Some minor rot repair and repainting is required at a few windows, entrance canopies, and the wood railing at the South steps.

● D1. 6: Rear Staff entry is not wheel chair accessible; wood trim and railing is decaying

| Fire Department 1, 73 Mountain Rd - ROM Summary | | | | | | | | | | | Building Area: 4,200 | | | | CIP Prioritization | | | | | |
|---|---|---|---|---|---|---|---|---|---|---|---|---|---|---|---|---|---|---|---|---|
| Repair/repaint misc. wood rot at rear entrance canopy, posts and railinas | 20 | LF | \$22 | \$ 440 | \$ 44 | \$ 7 | \$ 33 | \$ 22 | \$ 546 | \$ 68 | \$ 614 | \$ 123 | \$ 737 | | | | | | | |

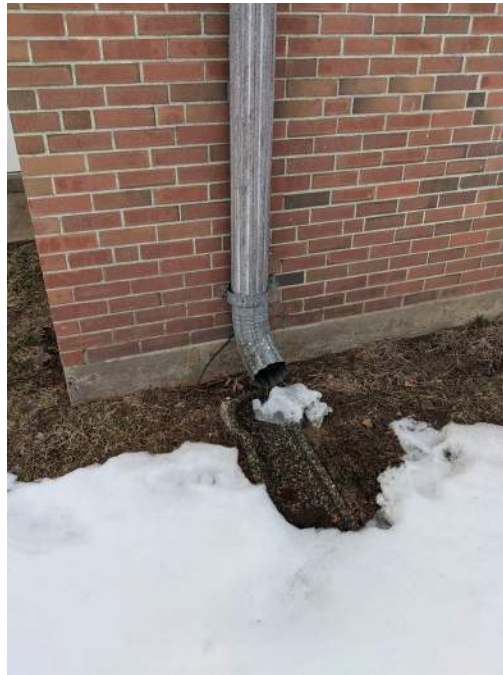
● D1. 7: Downspout splash block is under-sized, some soil erosion observed

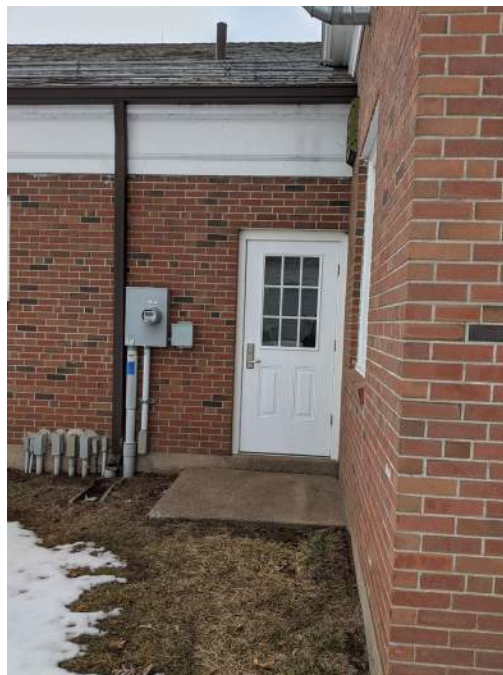
● D1. 8: Rear entry along East façade is not wheel chair accessible

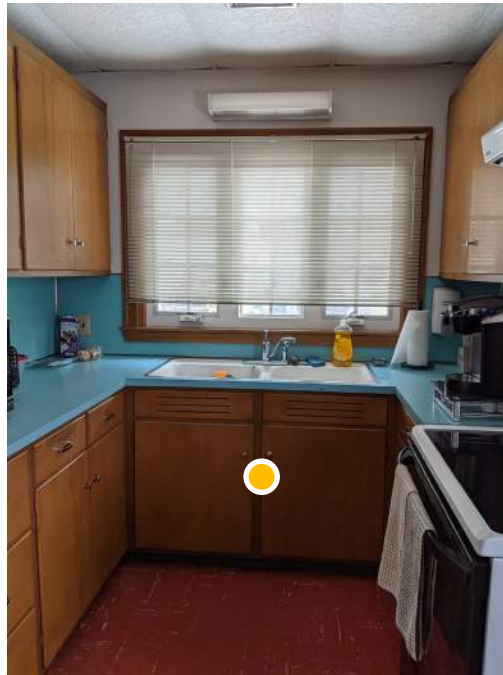
● D1. 11: Kitchen sink does not have required clear space to be considered accessible

| Fire Department 1, 73 Mountain Rd - ROM Summary | | | | | | | | | | | Building Area: 4,200 | | | | CIP Prioritization | | | | | |
|---|---|---|---|---|---|---|---|---|---|---|---|---|---|---|---|---|---|---|---|---|
| Replace kitchen sink/cabinet with ADA accessible sink and casework | 1 | EA | \$2,750 | \$ 2,750 | \$ 275 | \$ 41 | \$ 206 | \$ 138 | \$ 3,410 | \$ 426 | \$ 3,836 | \$ 767 | \$ 4,604 | | | | | | | |

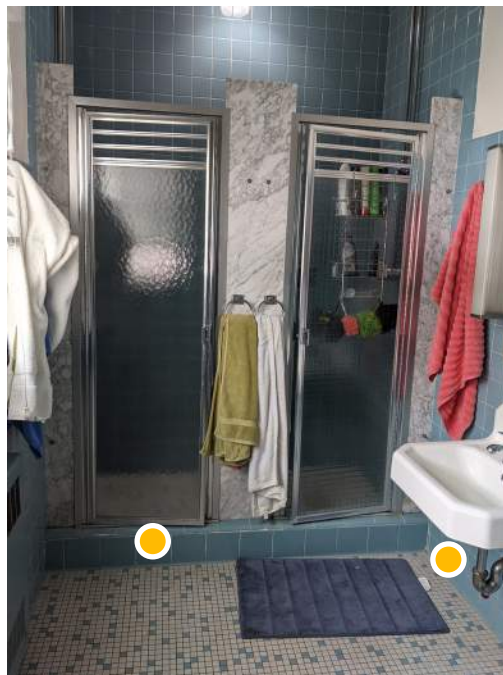
● D1. 12: Shower facilities are not wheel-chair accessible and sink does not have required pipe insulation to be considered ADA-compliant

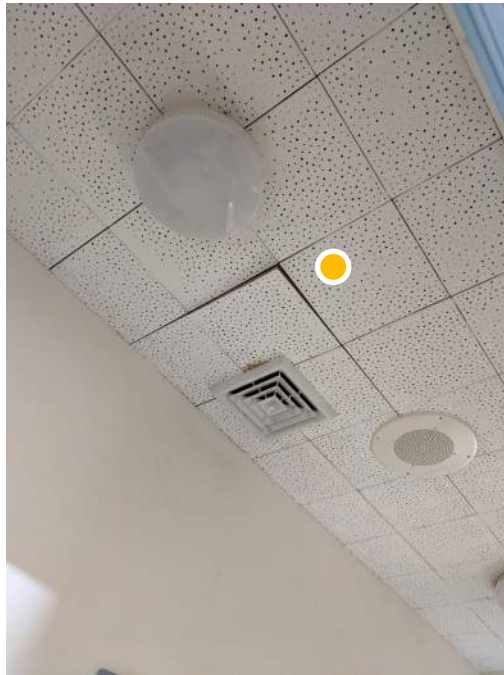
| Interior | | | |
|---|---|---|---|
| | Wood fiber ceilings | 1 | Removal recommended |

- D1. 13: Wood fiber ceilings throughout are beginning to peel away from substrate

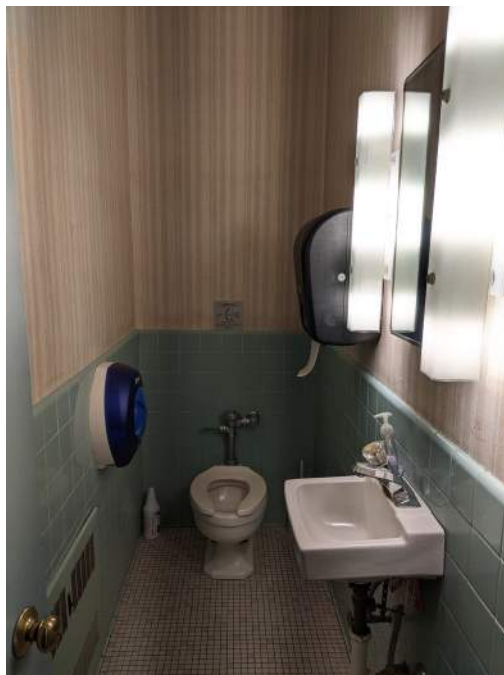
- D1. 14: Toilet room off main corridor is under-sized and sink does not have required pipe insulation to be considered ADA-compliant

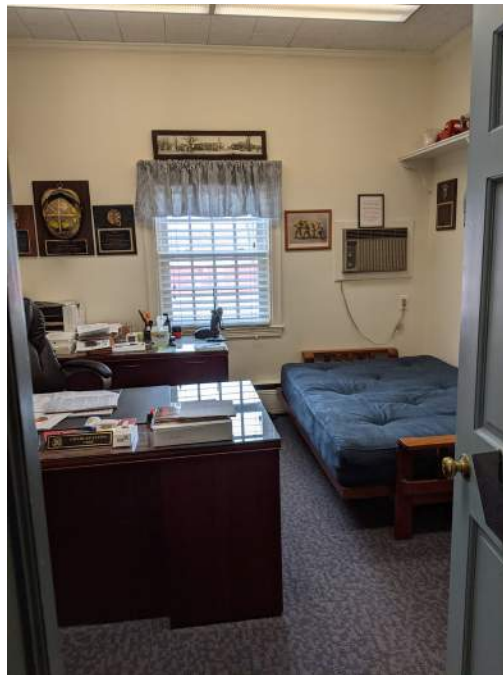
**OFFICES:** Offices throughout have carpet floors in good condition. Office spaces often double as bunk space.

● D1. 16: Office and bunk space has been combined due to space limitations

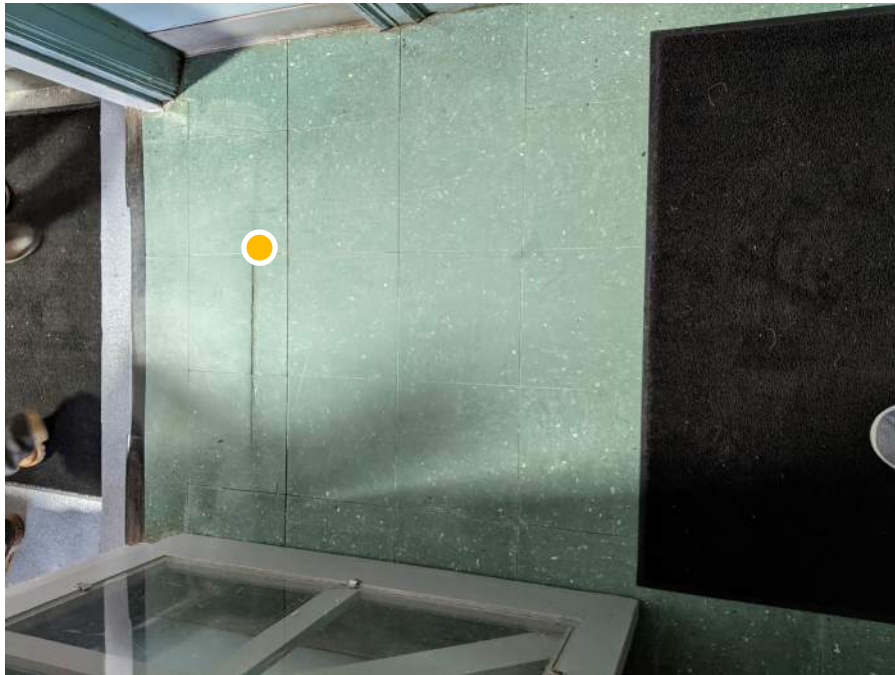
**INTERIOR SPACES (GENERAL):** While in good condition, vinyl asbestos tile is present throughout the building. Most of this flooring is not in a friable state although some cracking is beginning to show on the green tile near the apparatus bay. Wood fiber ceilings are also present throughout and are in fair condition. Some corners of the ceiling are beginning to peel and deteriorate. It is recommended to abate or encapsulate all vinyl asbestos tile and wood fiber ceilings. General finish material at most interior walls is painted plaster.

● D1. 17: Vinyl asbestos tile is present throughout, some cracking is beginning to show

| Fire Department 1, 73 Mountain Rd - ROM Summary | | | | | | | | | | | Building Area: 4,200 | | | | CIP Prioritization | | | | | |
|---|---|---|---|---|---|---|---|---|---|---|---|---|---|---|---|---|---|---|---|---|
| Replace VCT flooring | 1,200 | SF | \$8 | \$ 9,240 | \$ 924 | \$ 139 | \$ 693 | \$ 462 | \$ 11,458 | \$ 1,432 | \$ 12,890 | \$ 2,578 | \$ 15,468 | | | | | | | |

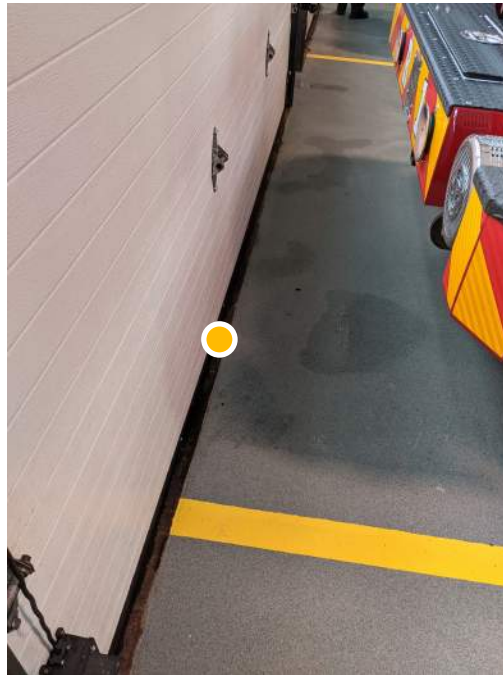
| Exterior | | | |
|---|---|---|---|
| | Overhead Doors | 3 | Thresholds beginning to rust |

**APPARATUS BAY:** The floors in the apparatus bay are epoxy-coated concrete with painted vehicle bay striping. The walls are painted masonry. All aspects of the apparatus bays are in good condition with exception to the steel angle at apparatus bay doors that are beginning to rust.

● D1. 19: Steel angle at Apparatus Bay doors is beginning to rust

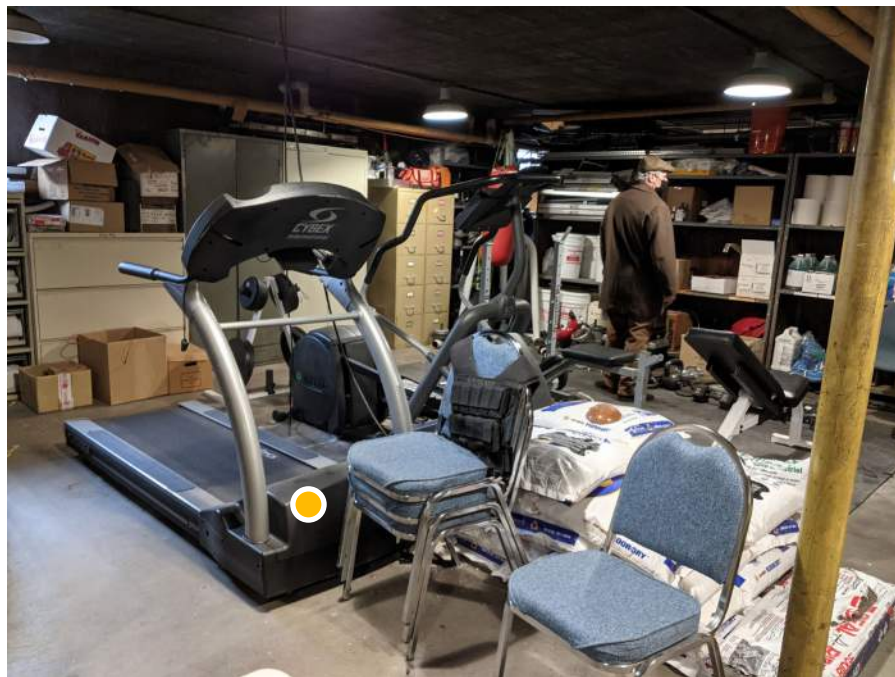
● D1. 20: Fitness equipment is located on the lower level, this space is not wheelchair accessible

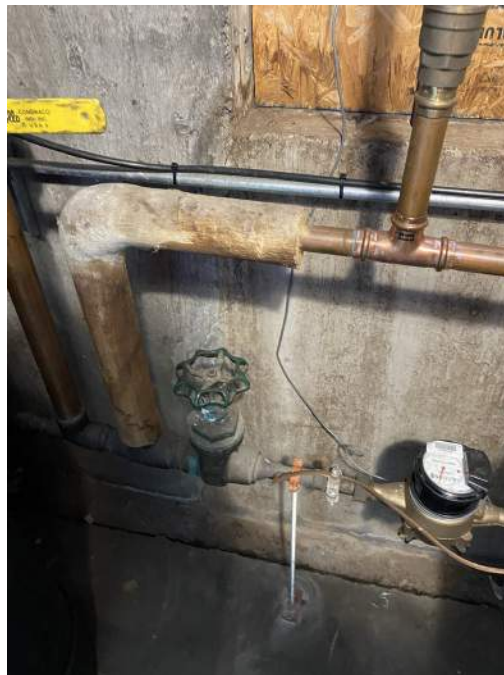
**DOMESTIC WATER SERVICE:** The existing building is currently served by a municipal water service. This service is 2" when it enters the building and is located in the mechanical room. The service appears to be original to the 1961 construction and is in poor working condition.

● D2. 11: Domestic Water Service Needs to be Updated

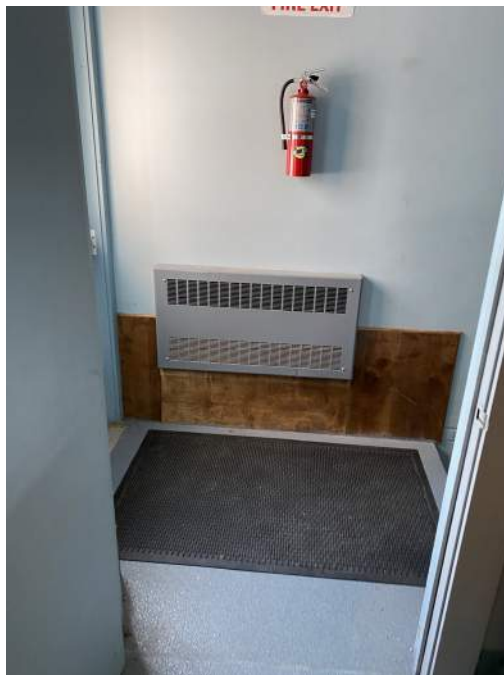
● D2. 18: Hot Water Wall Convactor Needs Replacing

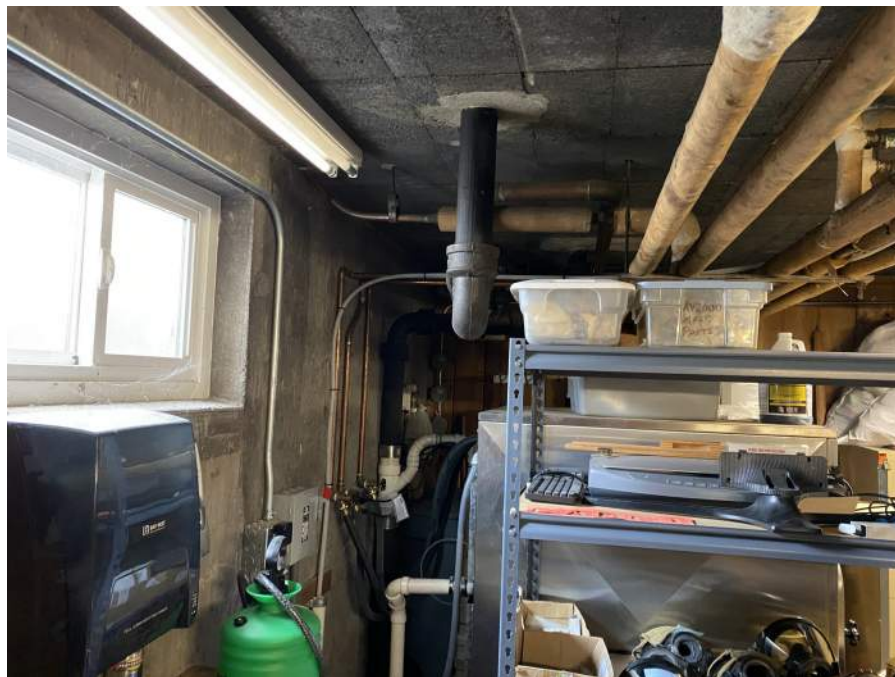
**DOMESTIC WATER PIPING:** Domestic water piping was observed to be a combination of copper and steel piping. The piping appears to be original to the 1961 construction and is past the end of its useful life.

**HOT WATER PIPING:** The hot water piping consists of steel and copper pipe throughout the building. The majority of the hot water piping is original to the 1961 building construction and at the end of its useful life. New piping connections at the boiler appear to be in good working condition.

● D2. 20: Hydronic and Domestic Water Piping Needs to be Replaced

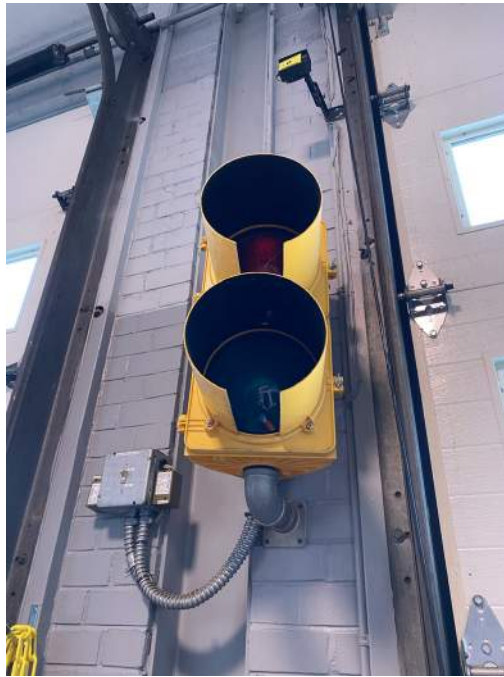
● D2. 25: Internal Traffic Control Light (Non-functional)

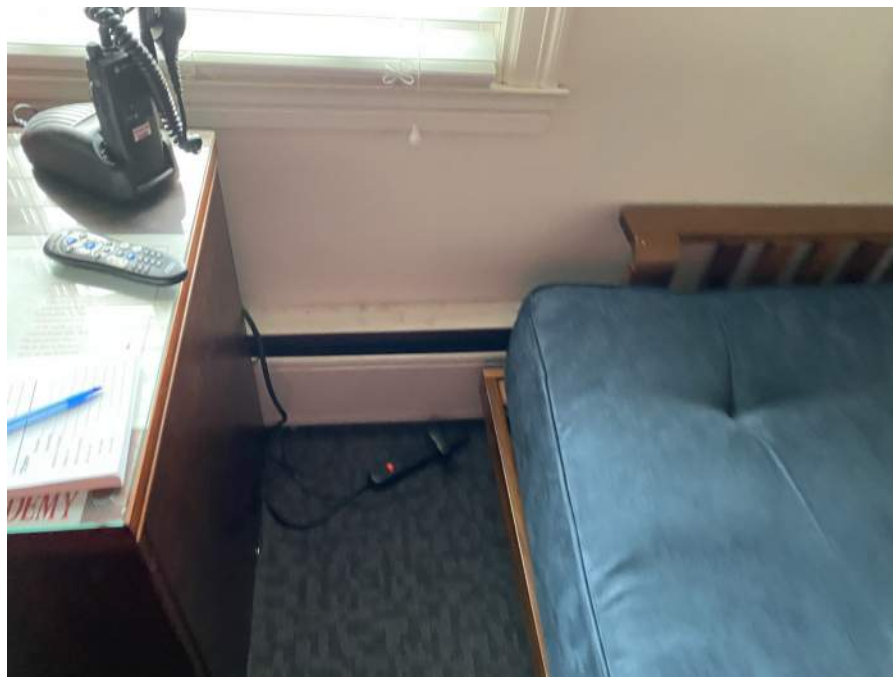
● D2. 31: Old Radiator Needs Replacement

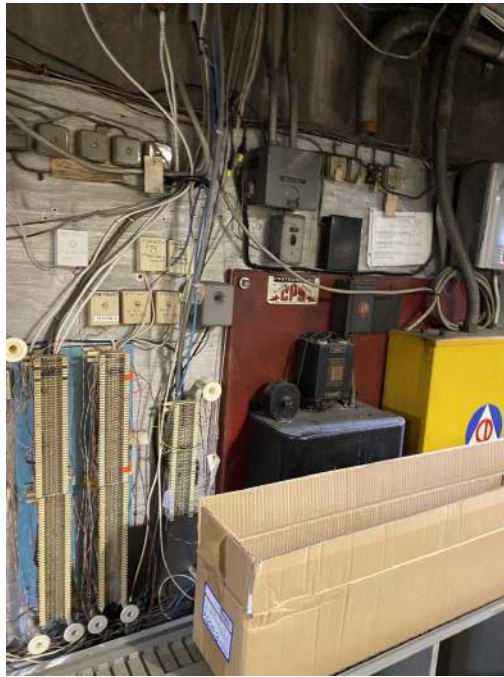
● D2. 33: Outdated Communication Infrastructure

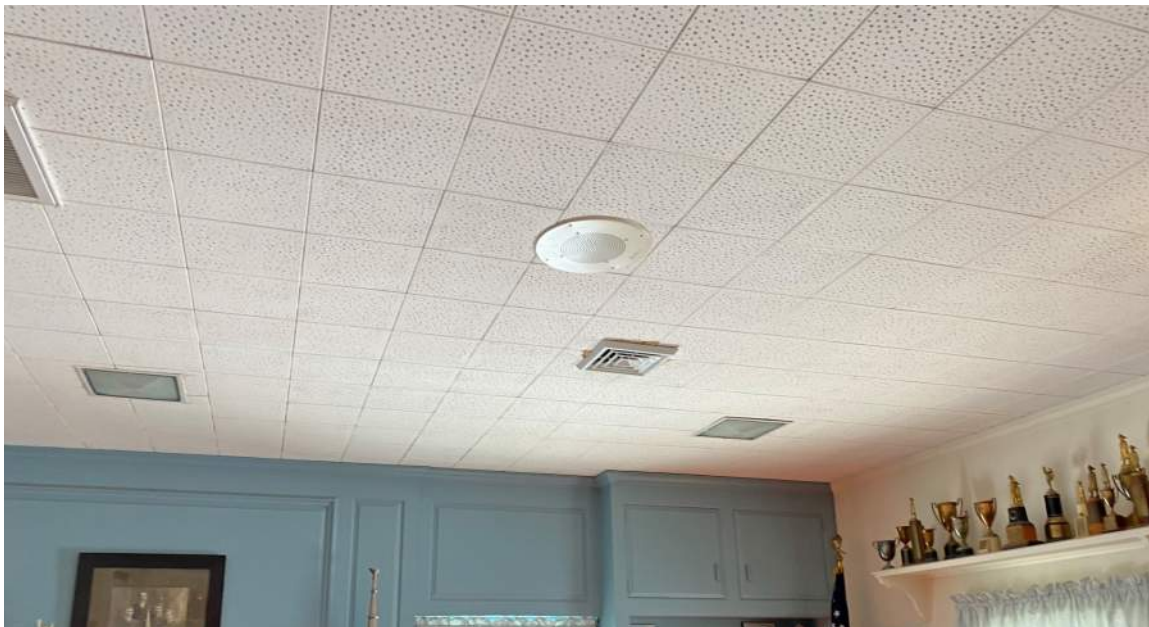
● D2. 34: Outdated Lighting

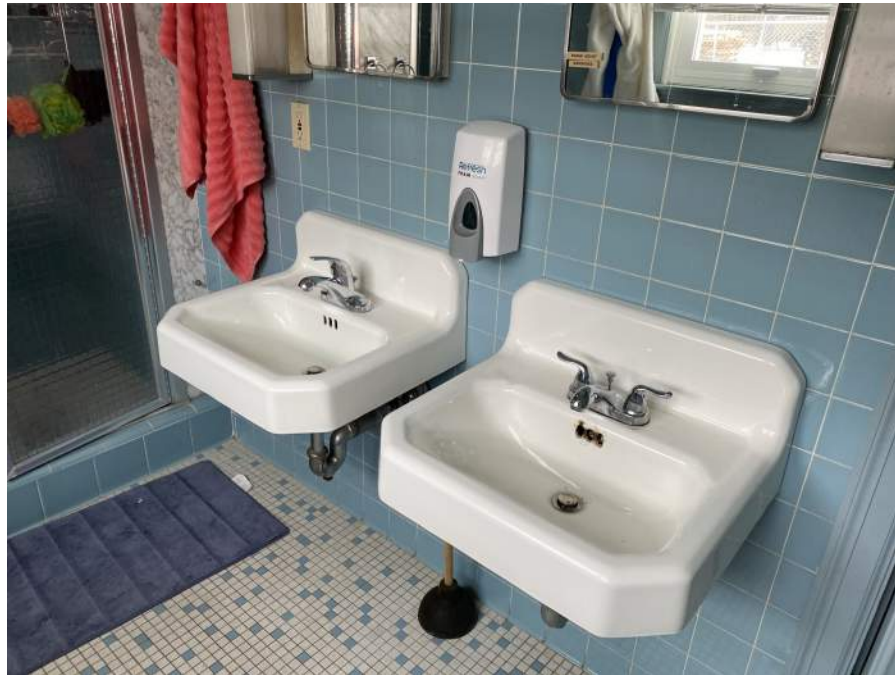
● D2. 35: Outdated Plumbing Fixtures

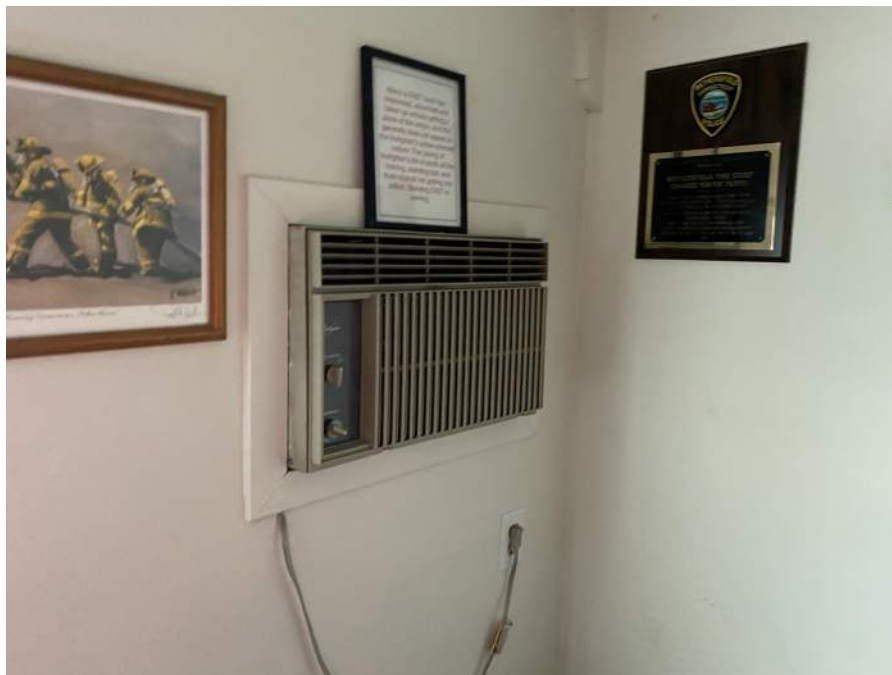
● D2. 42: Thru Wall AC Unit in Poor Condition

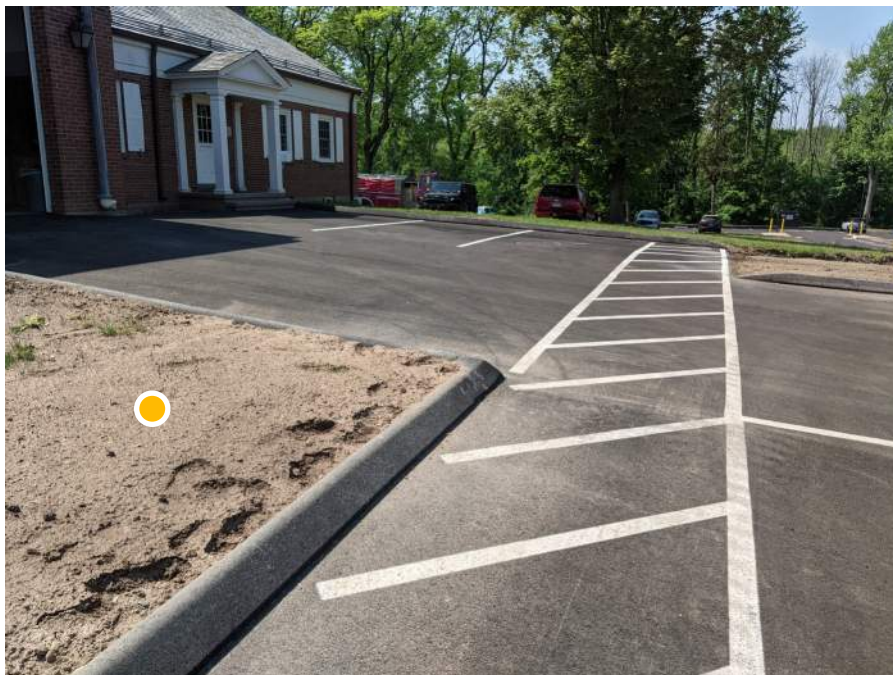
● D3. 2: Grass missing in lawn area due to parking lot work

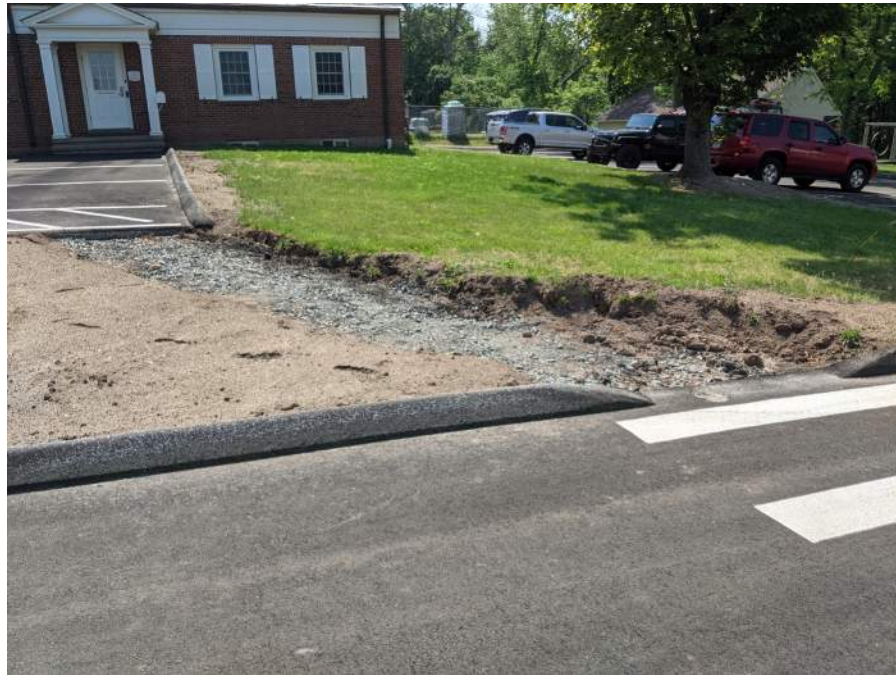
**WALKWAYS/SITE STAIRS:** Differential settlement and cracking was observed at the concrete sidewalks at rear entry. At the time of the site visits, some sidewalks had not yet been completed.

● D3. 3: New sidewalk substrate has been prepared but was not completed at the time of walkthrough

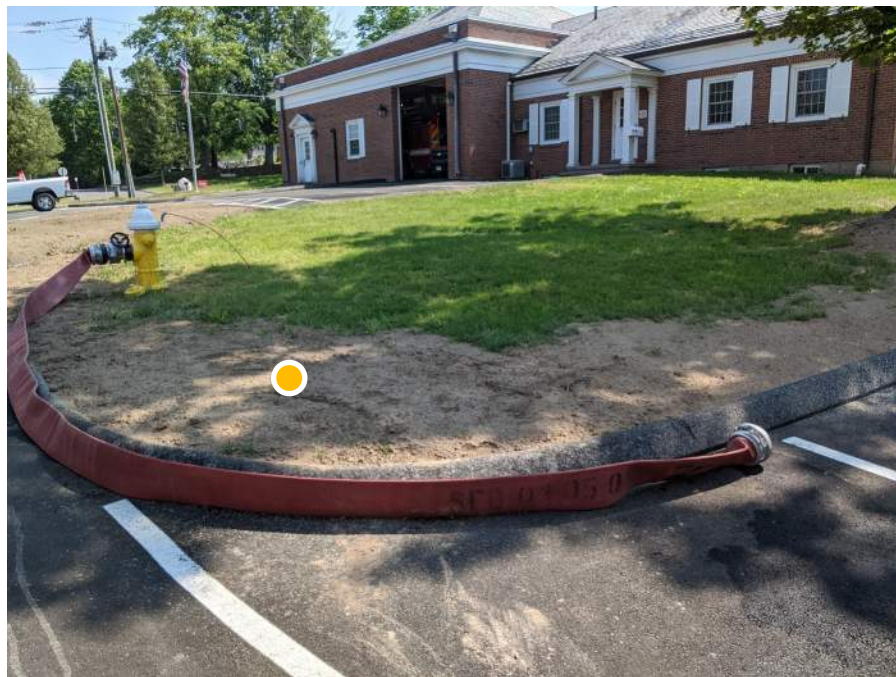
● D3. 4: Grass missing in lawn area due to parking lot work

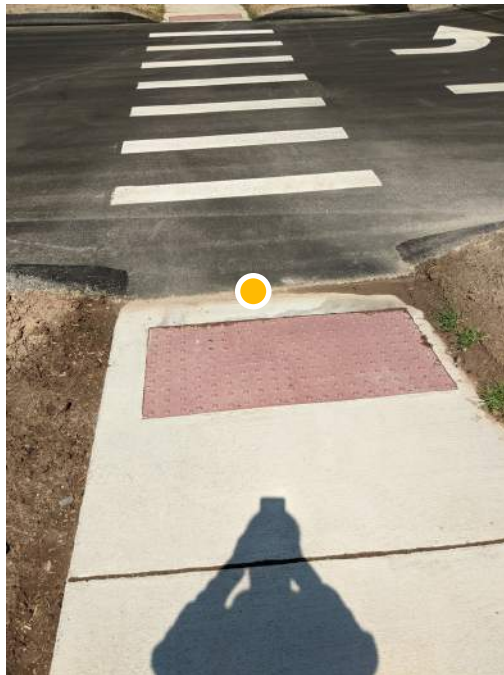
● D3. 6: A low point was observed between concrete sidewalk and parking area and may collect water

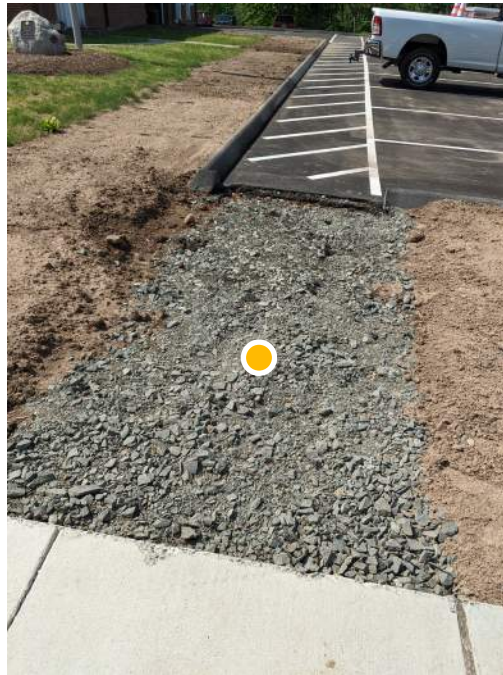
- D3. 7: New sidewalk substrate has been prepared but was not completed at the time of walkthrough
