AHERA Reinspection – Newington Elementary School  
Approximate Locations of ACBMs

10 King Charles Circle  
Summerville, South Carolina 29485

Project No.  
25-2340ES

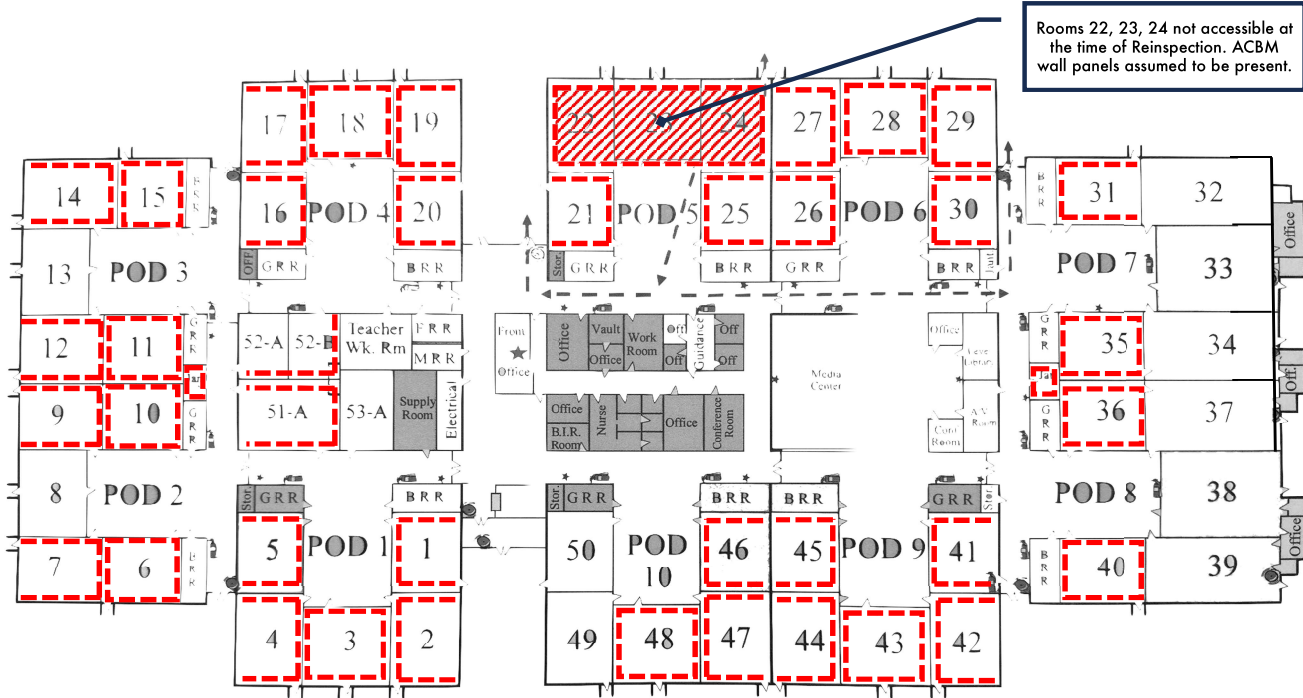
1

Cementitious (Transite) Wall Panels
