# INSPECTION REPORT

August 25, 2025

Pipe Segment Reference: DI-03 to DI-04\_

| Project | Street<br>St Cloud Drive | Upstream MH<br>DI-04 | Downstream MH<br>DI-03 |

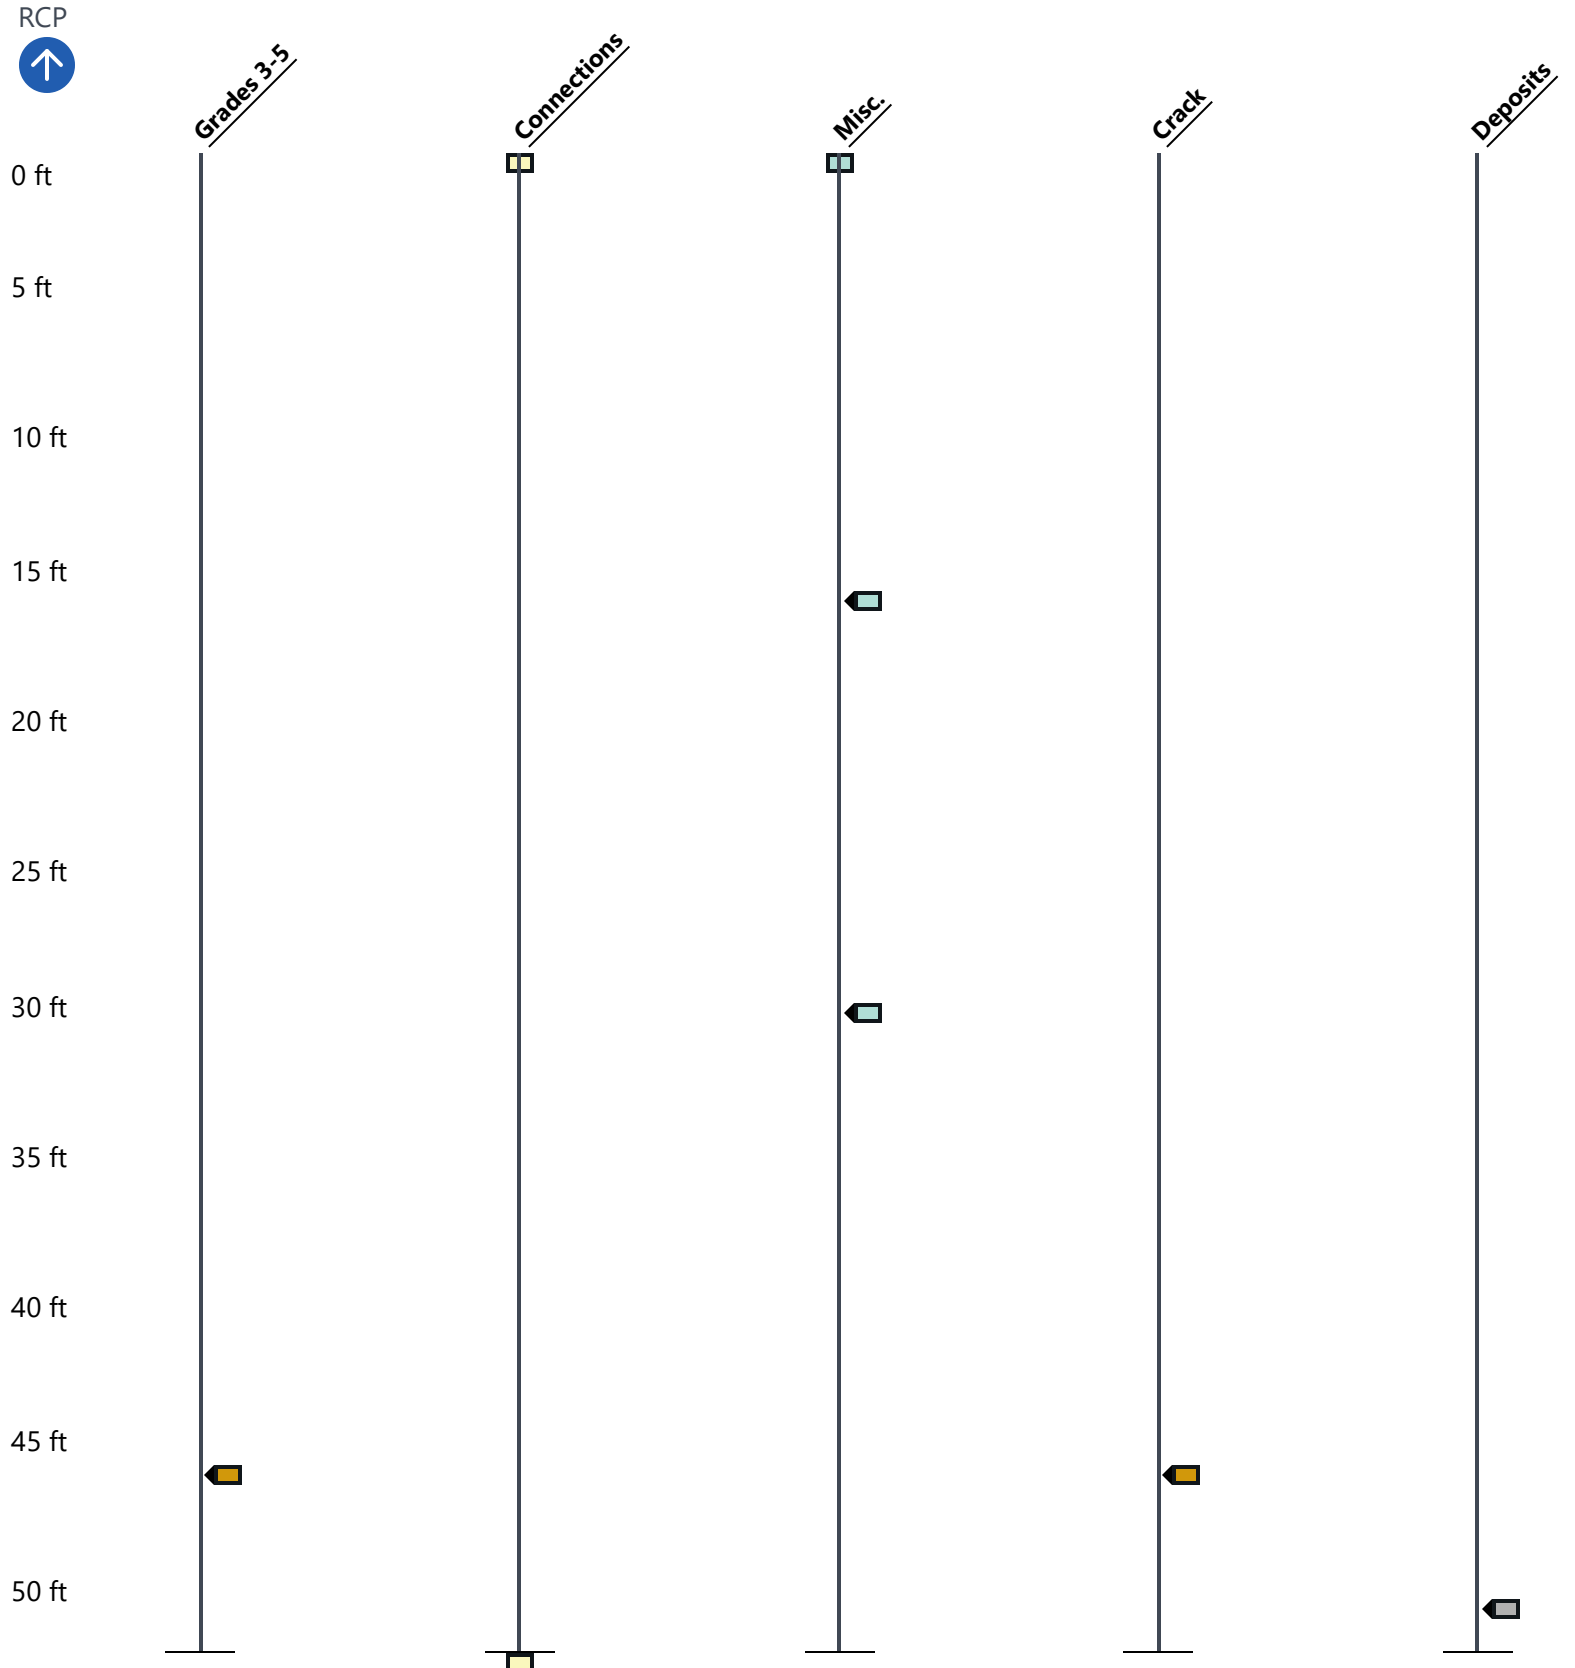
DATE: 7/22/2025  
 PIPE SEG REF. DI-03 to DI-04\_  
 UP MH: DI-04  
 DOWN MH: DI-03

| Dist | Time | Description | Code | Clock | Dim. 1 | Dim. 2 | % | Remarks | Cont. | Grade |
|---|---|---|---|---|---|---|---|---|---|---|
| 45.3 | 1:08 | Crack Multiple | CM | | - | - | - | MULTIPLE CRACKS NEAR JOINT | - | 3 |
| 49.9 | 1:20 | Deposits Attached Other | DAZ | | - | - | 5 | DEPOSITS AROUND JOINT | - | 2 |

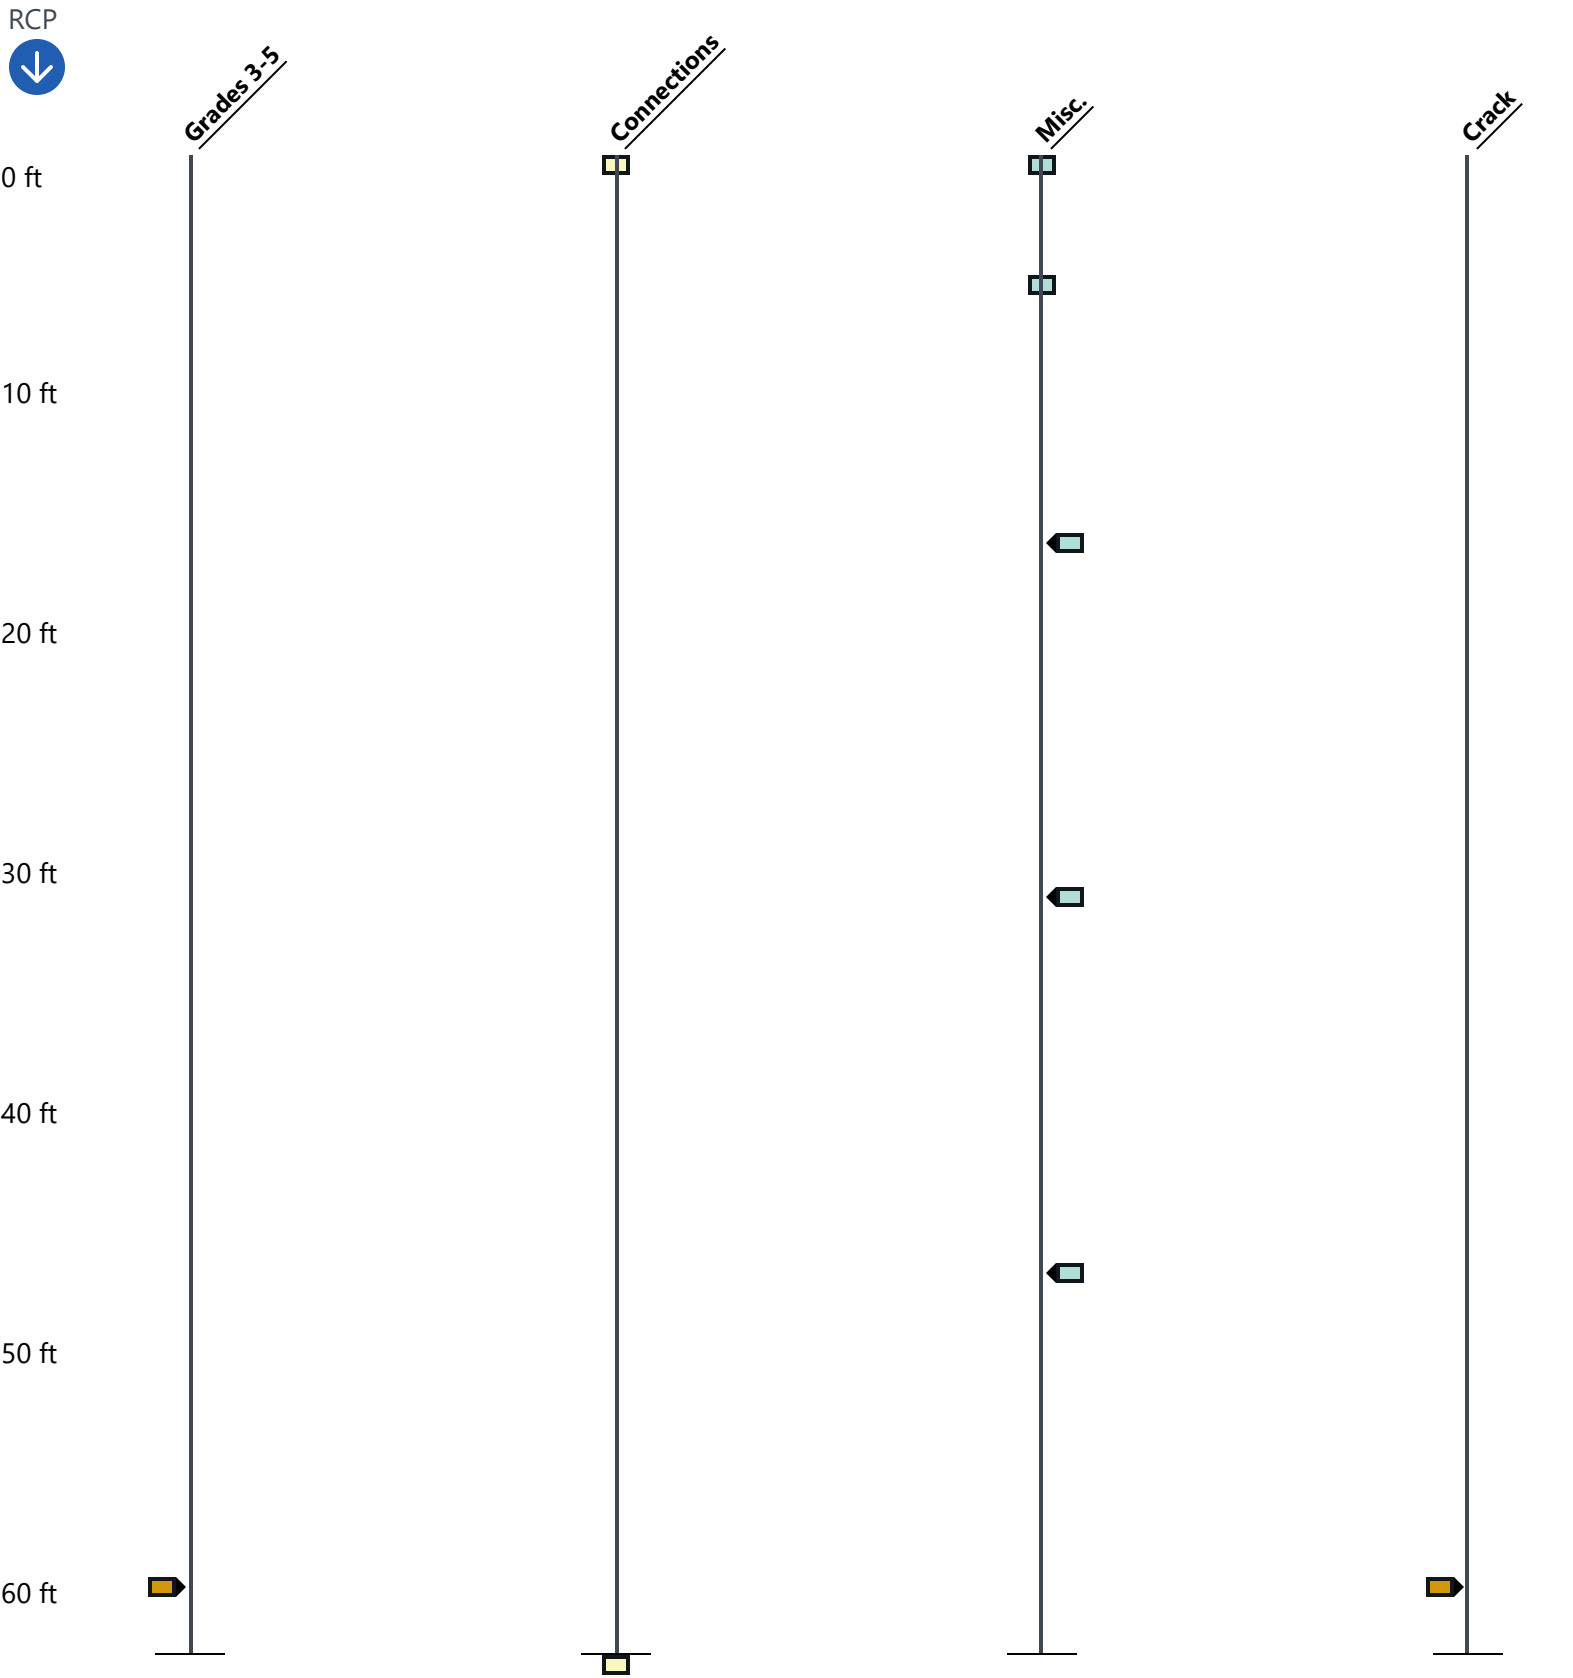
DATE: 7/22/2025  
PIPE SEG REF. DI-03 to DI-02  
UP MH: DI-03  
DOWN MH: DI-02

| Dist | Time | Description | Code | Clock | Dim. 1 | Dim. 2 | % | Remarks | Cont. | Grade |
|---|---|---|---|---|---|---|---|---|---|---|
| 59.1 | 1:58 | Crack Multiple | CM | | - | - | - | MULTIPLE CRACKS AT JOINT | - | 3 |

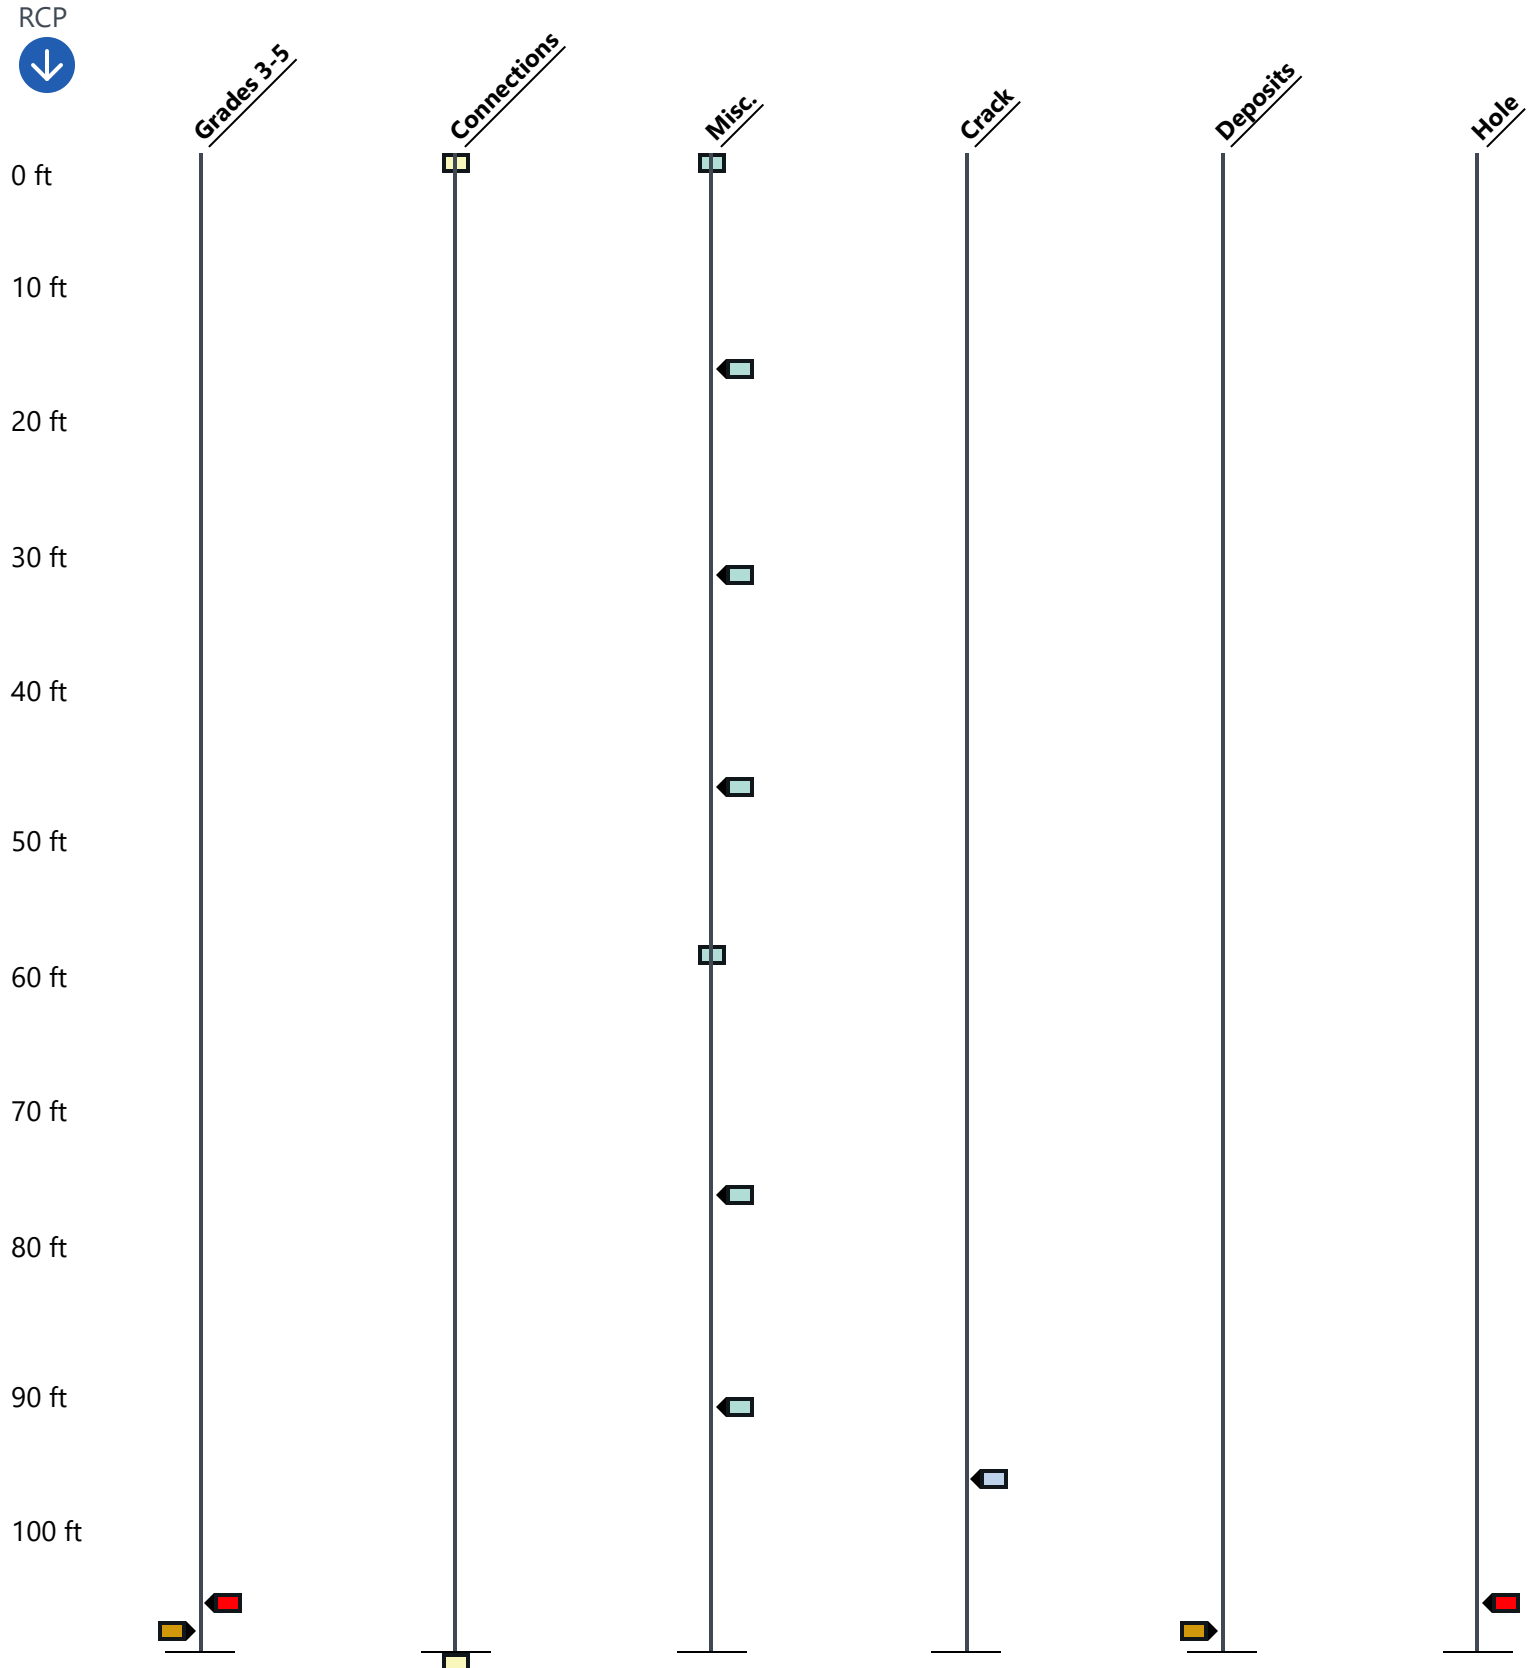
DATE: 7/22/2025  
 PIPE SEG REF. DI-02 to DI-01  
 UP MH: DI-02  
 DOWN MH: DI-01

| Dist | Time | Description | Code | Clock | Dim. 1 | Dim. 2 | % | Remarks | Cont. | Grade |
|---|---|---|---|---|---|---|---|---|---|---|
| 95.1 | 2:24 | Crack Circumferential | CC | | - | - | - | CIRCUMFERENTIAL CRACK AT JO<br>INT | - | 1 |
| 104 | 2:37 | Hole | H | | - | - | - | HOLE AT 12 O CLOCK POSITION | - | 4 |
| 106 | 2:39 | Deposits Attached Other | DAZ | | - | - | 15 | DEPOSIT AT BOTTOM OF STORM<br>PIPE | - | 3 |

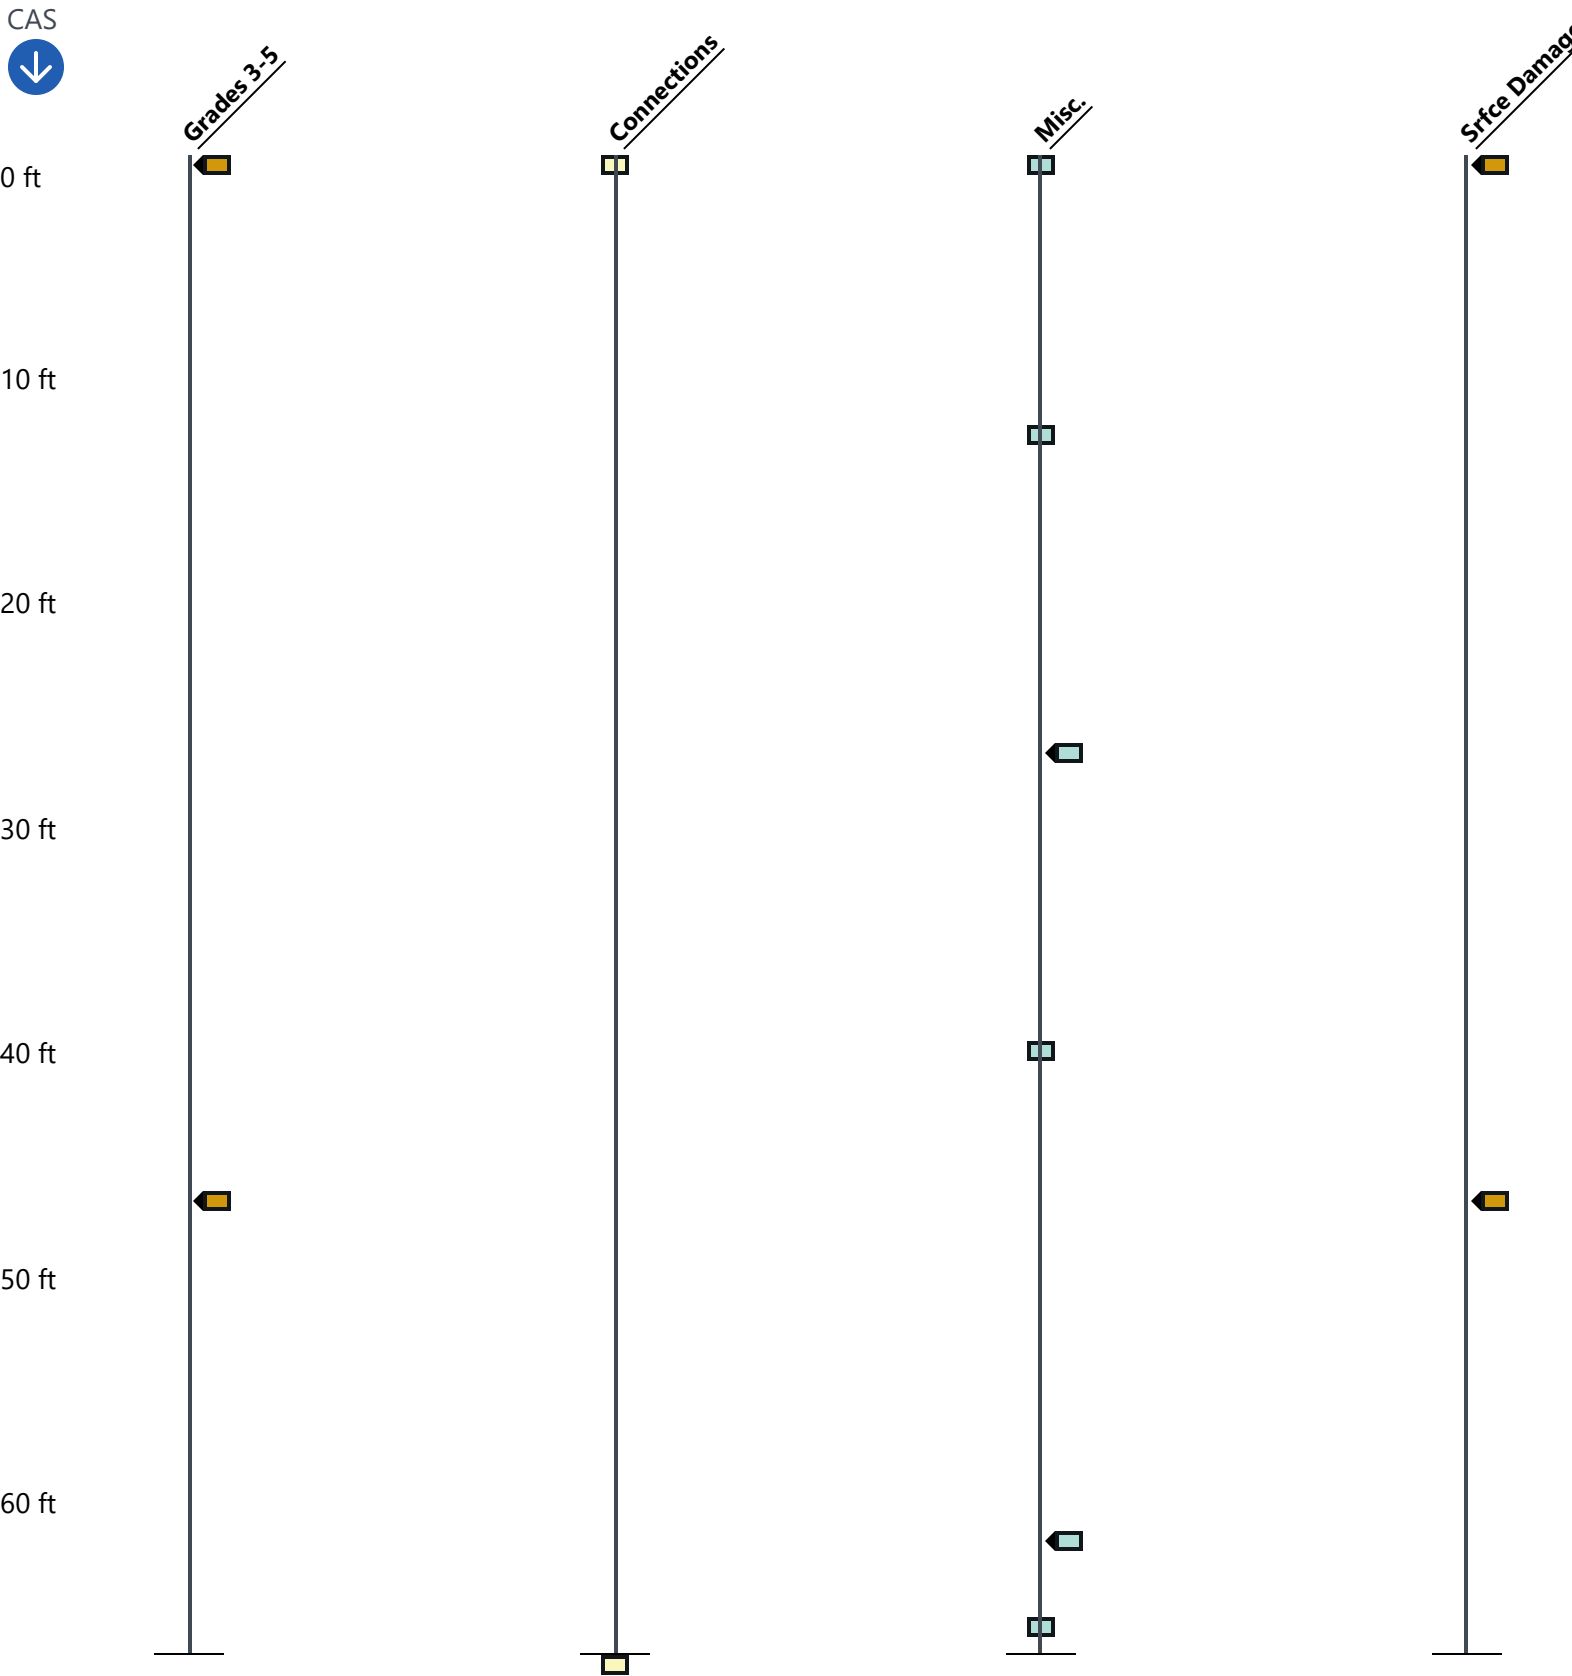
DATE: 7/22/2025  
PIPE SEG REF. SSCO-04 to SSCO-02  
UP MH: SSCO-04  
DOWN MH: SSCO-02

| Dist | Time | Description | Code | Clock | Dim. 1 | Dim. 2 | % | Remarks | Cont. | Grade |
|---|---|---|---|---|---|---|---|---|---|---|
| 0 | 0:33 | Surface Damage Corrosion | SCP | | - | - | - | START OF SURFACE CORROSION IN PIPE | S01 | 3 |
| 45.6 | 2:15 | Surface Damage Corrosion | SCP | | - | - | - | END OF SURFACE CORROSION IN PIPE | F01 | 3 |

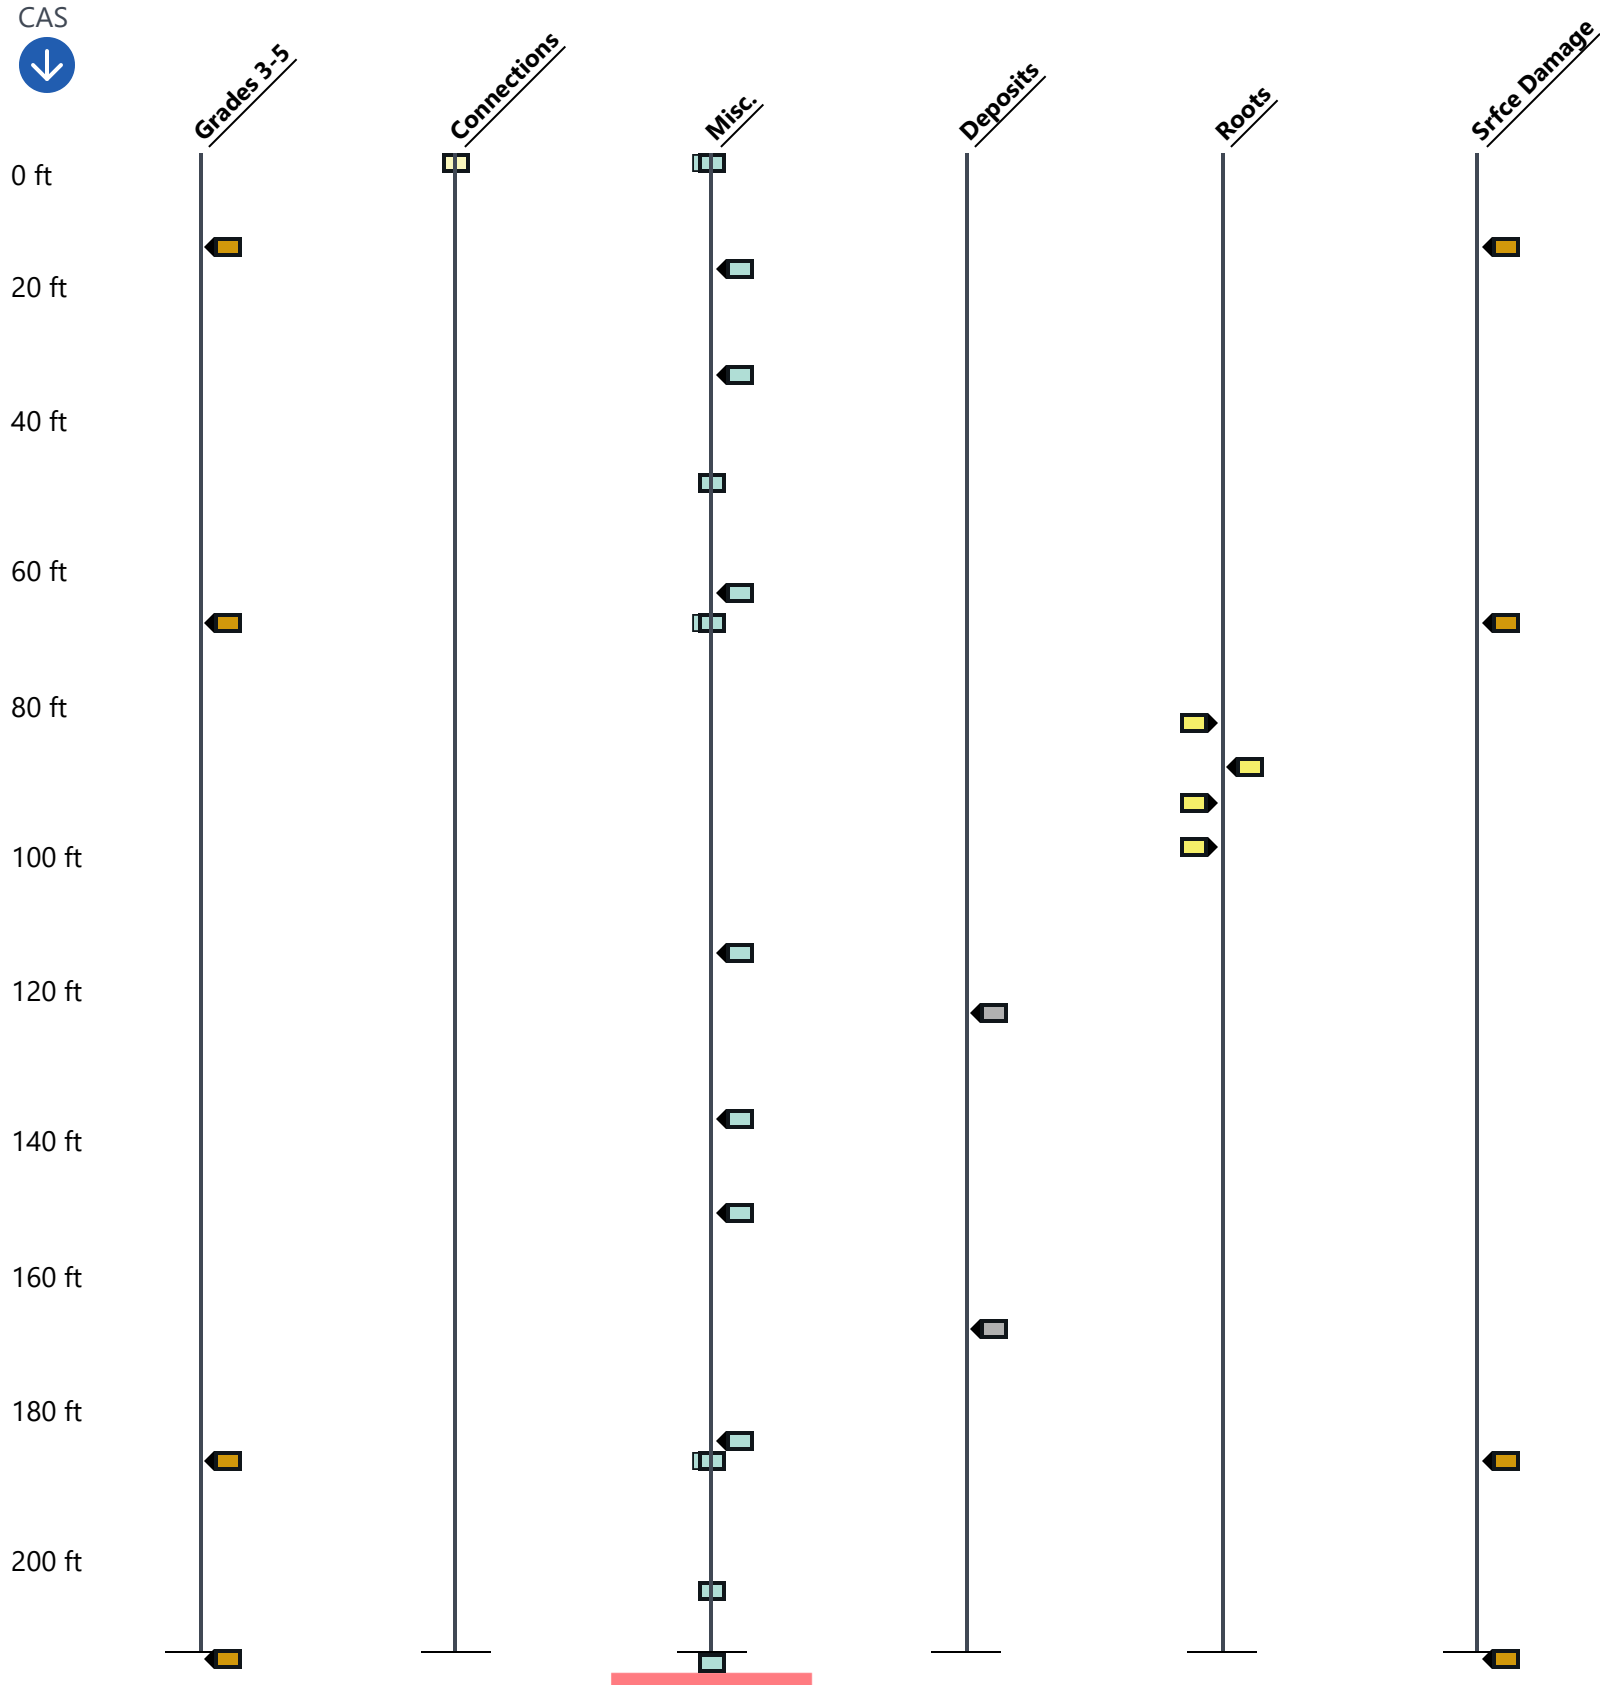
DATE: 7/22/2025  
 PIPE SEG REF. SSCO-02 to MH-01  
 UP MH: SSCO-02  
 DOWN MH: MH-01

| Dist | Time | Description | Code | Clock | Dim. 1 | Dim. 2 | % | Remarks | Cont. | Grade |
|---|---|---|---|---|---|---|---|---|---|---|
| 11.9 | 1:24 | Surface Damage Corrosion | SCP | | - | - | - | START OF SURFACE CORROSION | S01 | 3 |
| 65.1 | 2:54 | Surface Damage Corrosion | SCP | | - | - | - | START OF SURFACE CORROSION | F01 | 3 |
| 79.1 | 3:21 | Roots Fine Joint | RFJ | | - | - | - | FINE ROOTS AT JOINT | - | 1 |

| Dist | Time | Description | Code | Clock | Dim. 1 | Dim. 2 | % | Remarks | Cont. | Grade |
|---|---|---|---|---|---|---|---|---|---|---|
| 183.5 | 7:05 | Surface Damage Corrosion | SCP | | - | - | - | START OF SURFACE CORROSION | S02 | 3 |
| 211.4 | 9:04 | Surface Damage Corrosion | SCP | | - | - | - | START OF SURFACE CORROSION | F02 | 3 |

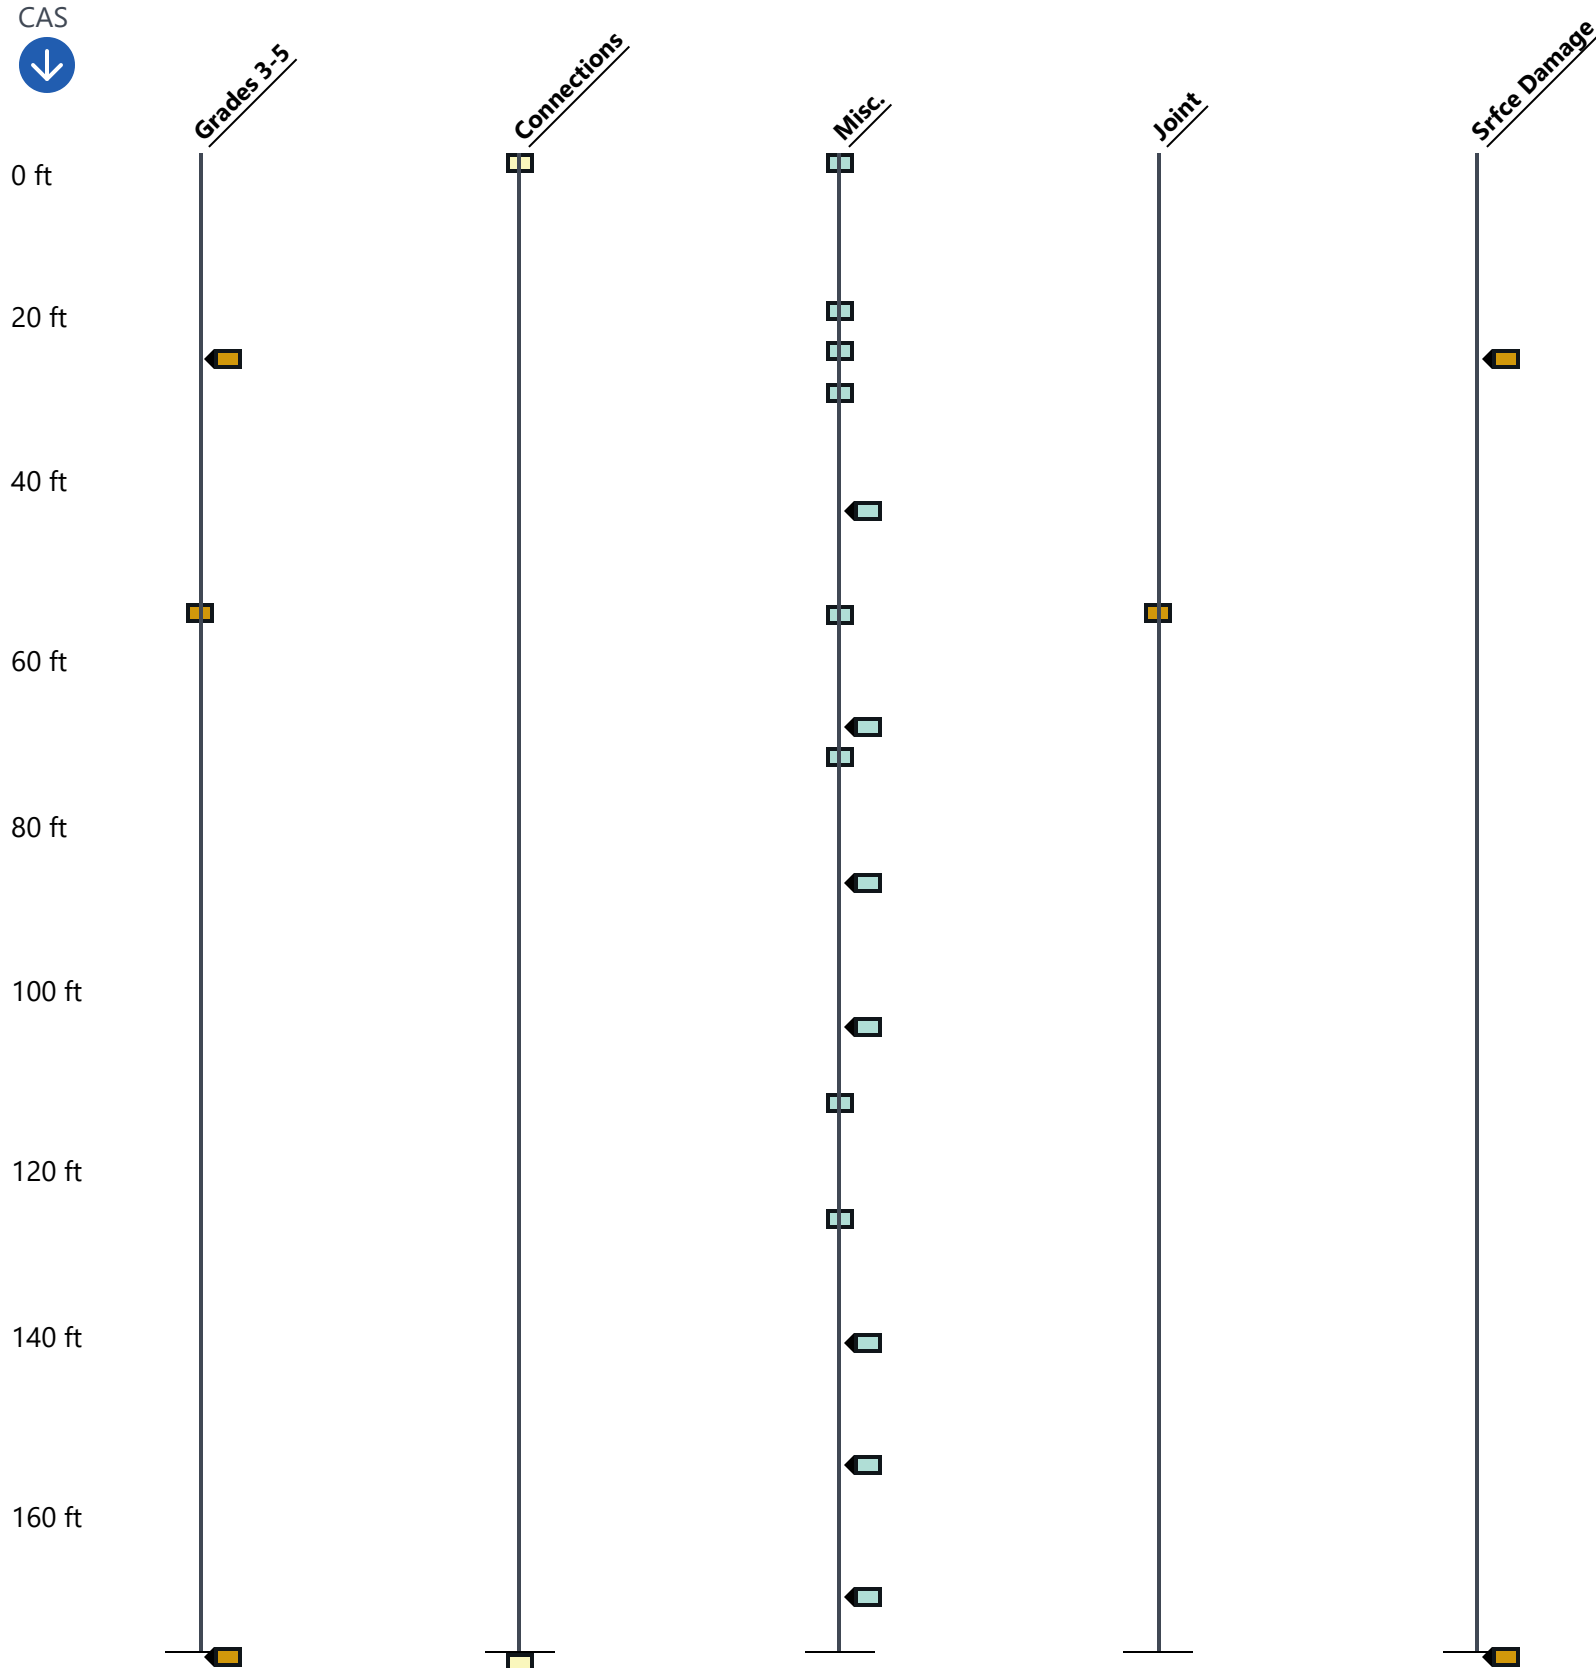
DATE: 7/22/2025  
 PIPE SEG REF. SSCO-01 to SSCO-02  
 UP MH: SSCO-01  
 DOWN MH: SSCO-02

| Dist | Time | Description | Code | Clock | Dim. 1 | Dim. 2 | % | Remarks | Cont. | Grade |
|---|---|---|---|---|---|---|---|---|---|---|
| 23 | 1:54 | Surface Damage Corrosion | SCP | | - | - | - | SURFACE CORROSION | S01 | 3 |

| Dist | Time | Description | Code | Clock | Dim. 1 | Dim. 2 | % | Remarks | Cont. | Grade |
|---|---|---|---|---|---|---|---|---|---|---|
| 175.1 | 8:51 | Surface Damage Corrosion | SCP | | - | - | - | SURFACE CORROSION | F01 | 3 |
