# New Hartford Public Schools Utilization Study- Facility Conditions Assessment

MARCH 25, 2026

Prepared for:  
**New Hartford Public Schools**  
**530 Main Street PO Box 315**  
**New Hartford, CT 06057**

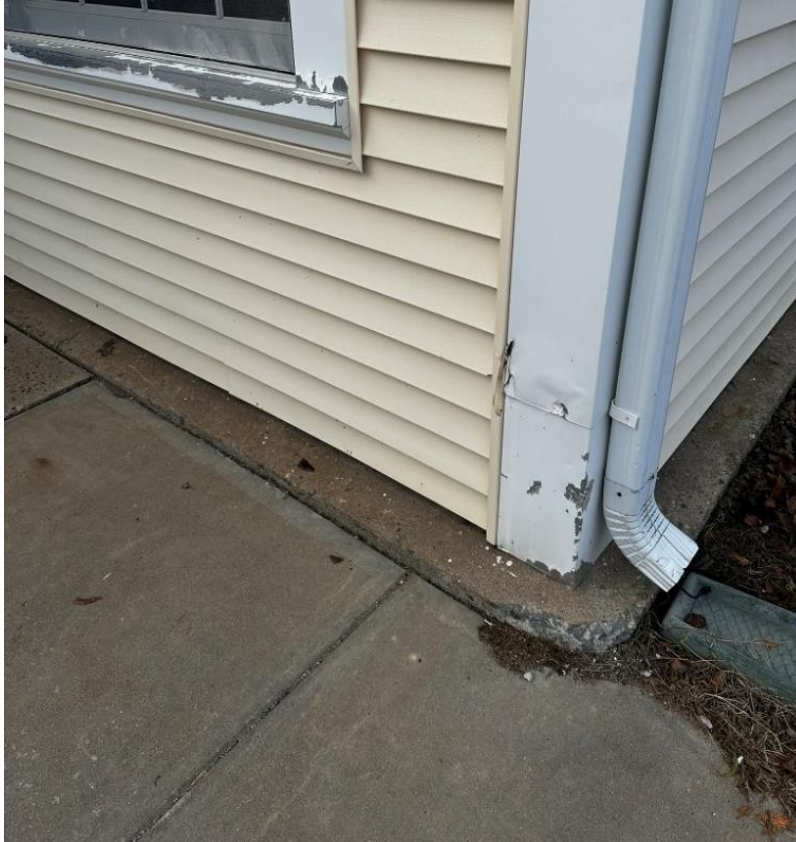
In several locations, the foundation projects beyond the plane of the wall — a non-typical condition that may allow water to pond at the base of the wall. While active infiltration was not observed, discharging downspouts directly onto these projections presents a concern.

Standard vinyl siding has an expected service life of 20–30 years. The siding appears approximately 25± years old and shows deterioration throughout therefore replacement should be considered in the near future. A siding replacement would also provide an opportunity to add continuous insulation and improved flashing to direct water away from the foundation.

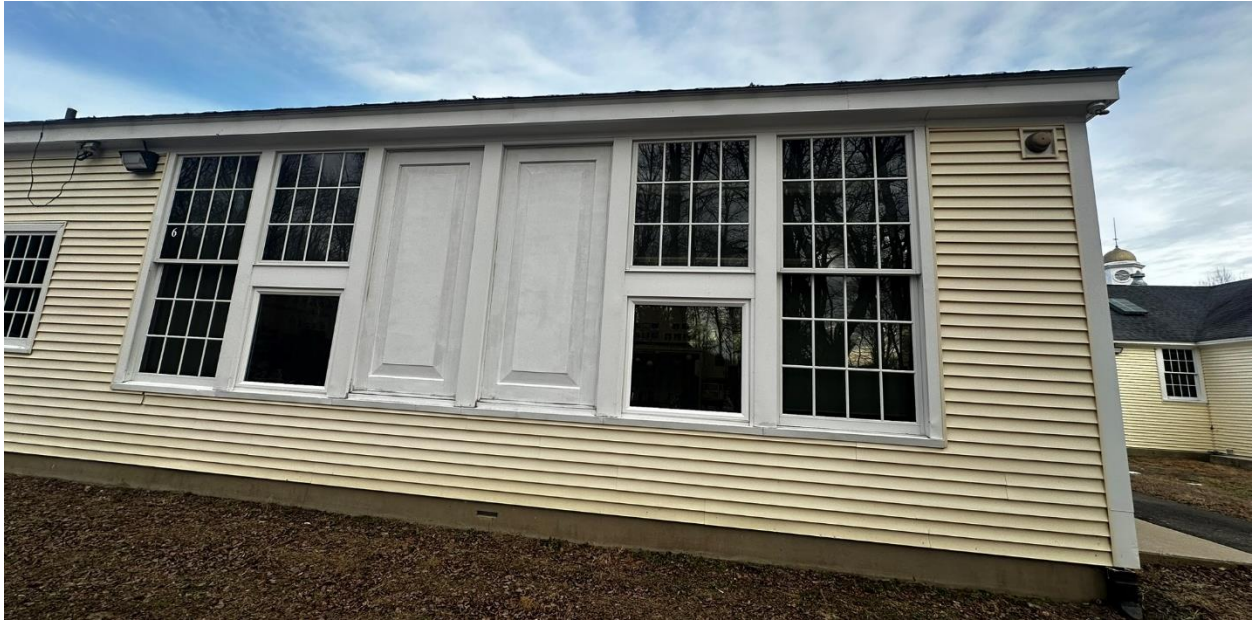
When evaluating the energy efficiency of a building, it is estimated that 25–40% of building heat loss occurs through windows. Based on archival references, the windows, siding, and roofing may have been replaced around 2002 during the modular addition; however, documentation is incomplete.

The windows are vinyl-clad wood, double-hung insulated double glazed systems. Each classroom also includes a casement window used as a secondary means of rescue which is required due to the absence of a sprinkler system at this school. These egress windows are not labeled, which while not mandated is recommended for clarity and safety compliance.

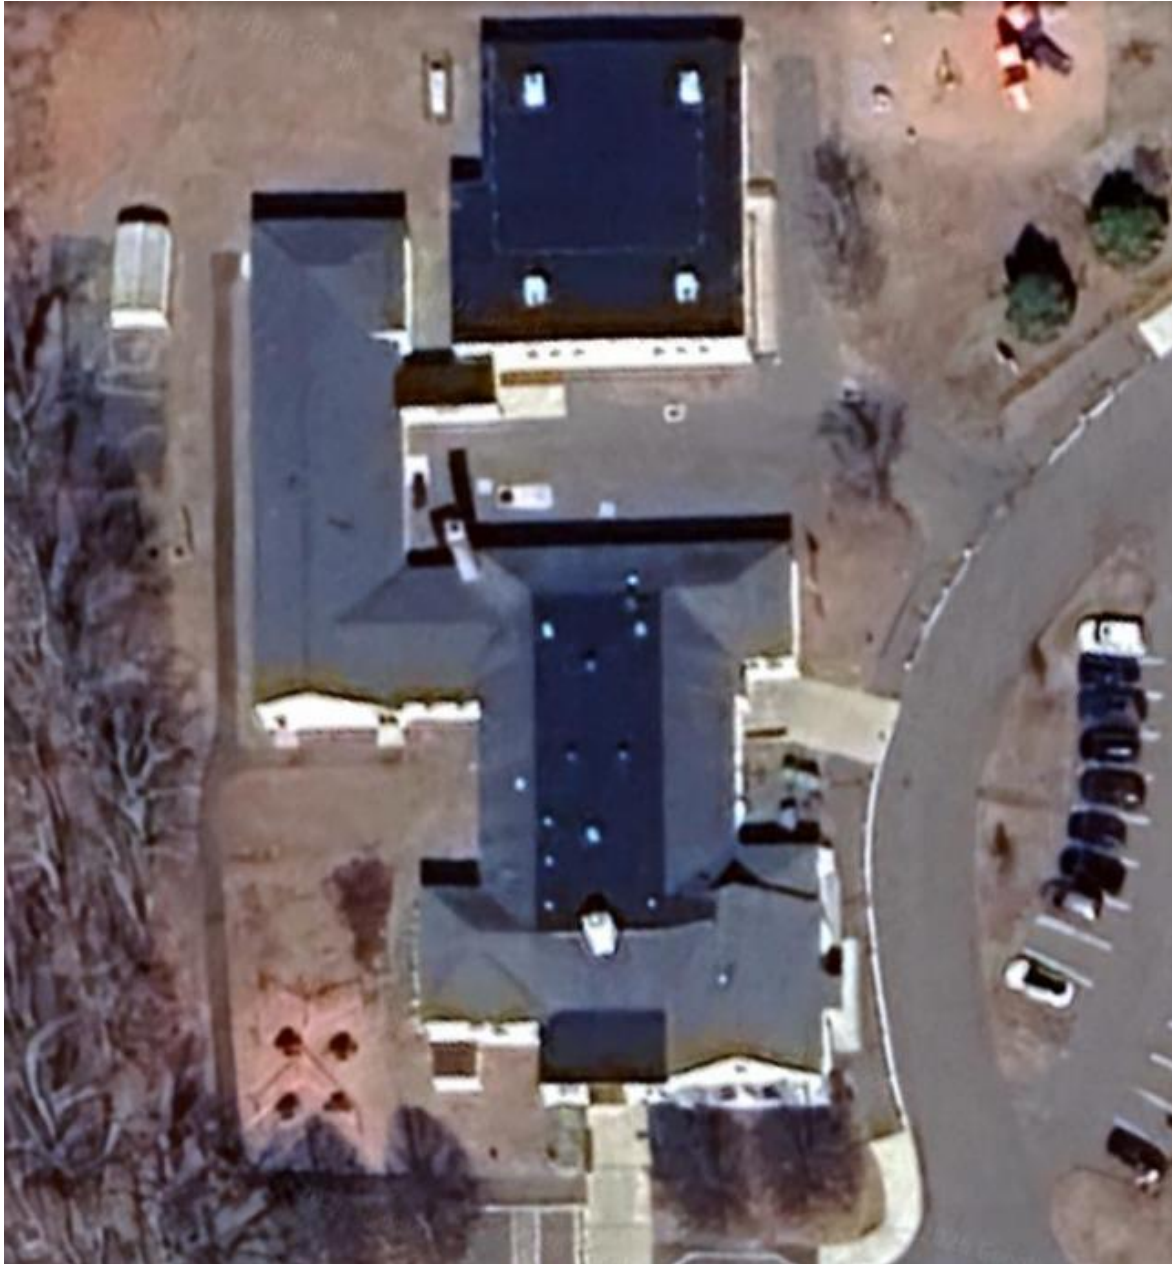
State records indicate roof replacement occurred around 2002. Due to weather and access limitations, roofs were not physically assessed. From ground observation, they appear generally serviceable. However, interior ceiling staining indicates possible active or historical leaks. Given their age, roof replacement should be anticipated in the near term.

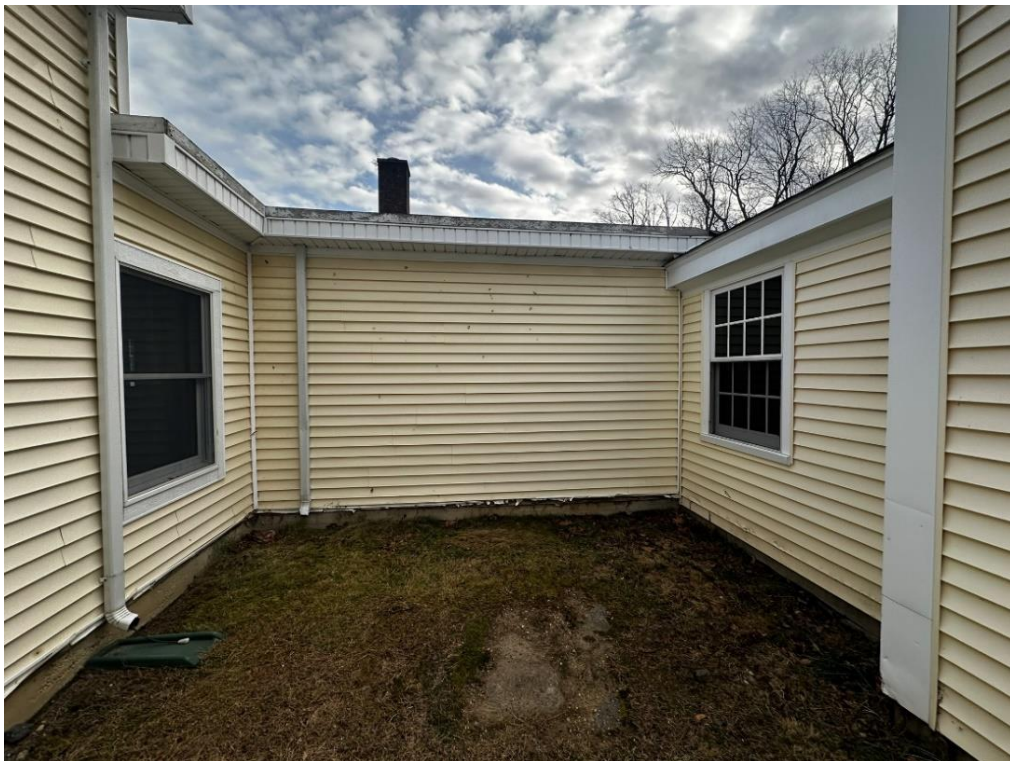
Gutters and downspouts are inconsistent throughout the perimeter. Some areas lack drainage entirely. Downspout terminations vary. Some terminate at splash blocks or underground piping. Many direct discharge at pavement and some over foundation projections as previously noted. The latter condition is particularly concerning. Improved perimeter drainage, including gravel edge strips and potential French drain systems, should be considered during roof replacement.

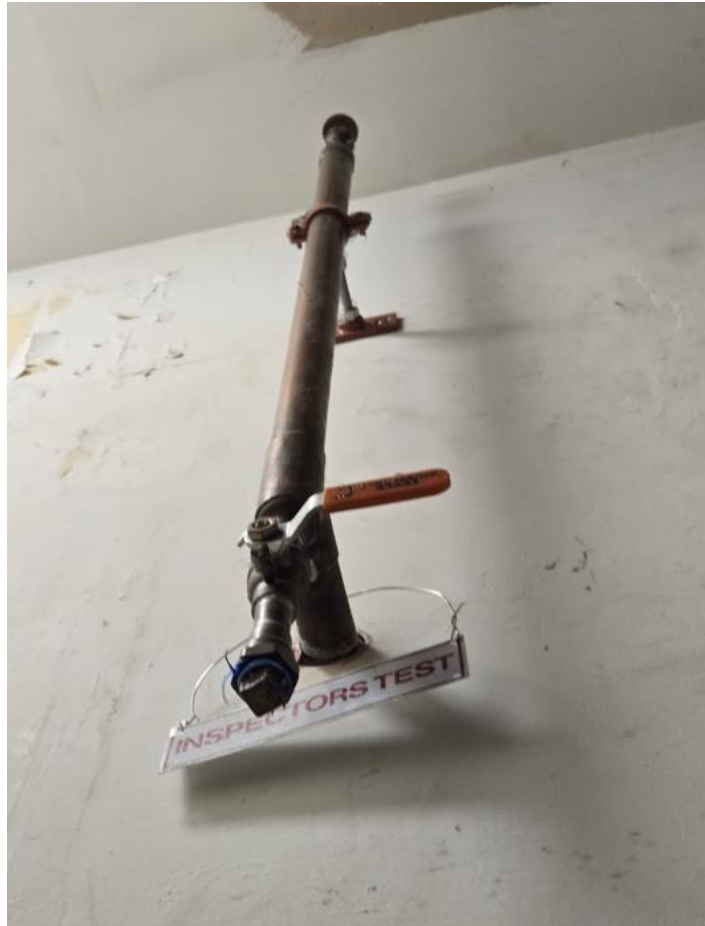
An approximately 400 SF Stage has been repurposed to a Resource room. This raised room is comprised of combustible material and space underneath should be rendered unoccupiable – non storage and classified as combustible concealed space if it cannot be retrofitted with a limited area sprinkler system. Note that further investigation is required to determine compliance with the existing stage structure, NFPA 13, and the International Building Code regarding hydraulic calculations and existing system storage capacities.

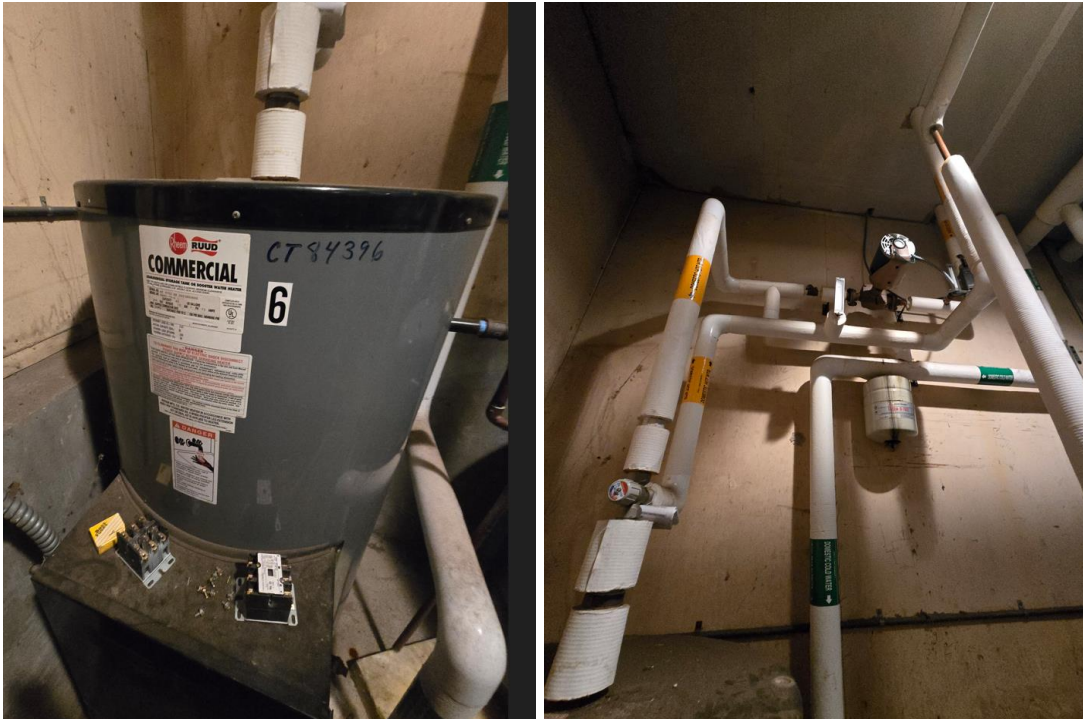
The Kitchen is provided with a dedicated 119-gallon water heater which was installed on 7/25/06, manufactured by Vaughn 240 V, 119-gallon 4500W upper element, 4500W lower element. A thermostatic mixing valve nor thermal expansion tank were provided. The unit is 20 years old and has a short life expectancy. Limited insulation has been provided but does not meet IECC / IPC requirements for continuous pipe coverage.

It is recommended to replace the existing electric water heaters in kind as they are both nearing or past their serviceable life expectancy.

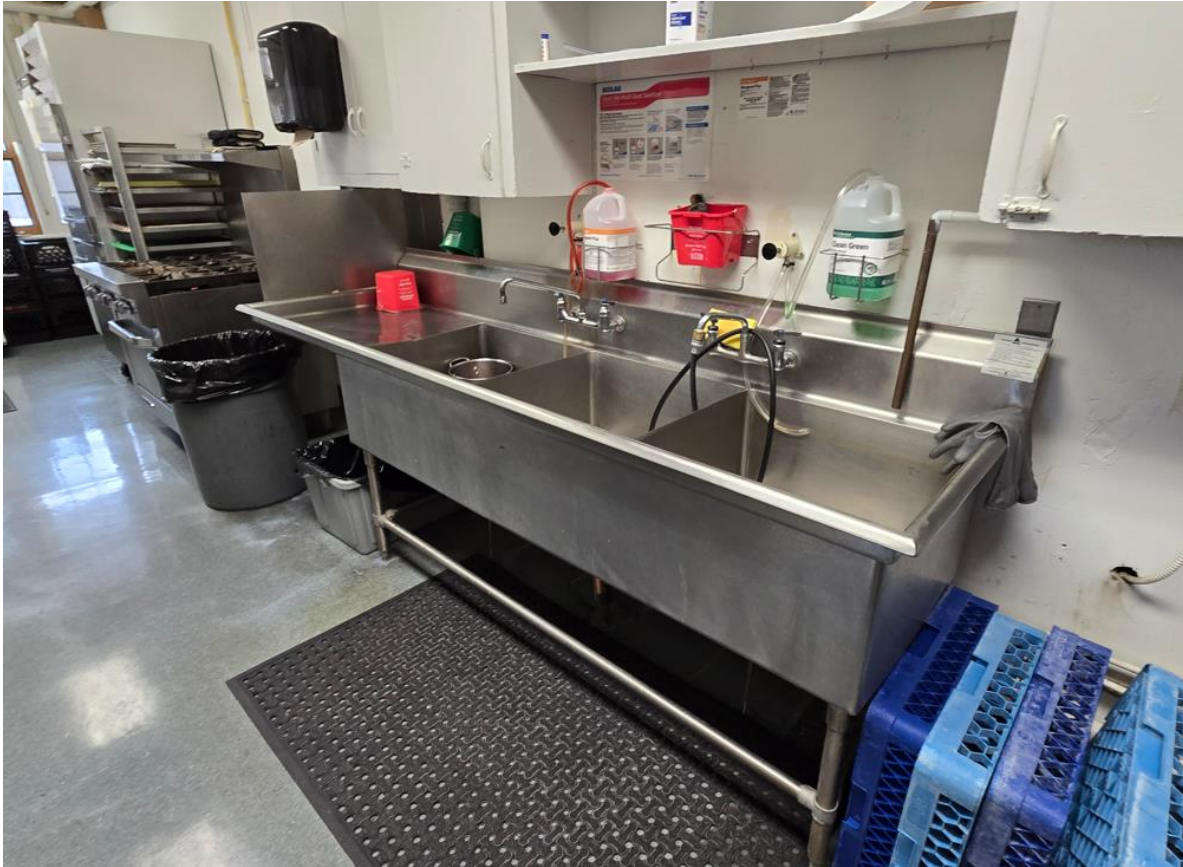
A hand sink with thermostatic mixing valve has been provided accordingly, the supply piping is loosely insulated with Armaflex elastomeric insulation.

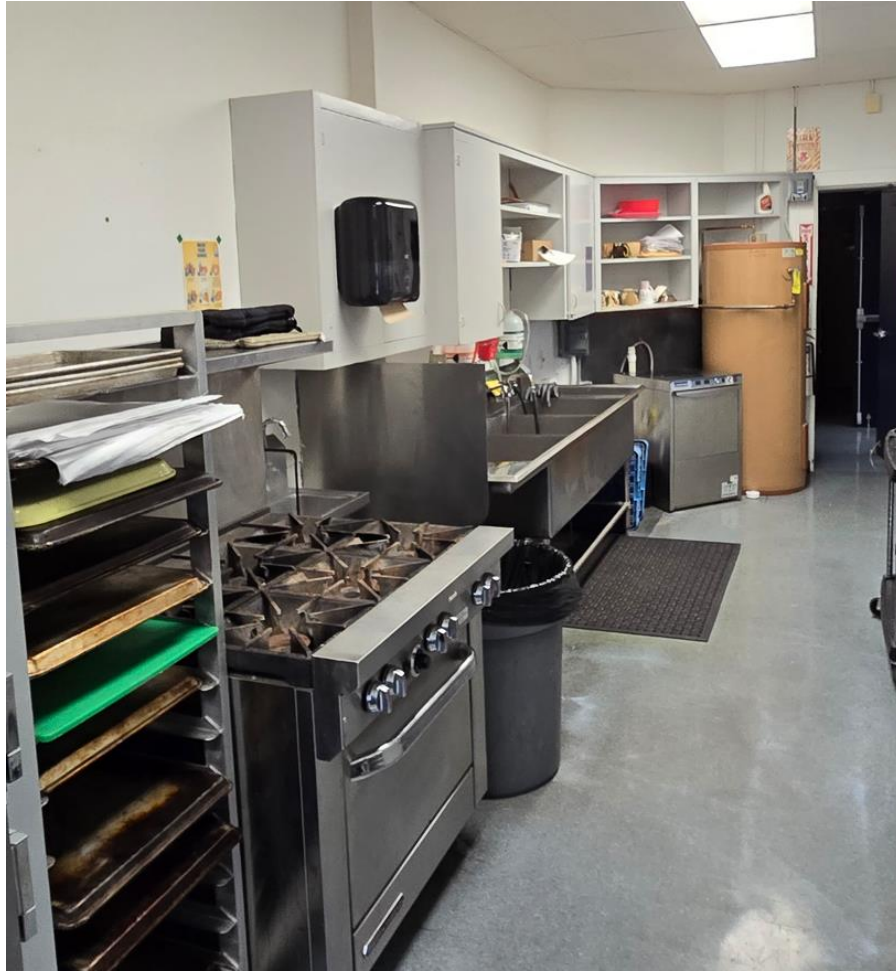
Based on information provided by the facility staff, the kitchen is for warming only, although to determine compliance with current codes, it is recommended to verify corresponding kitchen classification (I, II, III, or IV).

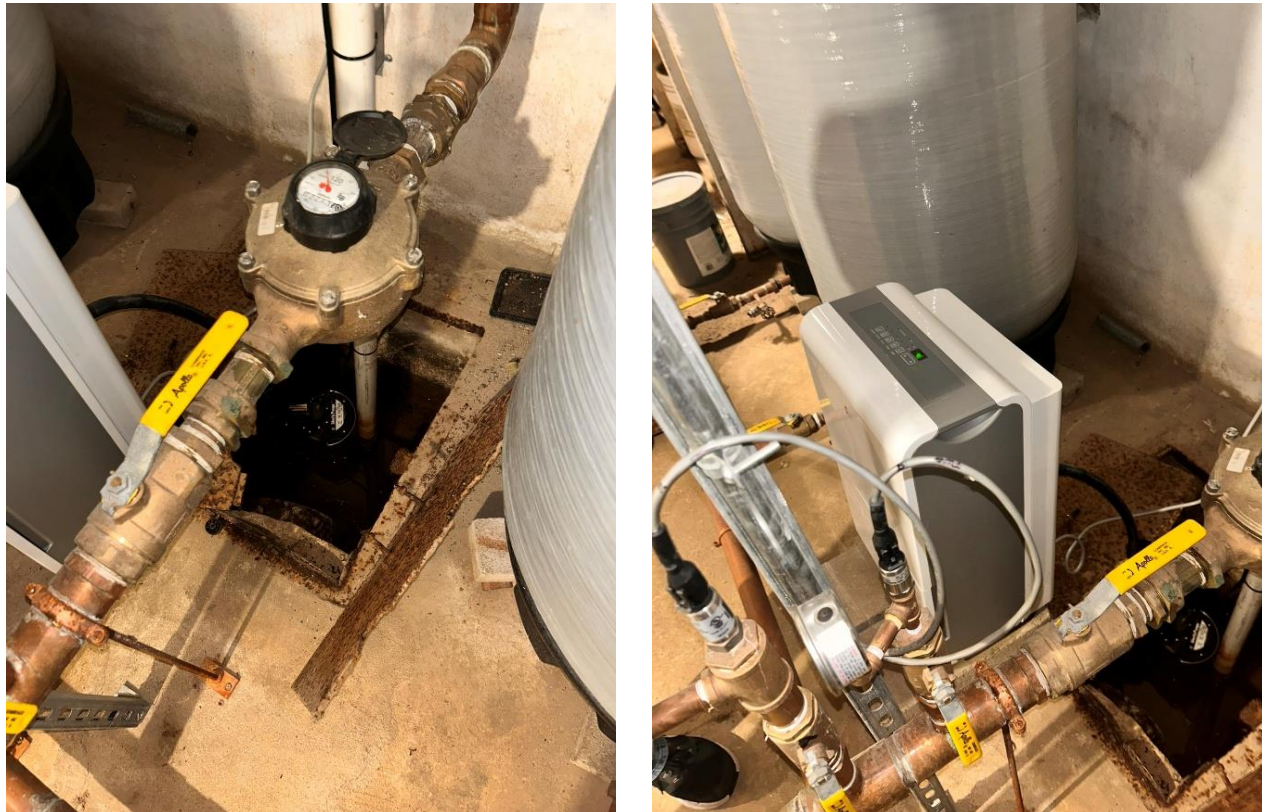
There are well pumps, a tank and equipment in the basement with open areas of water. Open water can evaporate in warm conditions and increase the overall humidity of a space. There is a residential-grade dehumidifier in the basement that is presumably there to control the humidity in the basement and decrease the likelihood microorganisms and materials damage.

SP+A recommends installing a commercial-grade dehumidifier with a floor drain connection to ensure the humidity is controlled in the basement. This configuration would be more efficient and reliable because equipment is sized adequately for the moisture present in the open water areas as well as the from the ground.

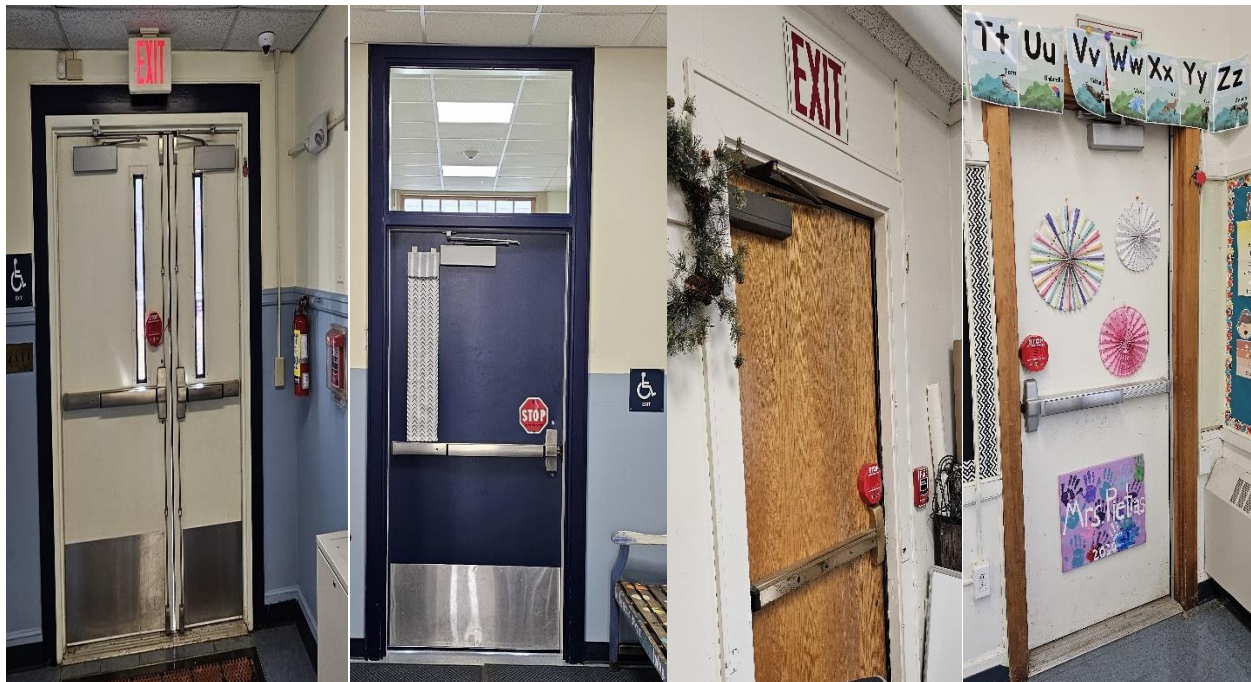
The exit light fixtures are LED with thermoplastic housing throughout the facility. There were no exit light fixtures at main entrance doors and exterior emergency egress door from speech room. Most exit light fixtures appear to be in good condition.

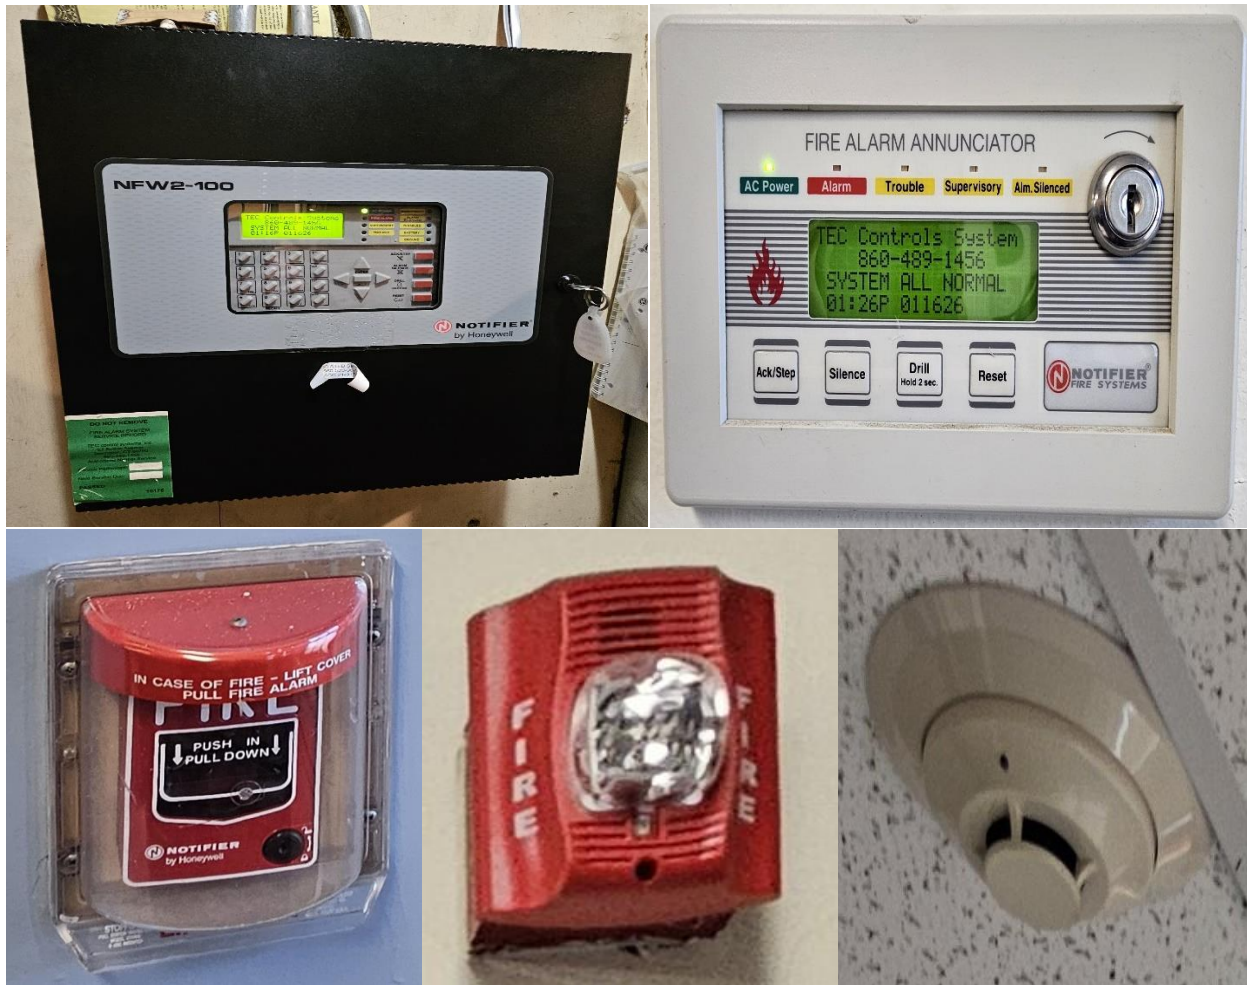
The building addressable fire alarm system is manufactured by Notifier/Honeywell. The main control panel is located in the basement with an annunciator panel at the front entrance. The equipment is in good condition. There are pull stations at egress doors, as well as smoke detectors and notification devices throughout the facility. Fire separation doors with magnetic door hold open devices are wired into fire alarm system for release upon fire alarm activation. Most devices appear to be in good condition. Exterior emergency egress door from speech room does not have a pull station.

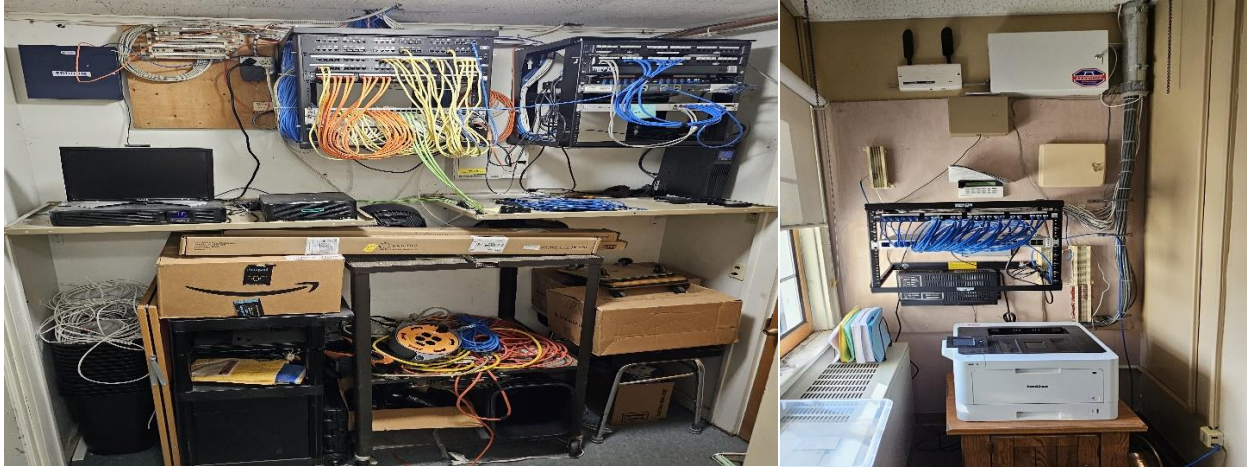
There is a main network rack located in passage between gym/café and old stage storage area. This area is not enclosed and temperature controlled suitable for data networks. Network and wi-fi equipment appear to be regularly upgraded and no significant issues were reported. The building is served by a new cloud-based VOIP telephone system which was installed in 2024. The intrusion detection system manufactured by Gemini is in the main electrical room and serviced by Associated Security has been recently upgraded. Video surveillance cameras and access control are by Verkada. These are in good condition. The building has a lockdown system with panic buttons accessible to staff. The Program Time Controller panel located in main office, which is manufactured by Standard Faraday is active and appears to be in good condition. The public address system is reported to be fully operational but is at least 15 years old. Promethean interactive instruction boards are installed in all classrooms and are in good condition.

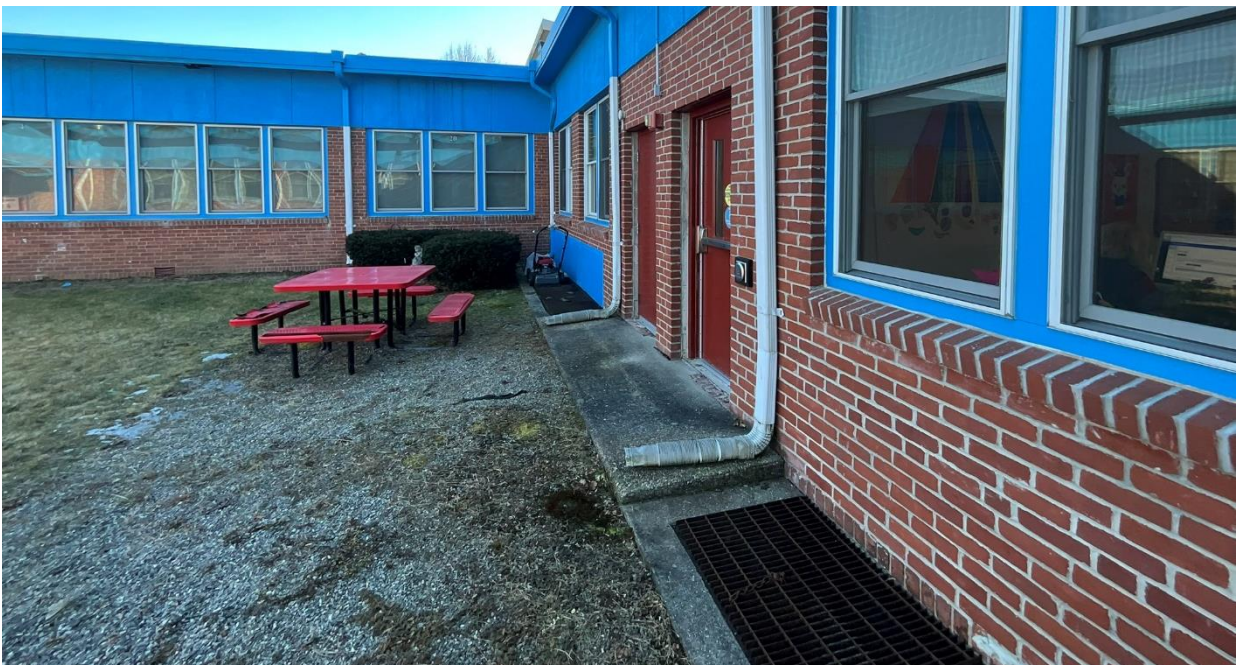
Perimeter drainage conditions vary. Downspouts discharge inconsistently, with some piped underground and others discharging directly at grade, with or without splash blocks. The site would benefit from a coordinated perimeter drainage strategy, potentially including gravel drip edge strips, improved discharge control, and consideration of French drain systems. These improvements should be evaluated in conjunction with future roof replacement work.

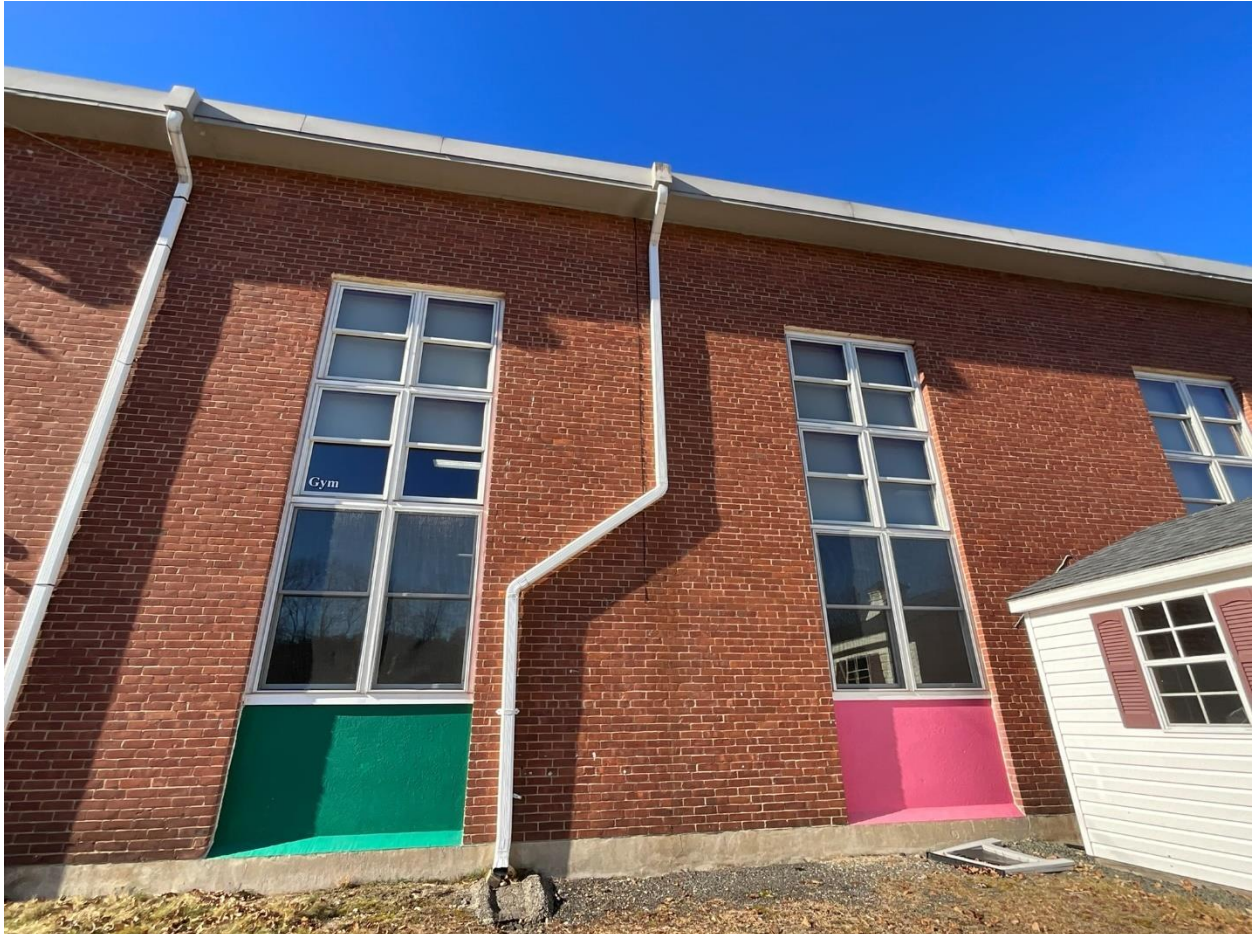
The original building is primarily constructed of brick masonry and is generally in fair condition considering its age. The structure utilizes a brick veneer system without an air cavity, a common construction method in the early 1950s prior to modern energy code requirements. As a result, the wall assembly provides limited thermal performance, and improving its energy efficiency is not easily accomplished without significant intervention.

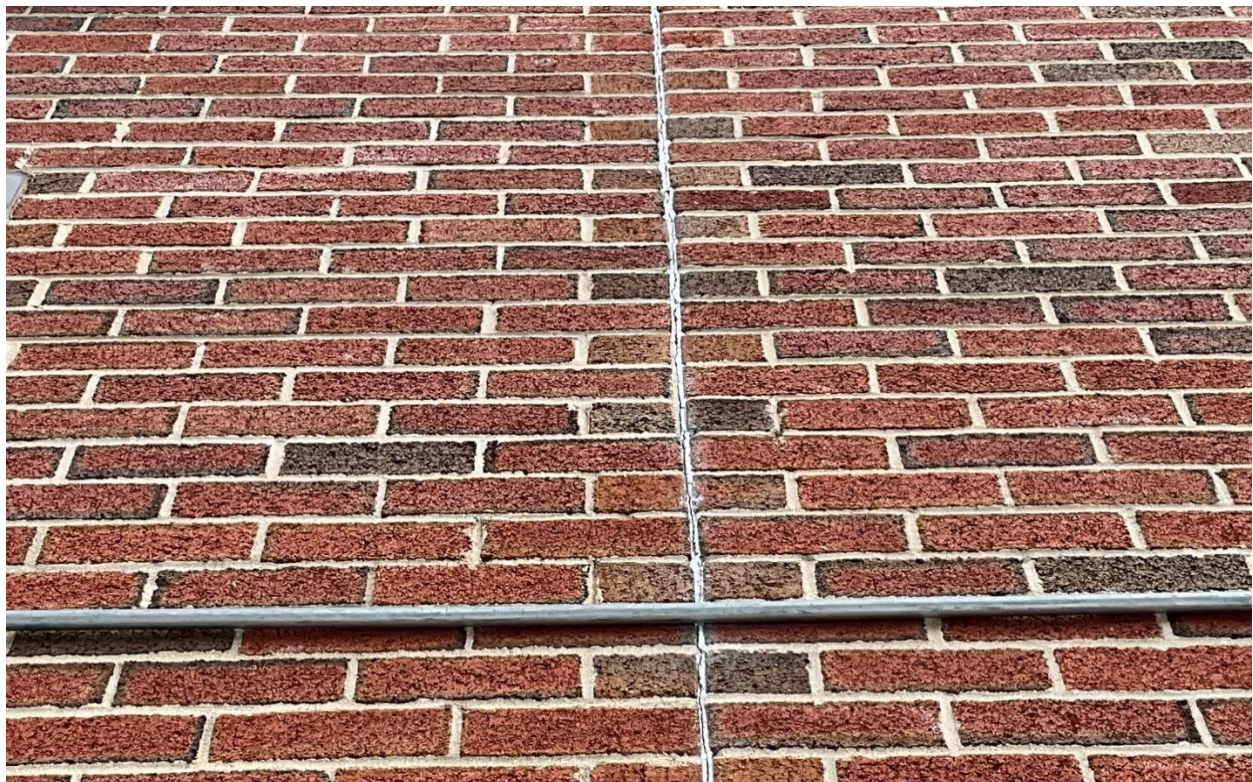
There was minor efflorescence noted in a few areas of the façade. It's very common in brick veneer and no major issues were associated with it. It should continue to be monitored and cleaned.

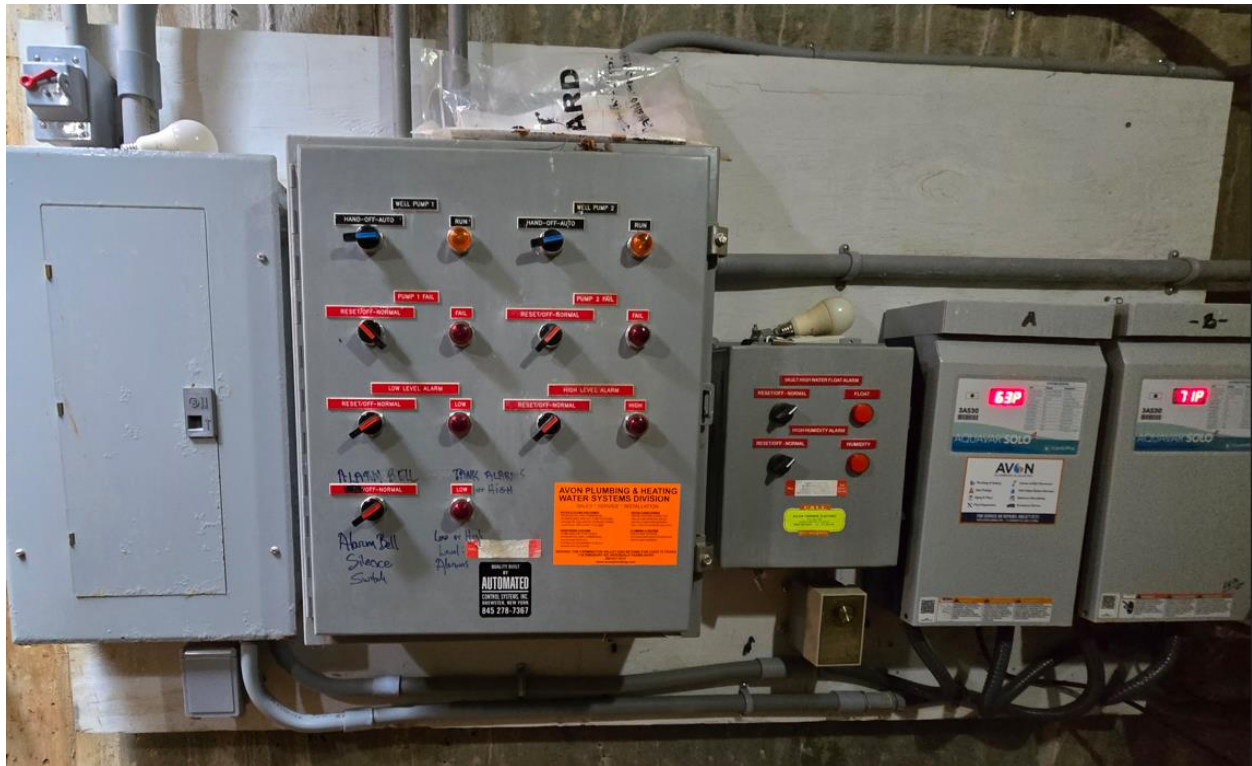
Piping consists of sweated copper joints which have developed a patina, ball valves are installed and exposed metal is rusting. Pipe insulation has not been provided. A residential dehumidifier has been provided and discharges to a floor drain. Humidity is a concern as it affects the electrical controllers and level sensors.

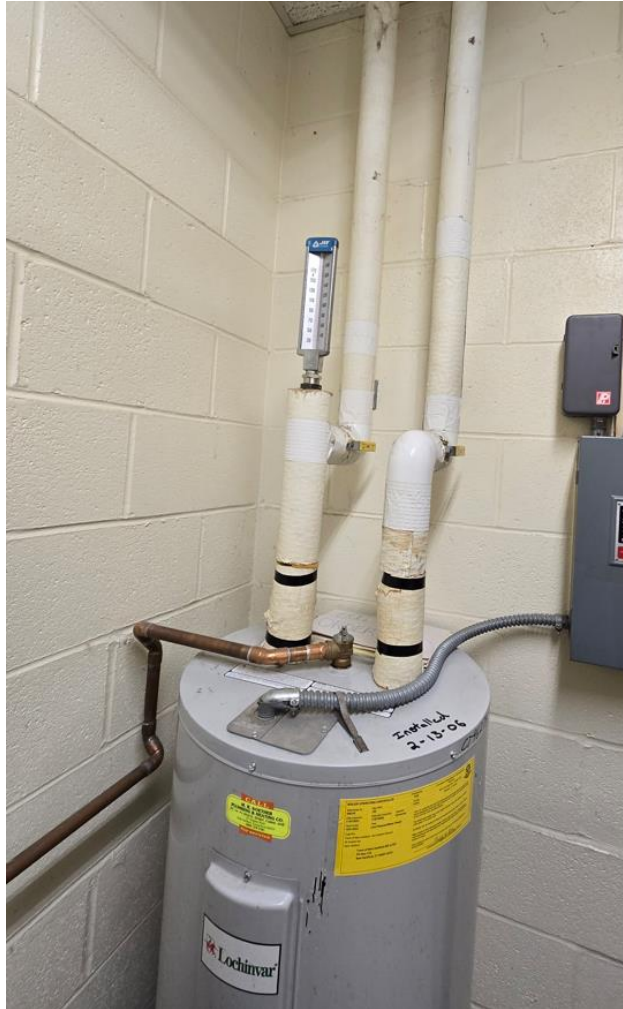
All the water heaters (except the unit serving the nurse area) pressure relief valves are piped to the floor where cups or buckets are placed under them, this indicates that the system is over pressurizing and relieving excess pressure. Thermal expansion tanks are required to eliminate nuisance discharges and or hazardous situations.

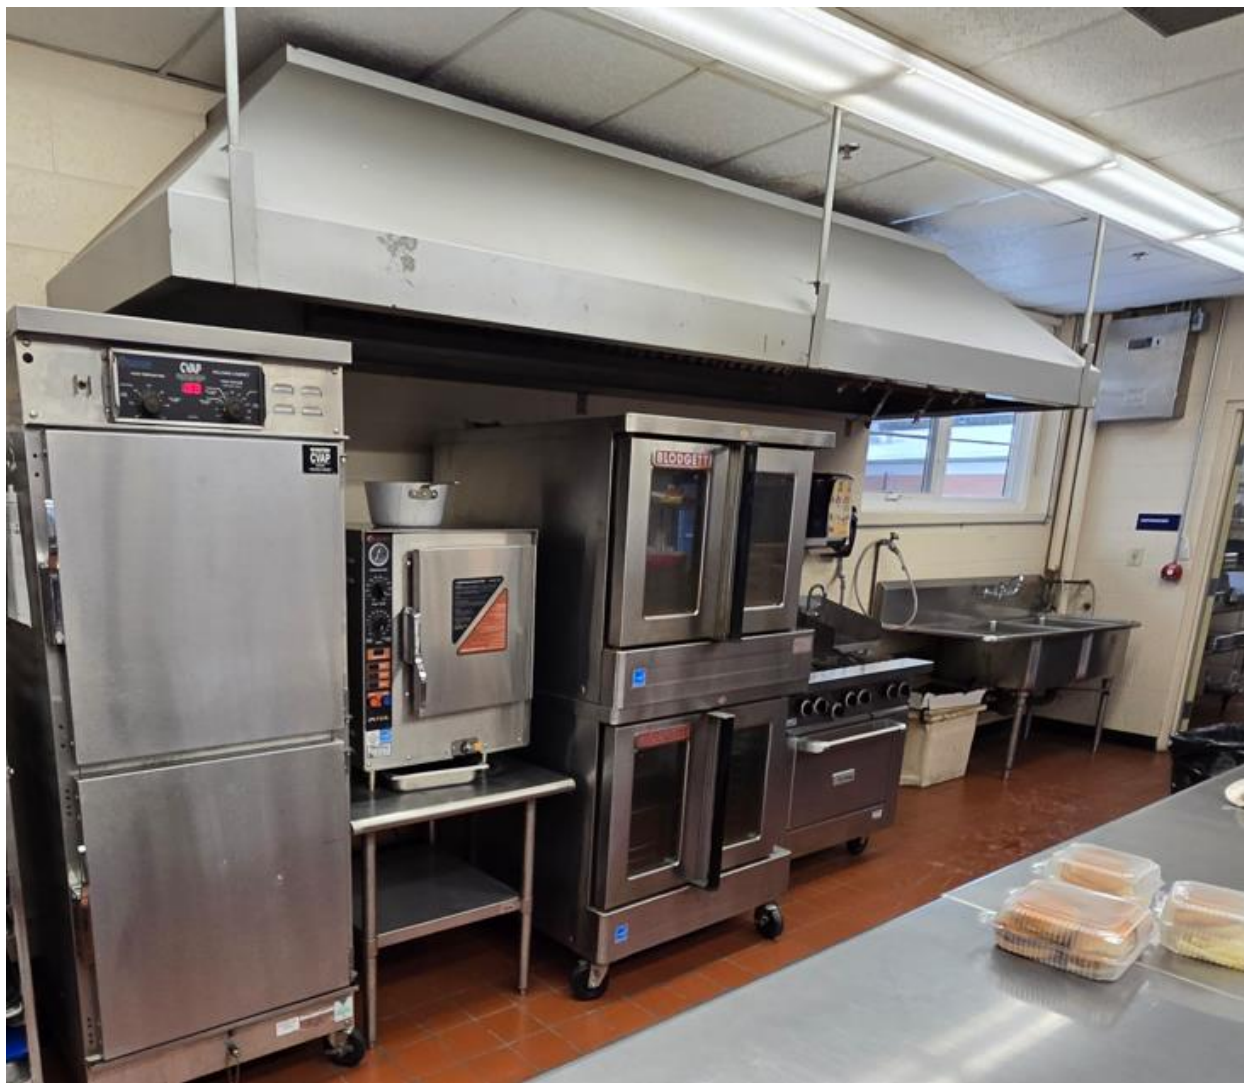
The current grease interceptor is a non-automatic passive type and appears to have been installed at the time of the original construction.

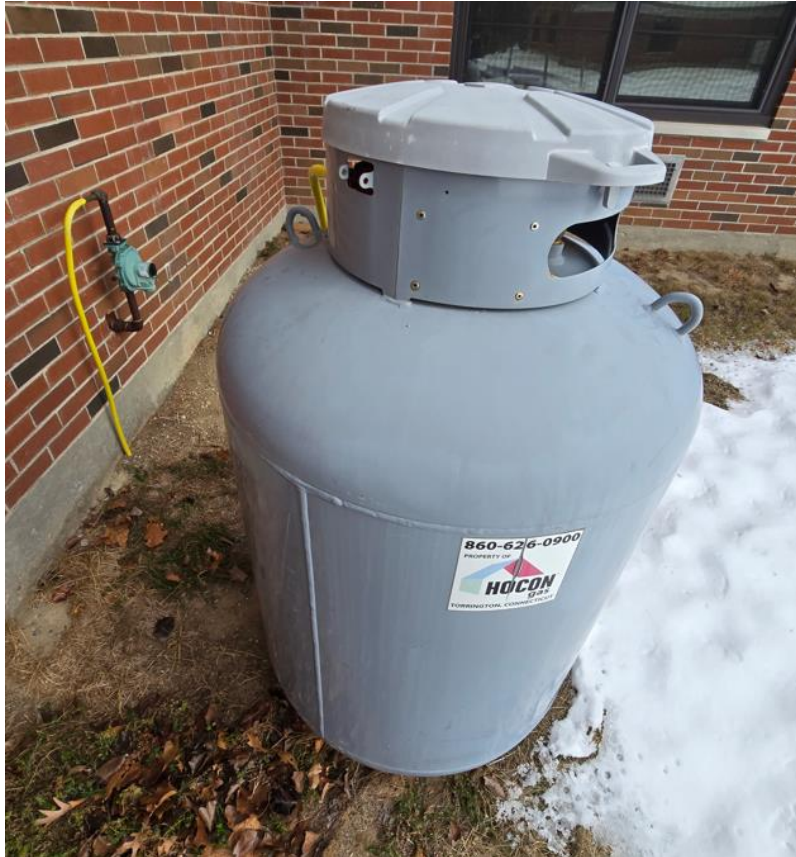
Exterior piping is unpainted threaded Sch. 40 black steel and is heavily corroded. Interior piping is the same material, just not corroded.
