RE: *SSCPS Drainage Repair*
100 Longwater Circle, Norwell, MA 02061
CHA Project: 105876
wheuer@sscps.org

Trench Drain Inspection and Recommendations

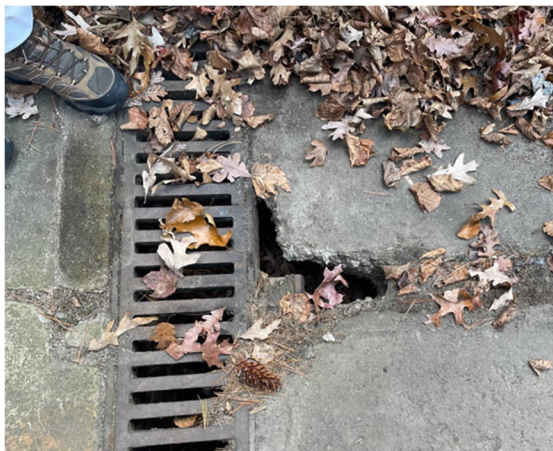
The existing trench drain structure exhibits failure of the side wall underneath where the concrete pad has been undermined (see picture below). Inspection of the trench drain interior indicated that some debris from the concrete and brick structure of the trench drain sidewall has fallen into the trench drain. There appears to be some undermining of the soils around the trench drain approximately 2-3 feet from the sidewall. Unfortunately, it is not clear the cause of the erosion. The cast iron grate is in relatively good condition for its age and with repair could potentially continue to be utilized.

We would suggest that the trench drain be exposed through cutting and removing the existing concrete slab approximately 3 to 5 feet from the edge of the drain outward towards the undermined area. This would allow a better inspection of the condition of the eroded sidewall and undermined area. Removal of the grates would allow for inspection of all sidewalls from the interior perspective. When the concrete has been cut and removed and the grate removed, CHA will perform an inspection. The inspection of the exposed sidewall will allow for further evaluation of the existing structure to try to determine the cause of the failure and determine if additional corrective actions are required.

If no additional corrective actions are required, we would suggest the sidewall be repaired by providing a new concrete and bricked sidewall to support the existing frame and grate. The eroded subgrade would be replaced with compacted structural fill and then the concrete pad replaced with a matching concrete surface thickness. We would also suggest cleaning out the seams of the concrete and sealing with an elastomeric concrete seam sealant product.

If total removal and replacement is determined to be necessary, then it would be suggested to cut out the existing trench drain to approximately 3 feet beyond the edges on all sides. This option would allow CHA to inspect the area for any instance of undermining beyond what can be seen currently. There may be some undermining on all sides which cannot be ascertained from the initial inspection. Full replacement would require a new concrete trench drain base to support a new cast iron frame and grate system. Any areas of erosion would be filled with structural soil base and compacted prior to replacing the concrete slab to match existing. Then all concrete seams should be cleaned, and the seams be sealed with an elastomeric concrete seam sealant product.

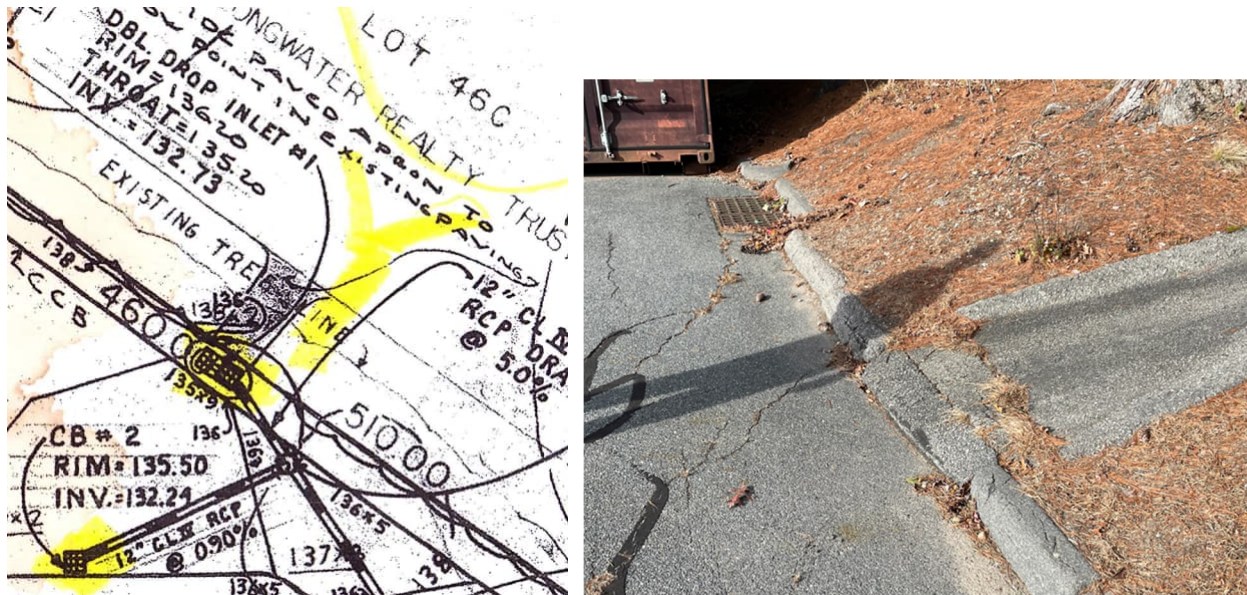
While out on the site inspection, an evaluation was performed of the drainage condition of the adjacent commercial building parcel 104/106 Longwater Drive draining directly onto the site. The roof area for the two buildings as well as the parking lot between the buildings drain onto the SSCPS parcel. Generally, the stormwater runoff is directed towards the site via grading in the paved area towards a double-grate catch basin proximate to the paved swale between the two parcels. In reviewing the drainage design plan, a double-grate catch basin was designed to be located at the discharge point of the swale. The on-site condition does not reflect the design plan (see below) with the double-grate catch basin offset from the paved swale.

The original drainage design was likely to control the runoff from the adjacent parcel and alleviate issues when the adjacent parcel drains onto the site. We would suggest installing a double-grate catch basin with 12" HPDE outlet at the bottom of the paved swale to collect and convey the water from the adjacent parcel to the adjacent manhole. The downstream drainage system was designed with 18-inch pipes and already conveys the offsite stormwater runoff drainage collected either through the adjacent double-grate catch basin (shown in the picture), the adjacent single-grate catch basin on the opposite side of the driveway, or the trench drain should those other two be clogged or overwhelmed with flow.
