Operations & Maintenance Plan

Bioretention / Raingarden

BMP ID
Owner Minneapolis Public Schools
Date xxxxx

Location Ramsey Fine Arts Magnet
Inspector Metro Blooms

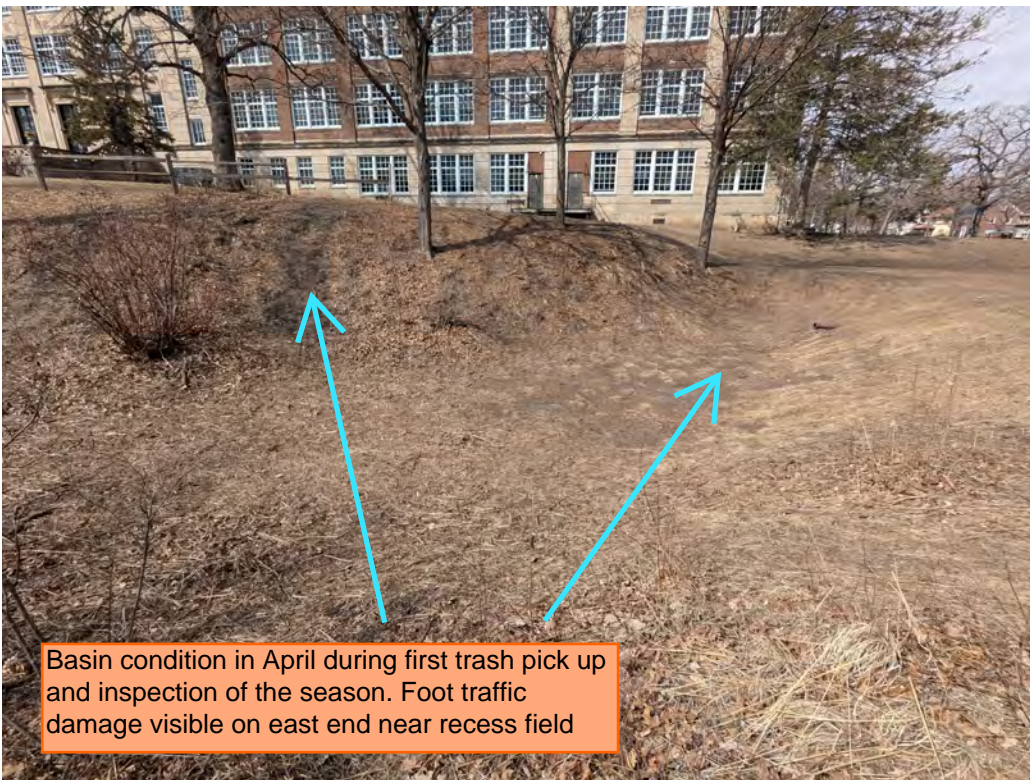
Basin condition in April during first trash pick up and inspection of the season. Foot traffic damage visible on east end near recess field

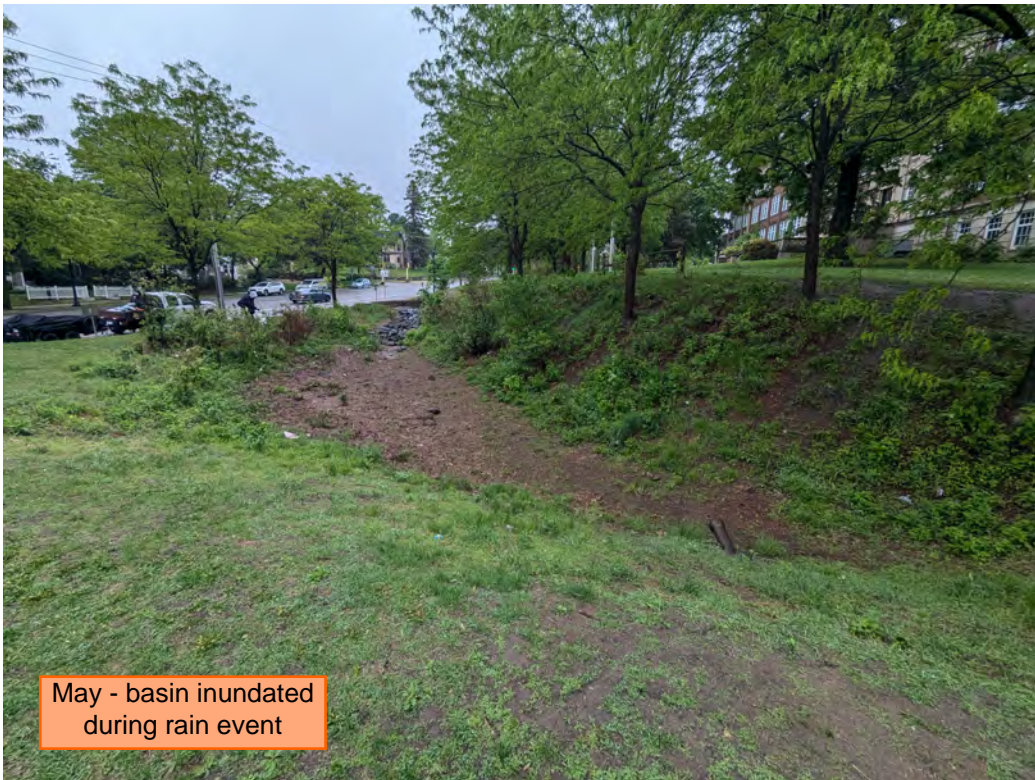
May - basin inundated during rain event

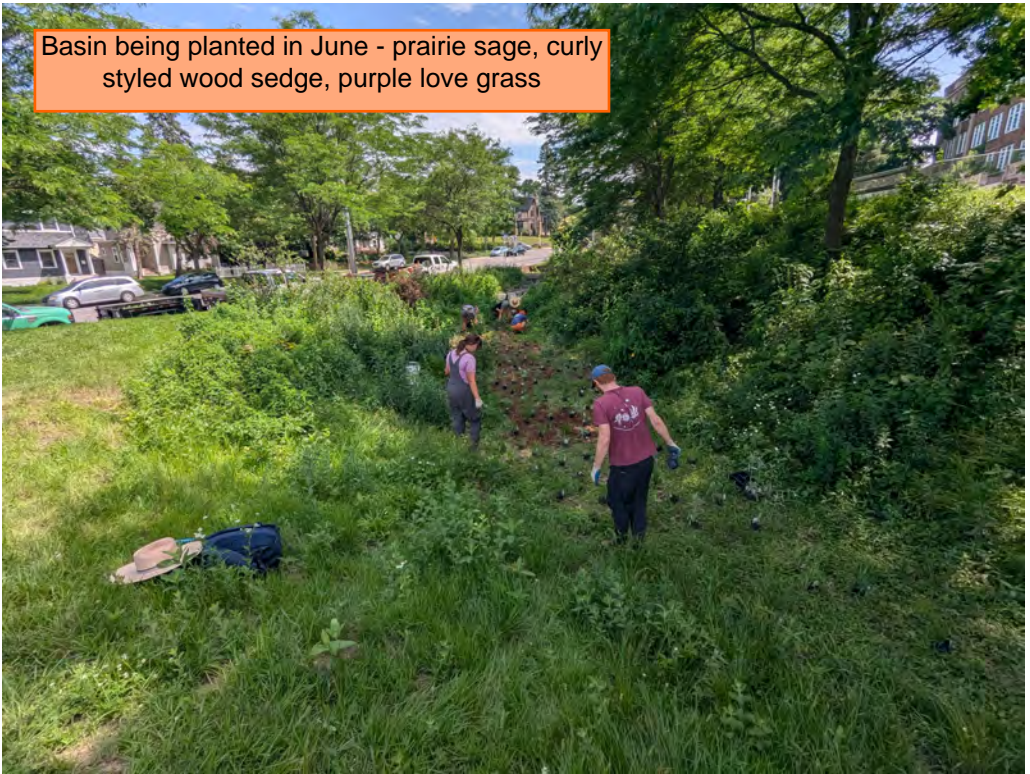
Basin being planted in June - prairie sage, curly styled wood sedge, purple love grass

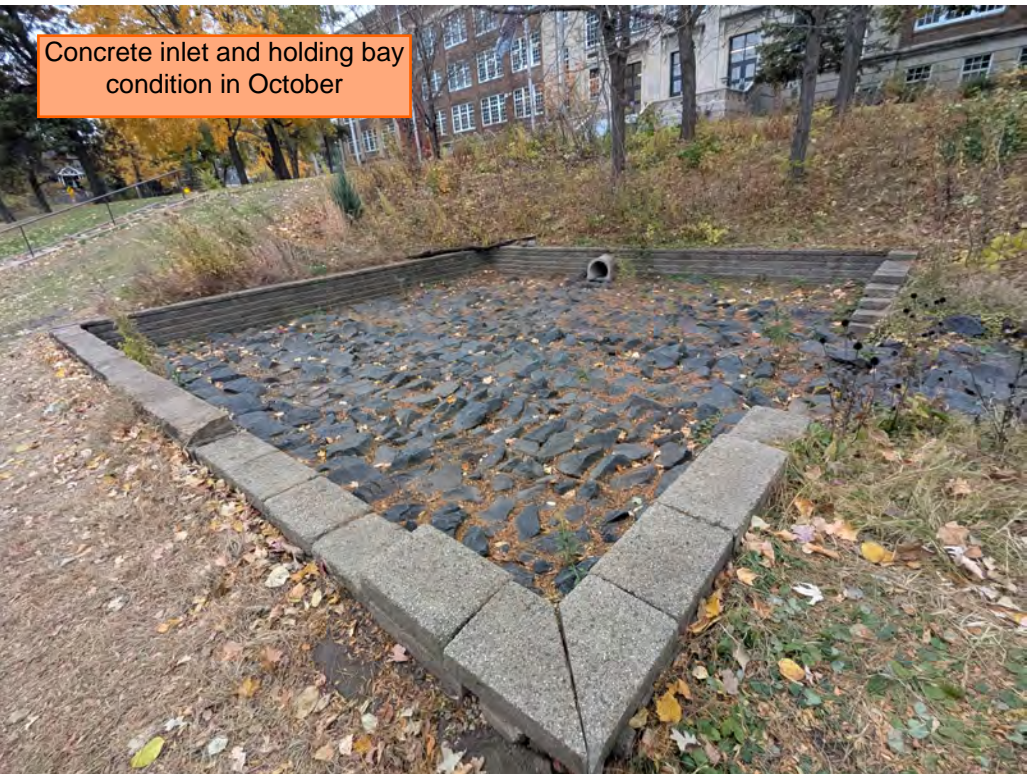
Concrete inlet and holding bay condition in October

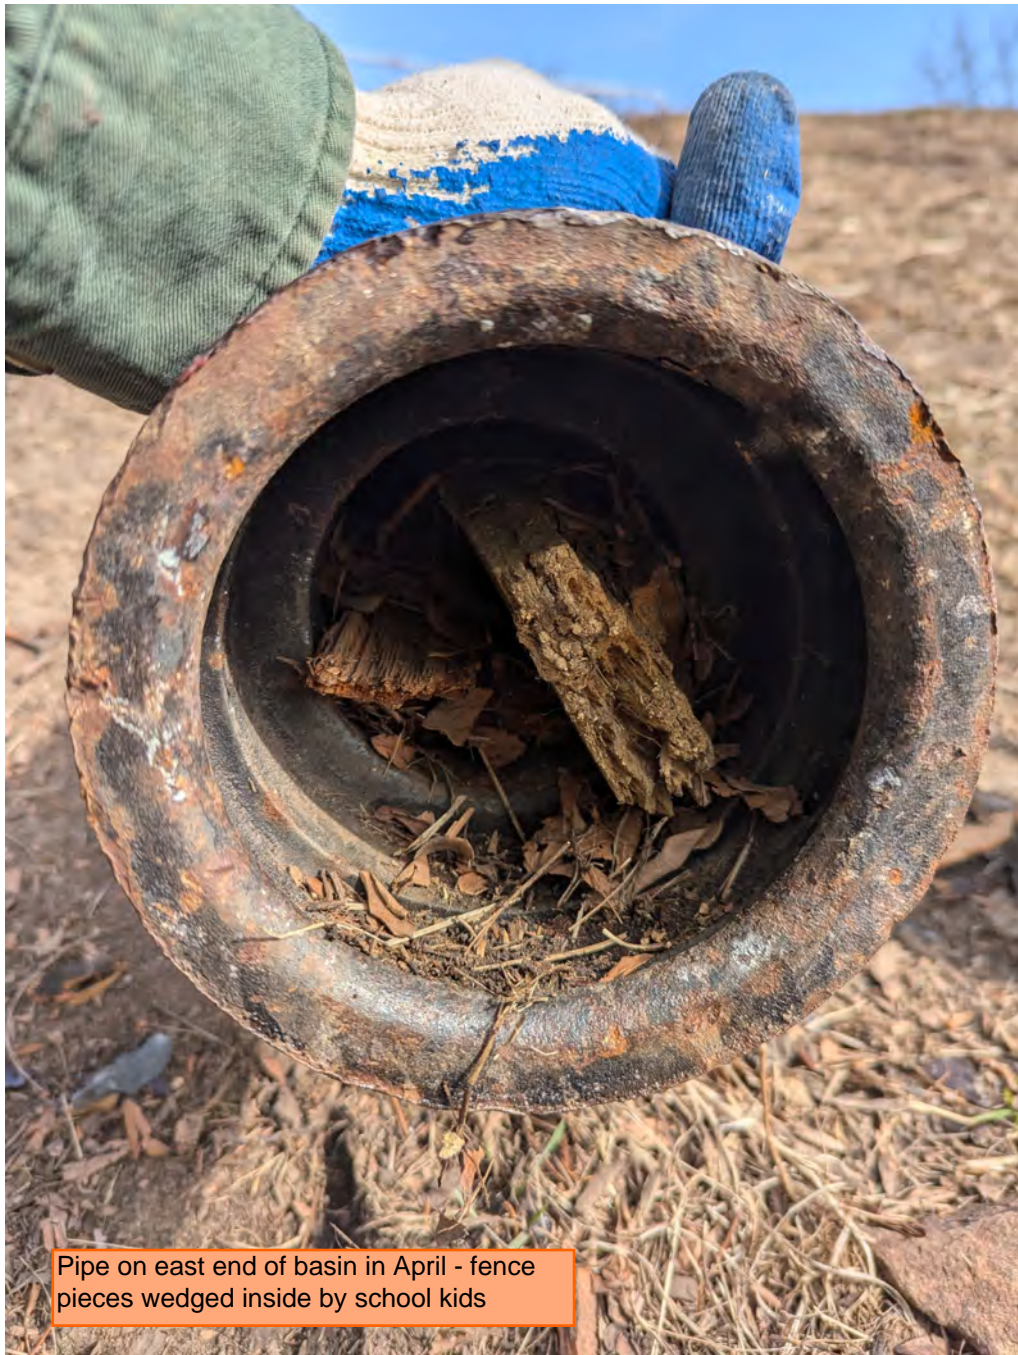
Pipe on east end of basin in April - fence pieces wedged inside by school kids

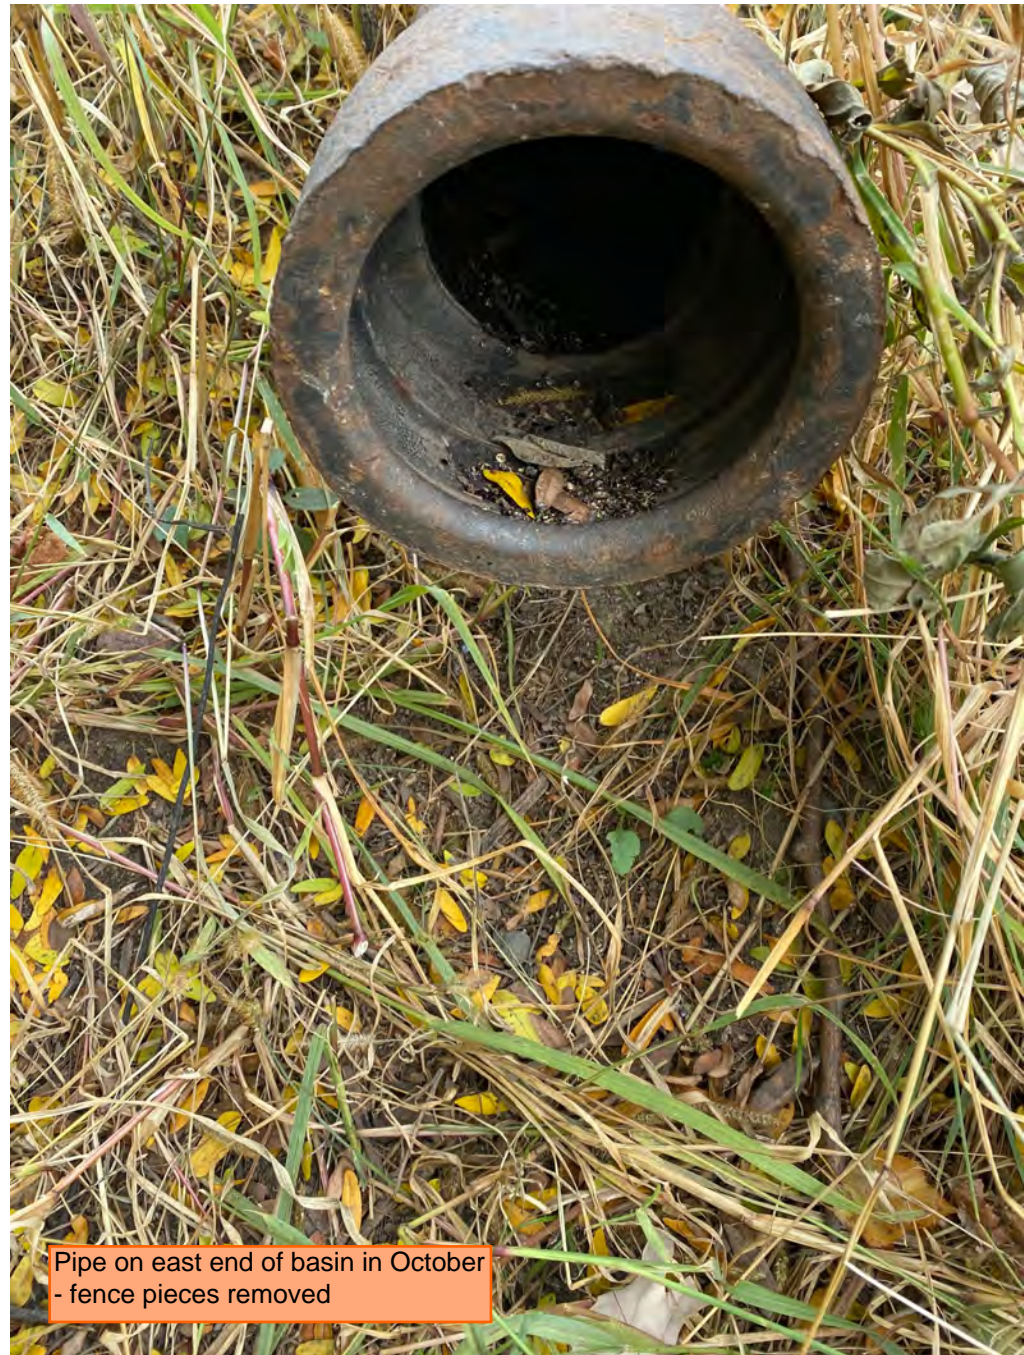
Pipe on east end of basin in October - fence pieces removed
