Underground Infiltration Chambers (parking lot)

Davis Educational Service Center
 1250 Broadway Ave W,
 Minneapolis MN,
 BMP ID: 8453

Stormwater Planters (in front of building)

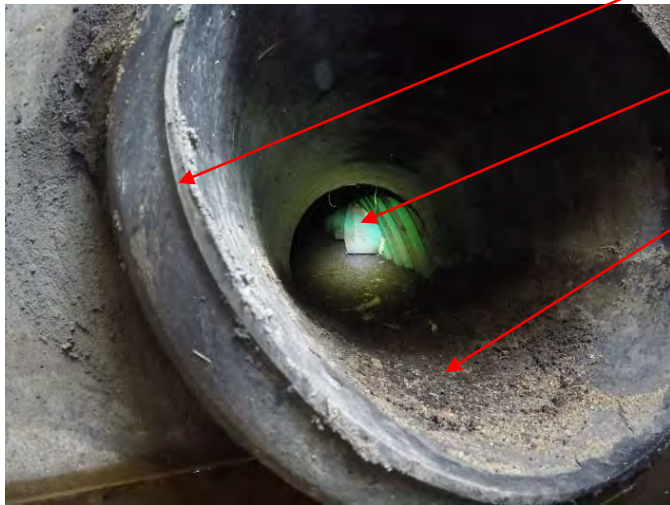
Picture from manhole access point

Distribution chamber rows

Sediment building up in header row, North chamber system

Sedimentation: Visual inspection of Header Row for sediment accumulation		Metro Blooms will advise Davis Center staff when a professional maintenance vacuuming service is needed in the main header rows. Header rows should be vacuumed every 2-5 years, or when sediment has accumulated to 11" in the header row.	Yes No	/ / 20 Responsible Party:
Pavement: Inspect ground surface above underground structure for sinkholes or other unusual depression areas		Metro Blooms will advise Davis Center staff when a professional maintenance service is needed.	Yes No	/ / 20 Responsible Party:
Dewatering Visual inspection for any standing water present in system		Metro Blooms will advise Davis Center staff when a professional maintenance service is needed.	Yes No	/ / 20 Responsible Party:

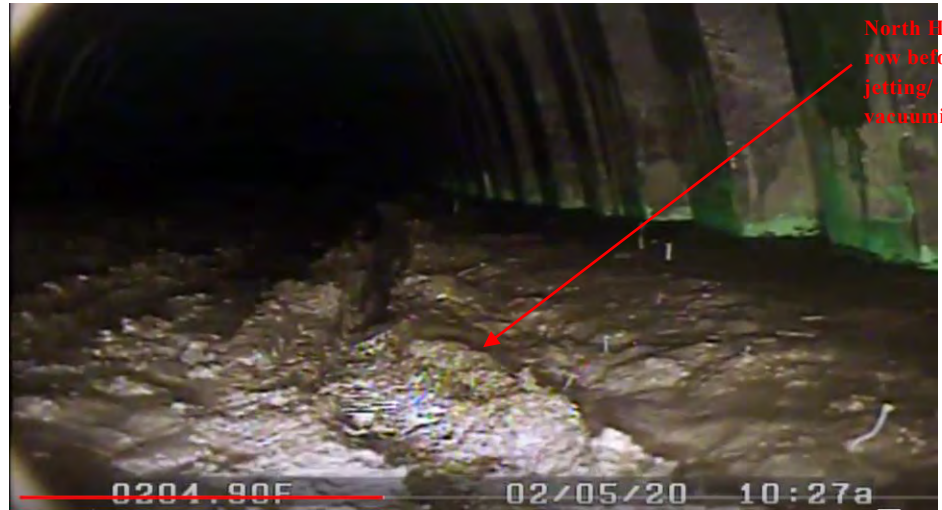
North Header row before any jetting/vacuuming

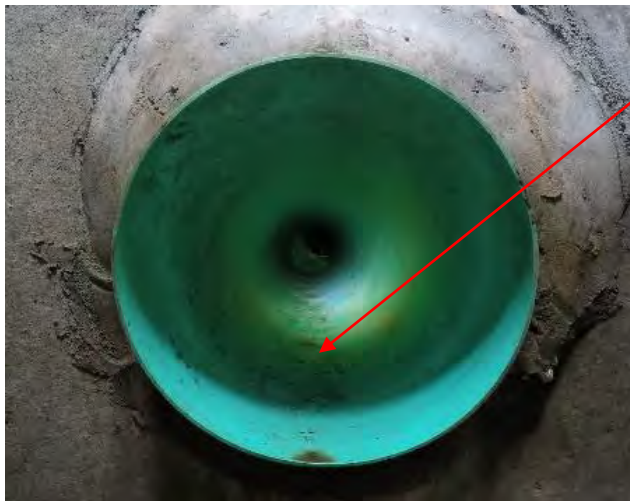
Clean and clear overflow pipe to city system

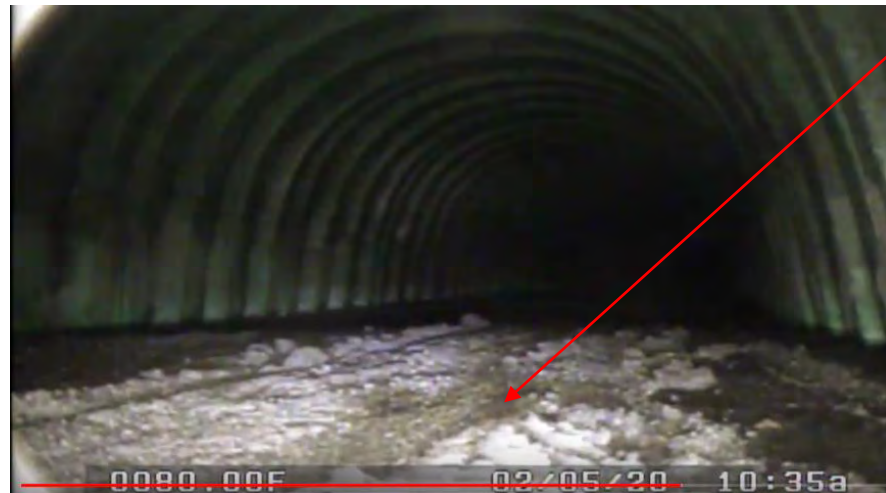
North Header row after first pass of jetter and vacuum

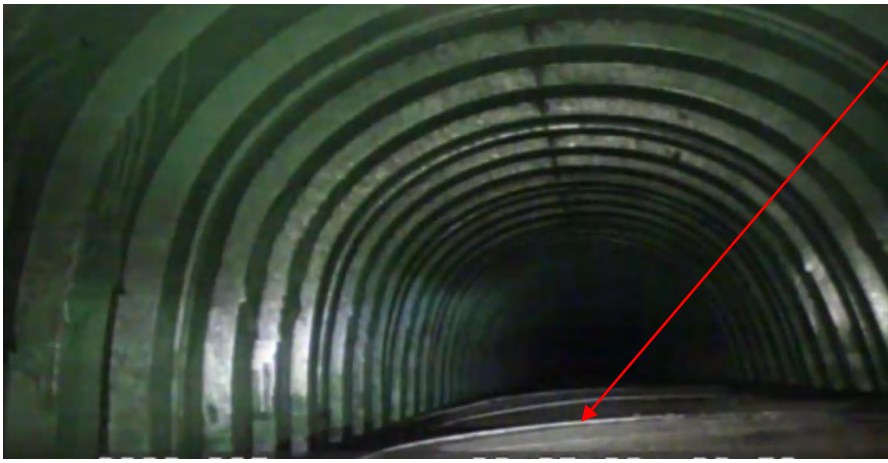
North Header row after final pass of jetter and vacuum

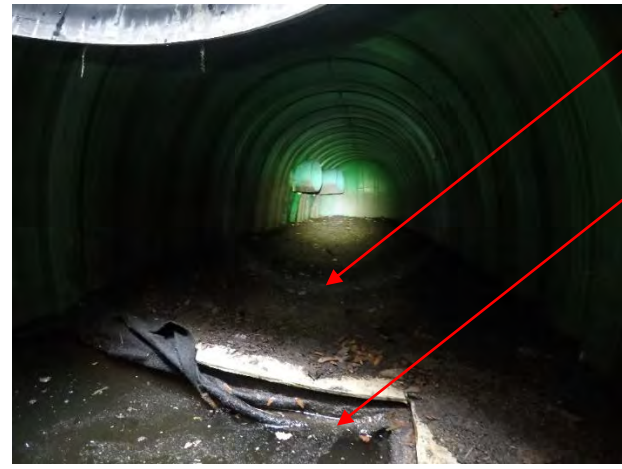
Main header row, south chamber system

Sump

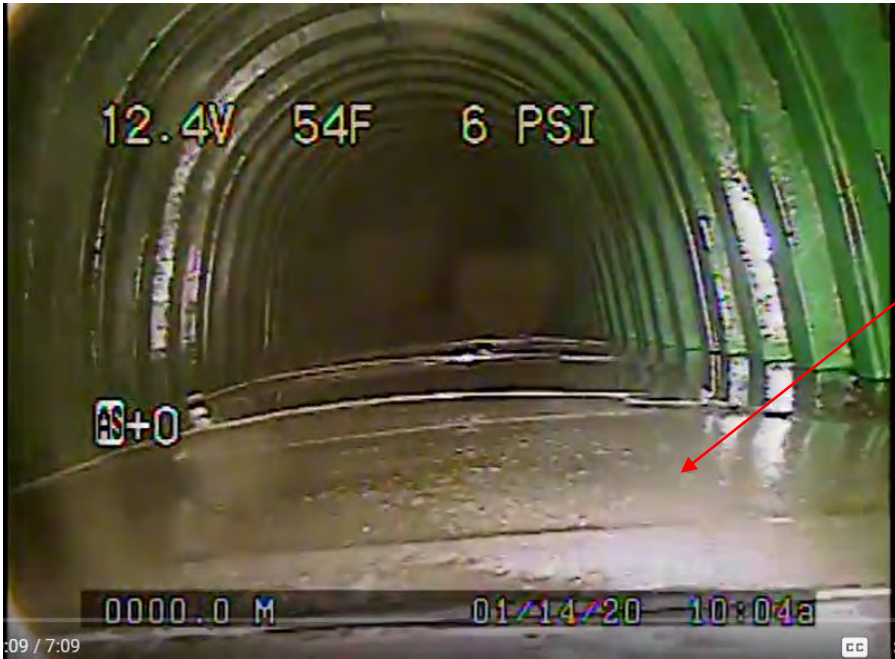
Header row floor of south system after cleaning

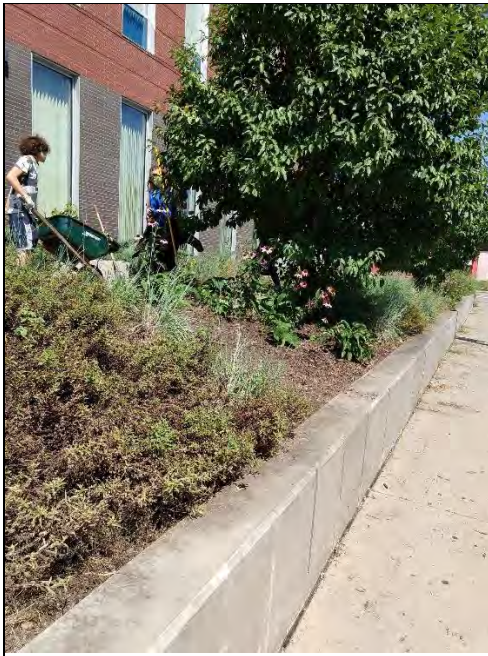
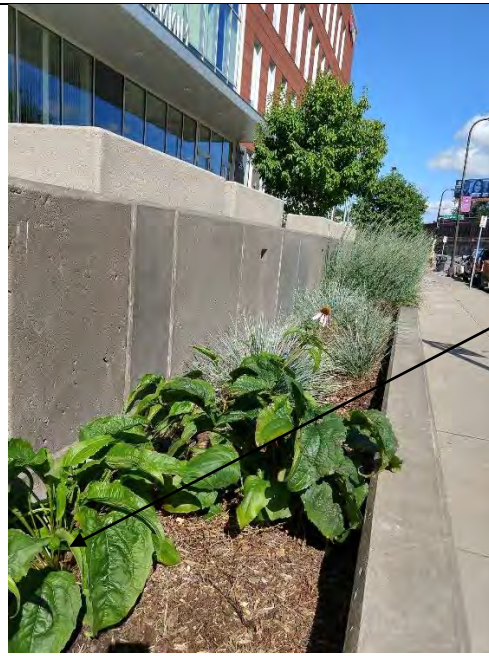
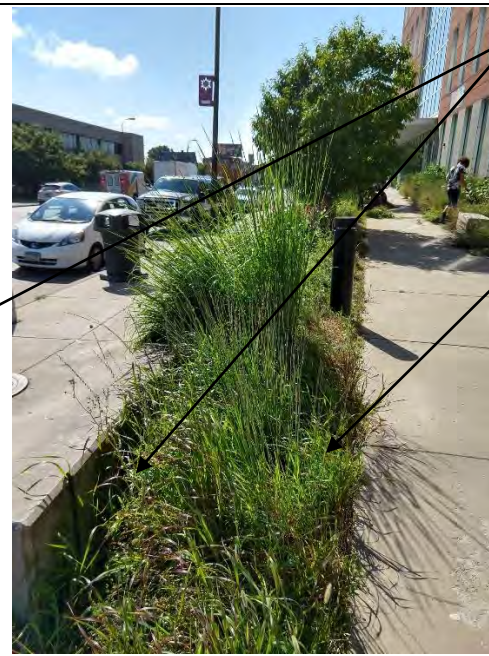
Native plants

Sidewalk – contributing area

Stormwater planter on front of building captures sheetflow from sidewalk into landscaping beds

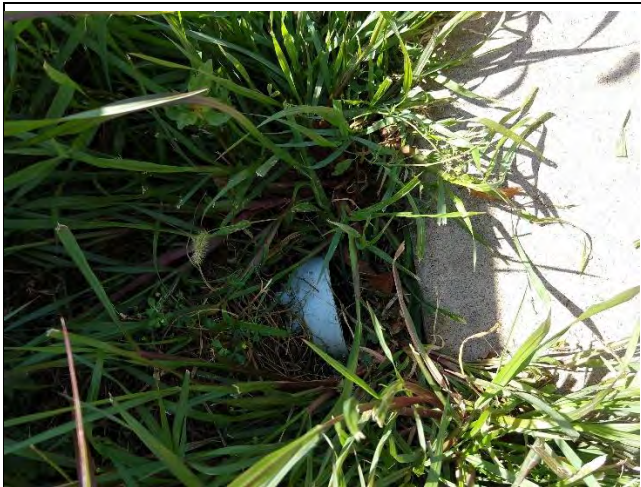
Underdrain outlet at west end of planter

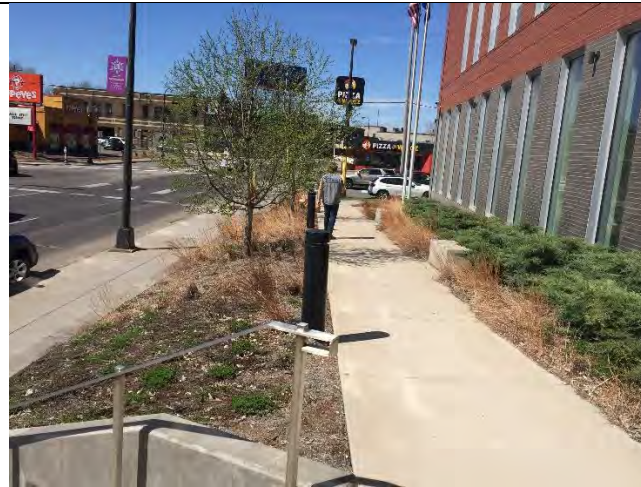
Stormwater planter after spring cleanup

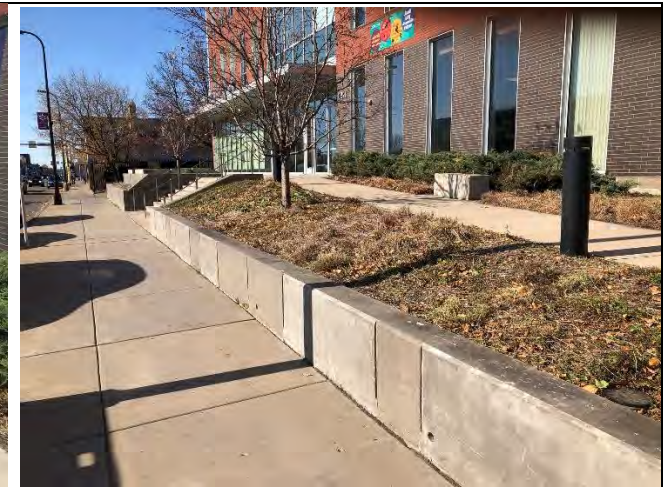
Stormwater planter after Fall cleanup
