Summit School District

Breckenridge Elementary School

District:	Summit School District
Facility:	Breckenridge Elementary School
Address:	312 S Harris St
City:	Breckenridge, CO
Site Area (AC):	4.98
Gross Building Area (SF):	35,467.00
Number of Stories:	1
Years Constructed / Renovated:	1972 / 1979 / 2000
Total Replacement Value:	\$33,089,853.70
Total Condition Budget:	\$17,190,120.19
Facility Condition Score:	48.1%
Educational Adequacy Score :	54%
Students Enrolled:	200
Capacity:	276
Utilization (% Capacity):	72%

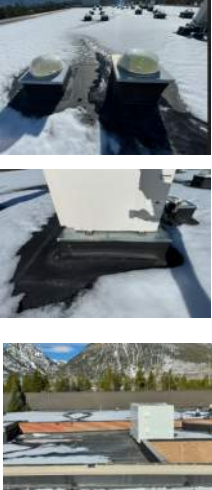
RF1	MAIN BLDG	MEMBRANE ROOFING B3010	M	4	<p>Single-ply membrane, Fully Adhered. Condition of roof and accessories is good</p> <p>Solution: Budget to replace roof in 10-15 years</p>	118592	SF	\$0.00	\$0.00	\$0.00

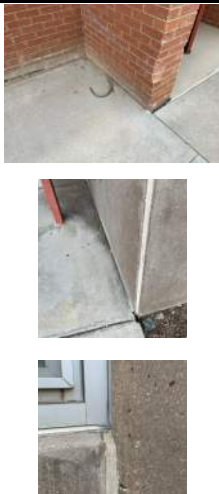
EX5	MAIN BLDG	EXTERIOR WALL - Masonry walls B2010	M	2	Deficiency: Typical, caulking and sealant is failing and most of exterior joints with hardscape Solution: Replace exterior building sealant at doors, windows, and paving.	2500	LF	\$26.92	\$67,300.00	\$70,665.00
	EX6	MAIN BLDG	WINDOWS - ALUMINUM B2020	M		The building includes aluminum framed exterior units with insulating glass. Solution: No deficiencies noted		SF	\$0.00	\$0.00	\$0.00
	EX7	MAIN BLDG	DOORS - ALUMINUM STOREFRONT B2030	M		The exterior doors include swinging glazed aluminum storefront leaf, a glazed transom, an aluminum frame, and hardware, including a closer. Solution: No deficiencies noted	0	LF	\$0.00	\$0.00	\$0.00
