Monticello Middle School Repair

Longview School District

PROJECT DESCRIPTION

The project will consist of repairing the columns, walls and countertops in classrooms #153 & #155 that were damaged by a roof leak. The roof leak has been repaired but these interior elements still need to be repaired.

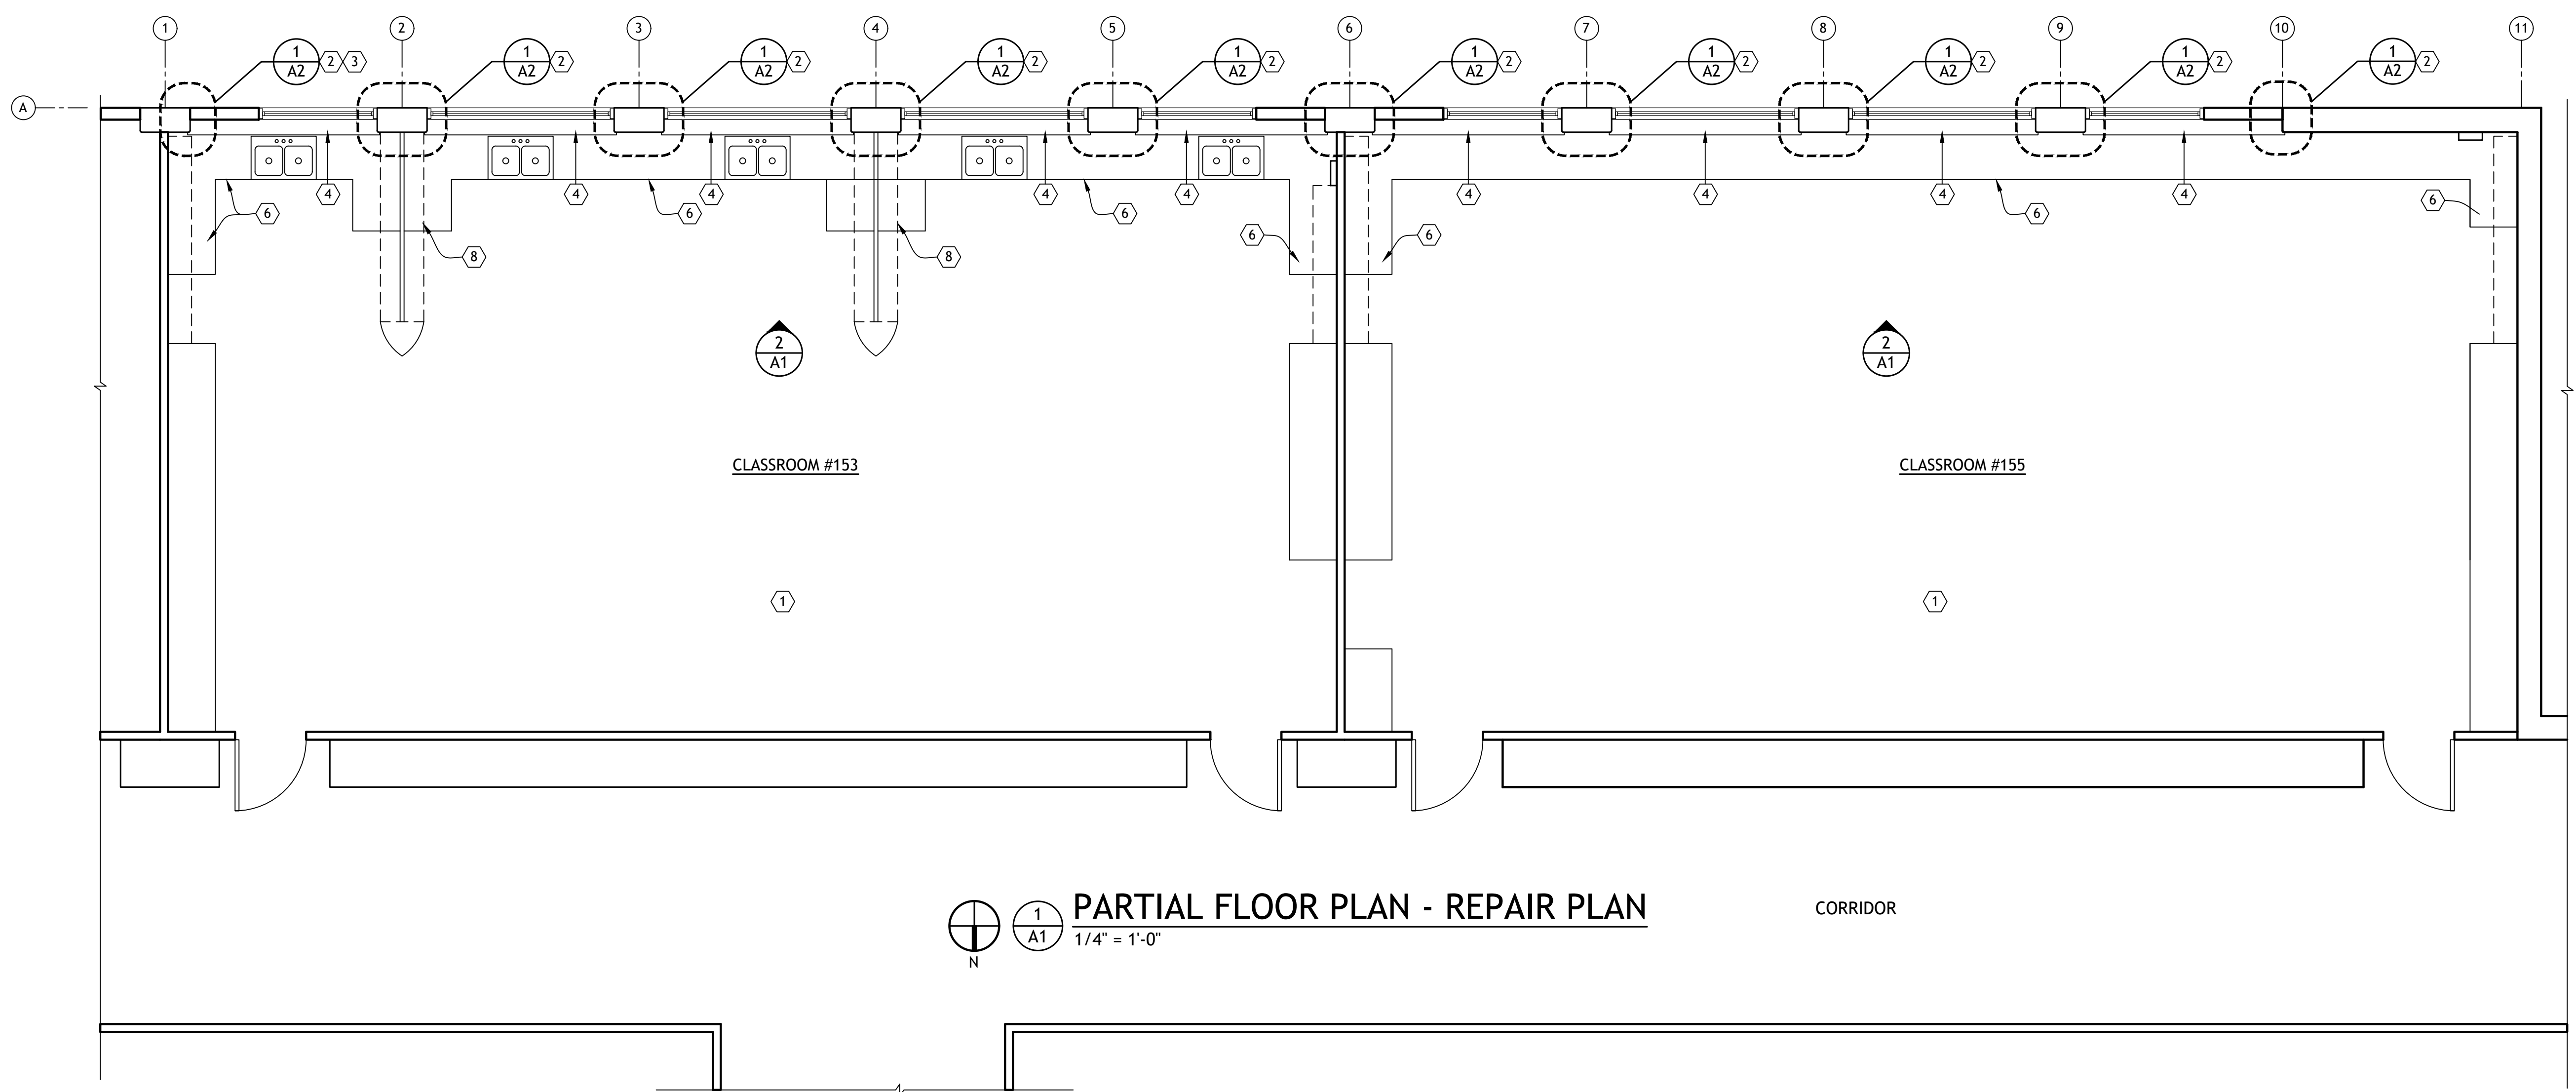
1 PARTIAL FLOOR PLAN - REPAIR PLAN
1/4" = 1'-0"

- KEYNOTES:
1. ROOM LAYOUT AND CASEWORK IS NOT SHOWN ON THIS SIDE OF THE CLASSROOM. NO WORK IN THIS AREA. ALL WORK IS ON THE SOUTH SIDE OF THE CLASSROOMS.

2. REMOVE DAMAGED PLASTER & LATH AND THOROUGHLY CLEAN ANY LOOSE DEBRIS FROM THE EXISTING CONCRETE COLUMNS. AFTER CLEANING & DRYING, APPLY BONDING AGENT IN PREPARATION FOR NEW PLASTER.

3. REPAIR COLUMN TO THE CORNER OF THE CLASSROOM.
 4. REMOVE AND REPLACE ALL P-LAM WINDOW SILLS.
 5. REMOVE AND REPLACE ALL P-LAM BACK SPLASHES.
 6. EXISTING CASEWORK TO REMAIN.

7. TEMPORARILY REMOVE ALL SURFACE MOUNTED WIRES, RACEWAYS, EMERGENCY LIGHTING AND OUTLETS. AFTER REPAIR IS COMPLETE RE-MOUNT THEM WHERE THEY WERE LOCATED BEFORE.

8. TEMPORARILY REMOVE OVERHEAD CABINET UNIT WHILE REPAIR WORK IS UNDERWAY. REPLACE CABINET IN THE SAME LOCATION AFTER REQUIRED WORK IS COMPLETE.
 9. TEMPORARILY REMOVE PAPER TOWEL DISPENSER WHILE REPAIR WORK IS UNDERWAY. REPLACE DISPENSER IN THE SAME LOCATION AFTER REQUIRED WORK IS COMPLETE.
