## **LIMITED LEAD AND ASBESTOS SURVEY**

**Columbia Heights  
2820 Parkview Drive  
Longview, Washington**

Report Date: March 31, 2025

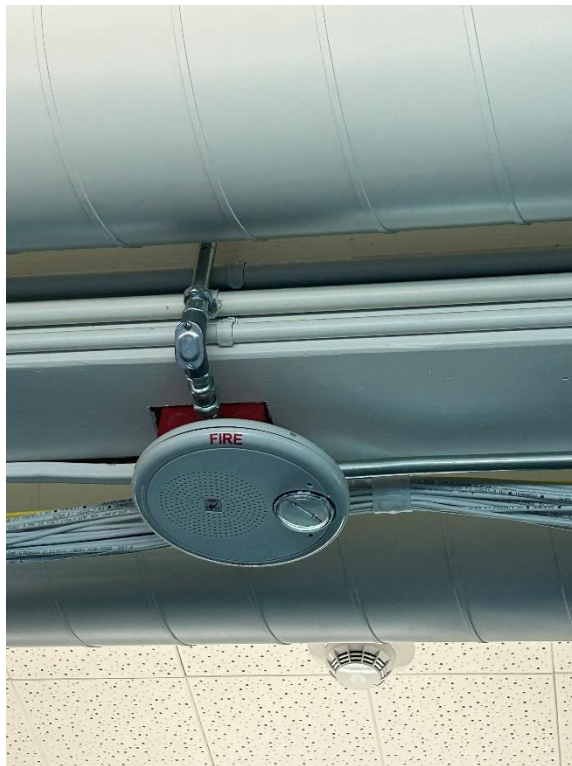
Sensor bound into plenum of cables

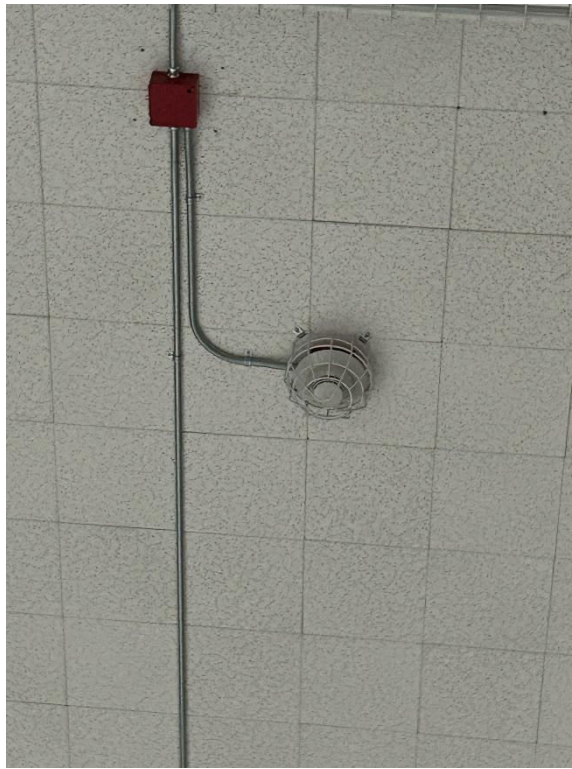
Higher reach tile similar to lower levels tile
