# **East High Structural Analysis**

## **Repair plan and temporary relocation overview**

### **Wichita Public Schools**

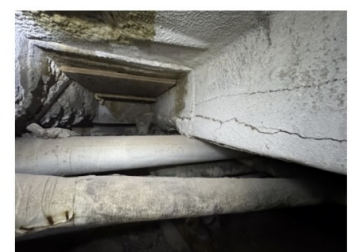
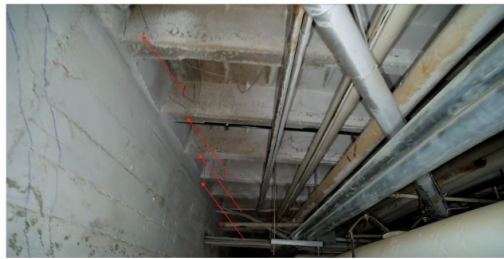
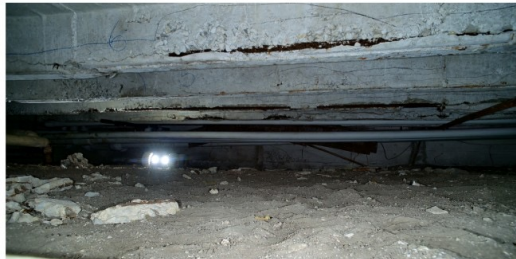
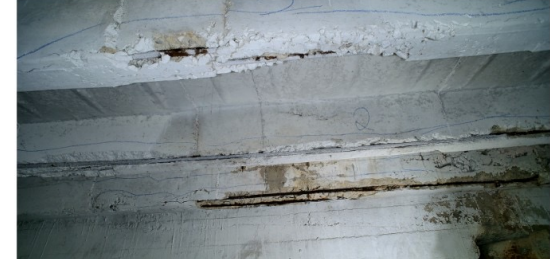
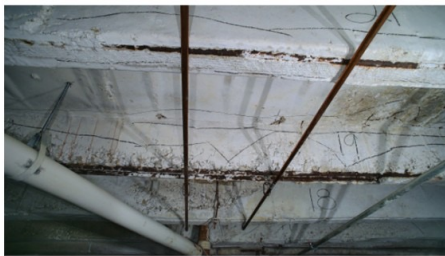
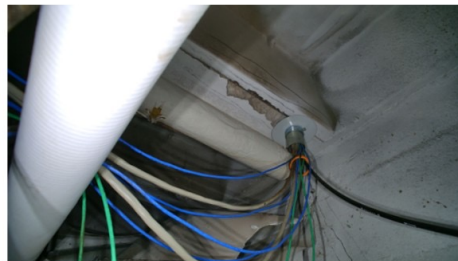
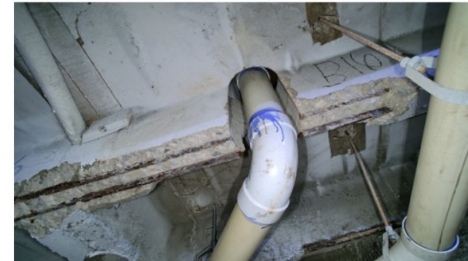
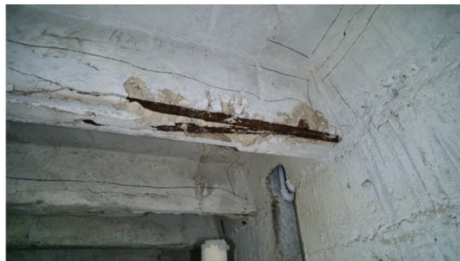
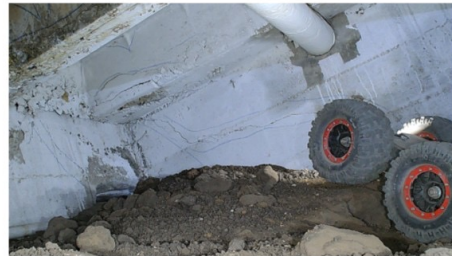
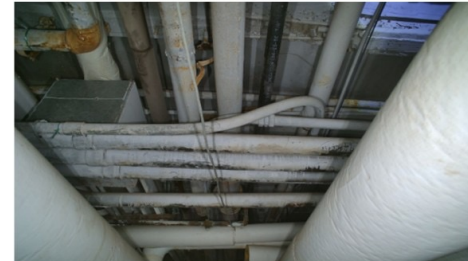
GENERAL PICTURES  
OF FLOOR CONDITIONS
