SCHOOL BUILDING .....9

# Executive Summary

Falls City ISD is a public school district primarily in Karnes County, Texas, with a small portion in Wilson County. The district buildings are situated in the same general vicinity, with the main school building and CTE building on one site and the football stadium, transportation, and maintenance buildings across the street. The district buildings include Falls City School, the Frank Paul Nieschwietz Career and Technology Building, maintenance and transportation buildings, and the Football Stadium.

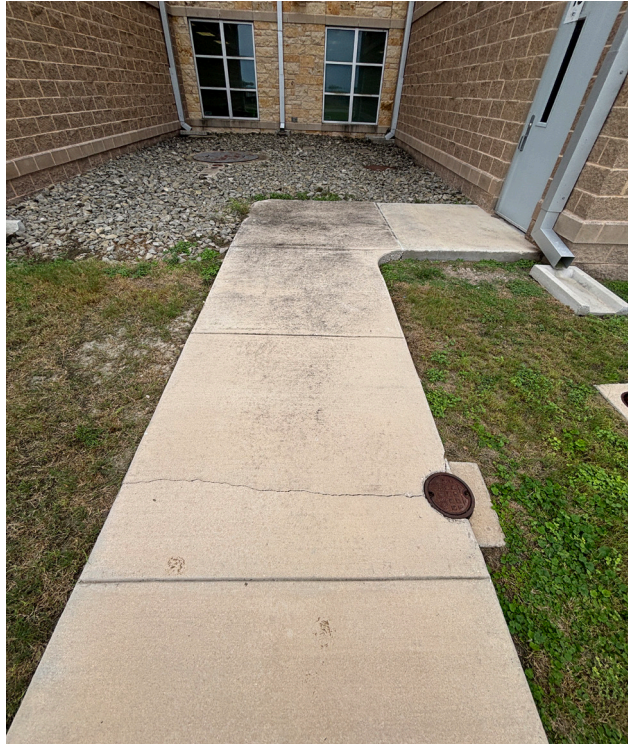
Evidence of structural movement

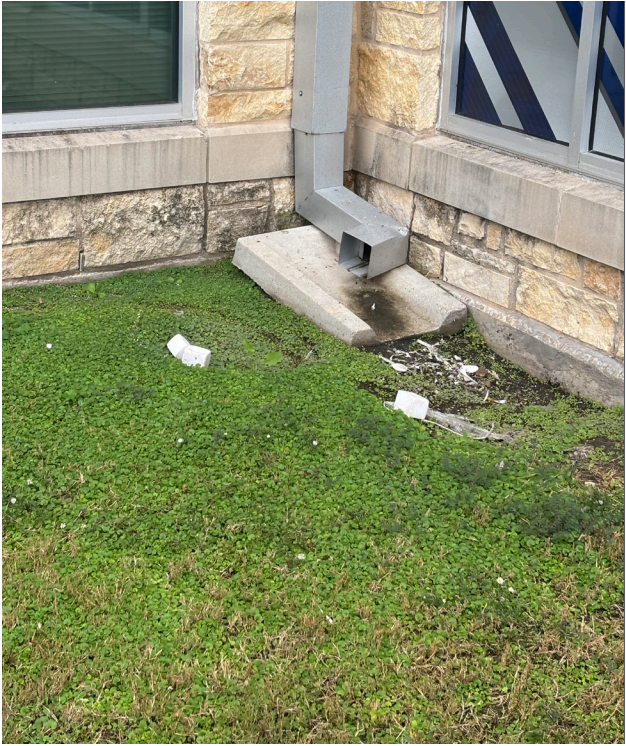
Poor drainage

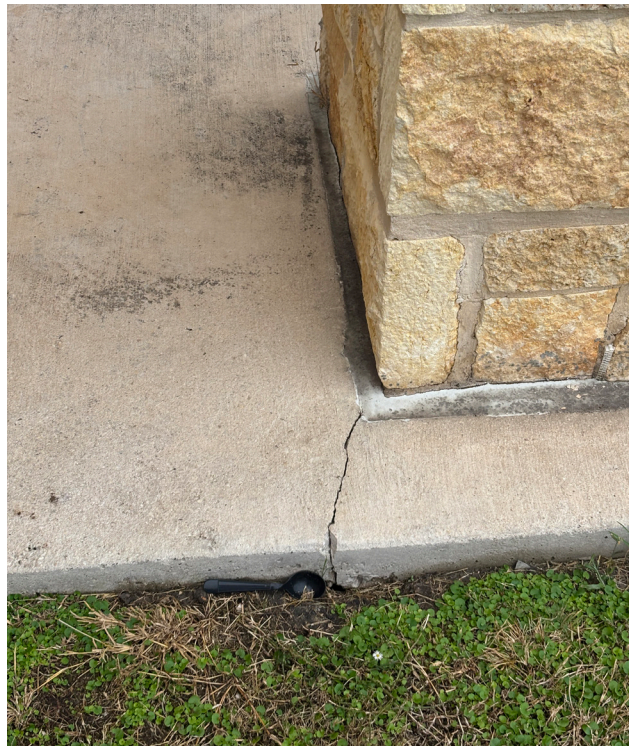
Evidence of structural movement

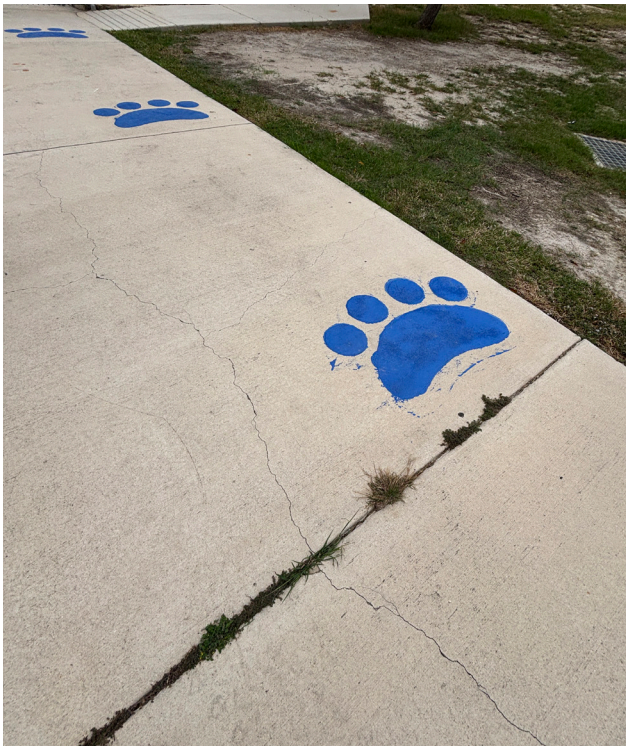
Evidence of structural movement

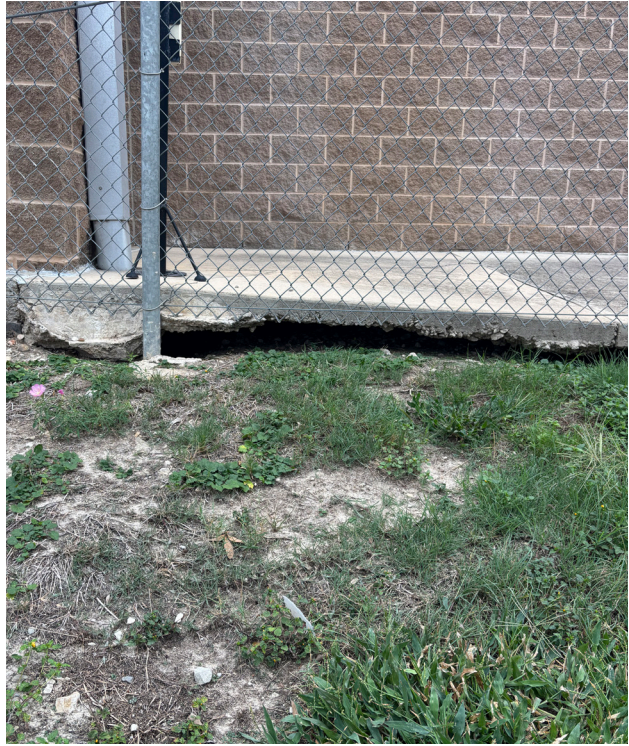
Inadequate drainage

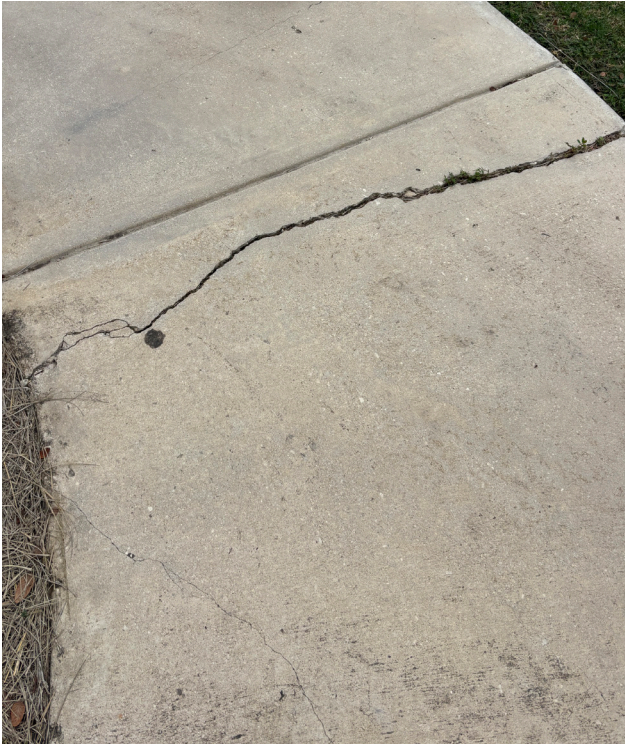
Evidence of structural movement

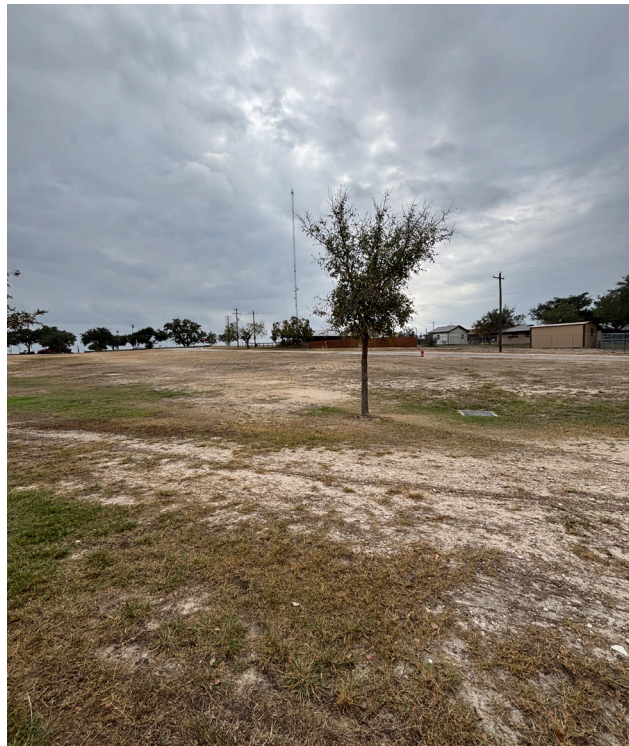
Inadequate grade covering

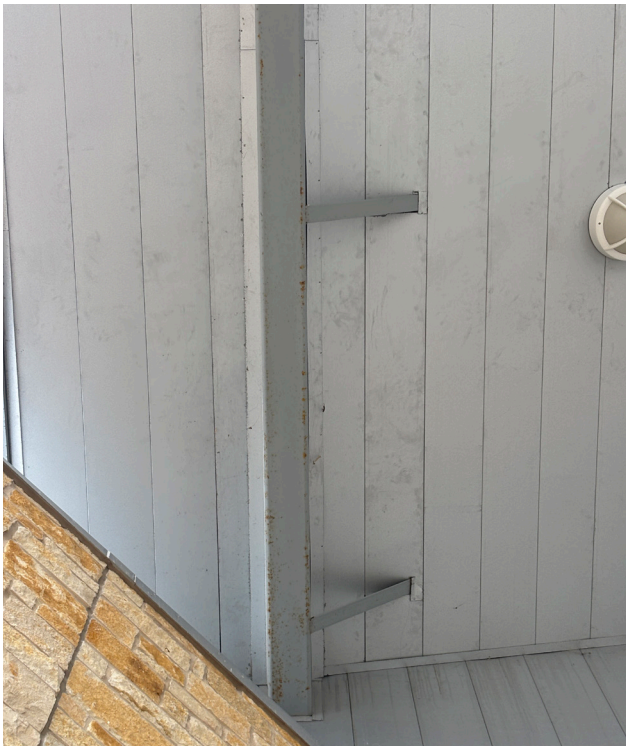
Deteriorating finish

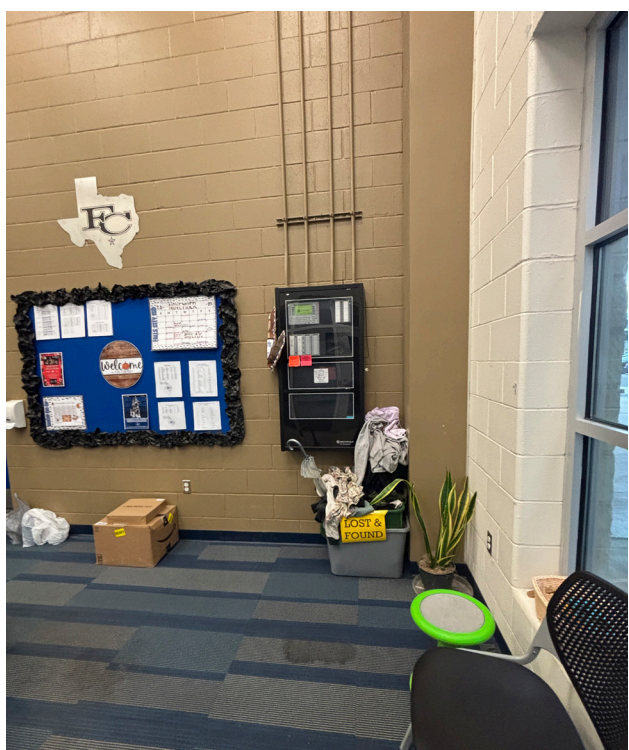
Evidence of moisture damage

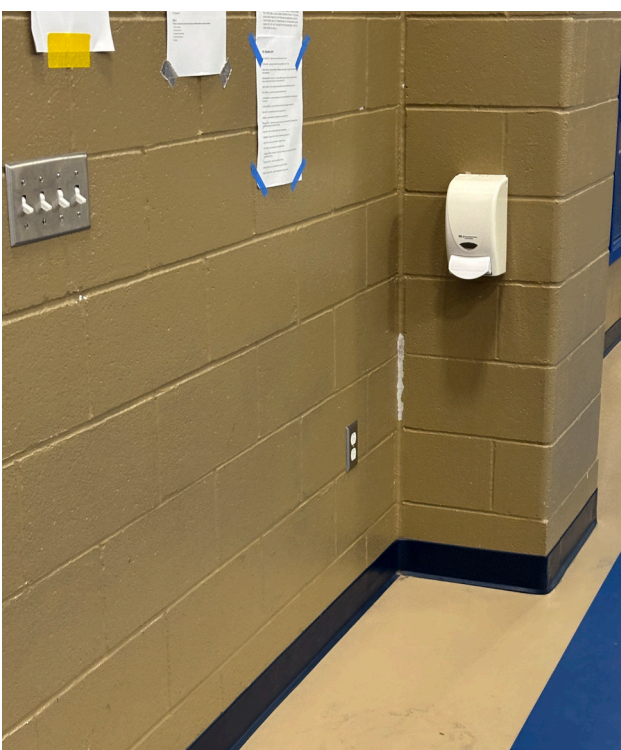
Deteriorating finish

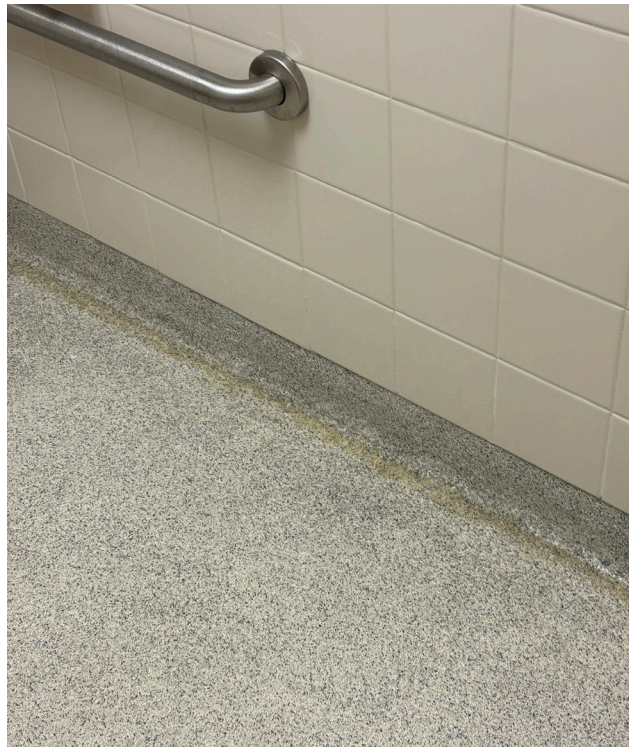
Discolored flooring

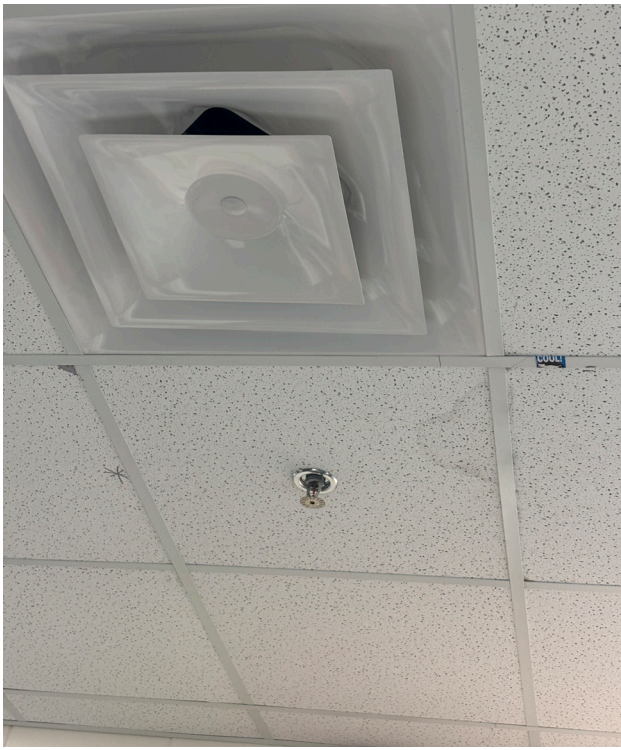
Evidence of moisture damage

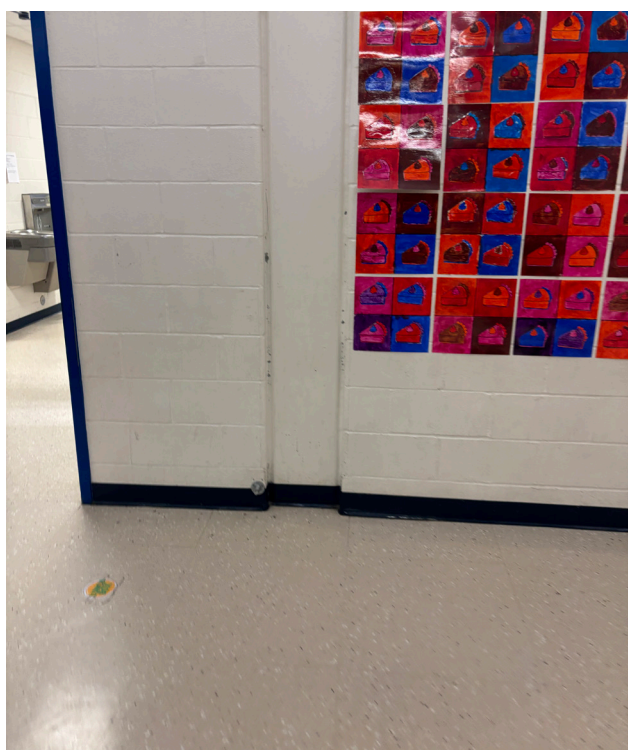
Deteriorating finish

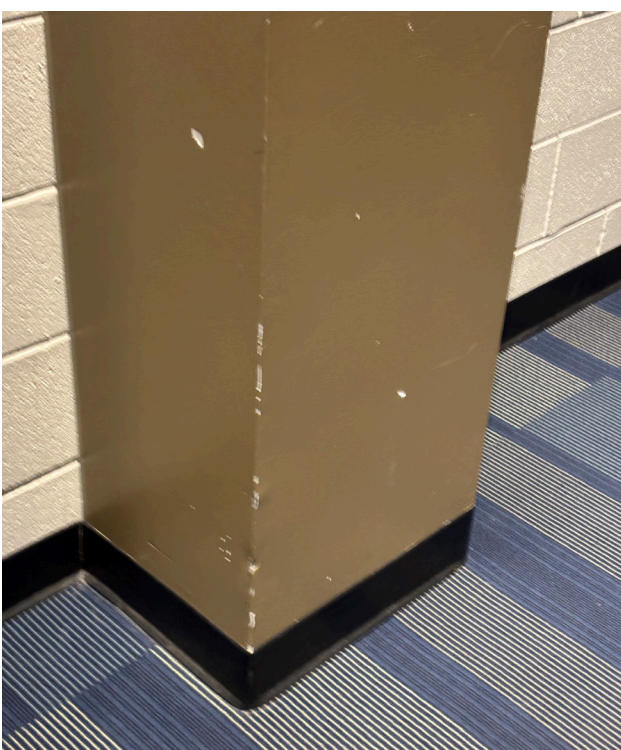
Deteriorating finish

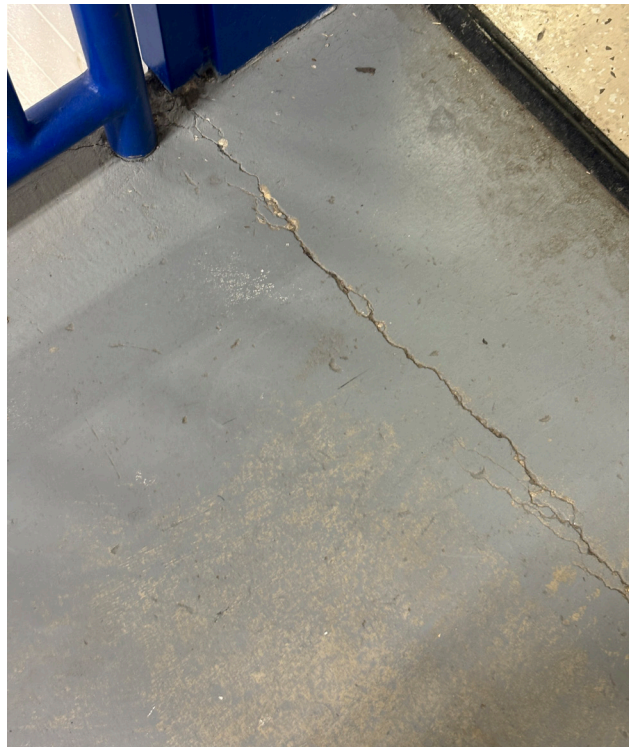
Evidence of structural movement

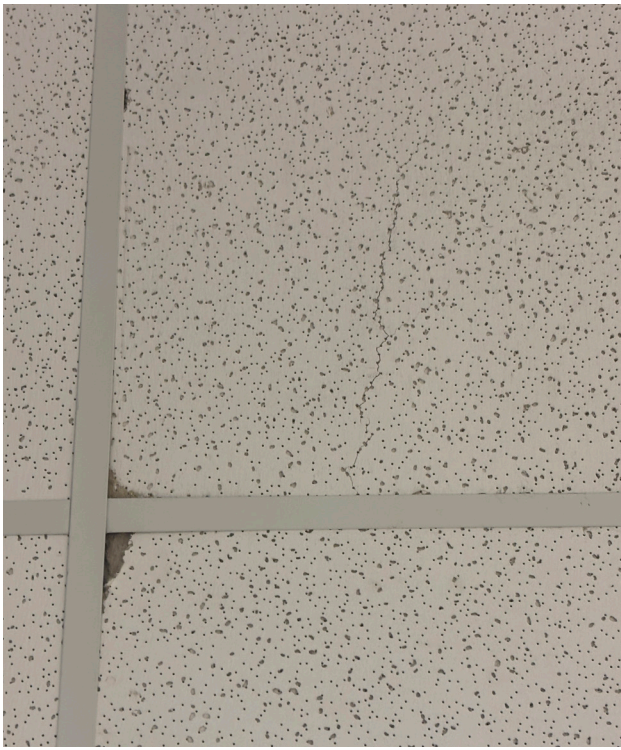
Damaged ceiling tile

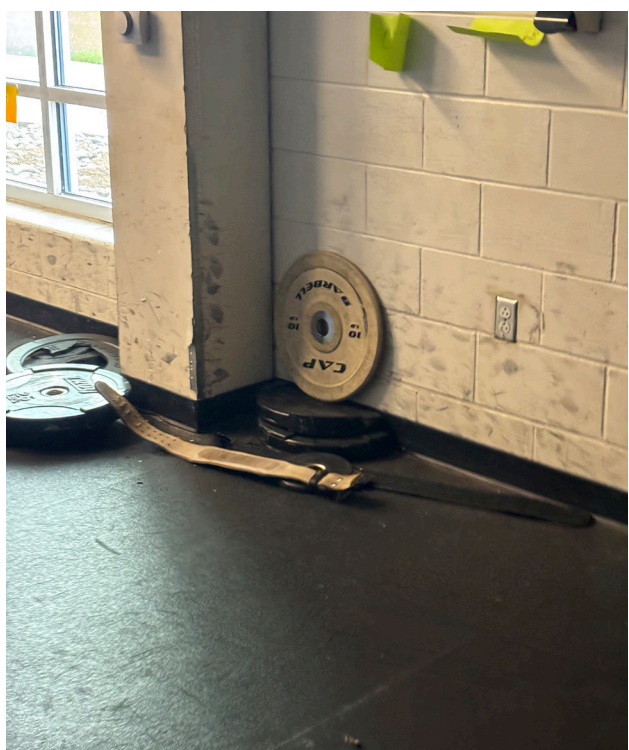
Damaged wall

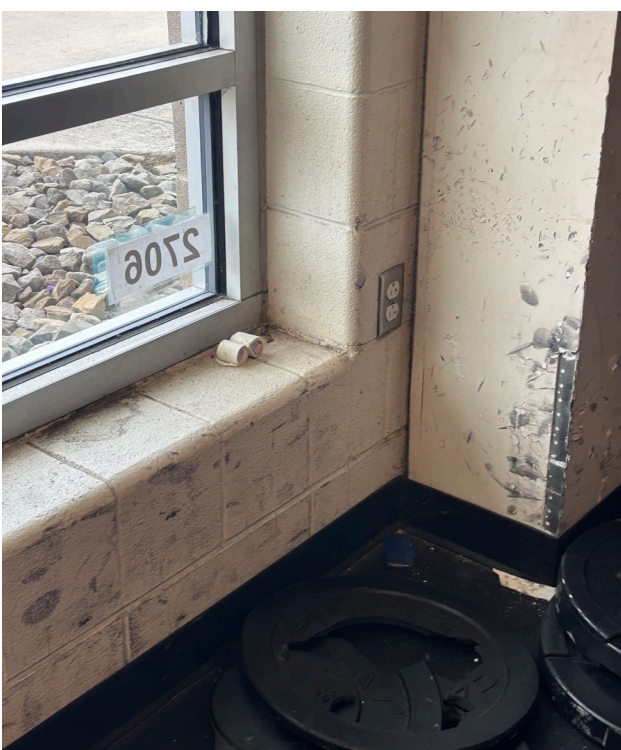
Damaged wall

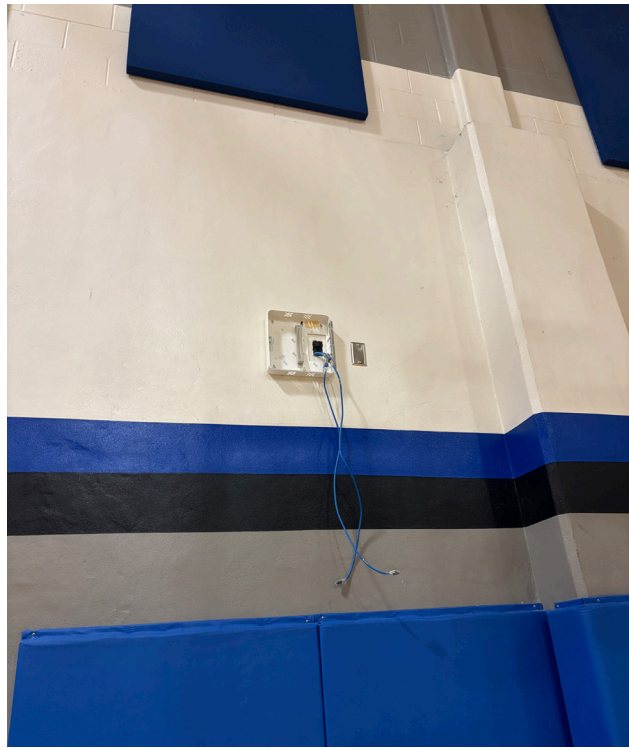
Inadequate electrical

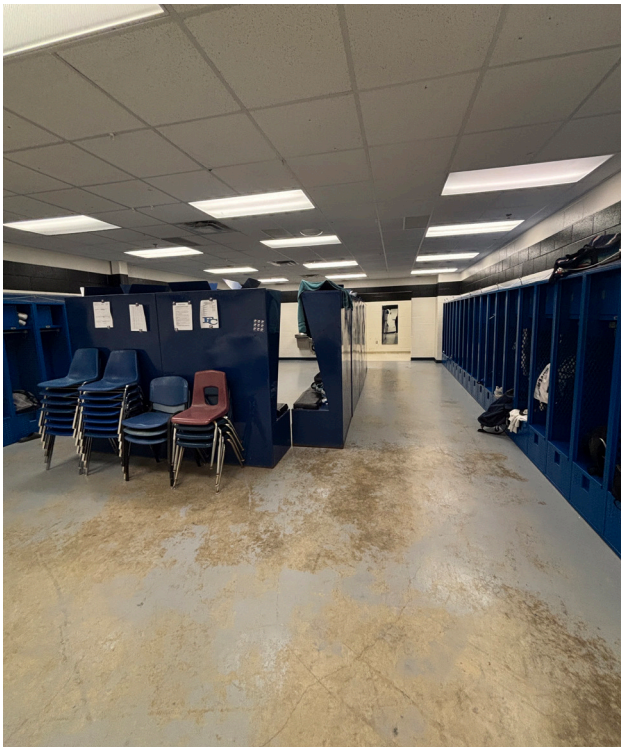
Deteriorating floor finish

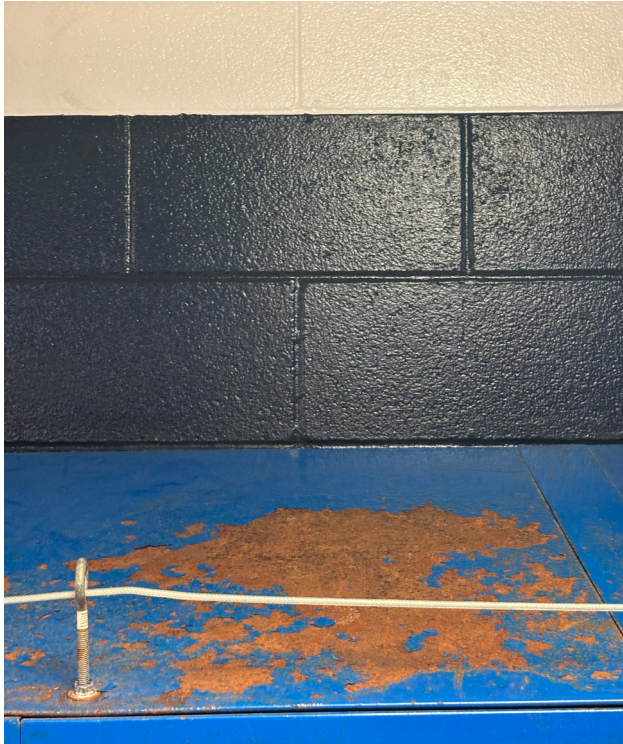
Deteriorating locker finish

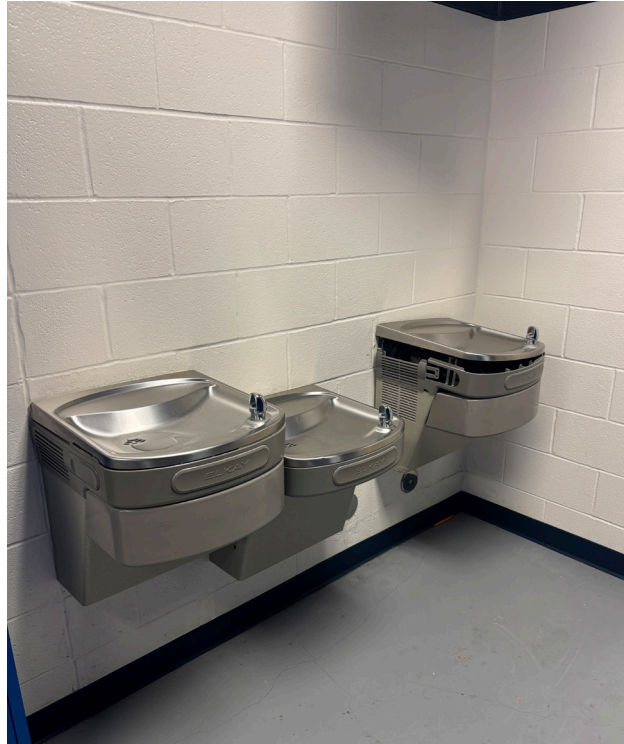
Damaged water fountain

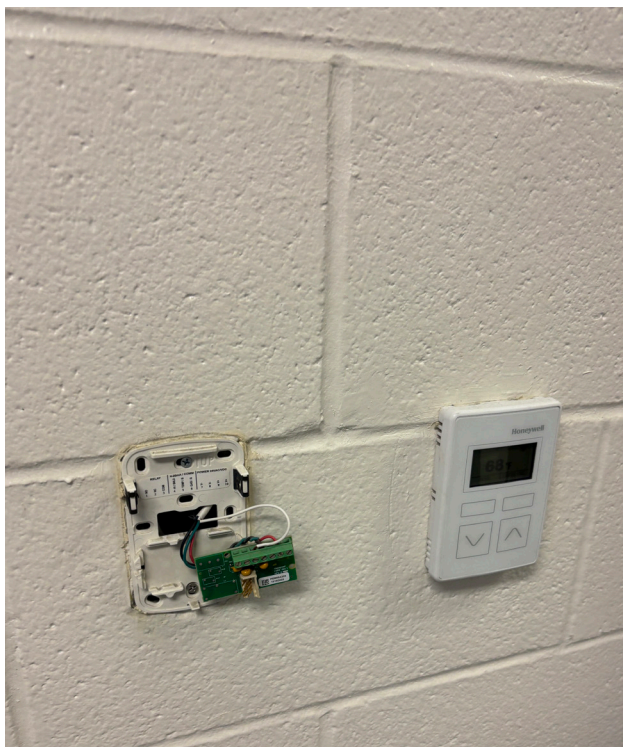
Inadequate electrical

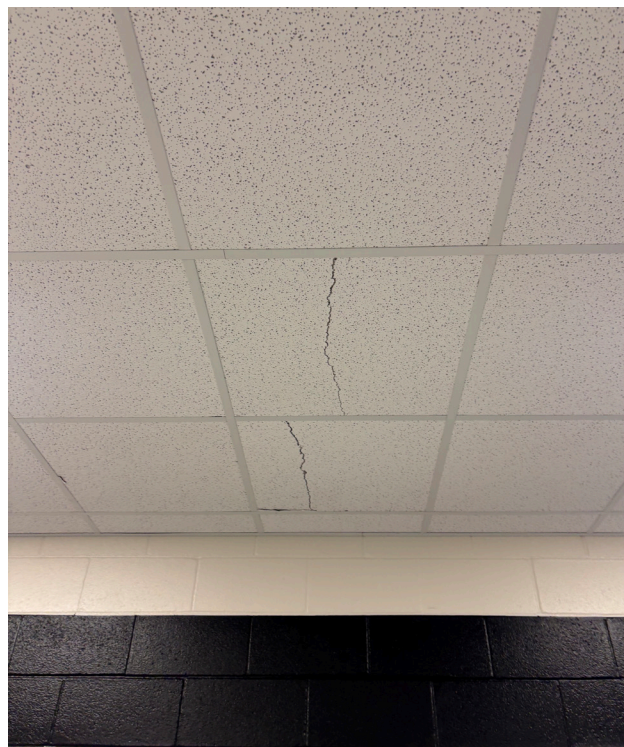
Damaged ceiling tiles

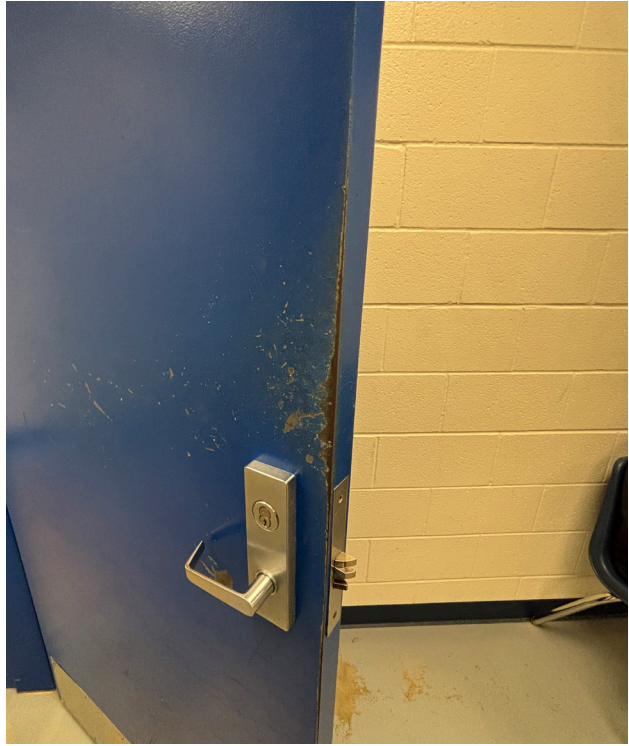
Deteriorating finish

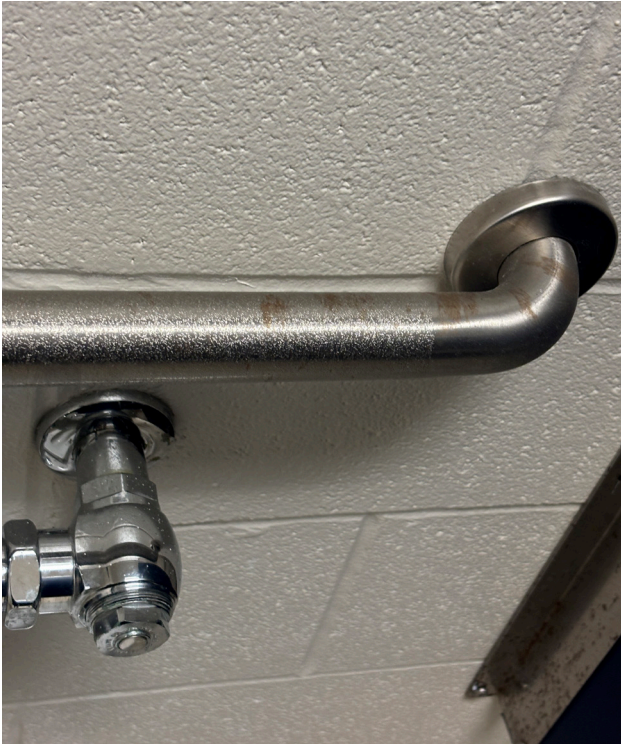
Deteriorating finish

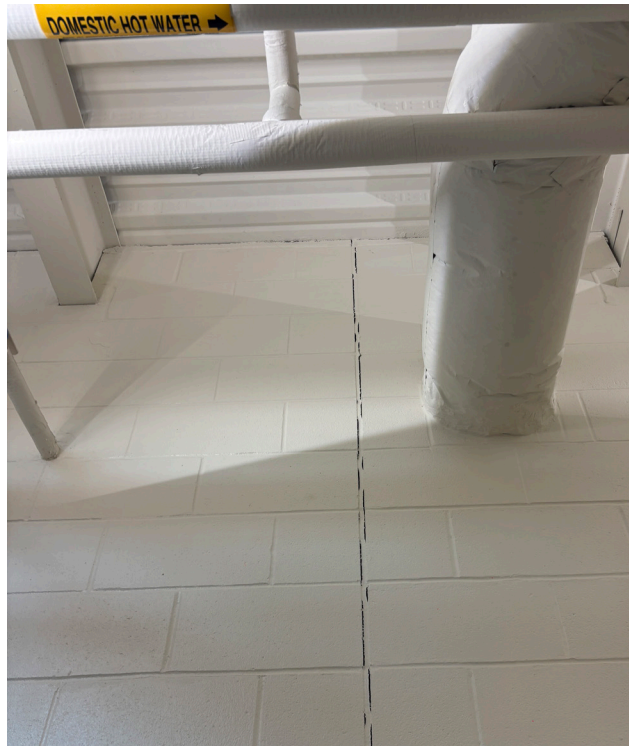
Deteriorating sealant

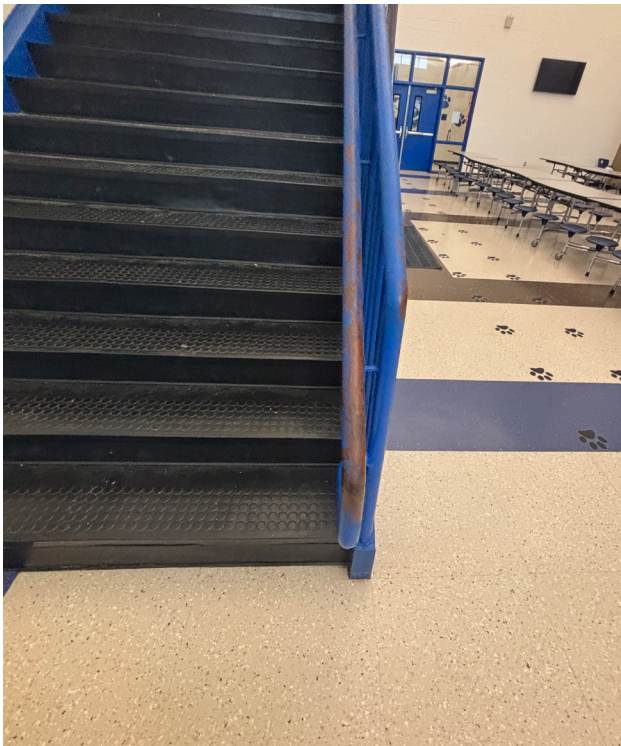
Deteriorating finish

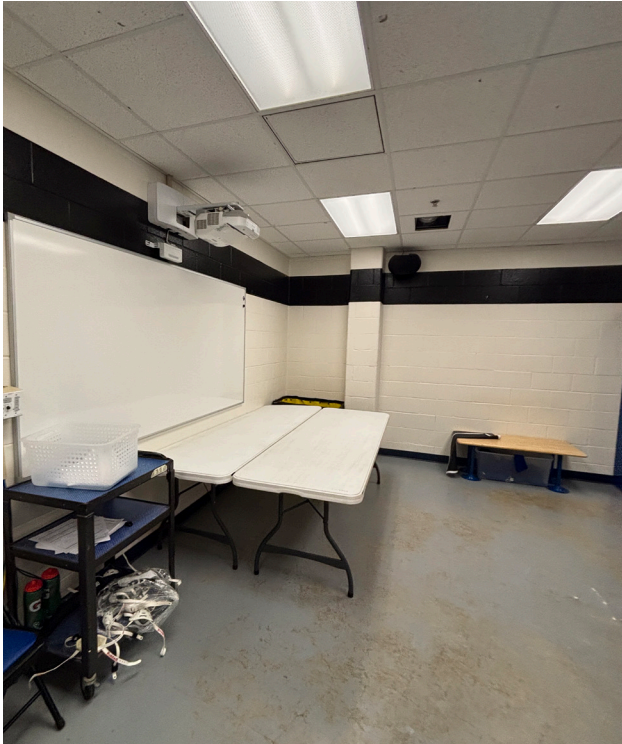
Defective intercom system

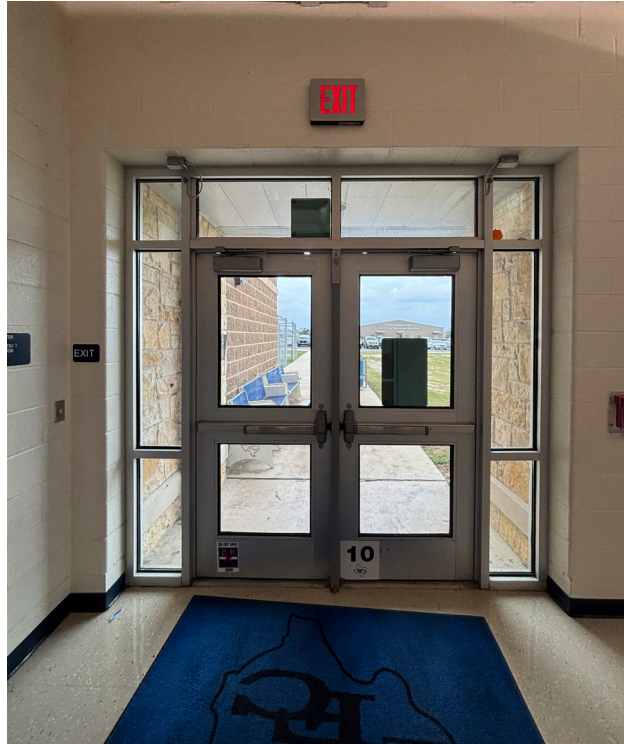
No secure vestibule on 1st floor

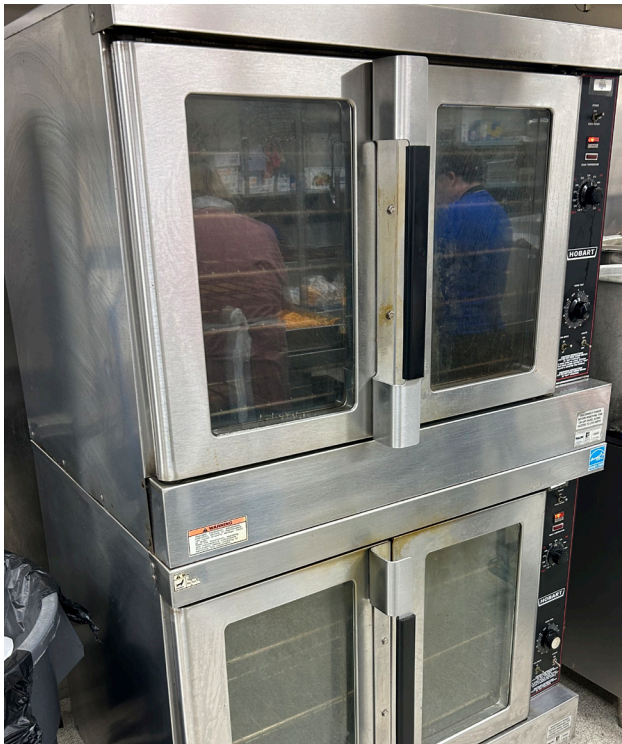
Older equipment

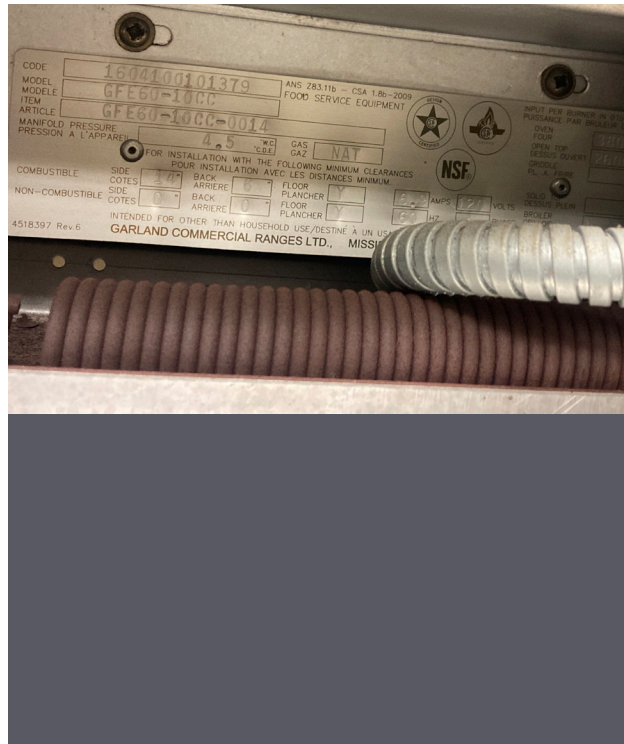
Equipment approaching end of typical life

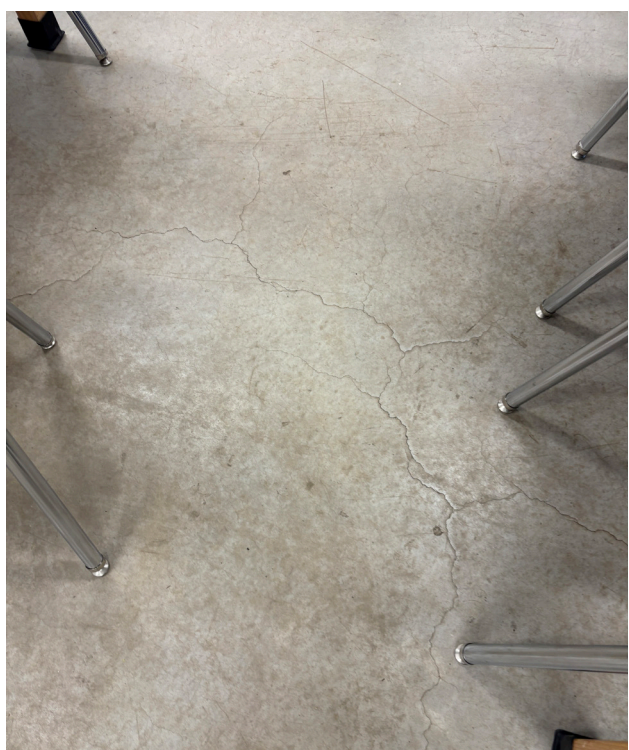
Evidence of structural movement

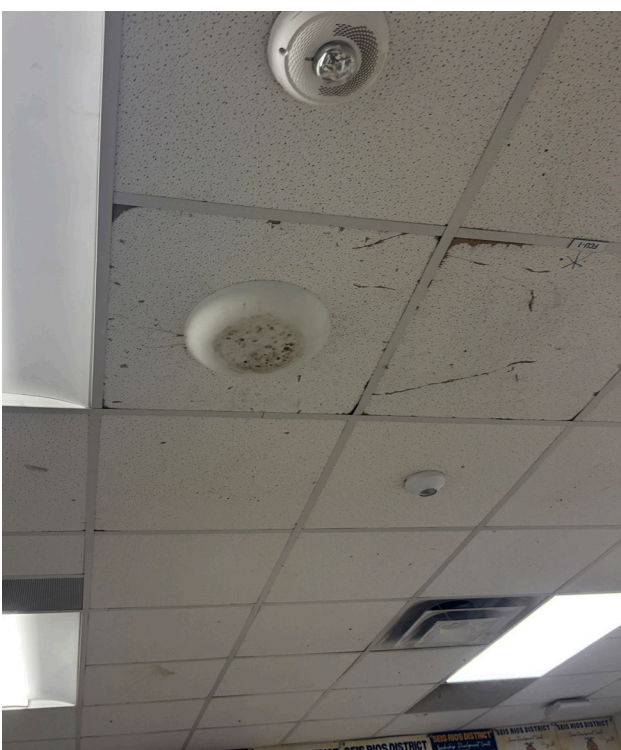
Damaged ceiling tiles

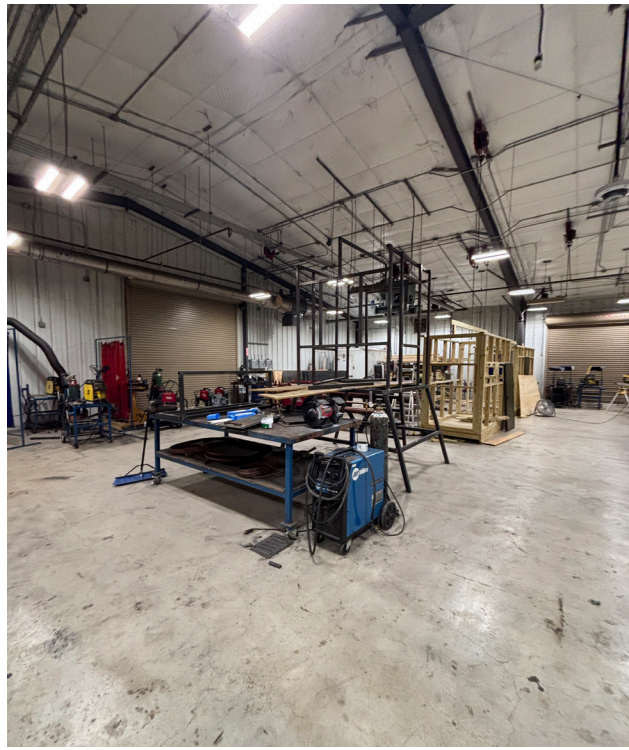
Missing floor safety markings

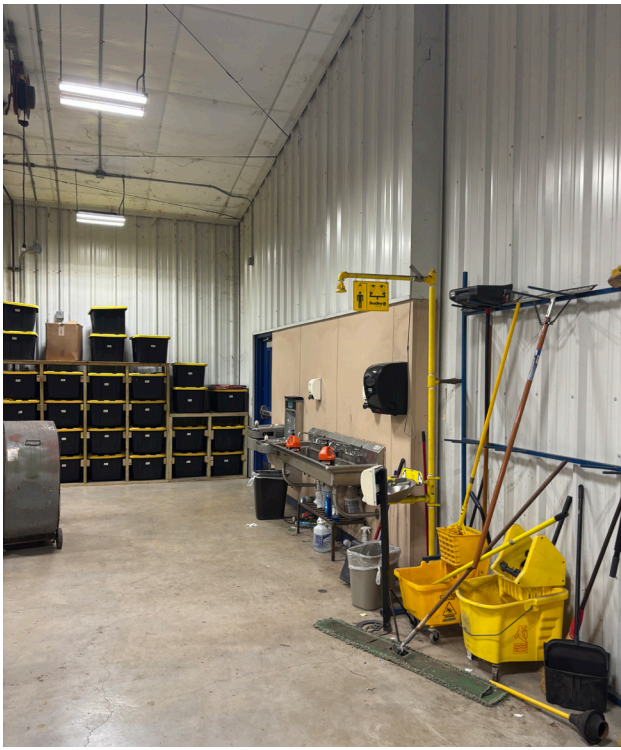
Missing drain at shower

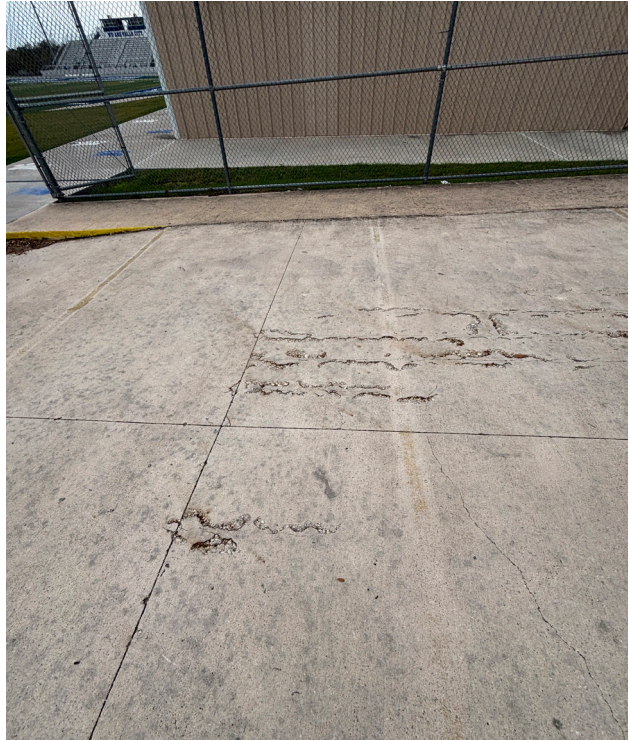
Deteriorating concrete

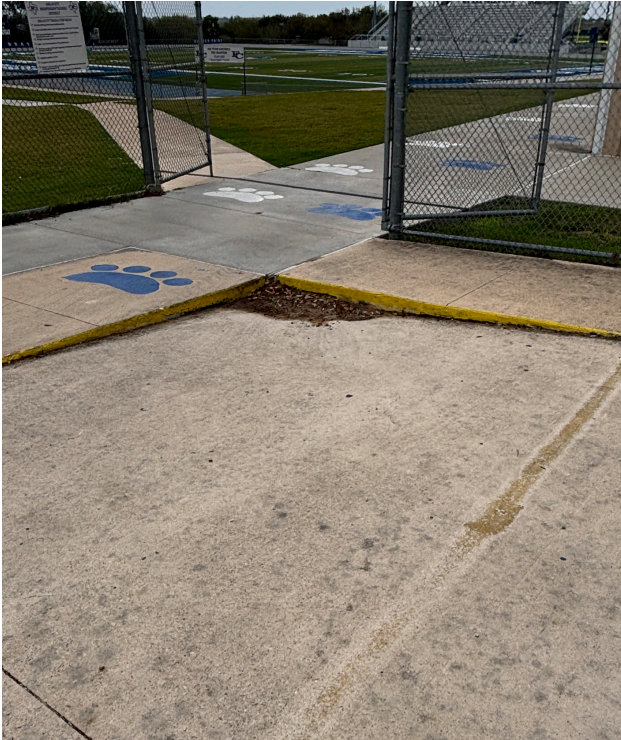
Evidence of structural movement

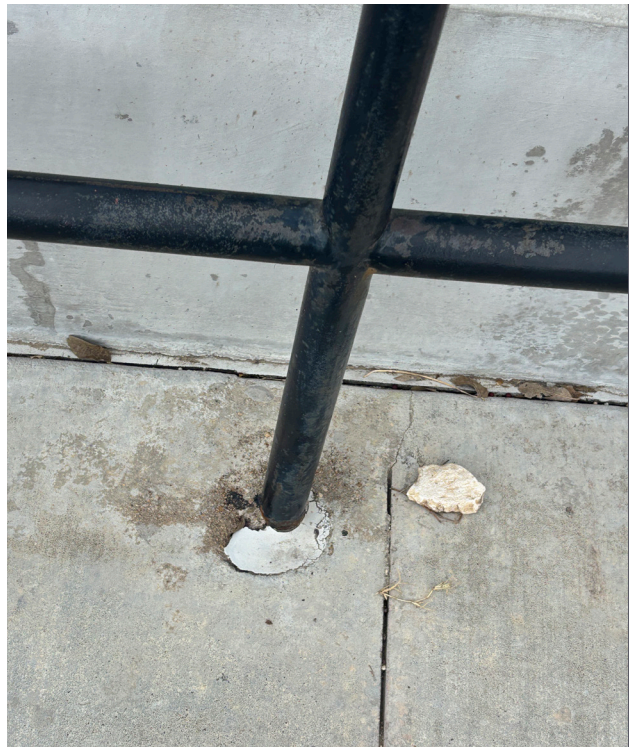
Deteriorating finish

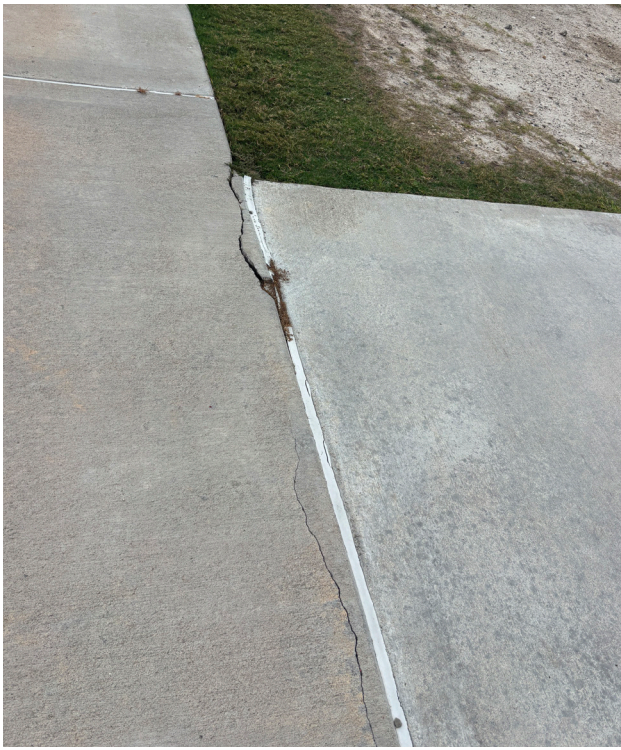
Evidence of structural movement
