# TOWN OF SUFFIELD

## CONDITIONS ASSESSMENT & MASTER PLAN

## SUFFIELD MIDDLE SCHOOL - 350 MOUNTAIN RD, SUFFIELD, CT

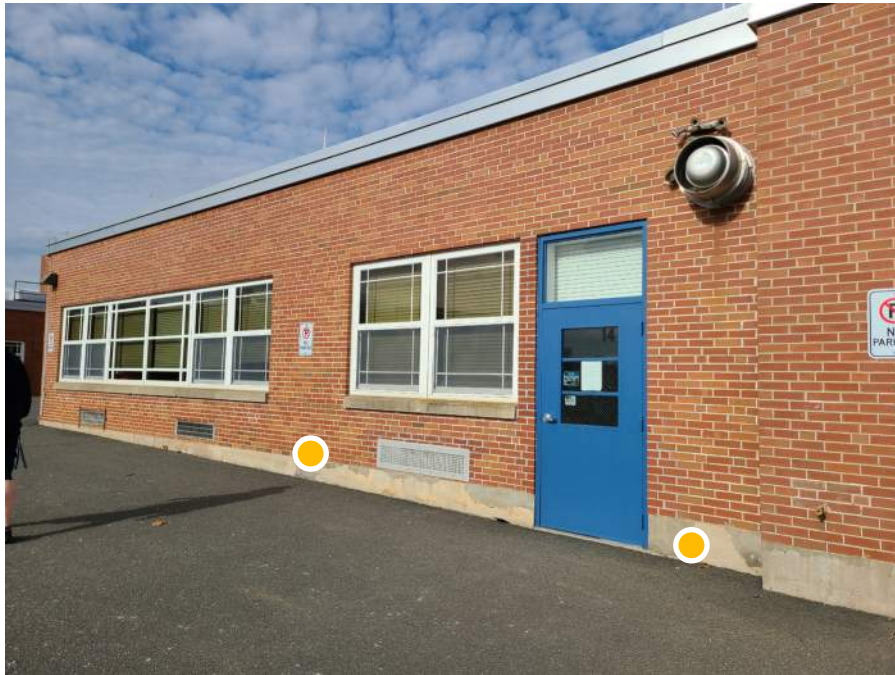
● D1. 5: View of typical exterior wall in 1965 Vo-ag addition. Note spalling concrete foundation wall

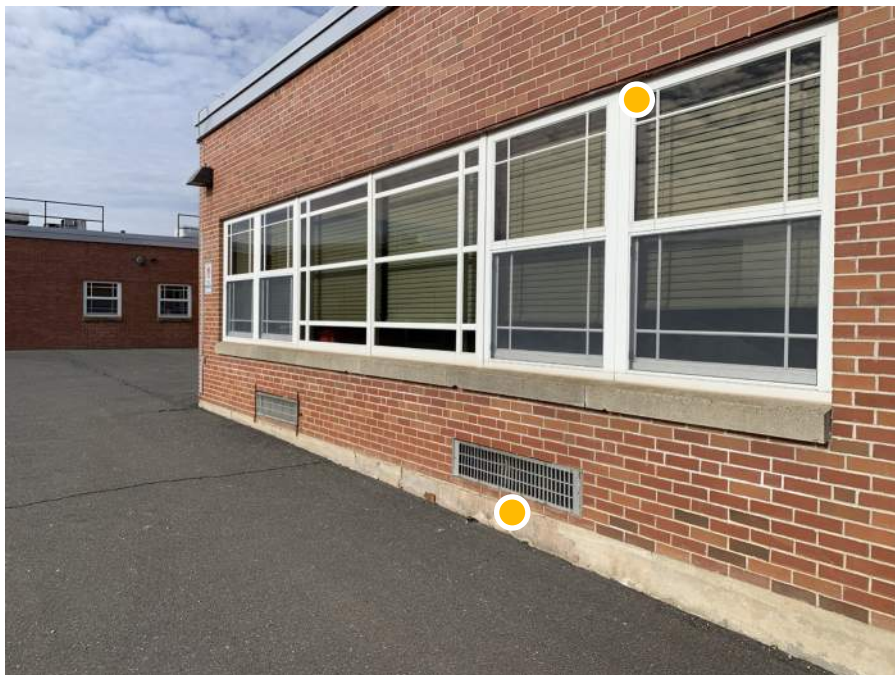
● D1. 6: Detail view of 1965 Vo-ag addition, note deteriorating steel lintels above windows and spalling concrete foundation wall below.

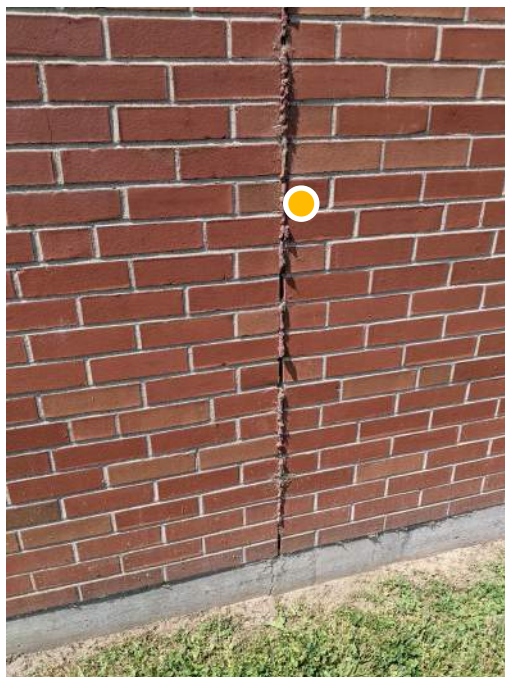
● D1. 17: Detail view of typical expansion joint in poor condition overall.

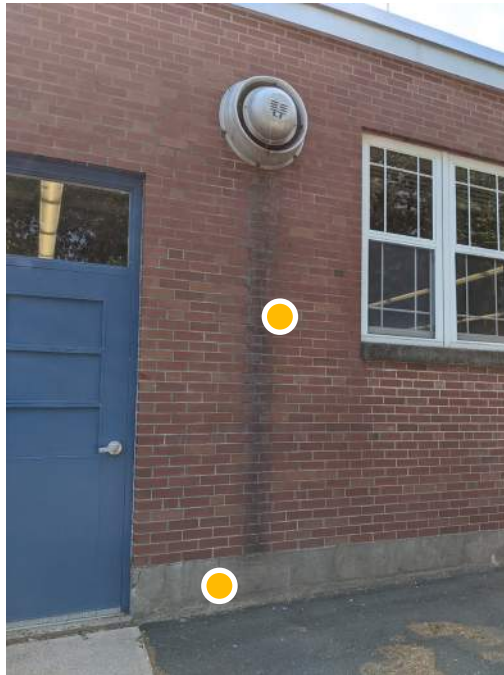
- D1. 21: Detail view of the original building facade. Note the overall fair condition of the masonry, jointing and the exposed concrete foundation wall.

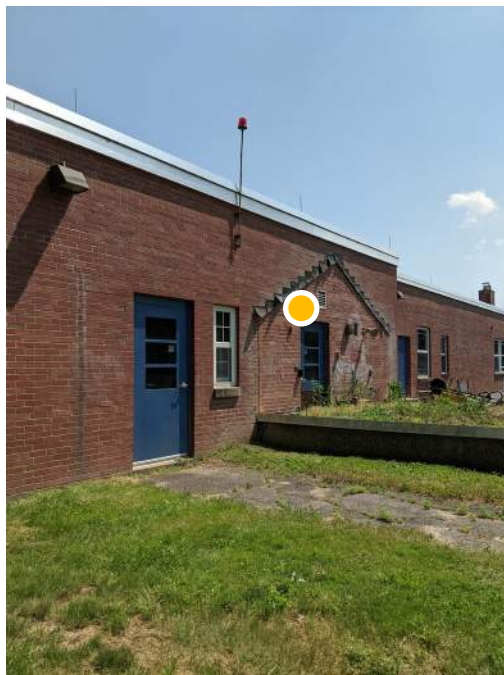
- D1. 22: View of the former greenhouse area of the 1965 Vo-ag addition, overall area in poor condition.

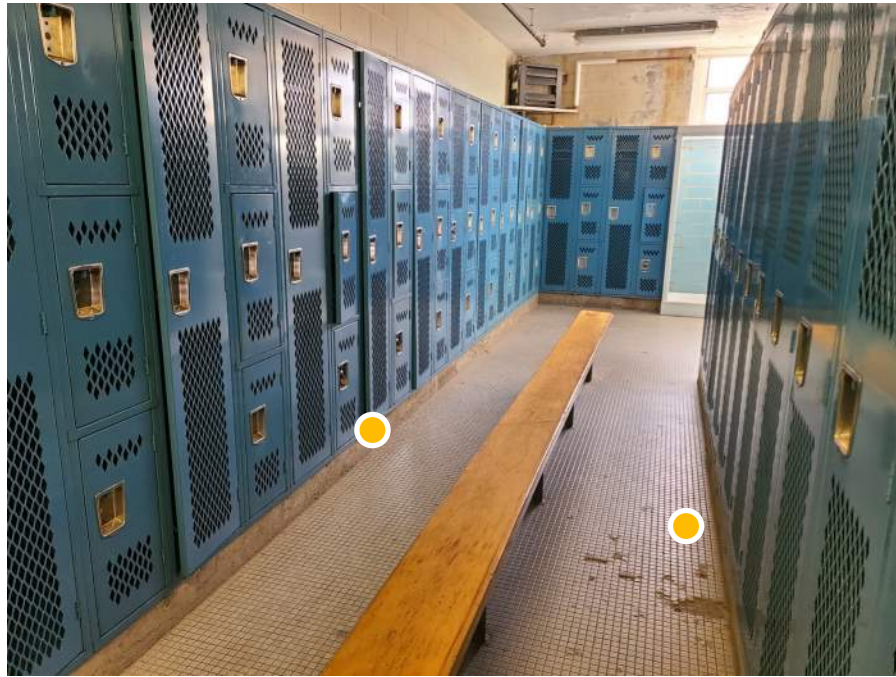
● D1. 39: Detail view of boys locker room area, does not meet current accessibility codes.

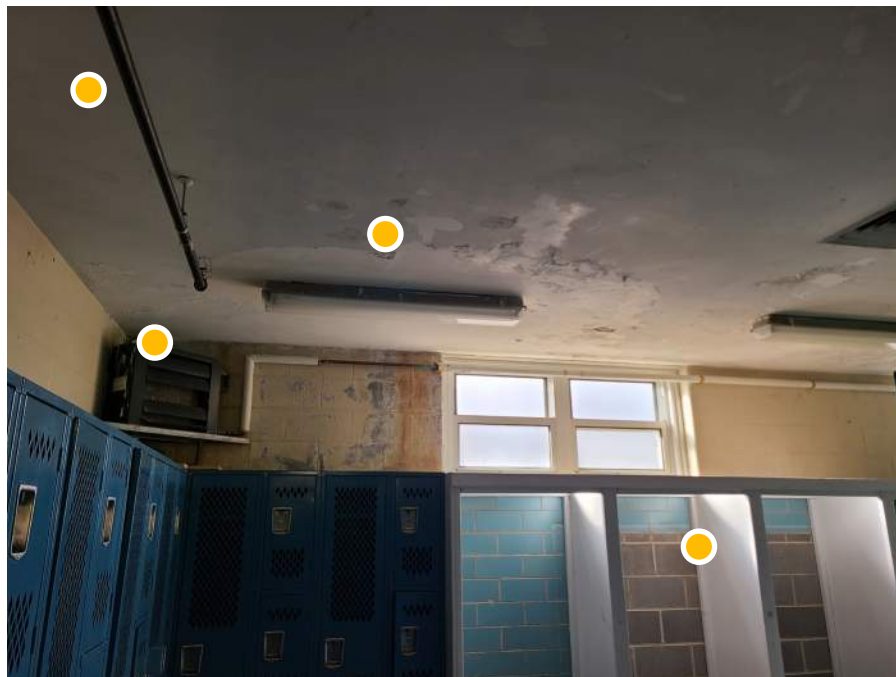
● D1. 40: Detail view of changing area retrofit in boys locker room, note poor condition of walls, ceilings, and exposed equipment and piping (original to the building).

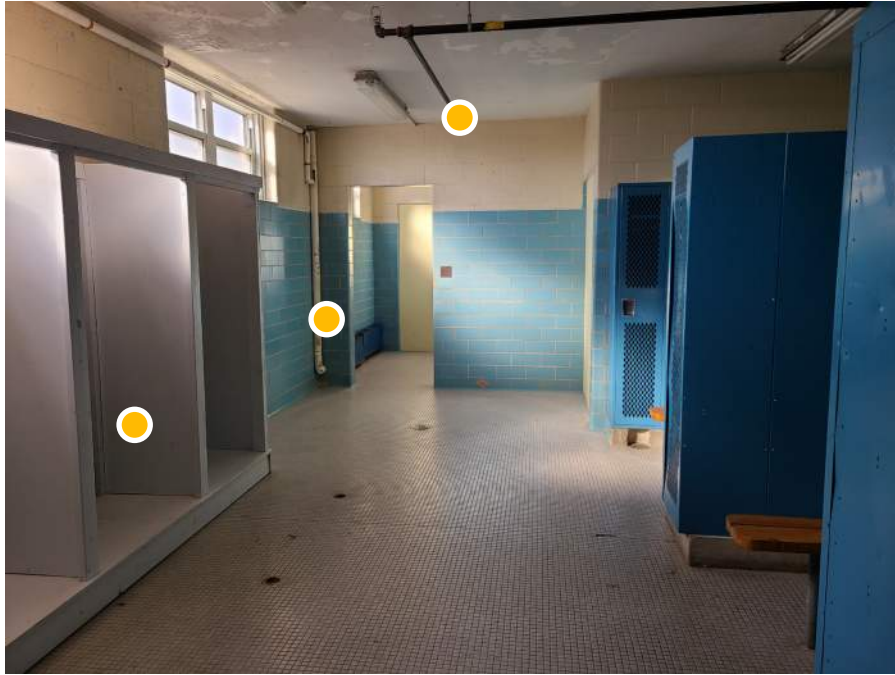
- D1. 41: Detail view of changing area retrofit in boys locker room, note poor condition of walls, ceilings, and exposed equipment and piping (original to the building).

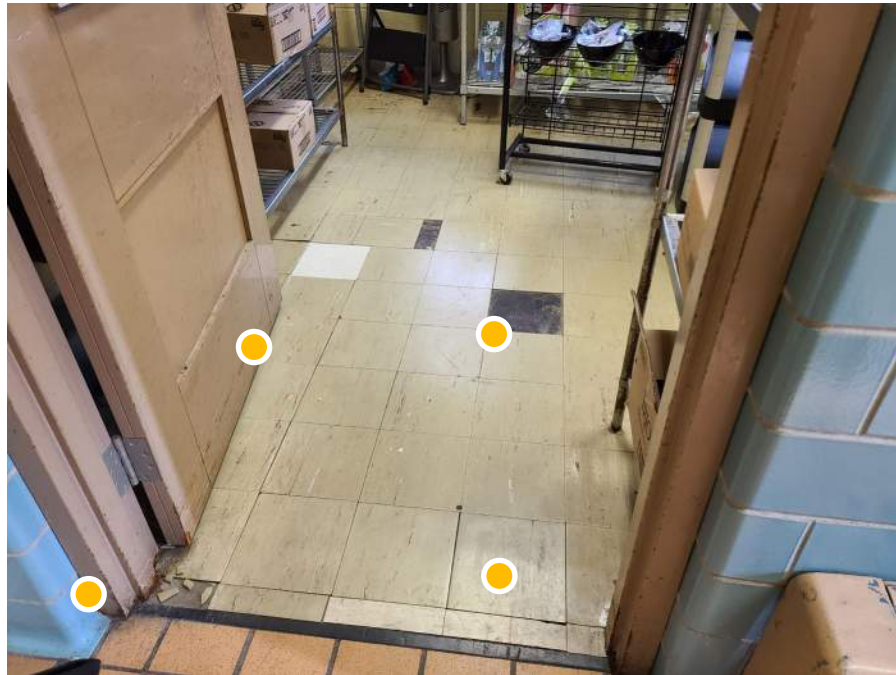
● D1. 51: Detail view of dry storage support space for the cafeteria, note the poor condition of the door, door frame and flooring.

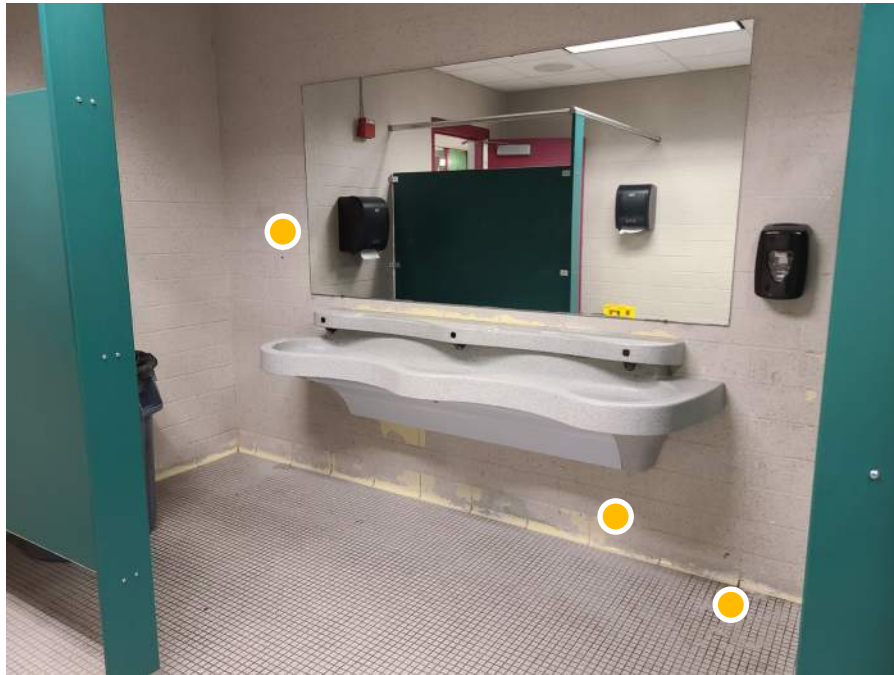
D1. 53: Typical bathroom retrofit in original two story classroom portion of the building, note the condition of the walls and floors

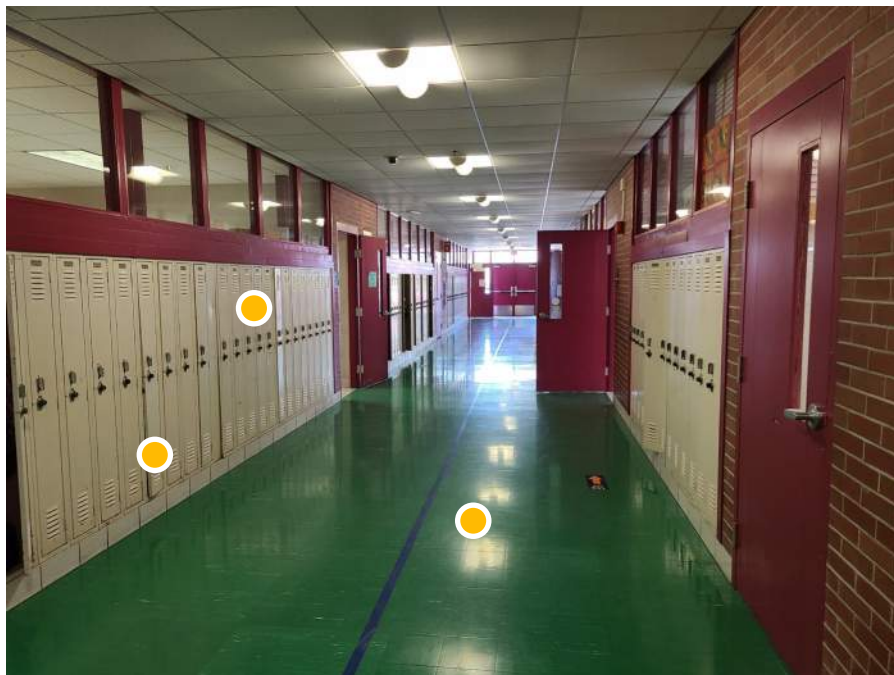
D1. 54: View of second floor classroom corridor, note possible vinyl asbestos tile flooring and overall condition of original lockers.

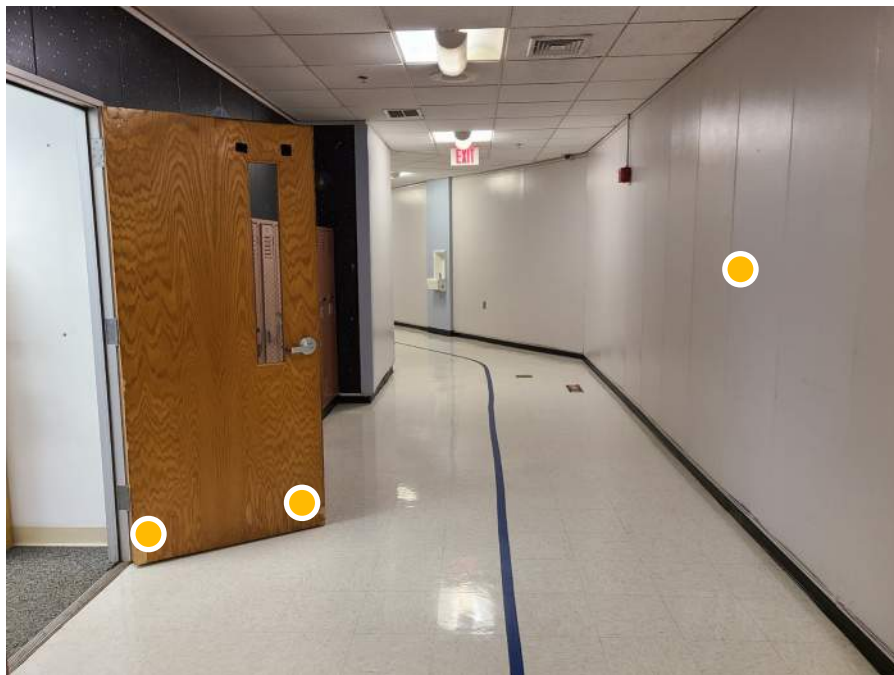
D1. 58: View of 1972 connecting corridor with modular wall construction, note condition of door and hardware.

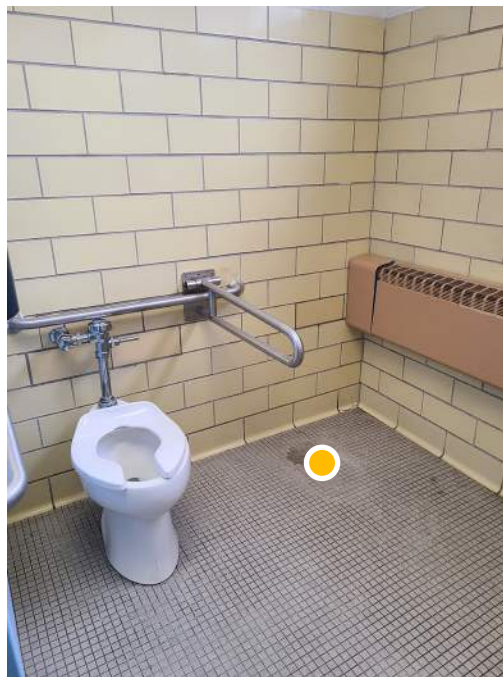
● D1. 60: Detail view of toilet fixture reconfiguration to meet accessibility codes, note floor patching and repairs

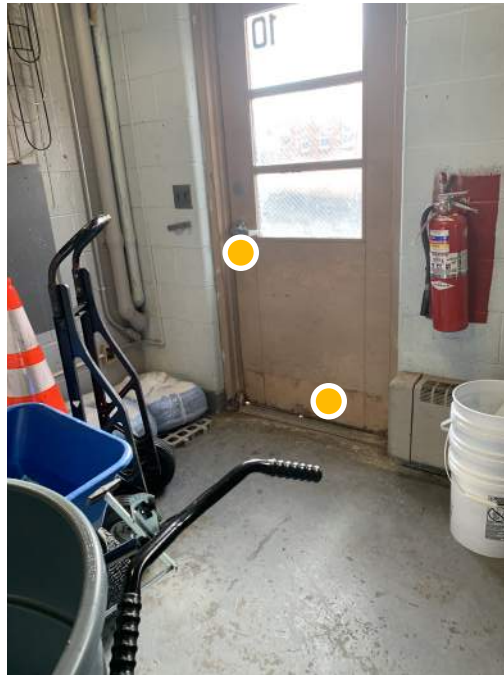
● D1. 65: Detail view of custodial / storage room, note condition of exterior door.

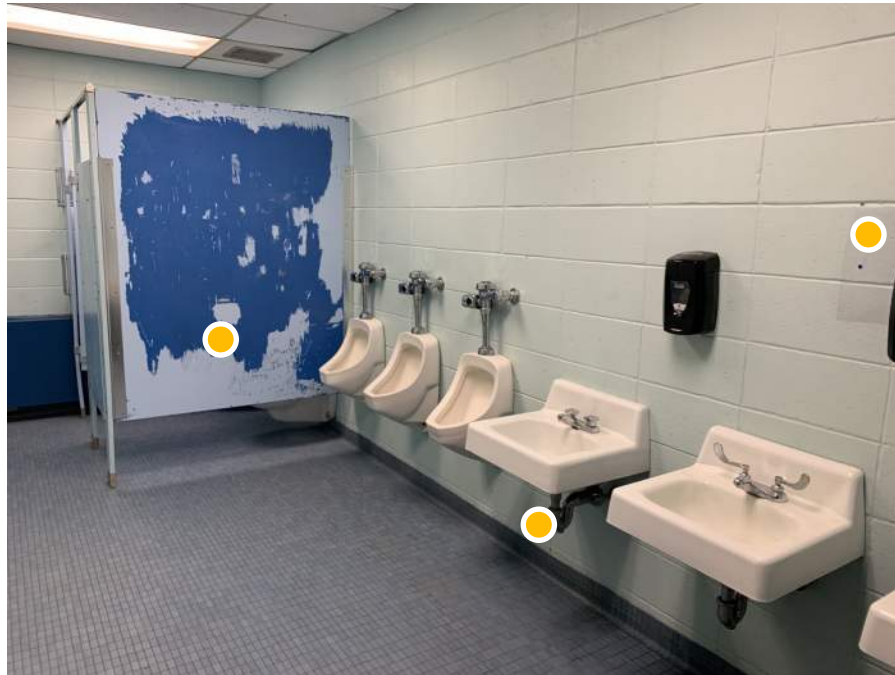
● D1. 67: Typical bathroom retrofit in original building, note the condition of the metal toilet partitions, does not meet current accessibility codes.

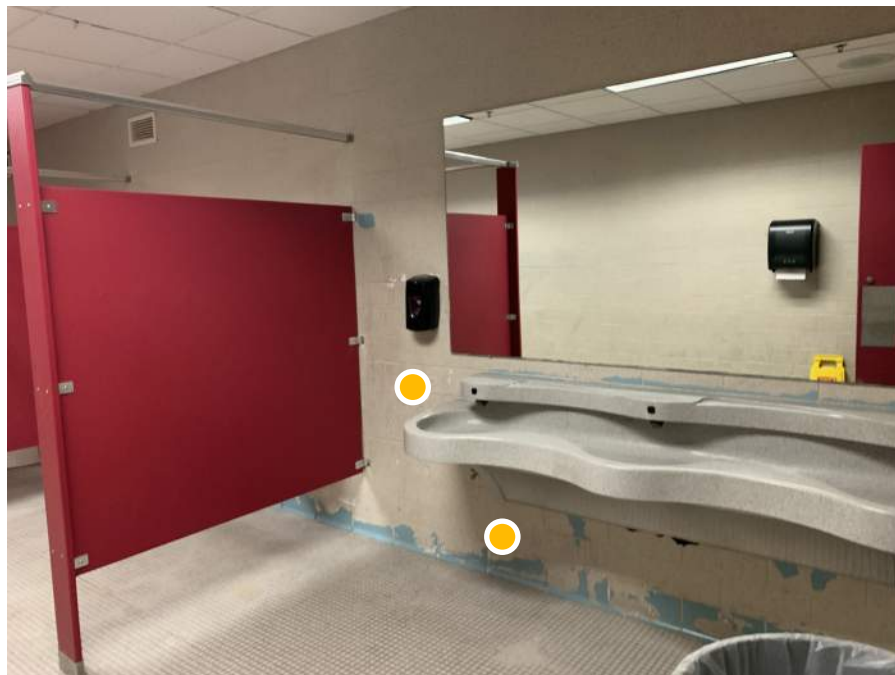
● D1. 68: Typical bathroom retrofit in original building of the building, note the condition of the walls.

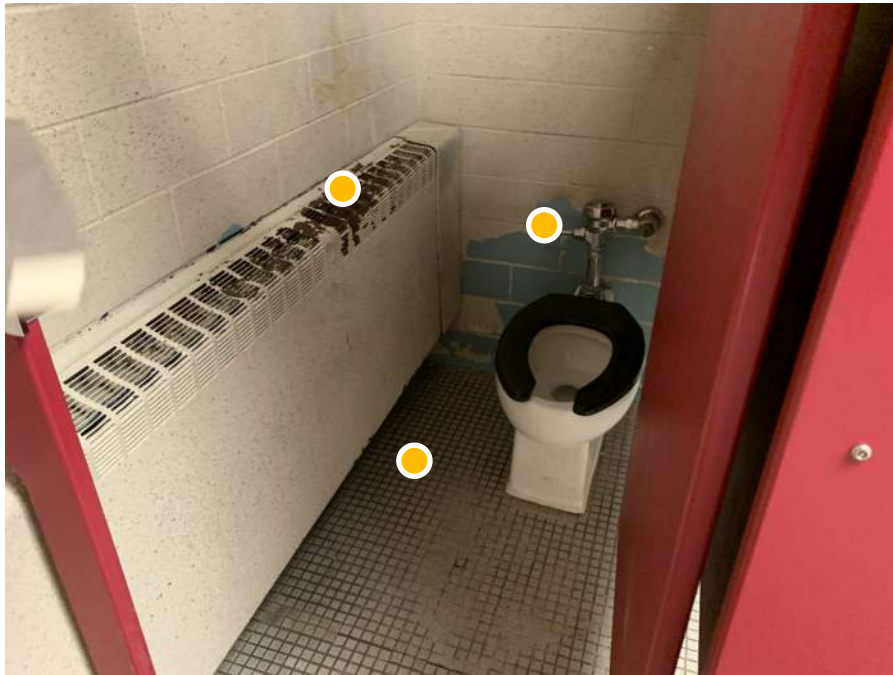
- D1. 69: Detail view of unit cabinet heater adjacent to plumbing fixture retrofit, does not meet current accessibility codes.

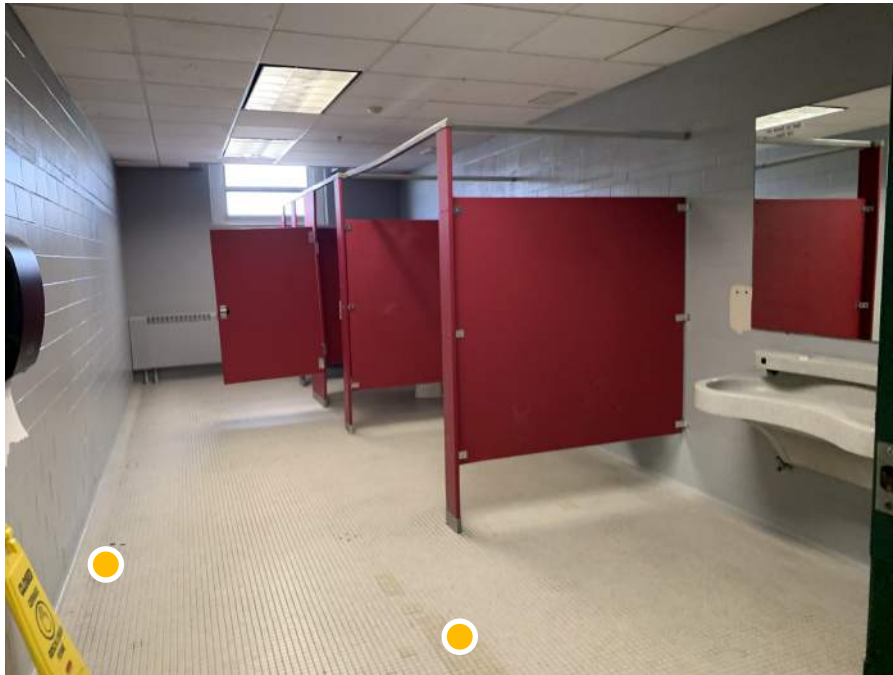
- D1. 73: Typical bathroom retrofit in original building, note the condition of the patched/retrofit floors, does not meet all current accessibility codes.

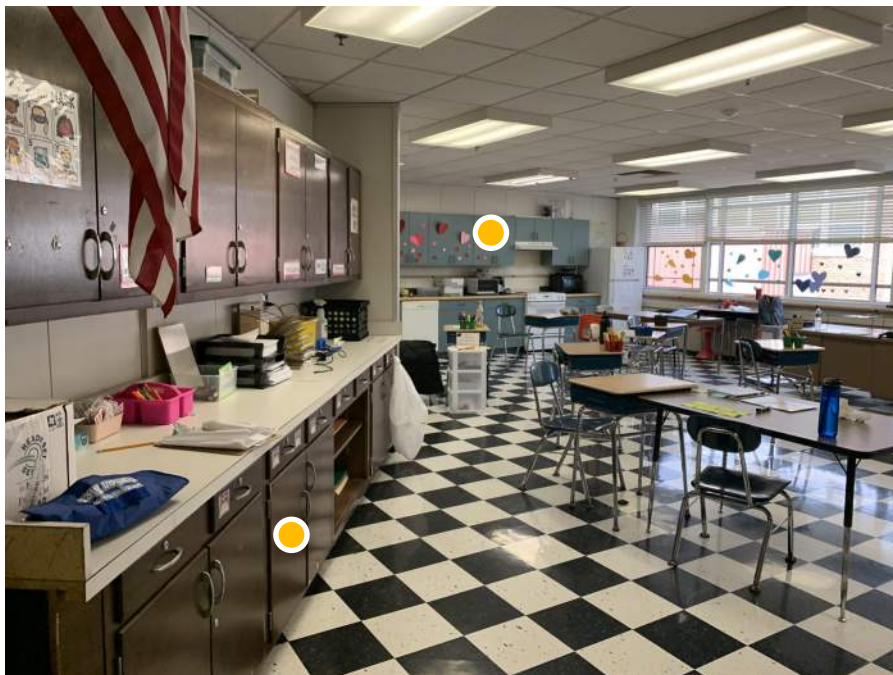
- D1. 74: View of home economic/life skills room with original cabinetry and millwork (left) and modest upgrades beyond, does not meet all current accessibility codes.

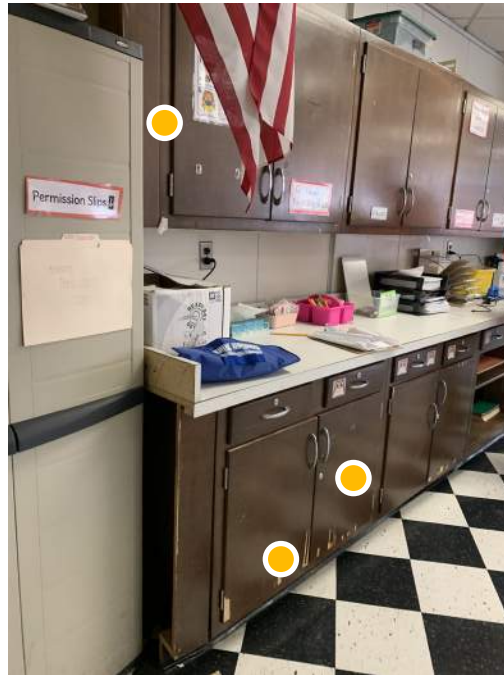
● D1. 75: View of home economic/life skills room with original cabinetry and millwork in poor condition, original to 1972 addition.

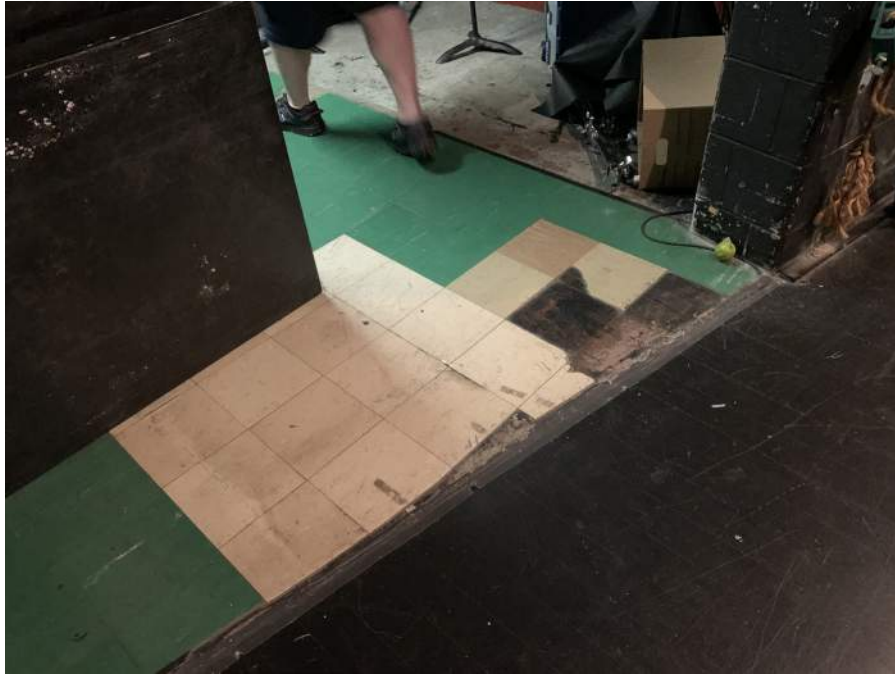
● D1. 81: Detail view of patched/retrofit flooring at stage/storage areas, note condition of floor and possible VAT flooring.

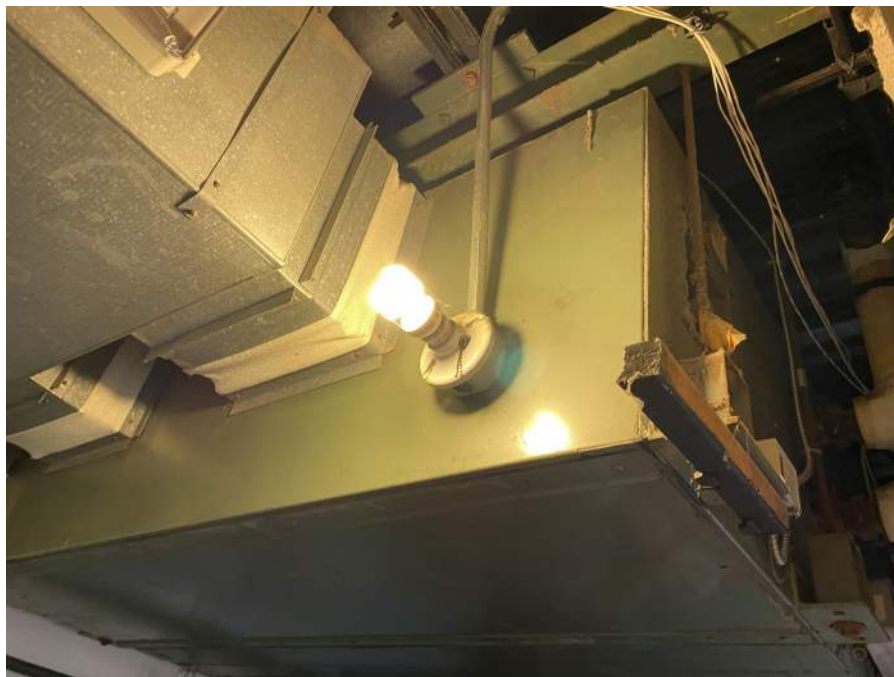
● D2. 2: Air Handling Unit Serving Girls Locker Room in Poor Condition.

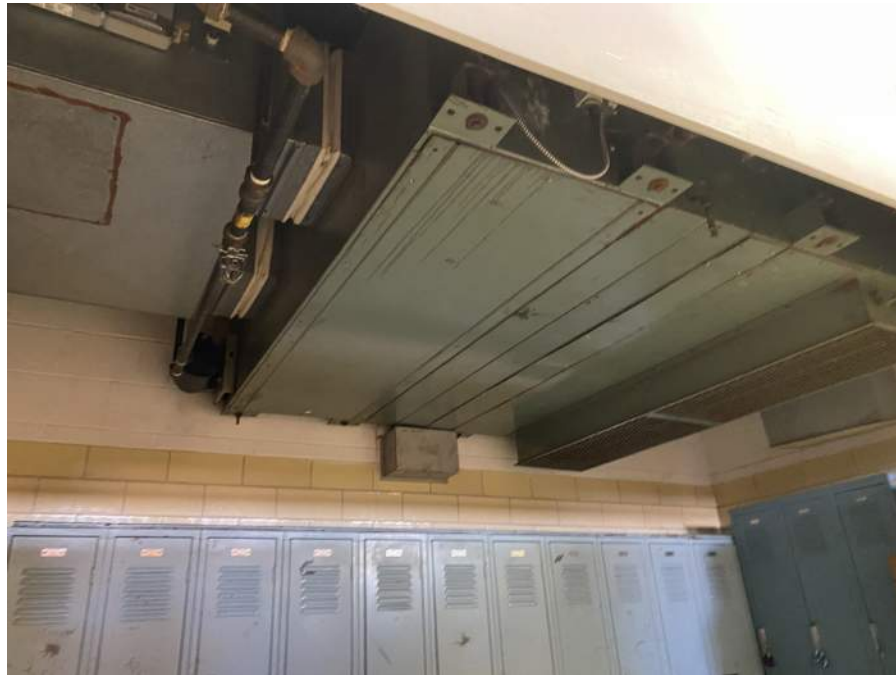
● D2. 3: Air Handling Unit Serving a Locker Room in Poor Condition.

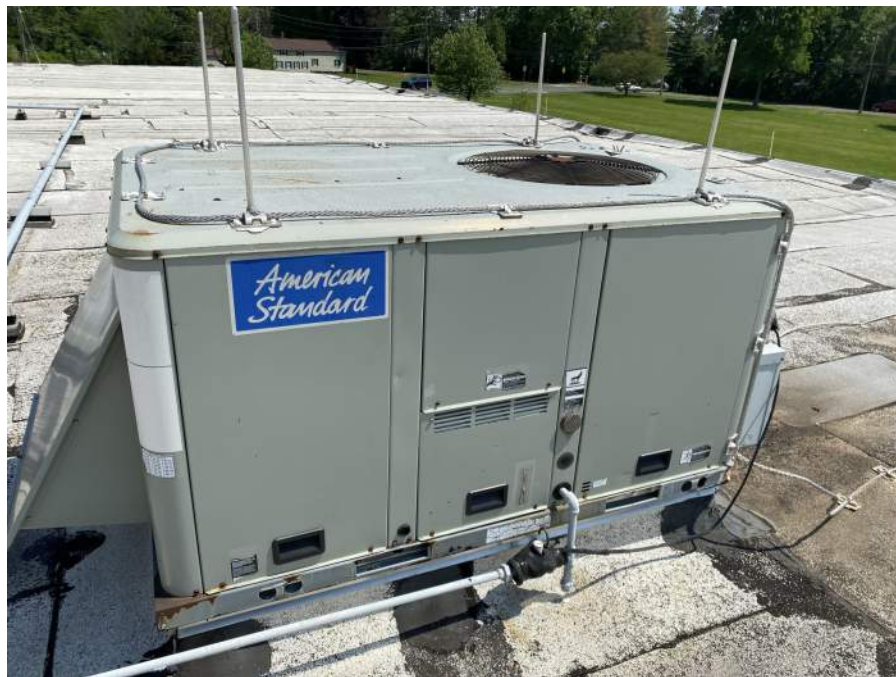
● D2. 4: American Standard Rooftop Unit in Poor Condition.

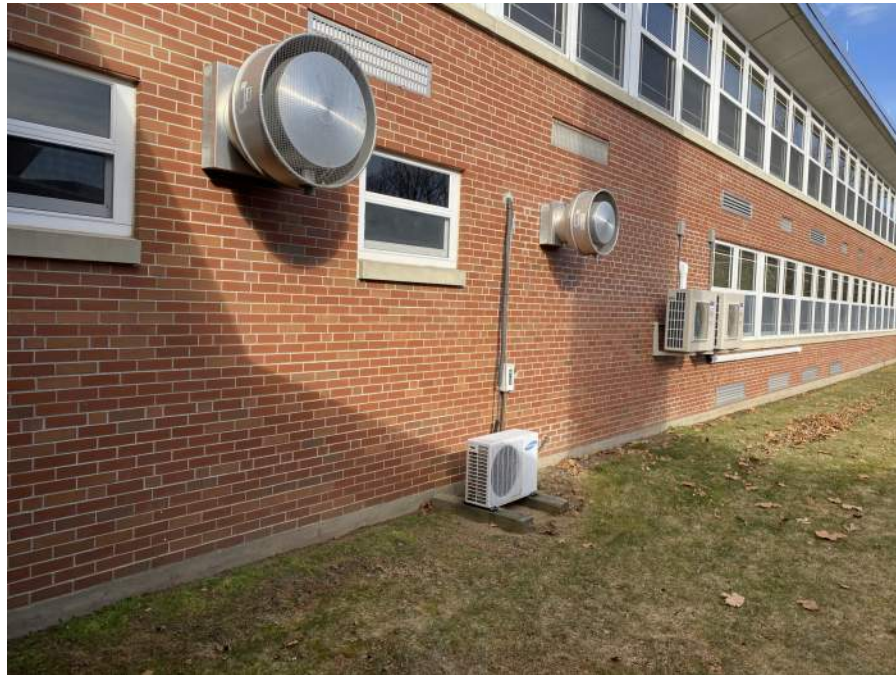
● D2. 7: Condensing Units and Wall Mounted Exhaust Fans Outside in Fair Condition.

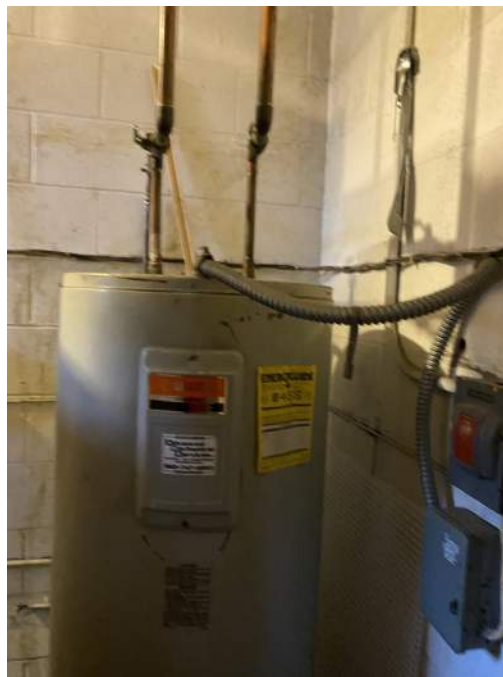
● D2. 8: Domestic Water Heater in Poor Condition.

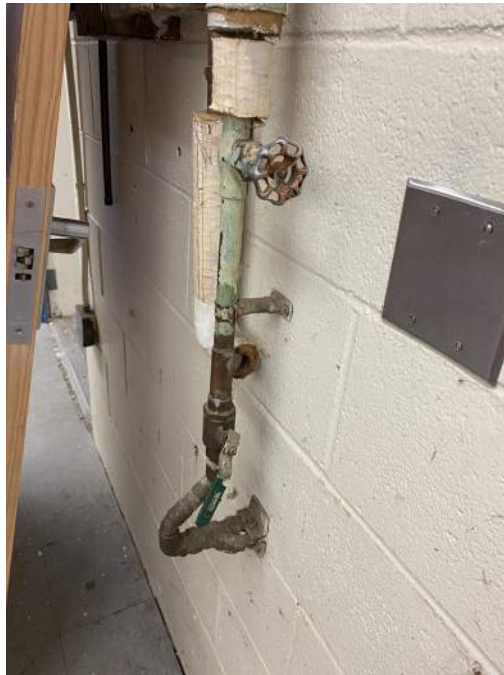
● D2. 9: Domestic Water Piping in Very Poor Condition.

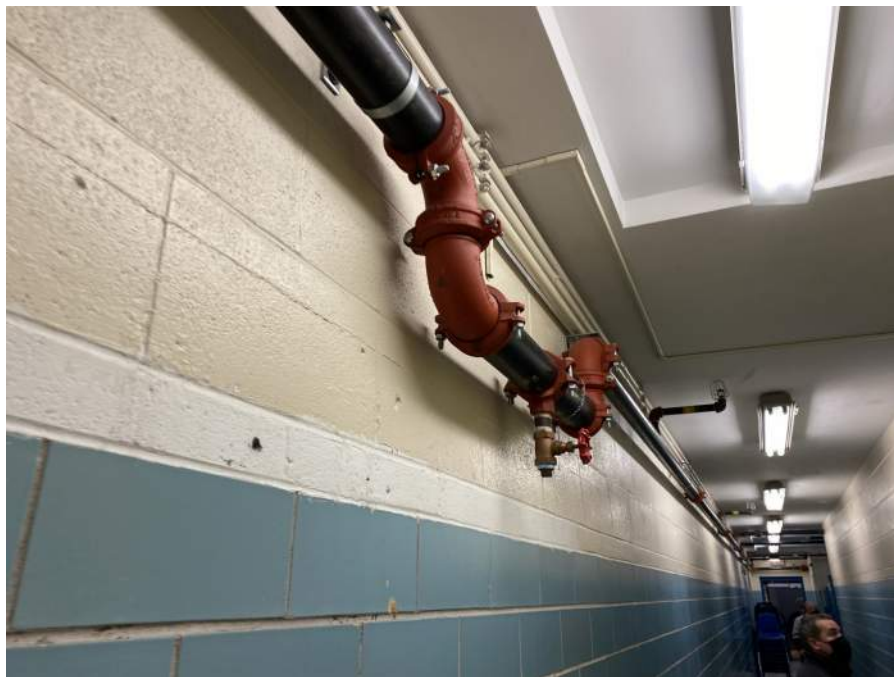
● D2. 26: Fire Protection Piping and Sprinkler Heads in Fair Condition.

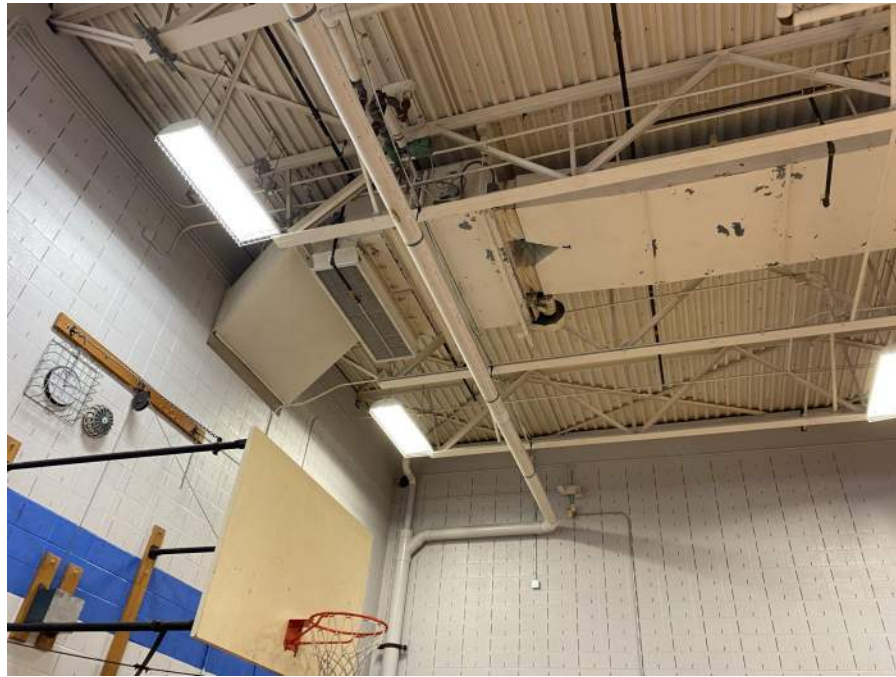
● D2. 27: Gymnasium Air Handler and Ductwork in Poor Condition.

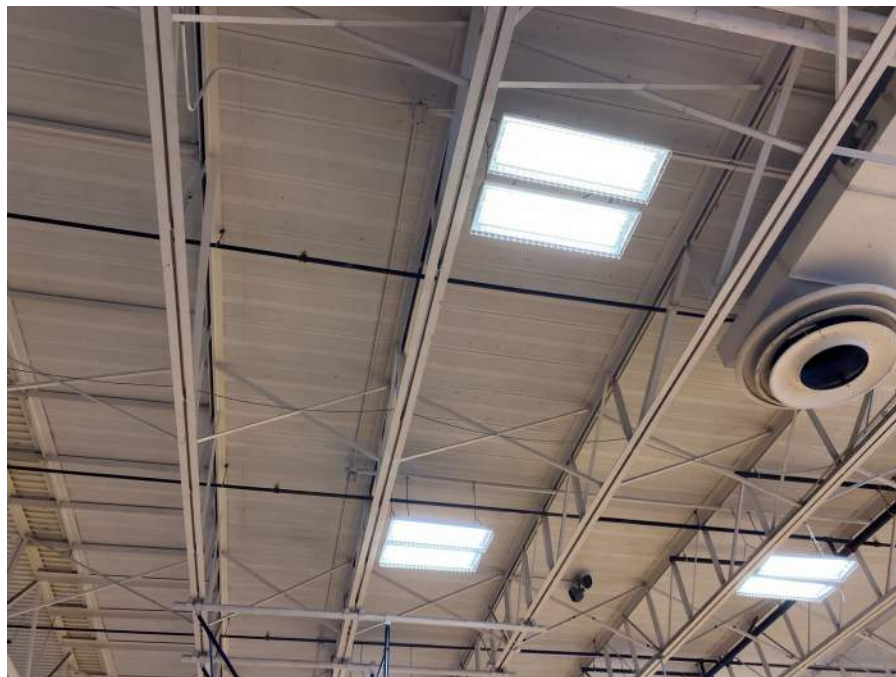
● D2. 28: Gymnasium Fire Protection Pipes and Sprinklers in Good Condition.

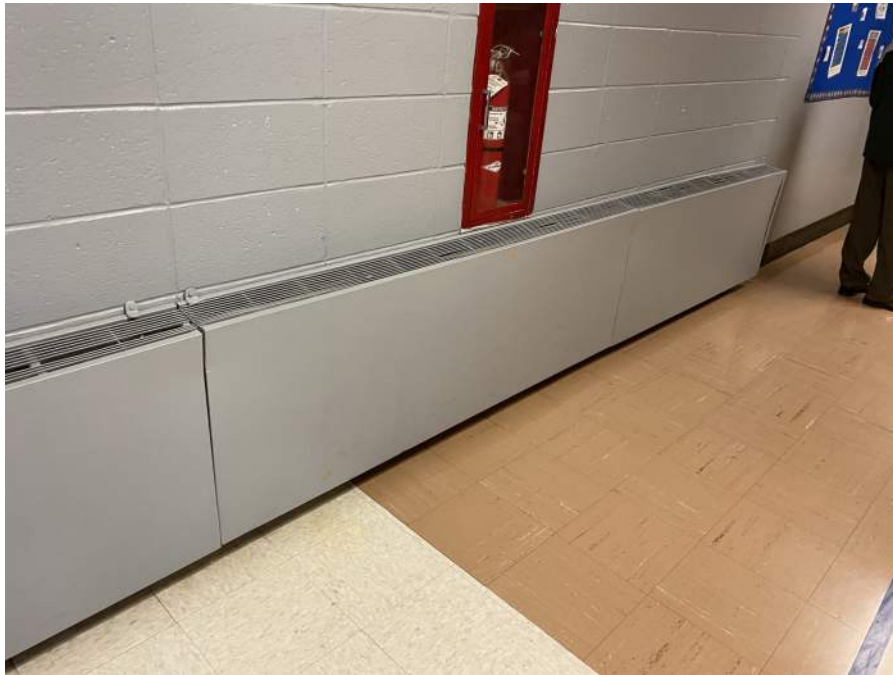
● D2. 33: Hot Water Convactor in Poor Condition.

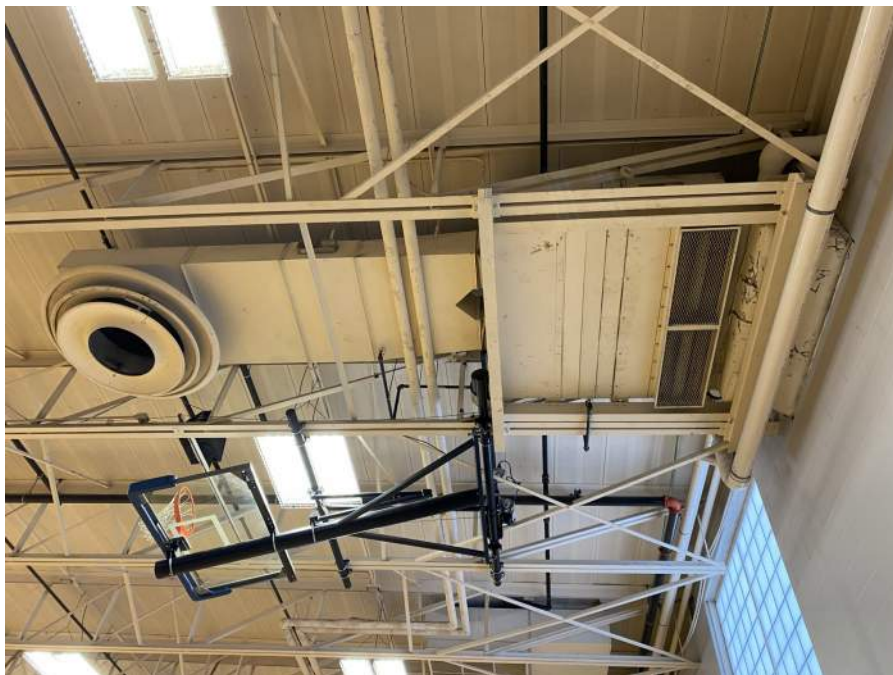
● D2. 34: Hot Water Piping in Gymnasium in Poor Condition.

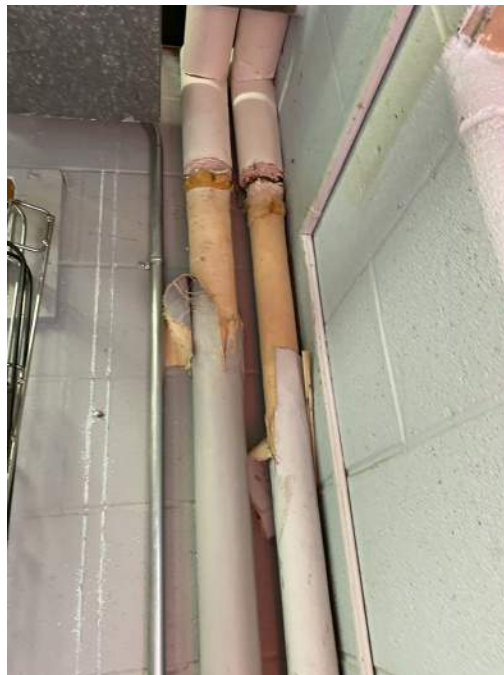
● D2. 35: Hot Water Piping in Poor Condition.

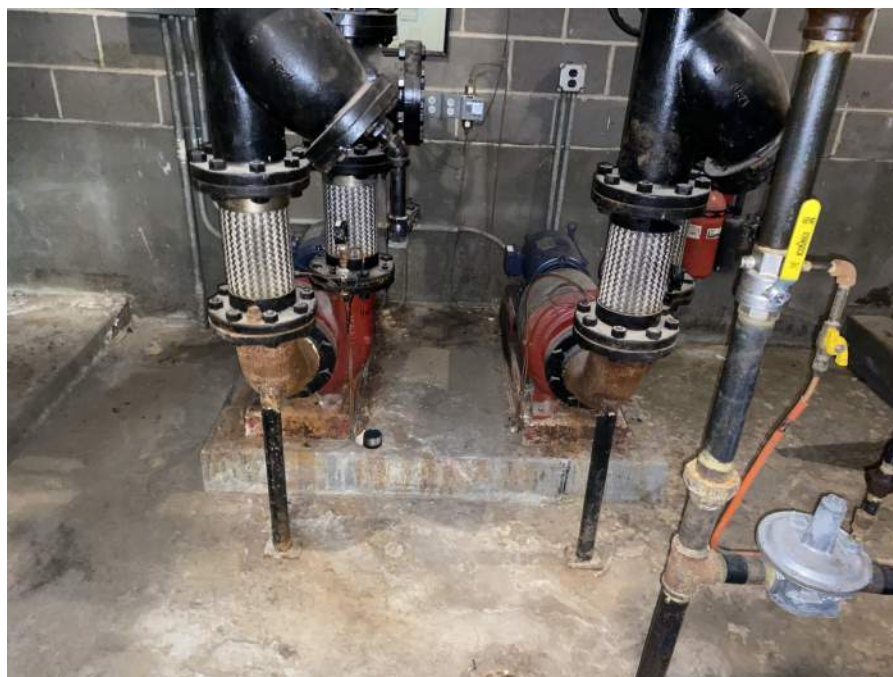
● D2. 36: Hot Water Pumps in Poor Condition.

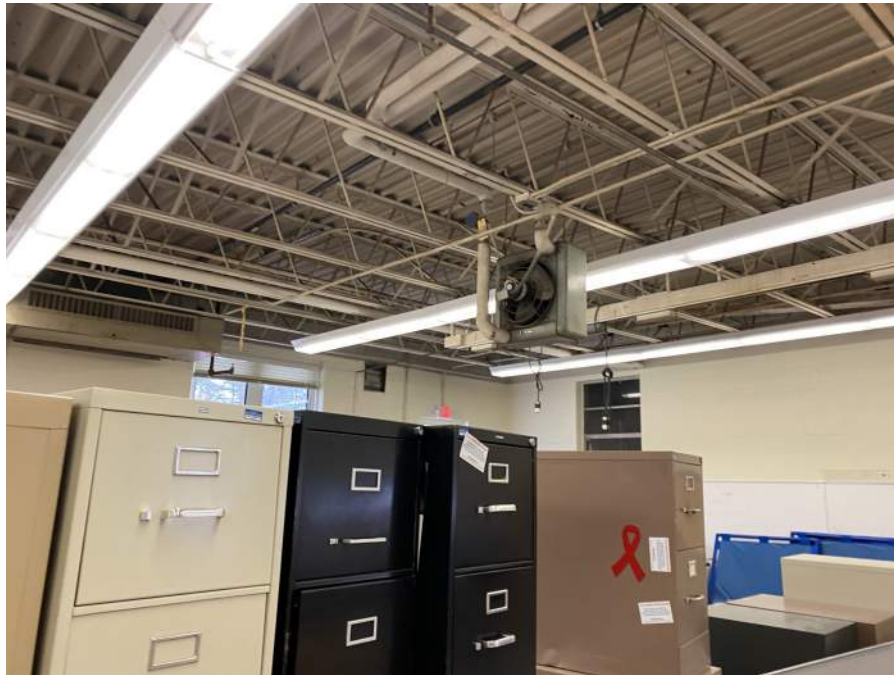
● D2. 37: Hot Water Unit Heater and Piping in Poor Condition.

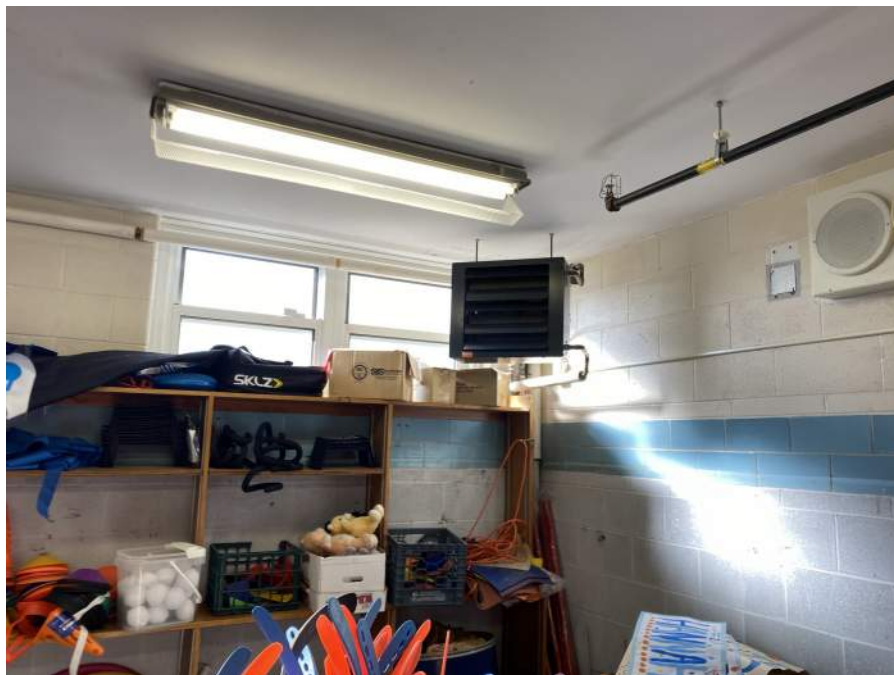
● D2. 38: Hot Water Unit Heater in Fair Condition.

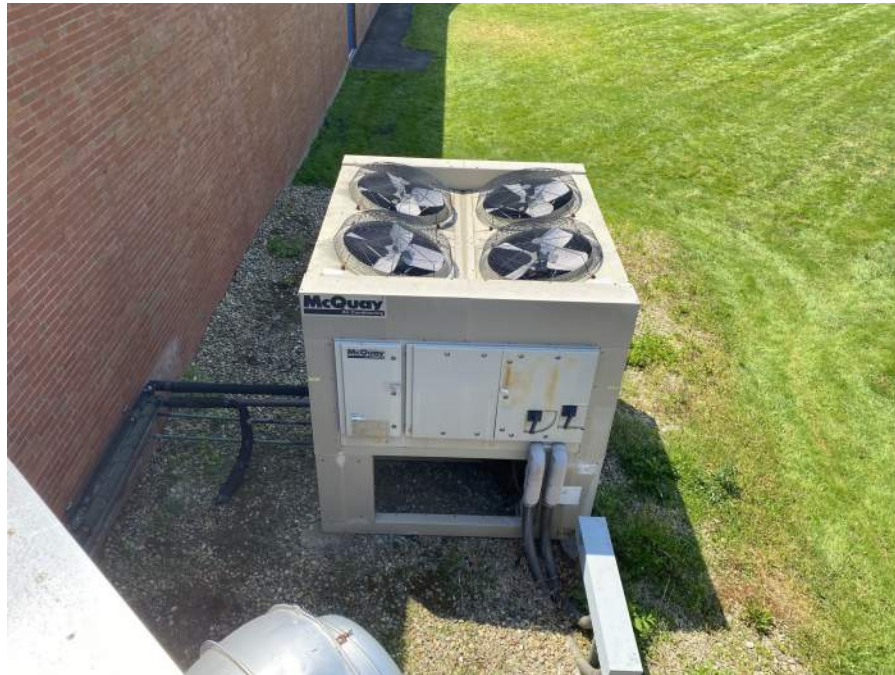
● D2. 47: McQuay Condensing Unit in Poor Condition.

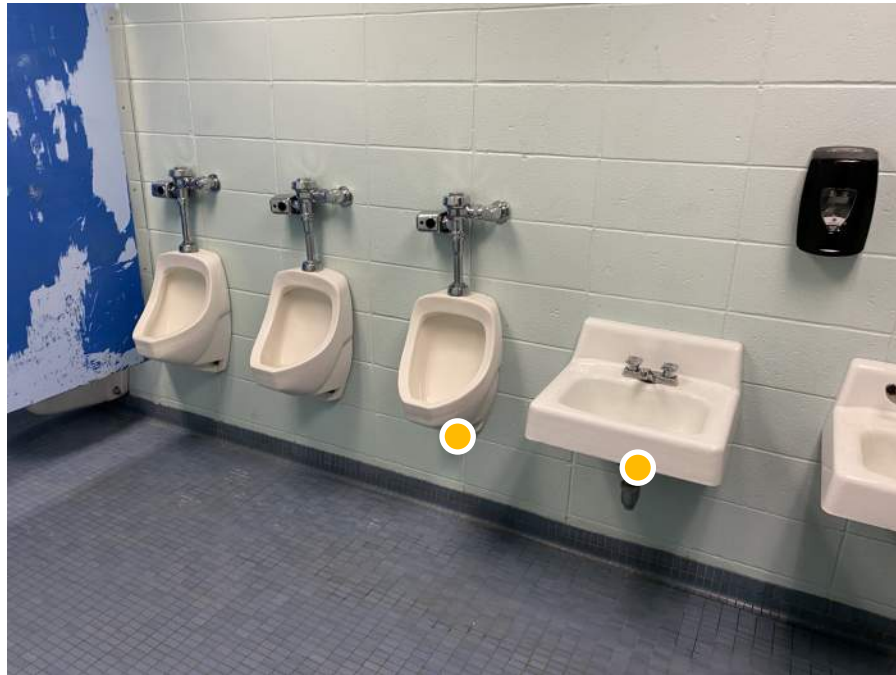
● D2. 51: Detail view of fixture replacement retrofit, does not meet all current accessibility codes.

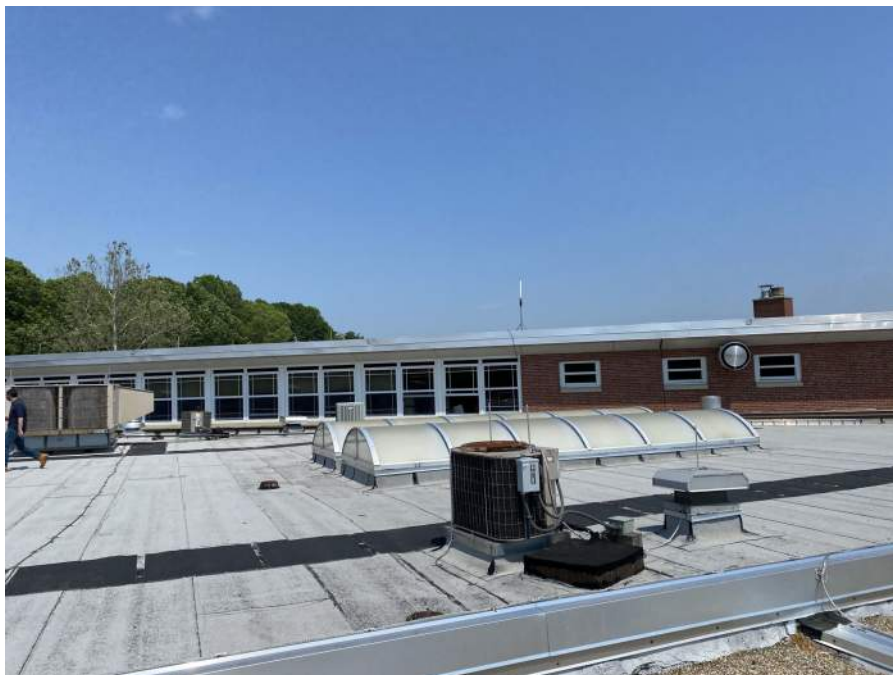
● D2. 54: Roof Mounted Condensing Unit in Poor Condition.

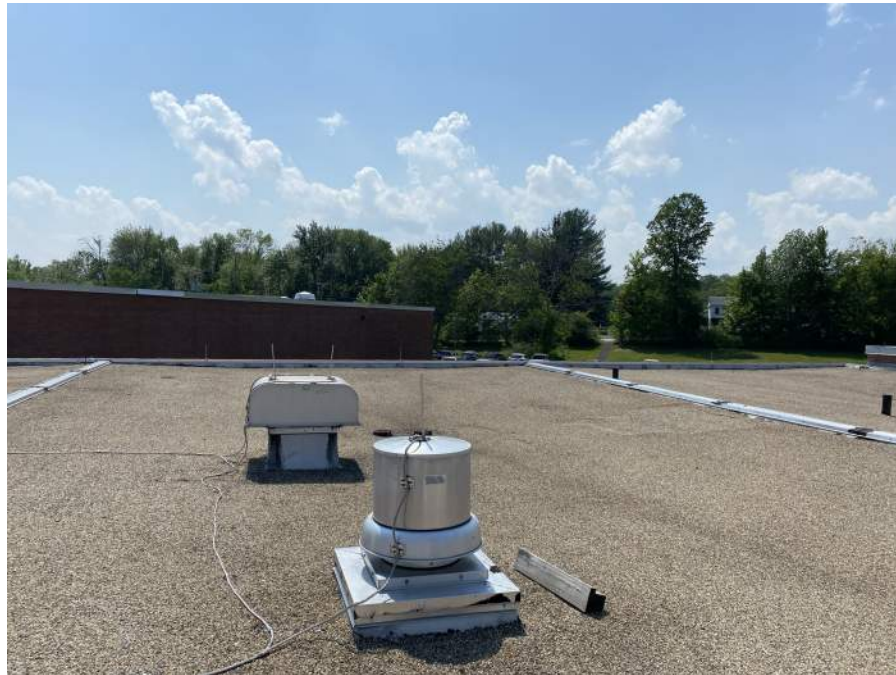
● D2. 55: Roof Mounted Exhaust Fans in Poor Condition.
