# TOWN OF SUFFIELD

## CONDITIONS ASSESSMENT & MASTER PLAN

## SUFFIELD MIDDLE SCHOOL - 350 MOUNTAIN RD, SUFFIELD, CT

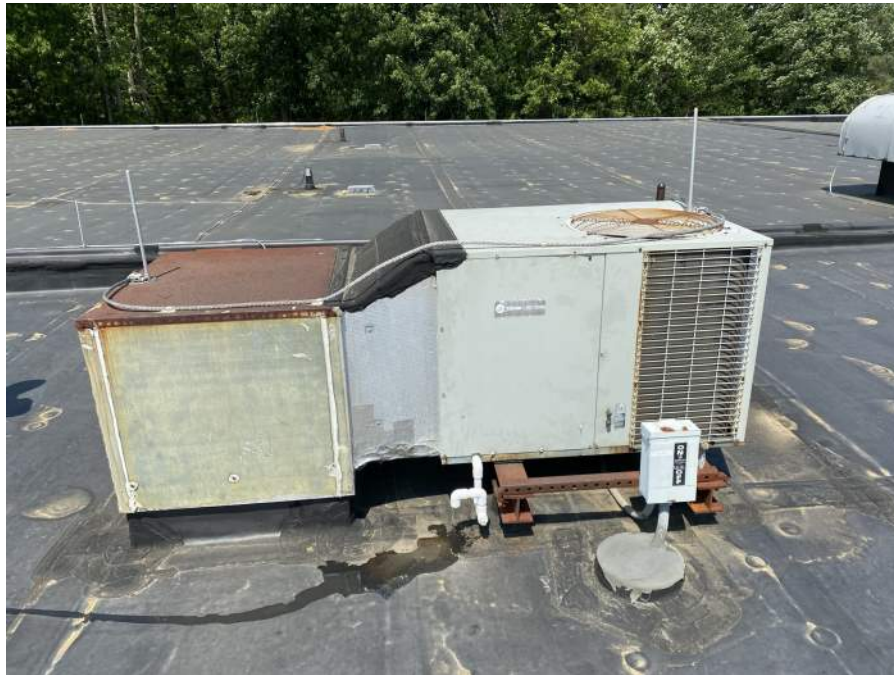
● D2. 57: Small Trane Unit in Poor Condition.

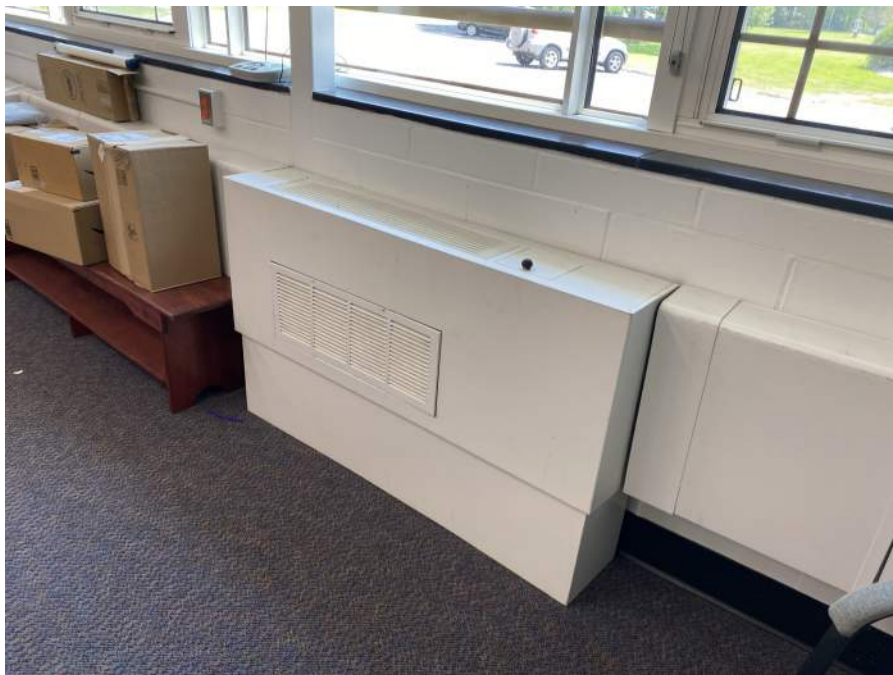
● D2. 62: Typical PTAC Unit in Poor Condition.

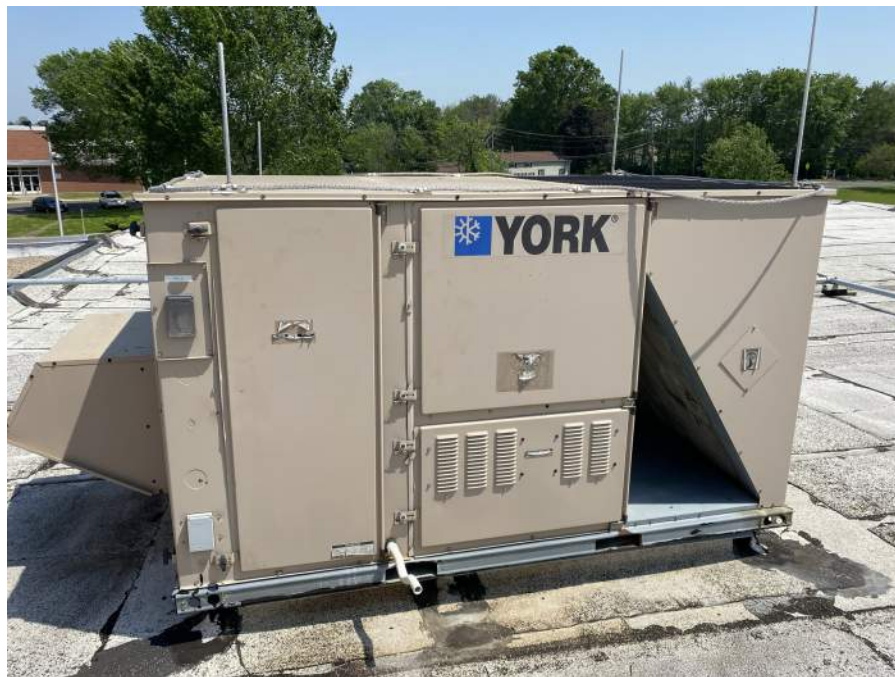
● D2. 64: Typical York Rooftop Unit in Poor Condition.

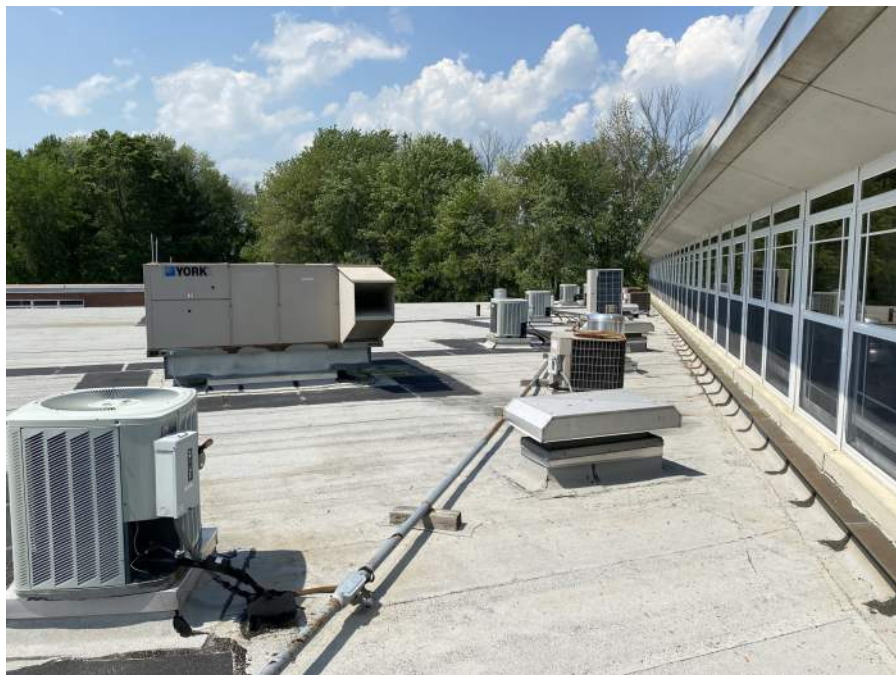
● D2. 66: Various Mechanical Equipment on Roof in Poor Working Condition.

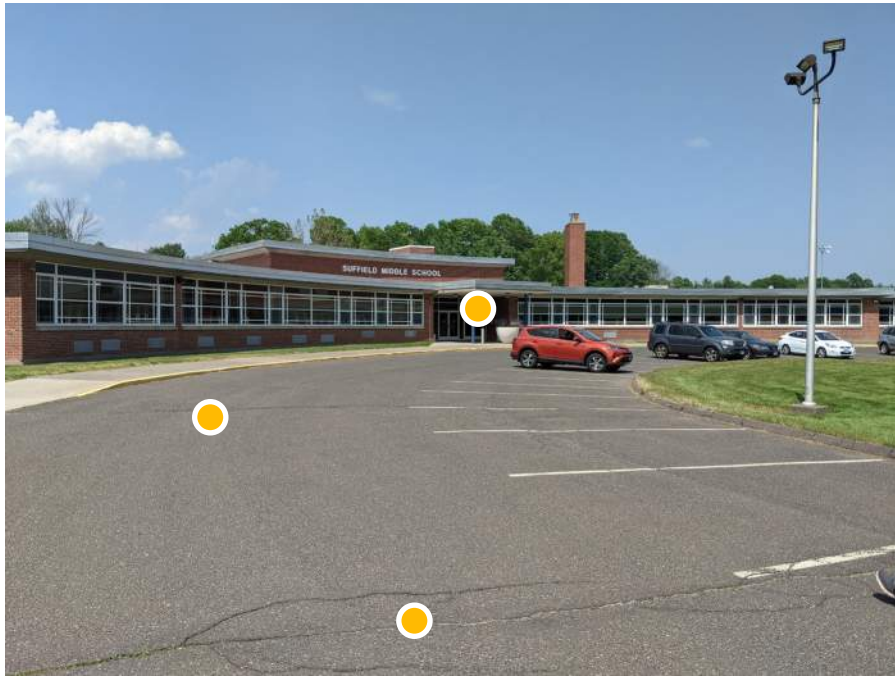
- D3. 5: View of main entry and administration offices to middle school, note the poor condition of asphalt drive and parking in the foreground.
