**Lead Inspection Report for  
Oxnard Union High School District  
Adolfo Camarillo High / Exterior Walls  
Camarillo, California 93012**

TC Project No. 104643

May 13, 2026

**LEAD INSPECTION REPORT**

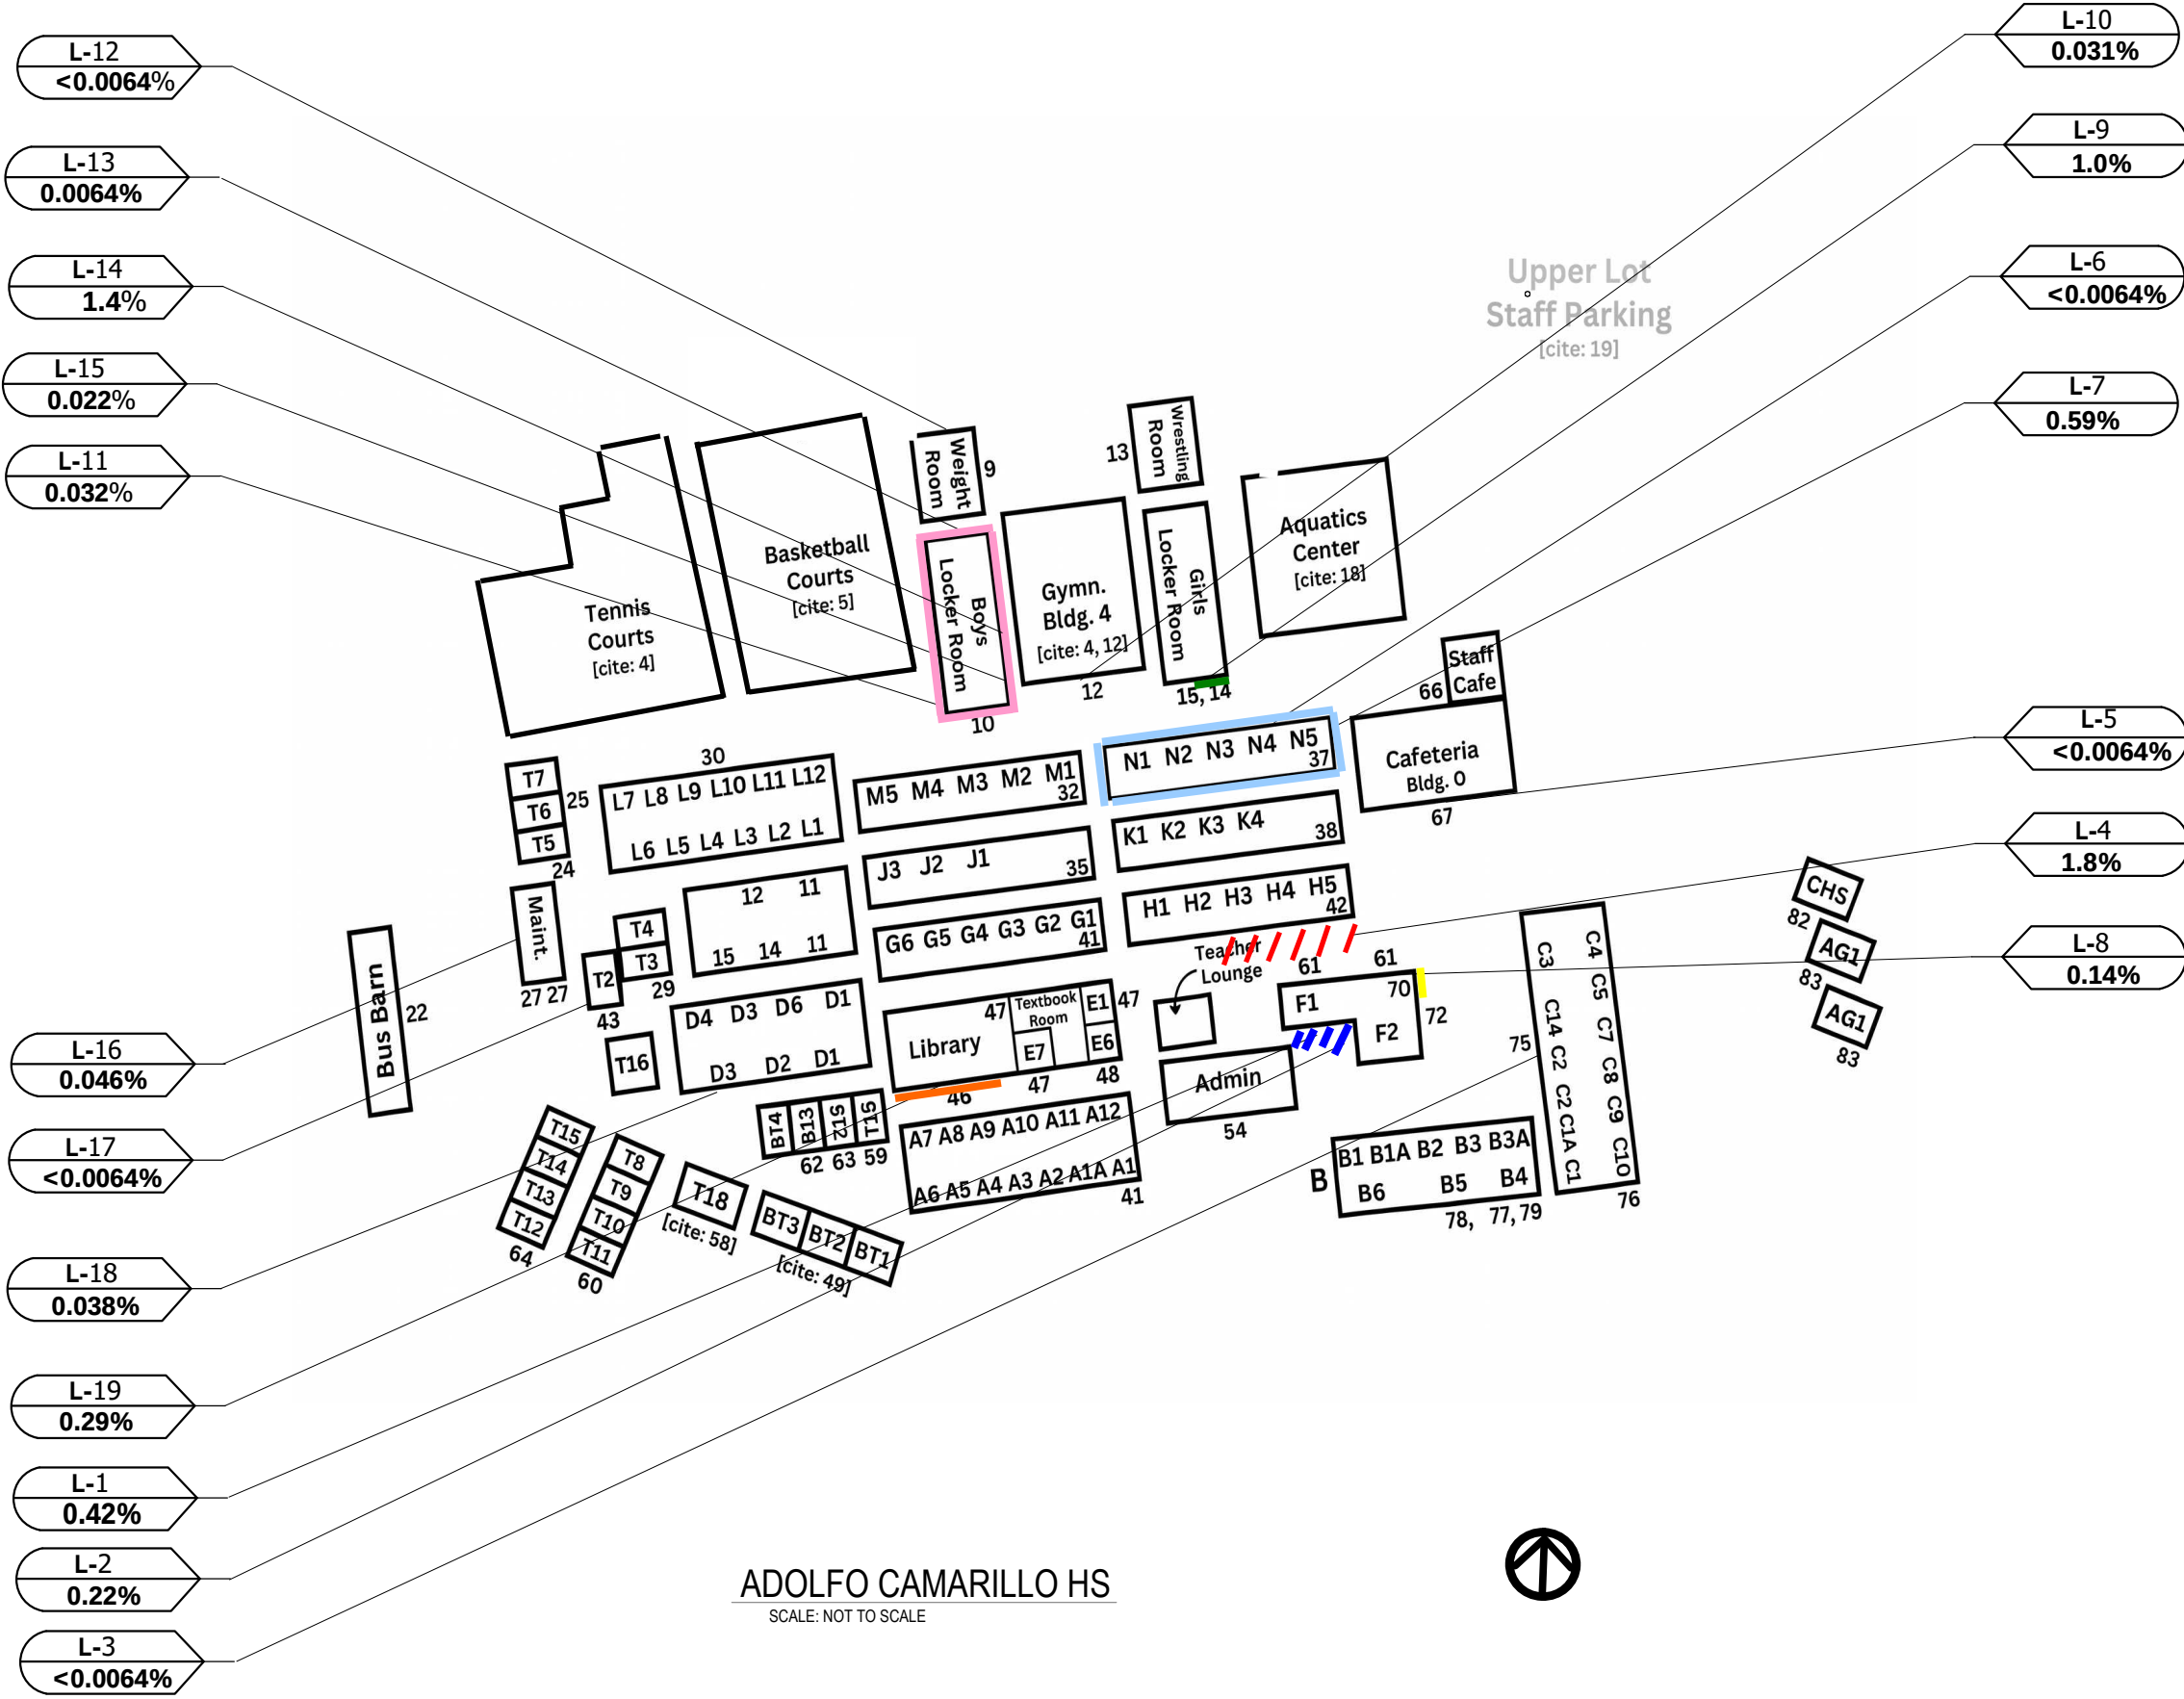
### **SAMPLE LOCATION PLAN**

| MATERIAL | QTY. | DESCRIPTION |
|---|---|---|
| | | Beige Wood Ceiling Walkway Containing 18,000 ppm |
| | | Beige Wood Window Frame Containing 1,400 ppm |
| | | Beige Ceiling & Blue Brown Fascia (wood) Containing 4,200 & 2,200 ppm |
| | | Blue Wood Fascia containing 5,900 ppm |
| | | Beige Window Frame Containing 1,000 ppm |
| | | Beige Soffit Containing 2,900 ppm |
| | | Blue Wood Fascia Containing 14,000 ppm |
