**CLOSE OUT REPORT FOR WORK  
ORDER #12281  
CAREY RIDGE ELEMENTARY  
May 29, 2026**

Facility: Carey Ridge Elementary

### Description of Problem

Water test in the cafeteria area.

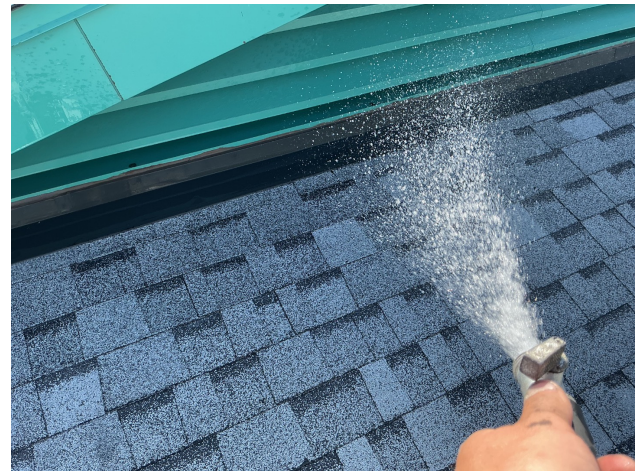
Water tested louver and counter flashing - leak did not activate

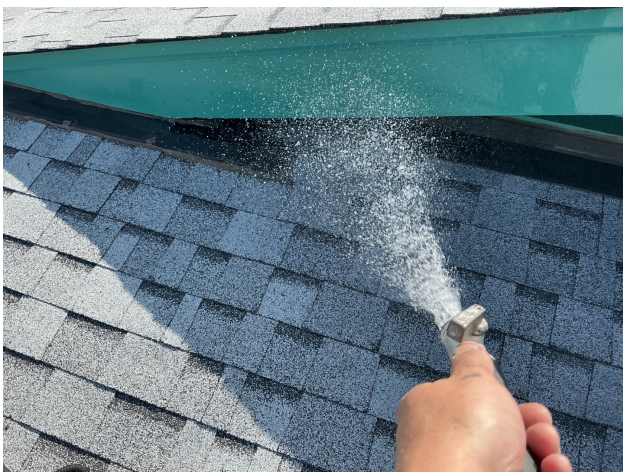
Water tested corner of louver and soffit - leak did not activate

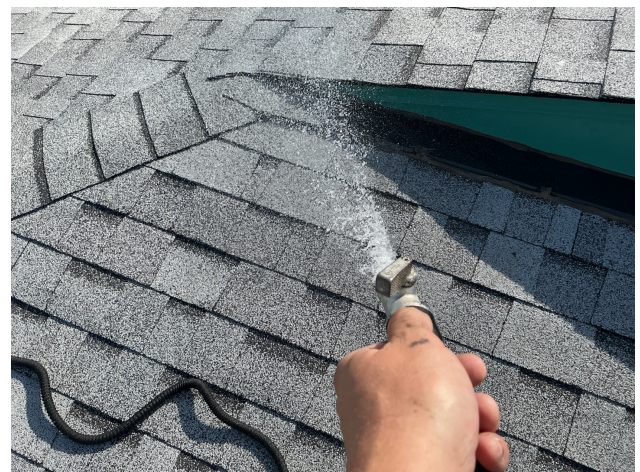
Water tested corner of hip cap where it meets the green metal - leak immediately activated inside cafeteria

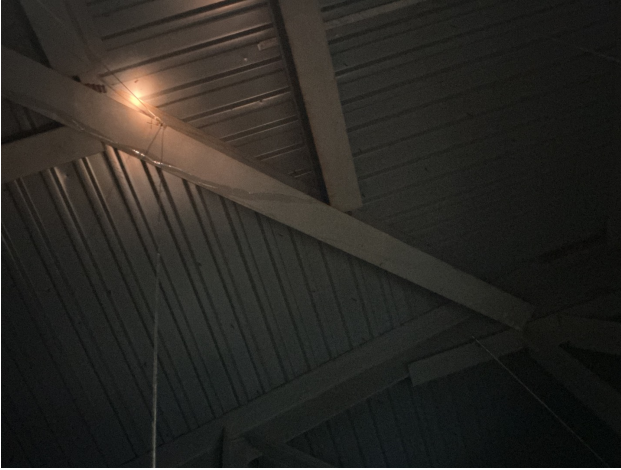
Water test performed and leaked an exact spot running down I-beam

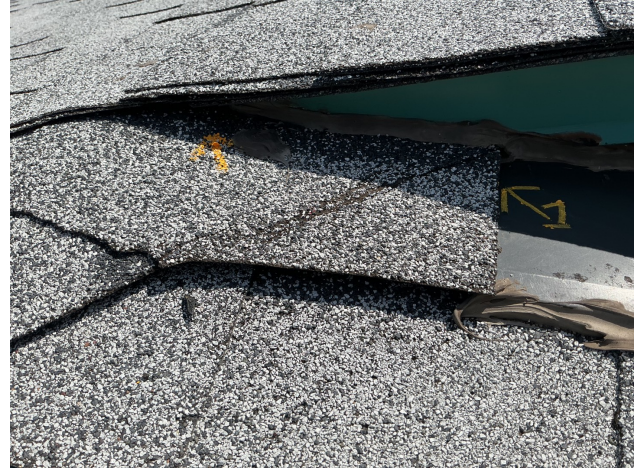
We returned on 5/28/2026 and we checked in at the front office. We then proceeded to water test leaking area in the cafeteria and was able to get it to leak in the exact spot. It was leaking from the corner of the louver where the hip cap meets the louver flashing. We removed the first hip cap and found it was wide open. The louver flashing did not extend far enough. We installed a diverter flashing, then reinstalled the hip cap for a permanent repair. We also performed another water test after the repair was complete, and the leak did not activate, indicating a successful repair. We cleaned up all work-related material and debris and demobilized from the site.

Corner of louver flashing was allowing water to enter the roof system

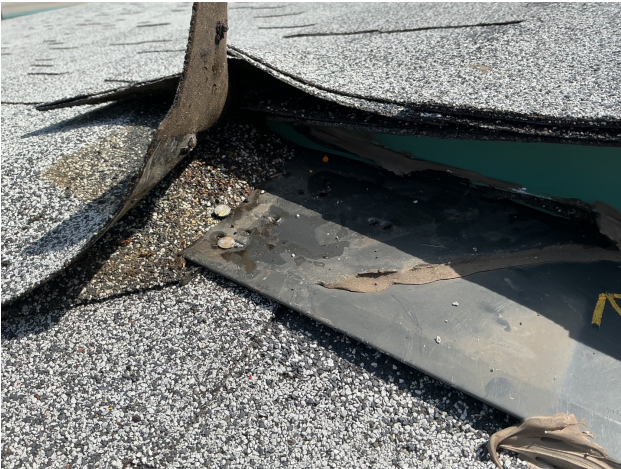
Removed first piece of hip, revealing that the area is wide open for water to enter the roof system
