DOTHAN CITY BOE

GIRARD INTERMEDIATE SCHOOL
MANAGEMENT PLAN

ASBESTOS-CONTAINING
MATERIALS

Updated
June 2, 2026
By

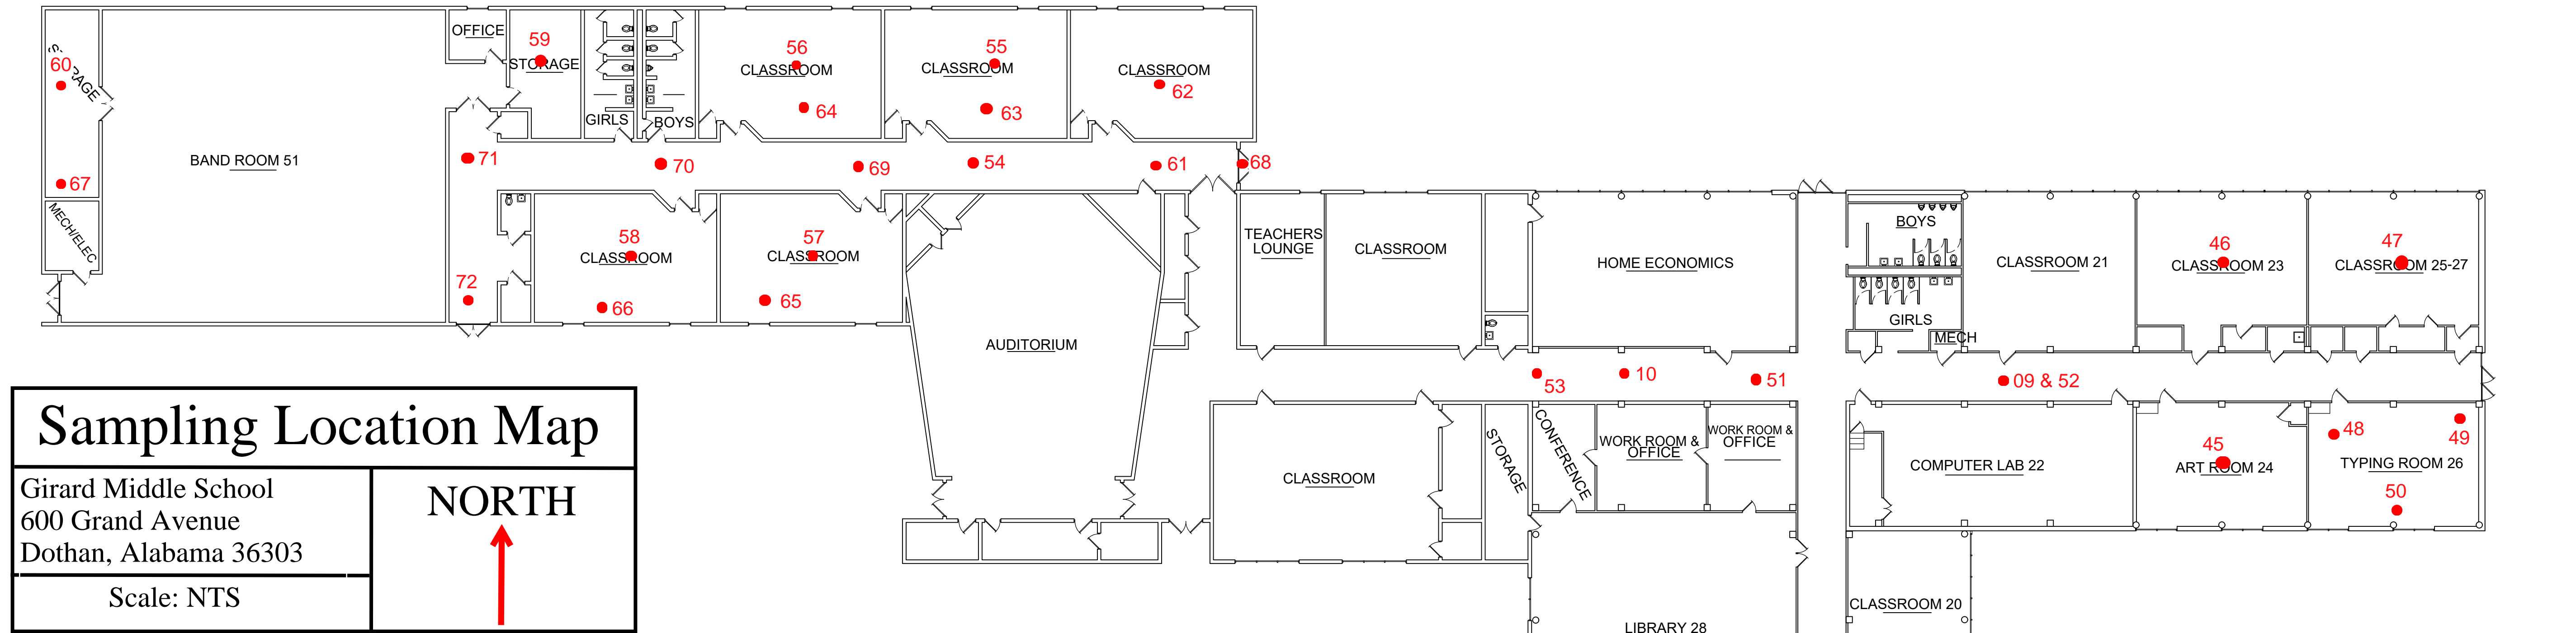
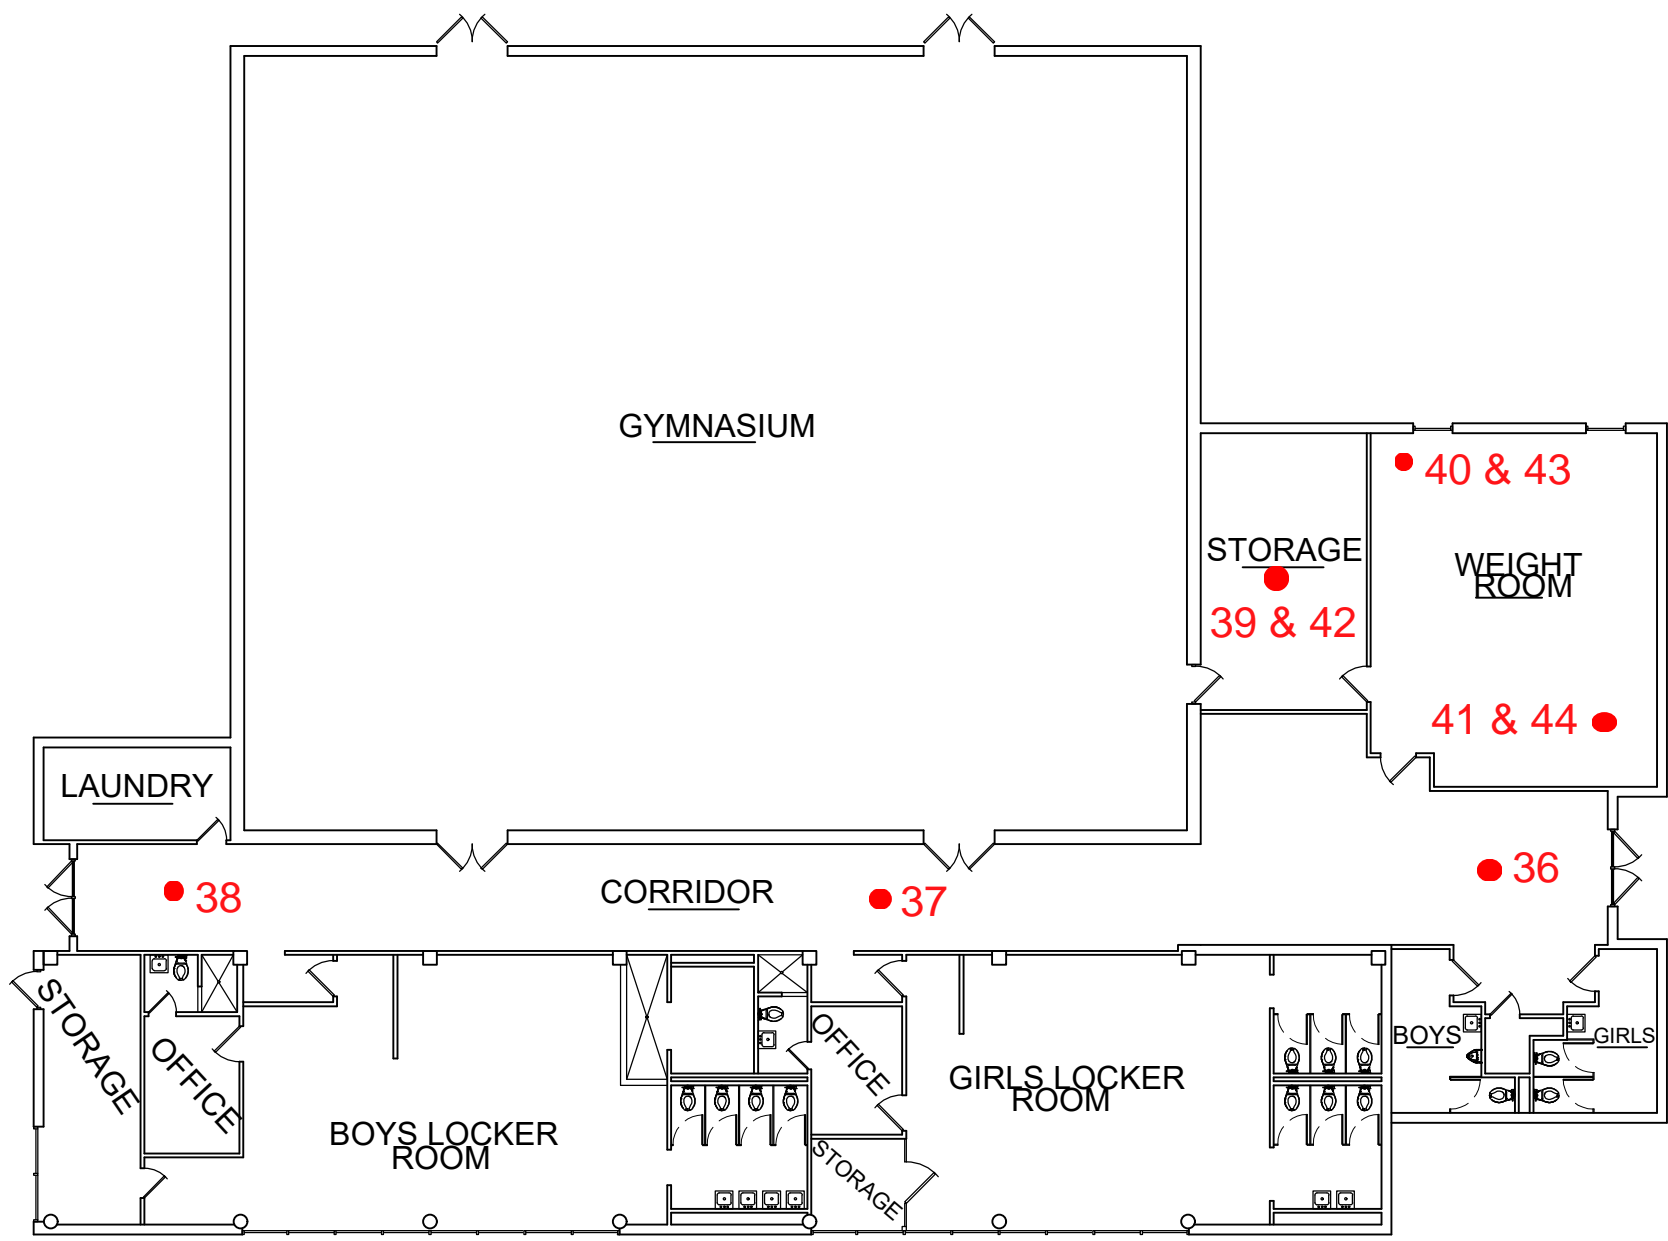
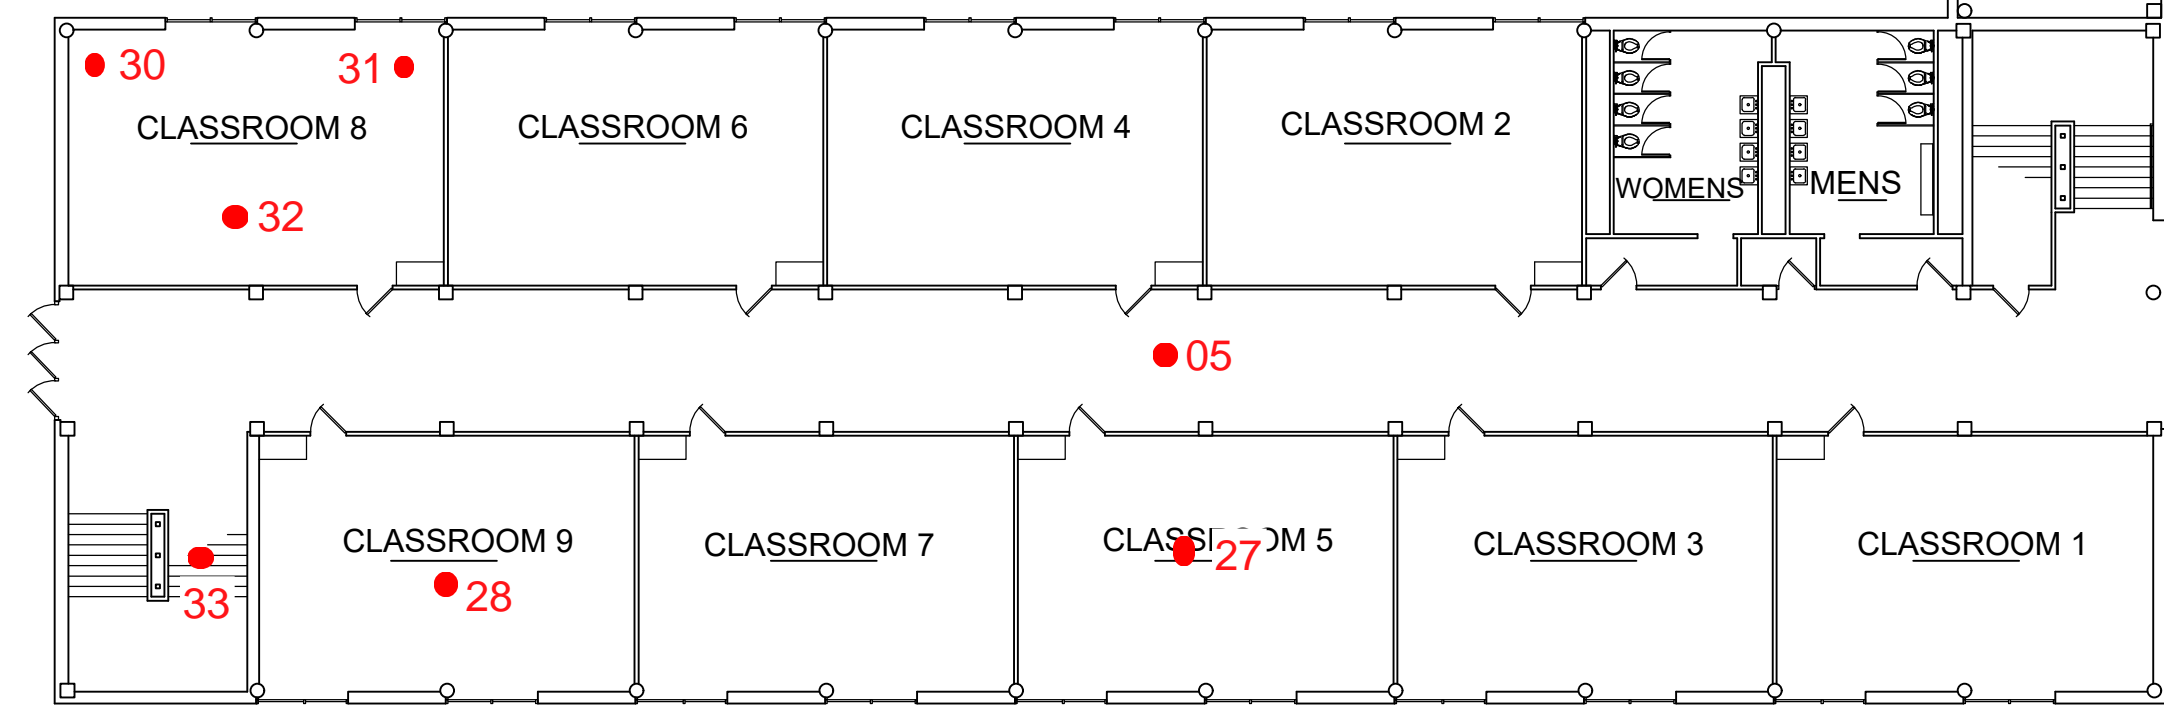
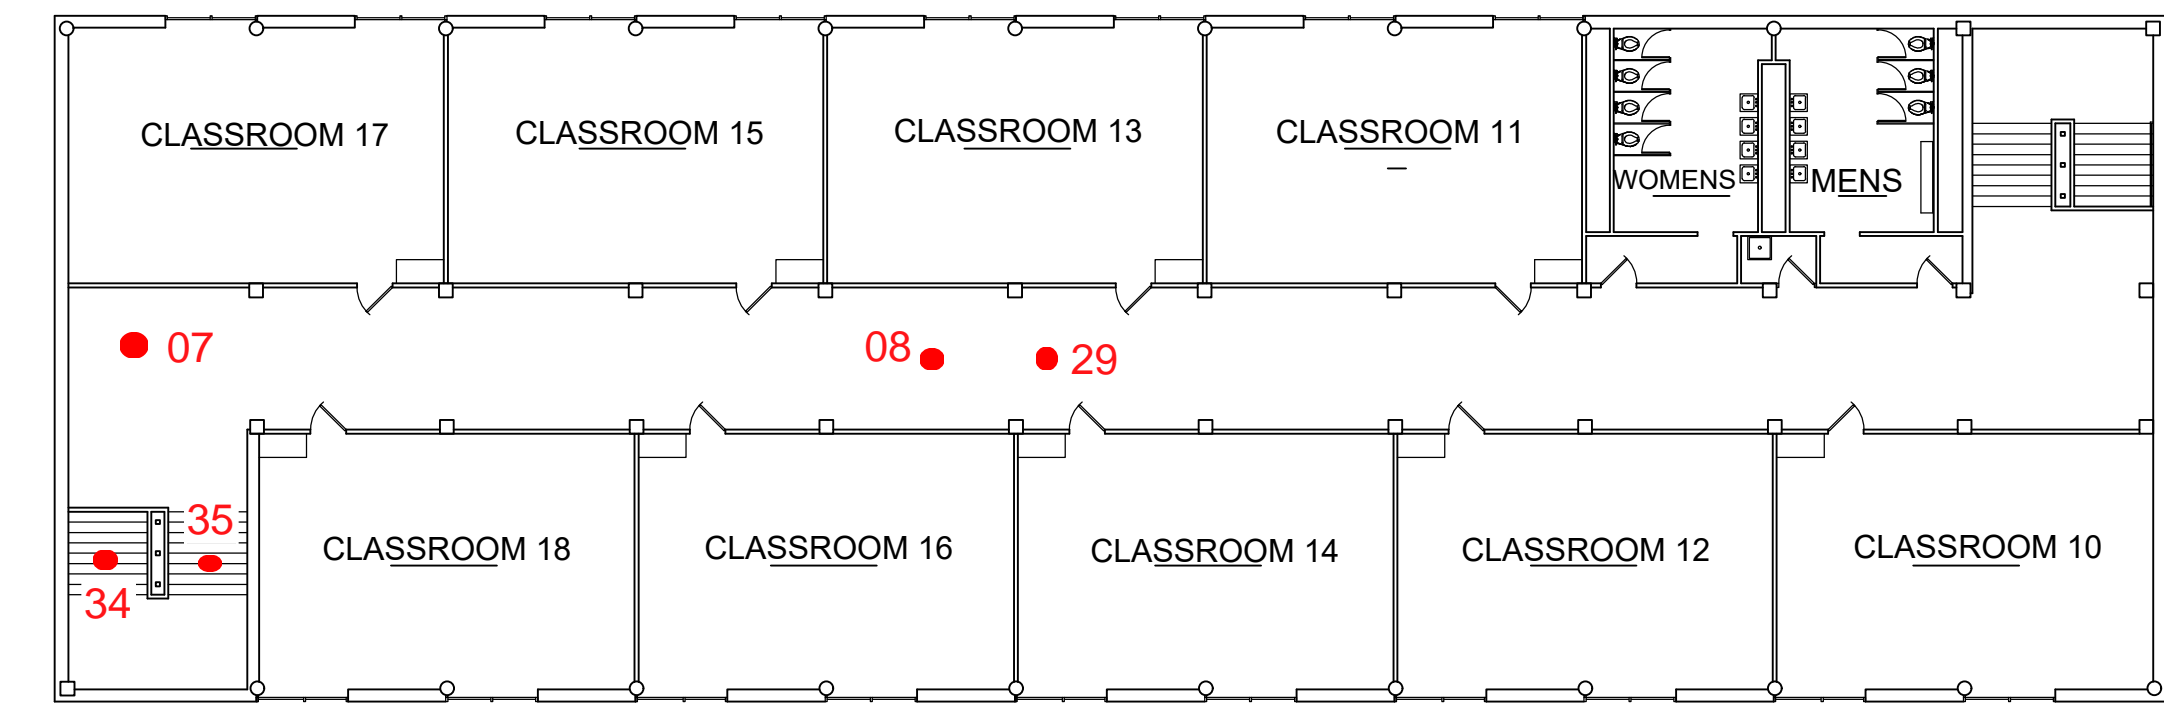
Sampling Location Map

ACBM BULK SAMPLING RESULTS Girard Middle School (GMS) 600 Grand Avenue Dothan, Alabama 36303					
Material (Classification)	Sample Number	Location of Material	Friable Yes/No	Condition	Asbestos Content
9"x9" Tan Vinyl Floor Tile w/ Black Mastic	GMS-01-Vinyl Floor Tile	Front Office Vault	No	Good	5% Chrysotile
9"x9" Tan Vinyl Floor Tile w/ Black Mastic	GMS-01-Mastic	Front Office Vault	No	Good	12% Chrysotile
9"x9" Tan Vinyl Floor Tile w/ Black Mastic	GMS-02-Vinyl Floor Tile	Front Office HVAC closet right of main office entrance door	No	Good	5% Chrysotile

Material (Classification)	Sample Number	Location of Material	Friable Yes/No	Condition	Asbestos Content
9"x9" Tan Vinyl Floor Tile w/ Black Mastic	GMS-02-Mastic	Front Office HVAC closet right of main office entrance door	No	Good	10% Chrysotile
9"x9" Tan Vinyl Floor Tile w/ Black Mastic	GMS-03-Vinyl Floor Tile	Front Office HVAC closet right of main office entrance door	No	Good	4% Chrysotile
9"x9" Tan Vinyl Floor Tile w/ Black Mastic	GMS-03-Mastic	Front Office HVAC closet right of main office entrance door	No	Good	12% Chrysotile
12"x12" Light Brown Vinyl Floor Tile w/ Gray Mastic	GMS-12-Mastic	Cafeteria	No	Good	3% Chrysotile
12"x12" Light Brown Vinyl Floor Tile w/ Gray Mastic	GMS-13-Mastic	Cafeteria	No	Good	5% Chrysotile
12"x12" Light Brown Vinyl Floor Tile w/ Gray Mastic	GMS-14-Mastic	Cafeteria	No	Good	4% Chrysotile
12"x12" White Vinyl Floor Tile w/ Brown Mastic	GMS-18-Mastic	Cafeteria	No	Good	4% Chrysotile

Material (Classification)	Sample Number	Location of Material	Friable Yes/No	Condition	Asbestos Content
12"x12" Blue Vinyl Floor Tile w/ Black Mastic	GMS-26-Mastic	Cafeteria	No	Good	2% Chrysotile
12"x12" Dark Blue Vinyl Floor Tile w/ Black Mastic	GMS-48-Mastic	Room 26	No	Good	2% Chrysotile
12"x12" Dark Blue Vinyl Floor Tile w/ Black Mastic	GMS-49-Mastic	Room 26	No	Good	3% Chrysotile
12"x12" Dark Blue Vinyl Floor Tile w/ Black Mastic	GMS-50-Mastic	Room 26	No	Good	2% Chrysotile
Plaster	Previously Identified	Throughout School	Yes	Good	1% Chrysotile
