**DOTHAN CITY BOE**

**KELLY SPRINGS ELEMENTARY  
SCHOOL  
MANAGEMENT PLAN**

**ASBESTOS-CONTAINING  
MATERIALS**

Updated  
June 2, 2026  
By

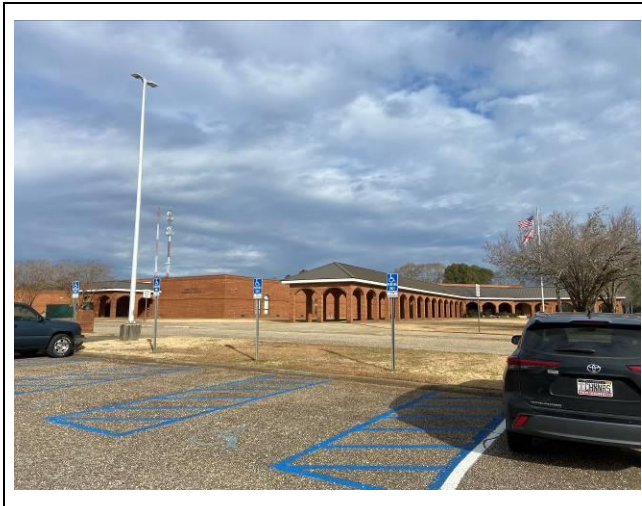
**Photo #1.** Northwest view of typical exterior building Materials observed along main entrance to school.

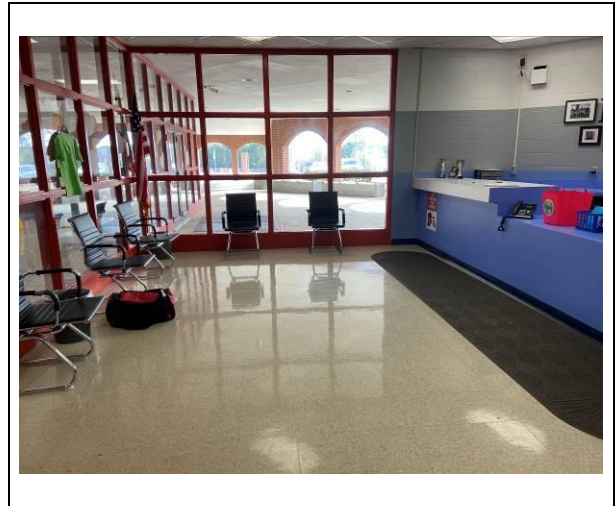
**Photo #2.** Typical non-detect asbestos materials observed in the front office.

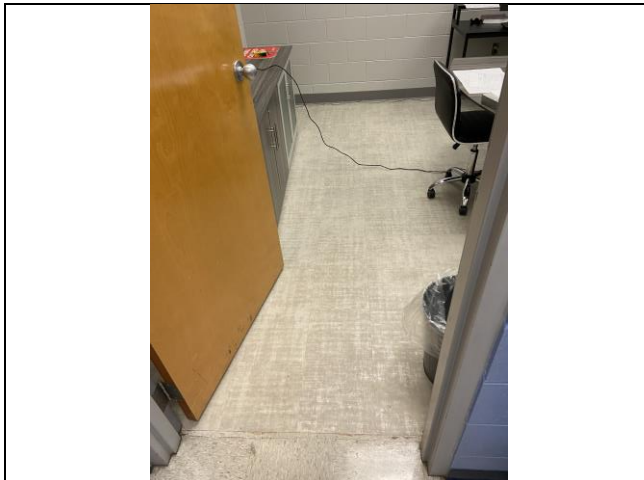
**Photo #3.** View of typical non-detect light/dark gray luxury vinyl flooring (LVT) in office conference room.

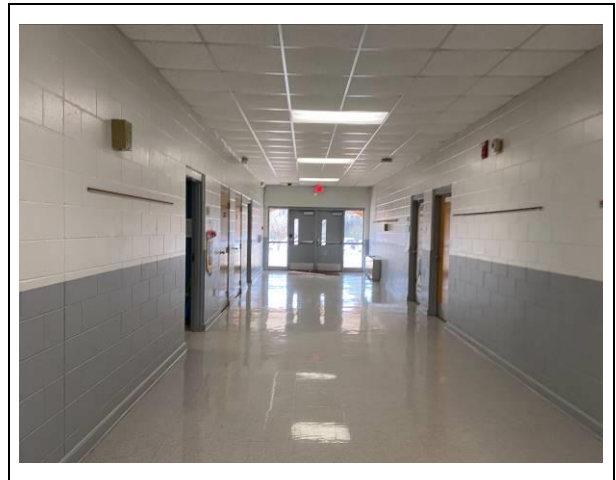
**Photo #4.** View of typical interior finishes in 100 hallway.

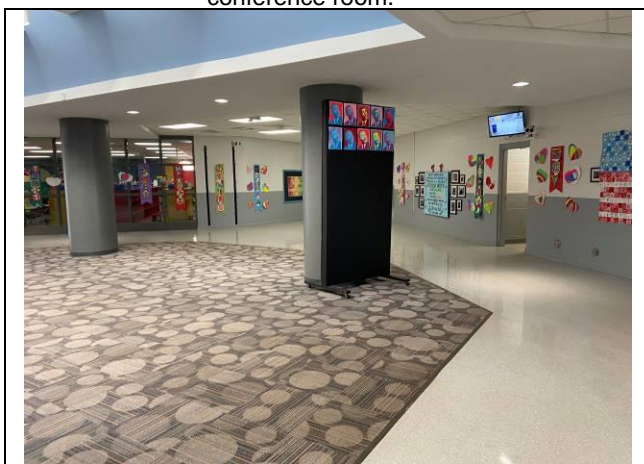
- III. Gray/brown/tan circular pattern carpet was observed in the central common area and computer lab room 400 that was not previously sampled during the 2019 asbestos inspection report. No analytical data is present to confirm this material is non-detect for asbestos. Therefore, the gray/brown/tan circular pattern carpet in the central commons area and room 400 is assumed ACBM until testing proves otherwise. This assumed material will be added to the updated site map.

**Photo #5.** Typical interior finishes observed in the central common area. View of assumed ACBM gray/brown/tan circular carpet central common area.

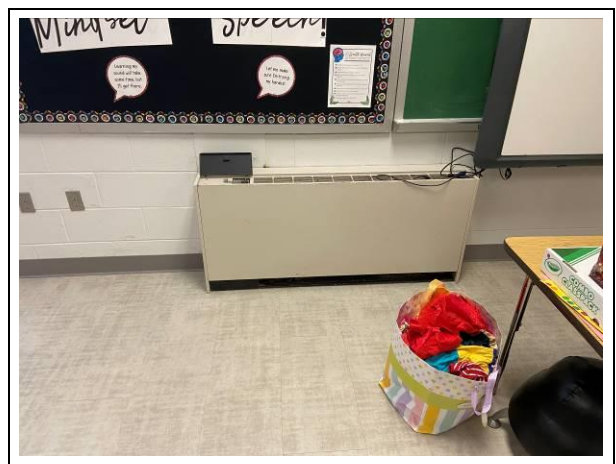
**Photo #6.** View of non-detected gray cove base with yellow mastic and light/dark gray LVT with yellow mastic sampled during February 2022 inspection.

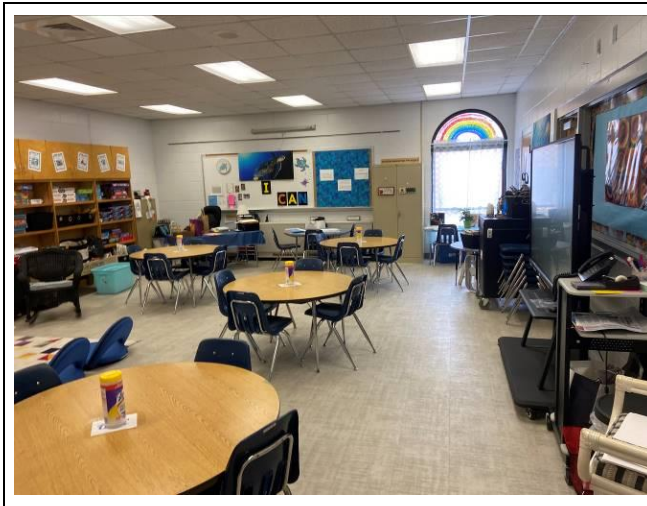
**Photo #7.** View of non-detect light/gray LVT flooring observed in classroom 105.

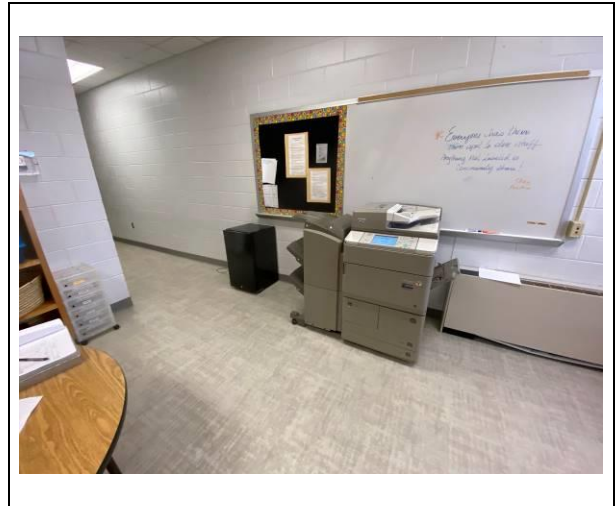
**Photo #8.** Typical non-detect light/dark gray LVT flooring in 200 hall teacher work room.

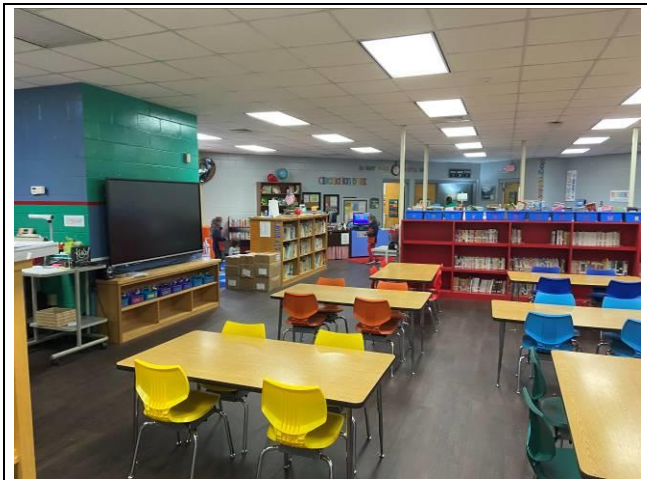
brown LVT observed in the media center is assumed ACBM until testing proves otherwise. This assumed material will be added to the updated site map.

**Photo #9.** View of assumed ACBM dark brown laminate in the Media Center, room 300.

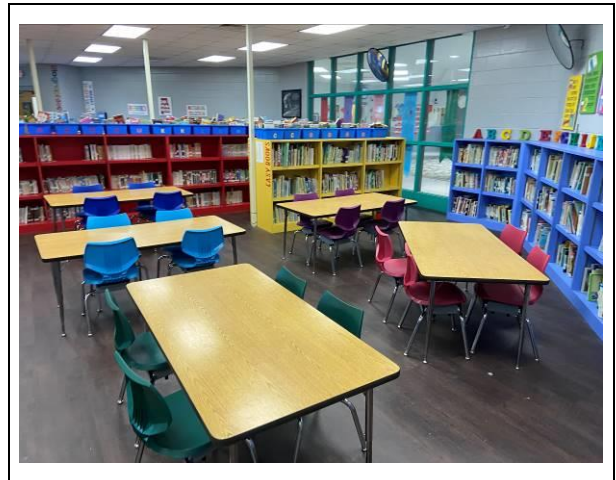
**Photo #10.** Another view of typical interior finishes observed in the media center.

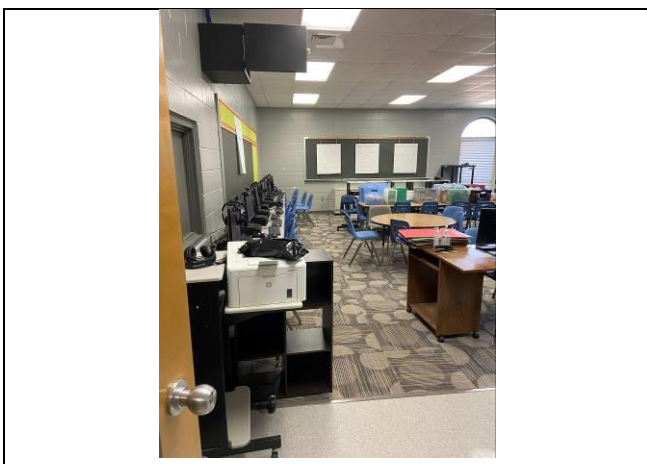
**Photo #11.** View of assumed ACBM gray/brown/tan carpet in computer lab room 400.

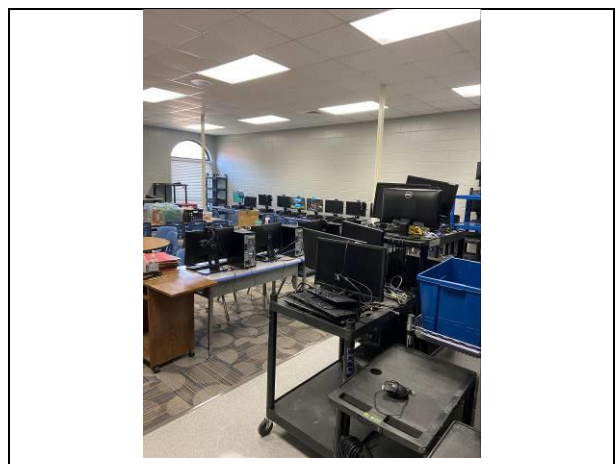
**Photo #12.** Another view of assumed ACBM gray/brown/tan carpet in computer lab room 400.

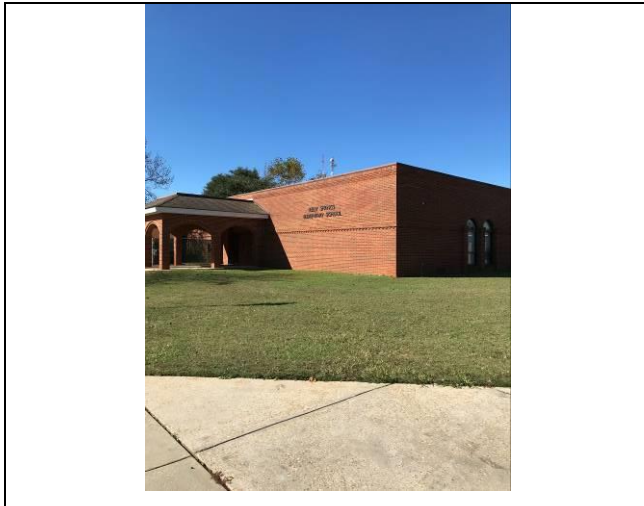
**Photo #1.** Typical Exterior Building Materials.

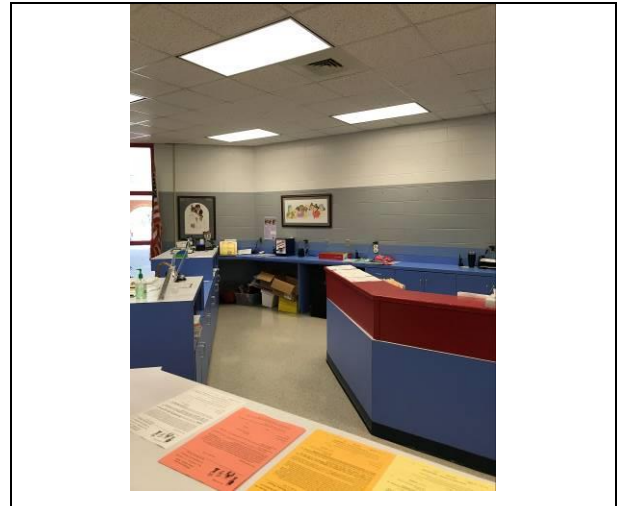
**Photo #2.** Typical interior finishes in main office.

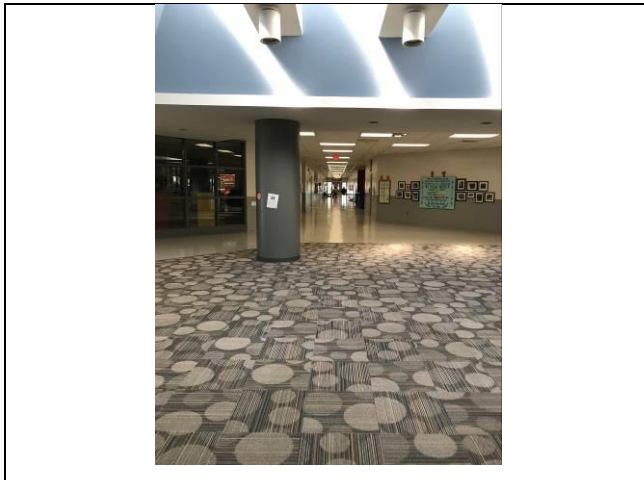
**Photo #3.** View of assumed ACBM in main rotunda of school.

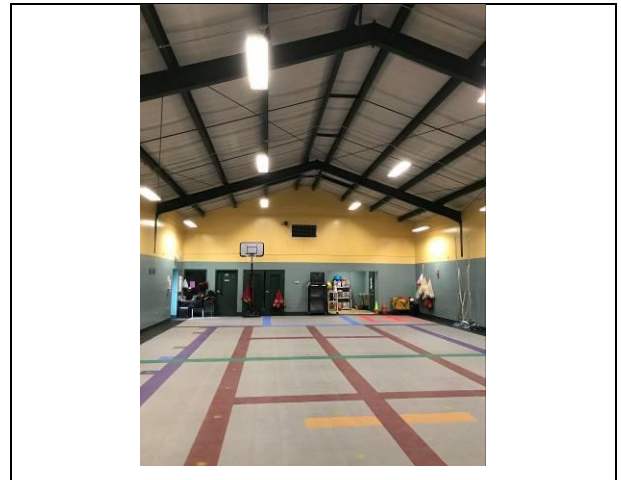
**Photo #4.** View of assumed ACBM within the gym.

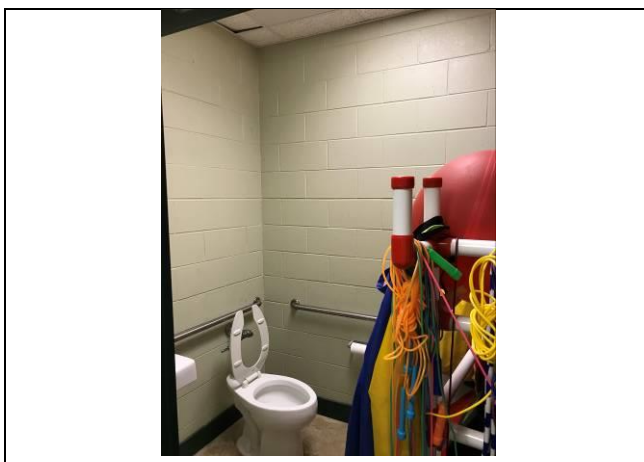
**Photo #5.** Typical interior finishes inside the gym bathroom.

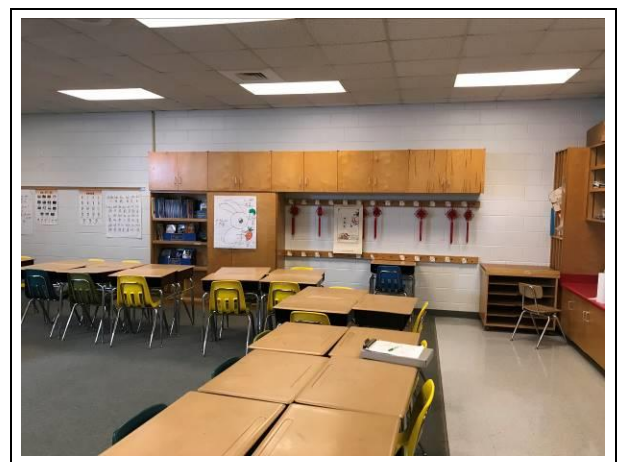
**Photo #6.** View of typical interior finishes inside classroom.
