DOTHAN CITY BOE

DOTHAN HIGH SCHOOL
MANAGEMENT PLAN

ASBESTOS-CONTAINING
MATERIALS

Updated
June 2, 2026
By

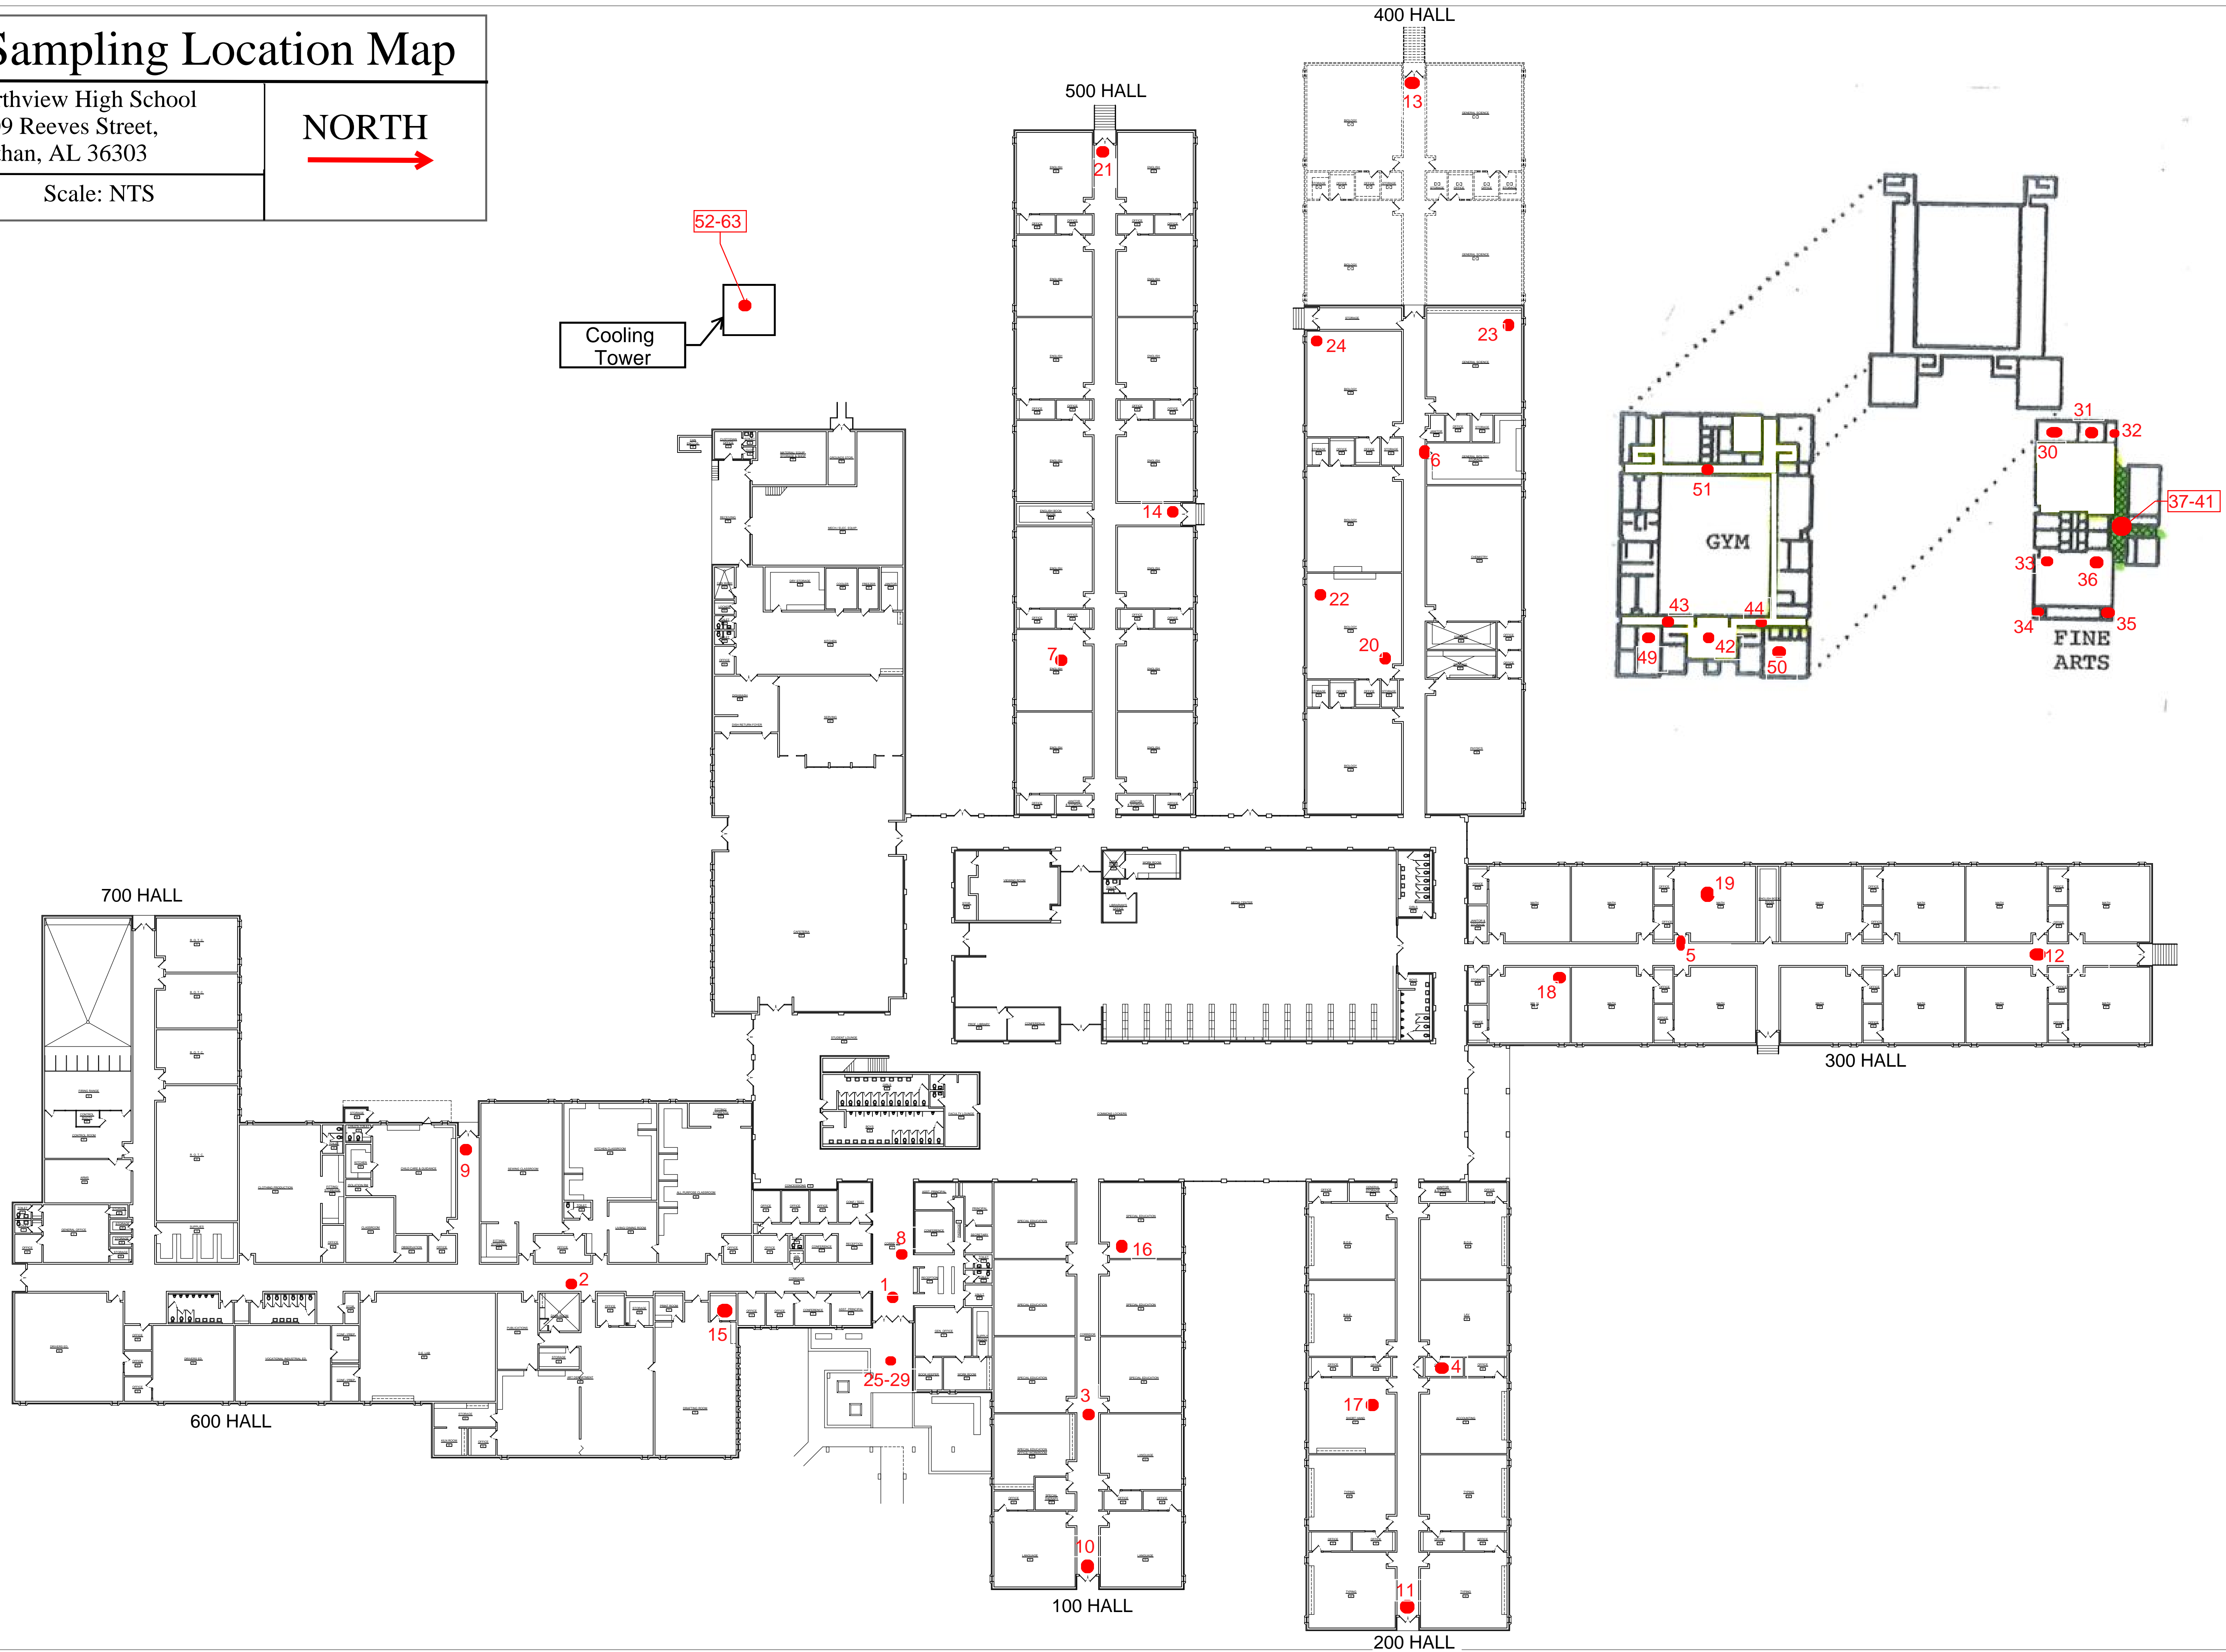
*Please note that the cooling tower exterior panels and roofing material were in extremely poor condition. Due to the poor condition of the cooling tower, panels have fallen and broken which has created the potential for fiber release. It is recommended that the identified ACM associated with this cooling tower be completely abated to remove the potential exposure from the campuses of NHS and DTC.

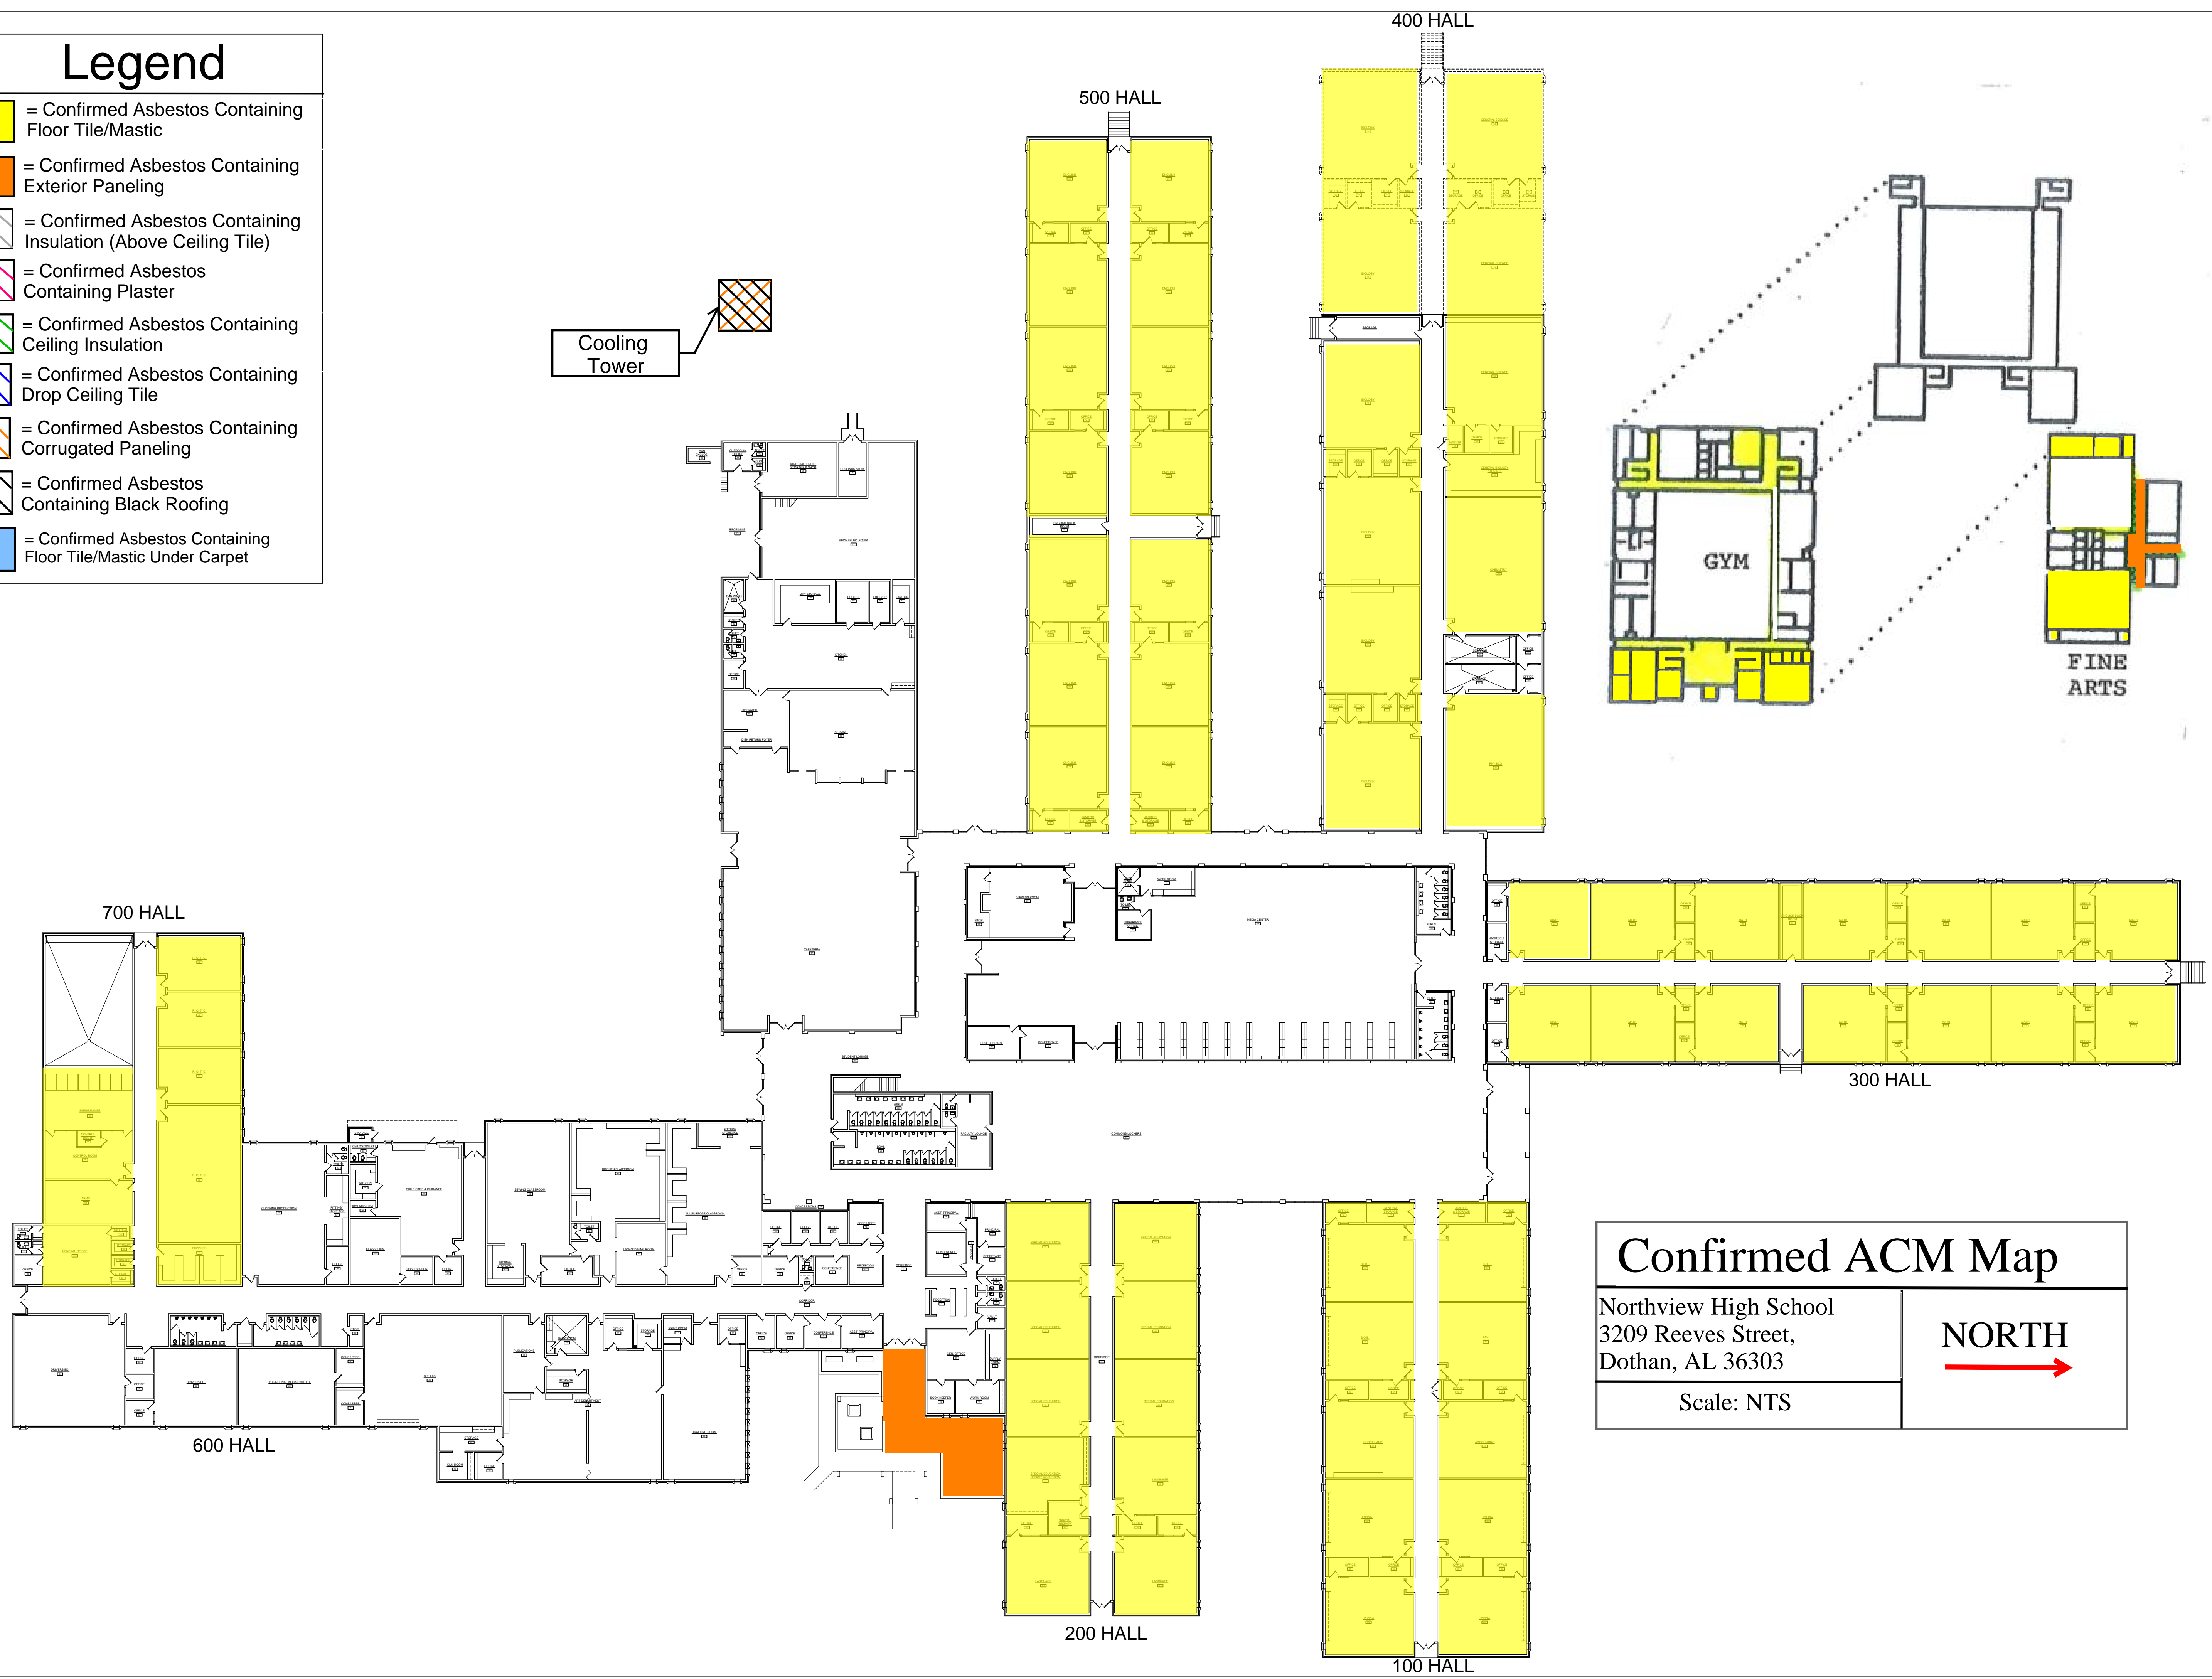
<h2>Confirmed ACM Map</h2>	
Northview High School 3209 Reeves Street, Dothan, AL 36303	NORTH
Scale: NTS

- = Confirmed Asbestos Containing Floor Tile/Mastic
- = Confirmed Asbestos Containing Exterior Paneling
- = Confirmed Asbestos Containing Insulation (Above Ceiling Tile)
- = Confirmed Asbestos Containing Plaster
- = Confirmed Asbestos Containing Ceiling Insulation
- = Confirmed Asbestos Containing Drop Ceiling Tile
- = Confirmed Asbestos Containing Corrugated Paneling
- = Confirmed Asbestos Containing Black Roofing
- = Confirmed Asbestos Containing Floor Tile/Mastic Under Carpet
