# **DODGE COUNTY MASTER PLAN**

VENTURE ARCHITECTS  
DODGE COUNTY, WISCONSIN  
MARCH 2026

## EXECUTIVE SUMMARY

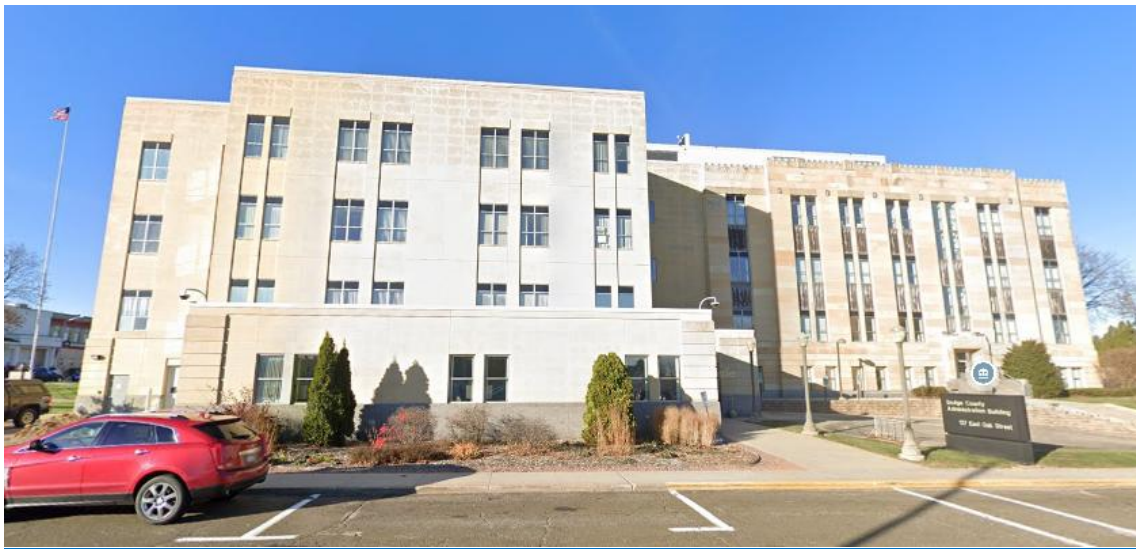
### Dodge County Administration Building

The Administration Building was built in two different phases. The original construction began in 1937 with the addition being built in 1995. The addition more than doubled the building footprint to its current size of 85,100 sf. In general, the departmental office spaces are oversized and the storage for most departments is scattered throughout the building. For some departments, related storage is on multiple floors. Large storage rooms are used by multiple departments and often there is nothing preventing one department from accessing the files of another. Digitizing files could alleviate a significant portion of the storage issues. Also, there is a need for conference rooms with proper technology for sharing information on screen, conducting virtual meetings, and for having private conversations with the public. Restrooms in the original portion of the building do not meet current accessibility requirements. There are several vacant spaces, many of which appear to have become holding centers for equipment and furniture that “could be used for something, some day.” The building is generally under-utilized. The building is in good condition but renovation for current needs would make it much more efficient and cost effective.

The most significant issue with the Administration Building revolves around security. There is no security screening for anyone entering the building, and, in general, no significant separation between the public and staff at most departmental reception desks. Upset constituents have easy access to all staff. With a single, central corridor for all users, there is no separation between staff and public. A related safety concern is that everyone in the building uses the same public restrooms. It is possible that someone could lay in wait in a

The mechanical equipment was replaced as part of building expansion and renovation in 1995. The equipment appears to be unchanged but well maintained since then. The electrical system is generally in good condition and could have another 10-20 years of useful life based on component availability. The emergency generator is approximately 30 years old and proprietary replacement parts are no longer manufactured; and therefore, it is considered obsolete.

Plumbing fixtures are generally in poor to fair condition and are neither a water conserving type nor ADA compliant. The domestic hot water circulating systems do not comply with current codes. The basement is the only floor with an automatic fire suppression system. For a complete summary of these issues see the Facility Assessment attached at the end of this plan report.

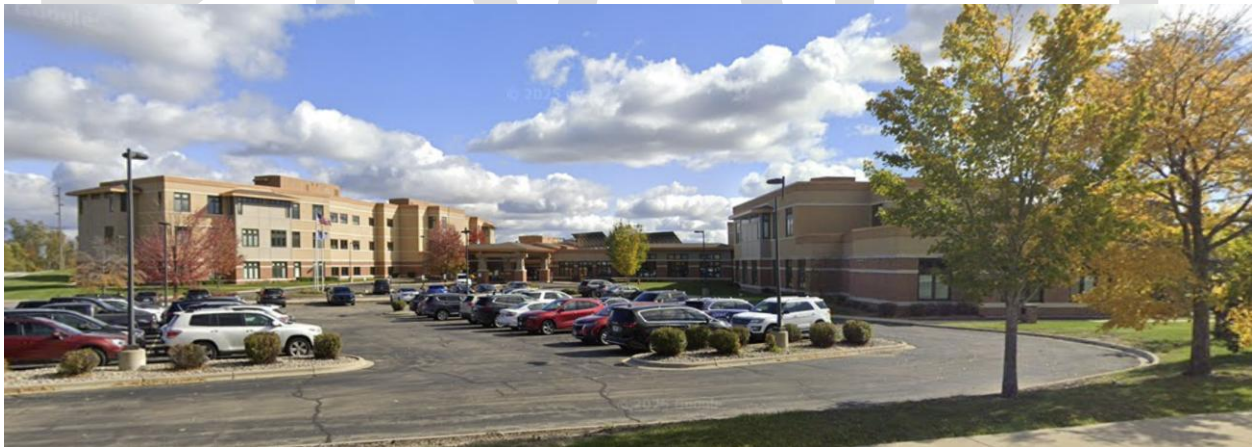
#### Clearview Care Facility

Clearview is a relatively new building and is in good working order with many years of life remaining. Its most significant drawback is that it is under-utilized with some vacant floors. Because of the young age and use of the building, a full assessment was not part of the scope of the master plan.

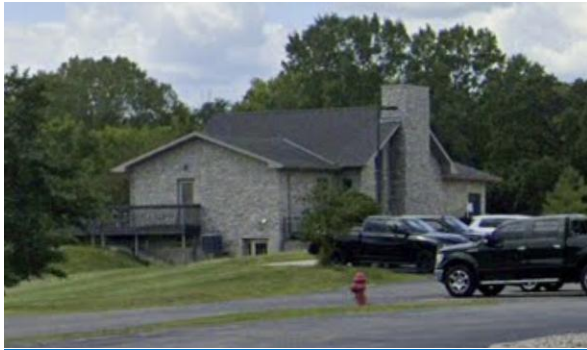
### Female Group Home

This building was heavily damaged in the 2025 tornado. In addition to the necessary repairs to the exterior building envelope, the interior was gutted and rebuilt. The building is essentially new and not included in the scope of the master plan.

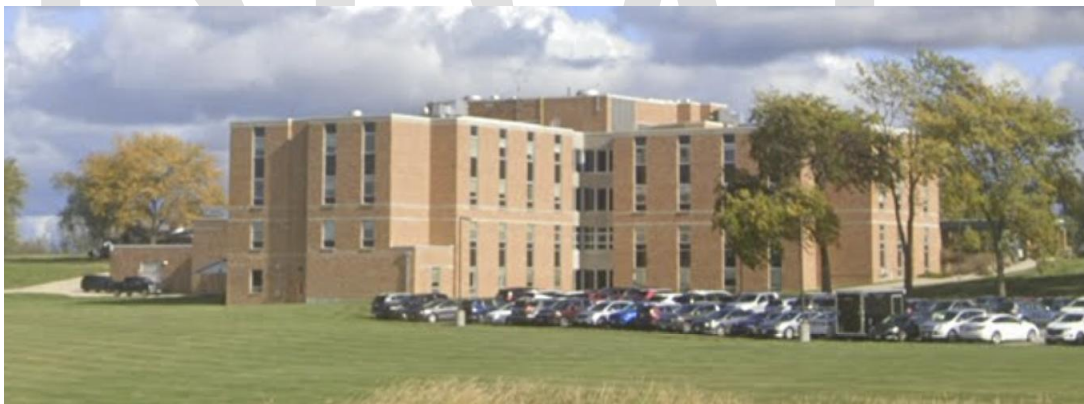
### Henry Dodge Building

The Henry Dodge Building appears to be structurally sound, but the mechanical systems have been a known problem for maintenance for at least the last dozen years. Much of the equipment is so obsolete that the only way certain replacement parts can be purchased is when they appear on eBay.

The mechanical equipment and controls of the Henry Dodge Building are generally beyond life expectancy, inefficient, and in some instances, degrading and causing leaks around the building. The electrical system is generally in better shape than mechanical, though it does have some obsolete panels. The generator is approximately 35 years old and considered obsolete.

Plumbing fixtures are generally in good condition and are ADA compliant. Water heaters and softeners are in fair to great condition. Code required hose thread vacuum breakers at mop basins and service sink faucets are missing. Some cast iron sanitary drainpipes are rusting and show signs of leaking and failure. Underground piping is assumed to be the same condition. Facility is fully protected by an automatic fire suppression system.

The building is structurally sound but major portions of the MEP systems need to be replaced at substantial cost and potential downtime. With the extent of the replacement needed and the potential building modifications required to accommodate the work, it would be difficult to realize a return on investment. Maintaining the existing Henry Dodge Building systems is costly in the short term and not viable in the long term.

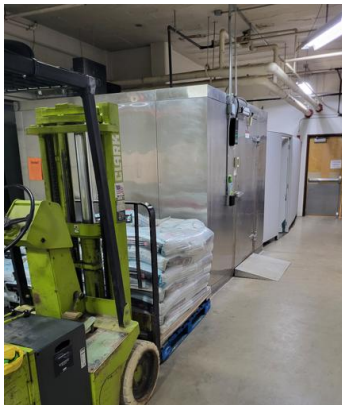
The Medical Examiner department is the most prominent example of a Dodge County department adapting to available space no matter how inefficient. The Medical Examiner department has two office spaces across the hall from each other in the Administration Building and two additional areas in the Henry Dodge Building. The area where decedents are examined at Henry Dodge is a small storage area separated from a larger corridor using movable office partitions and an unstable door, spanning from a cooler to a wall. There is a second cooler that is only accessible from the main lower-level corridor, which dictates movement of decedents is limited to after hours to prevent contact with the public or other staff. The Medical Examiner processes approximately 100 decedents for autopsies each year. The logistical challenges combined with volume make these conditions far below acceptable standards.

Medical Examiner: Cooler & Exam Area

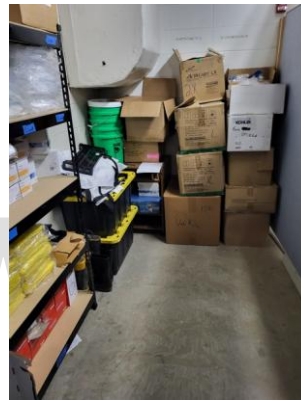
Medical Examiner: Exam Area/Storage Room

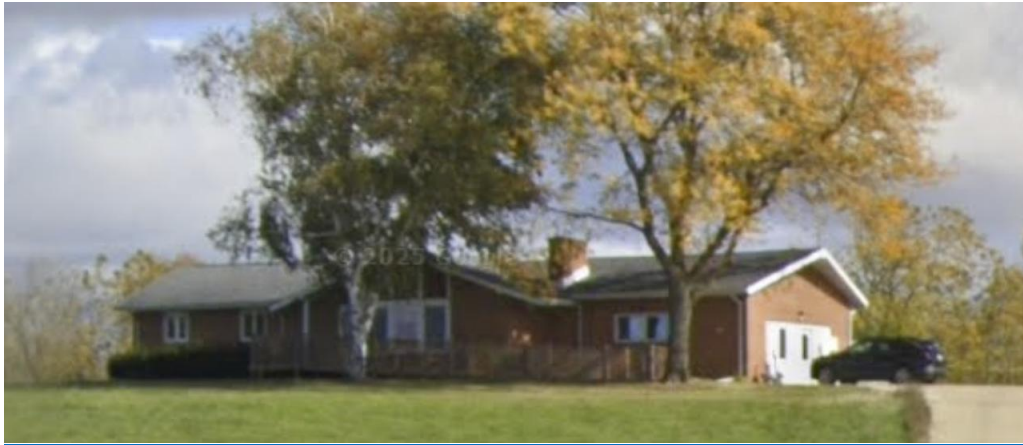
### Male Group Home

The Male Group Home, located at the top of a small hill to the north of the Henry Dodge Building, currently houses four men. A ramp has been constructed to create an accessible approach, but the interior spaces and doors create challenges for wheelchair-bound residents as they are not ADA compliant. The door frames have significant damage from wheelchairs. The size of the rooms do not lend themselves well to modification to achieve ADA compliance. Because of code concerns, the existing building is not the best long-term solution. Extensive renovation or a new building is recommended.

- The Men's Group Home located north of Henry Dodge needs replacement because it is not ADA compliant, has had significant unintentional damage to door frames by wheelchairs, and is generally infeasible to modify appropriately. A new, ADA compliant group home to house at least four men should be considered. There is room east of the Female Group Home where it could be constructed. This is not a high priority relative to other needs but would make daily life for the users much easier.

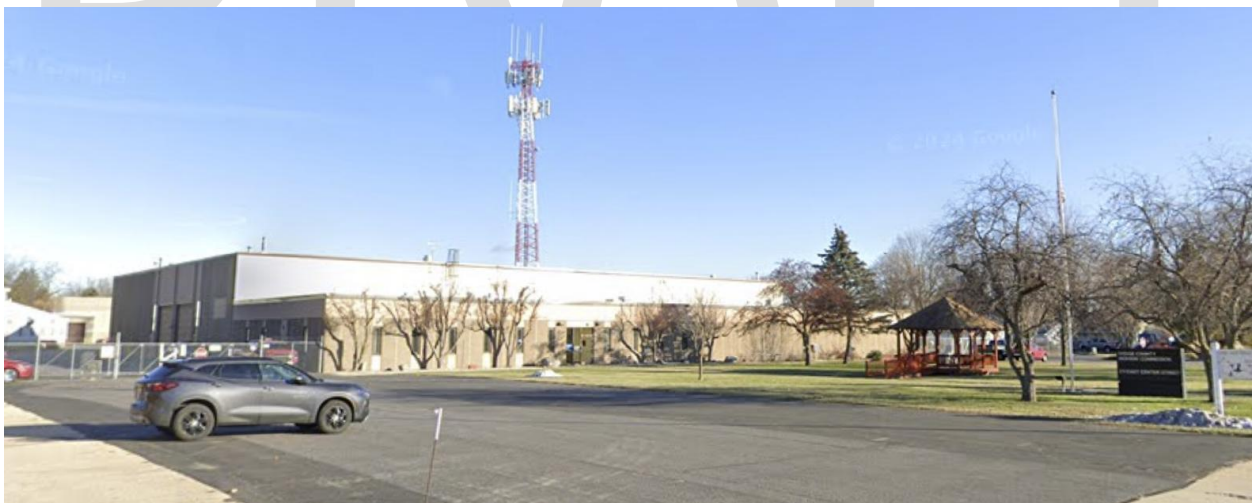
### Highway Department

Other than lingering tornado damage to a salt storage structure and a nearby canopy, the Highway Department buildings are in good shape and have few needs. One of the buildings at the Neosho satellite shop is an aged structure that is too small to house equipment, so it is used only for cold storage. It is important to pay attention to the structure as any new cracking may be indications that the building is near

the end of its useful life. Additionally, the Mayville shop has a vacant two-story office space that currently has no practical use.

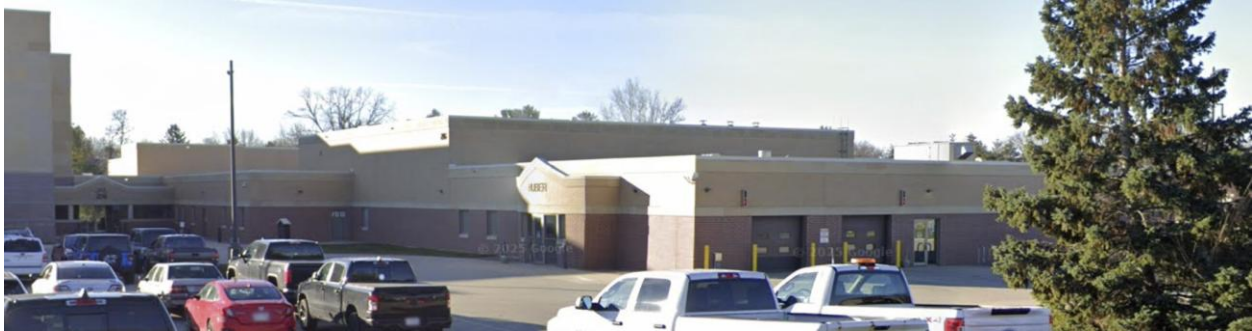
### Jail

The Dodge County Jail is a 358 bed facility that has agreements with state and federal agencies to house inmates beyond those from Dodge County. The building was constructed in 1999 and is in good condition. Functionally, however, being disconnected from the sheriff's office isn't optimal, and the medical unit—which was probably appropriate when built—is undersized for current use. The in-person visitation rooms are rarely used because of issues that have been discovered regarding the passing of contraband. Additionally, locker vents have also been found to be a location for the passing of contraband.

Individual housing pods have unique concerns. H-Pod's Multi-Purpose room is too small. C and D-Pods do not have an appropriately secure corrections officer station, creating vulnerability from behind the C.O. station. Neither C nor D pods can communicate with inmates in cells from the C.O. station. C pod has privacy concerns that cause inmates to cover the window when using the toilet.

Intake booths are too close together which could cause privacy / PRIA concerns. There are also sightline concerns from cell to cell which are problematic when women or juveniles are brought in. In general, Intake is too small and the layout is problematic regarding flow, sightlines and routine daily activities.

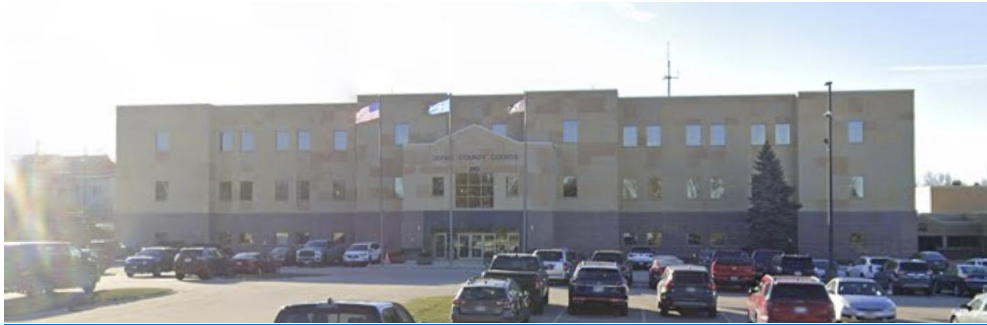
### Justice Center

The 114,450 sf courthouse building was constructed in 1999 and had a partial 3<sup>rd</sup> floor buildout in 2006 for Child Support and the District Attorney. There is still available space that was intended for additional courtroom and support spaces to be built out. Functionally the building works and departmental spatial needs are met or exceeded. The entrance has security screening; however, there are safety concerns related to the staff needing to use public restrooms similarly as described for the Administration Building. Additionally, because of the sensitive nature of the departments and the likelihood of encountering agitated users, several departments have requested bullet resistant glass at their lobby areas.

Mechanically, the equipment is well maintained but some are nearing the end of their useful life expectancy. Select items have already been replaced. All elements of the electrical system are generally in good condition. It is recommended that the obsolete analog controls of the generator be replaced with digital controls. For an extensive summary of mechanical equipment, see the Mechanical & Electrical Building Assessment attached at the end of this plan report.

Plumbing fixtures are generally in fair to good condition and are ADA compliant. Water heater and softener are in good condition. Code required hose thread vacuum breakers are missing on mop basins and service sinks. Facility is fully protected by an automatic fire suppression system.

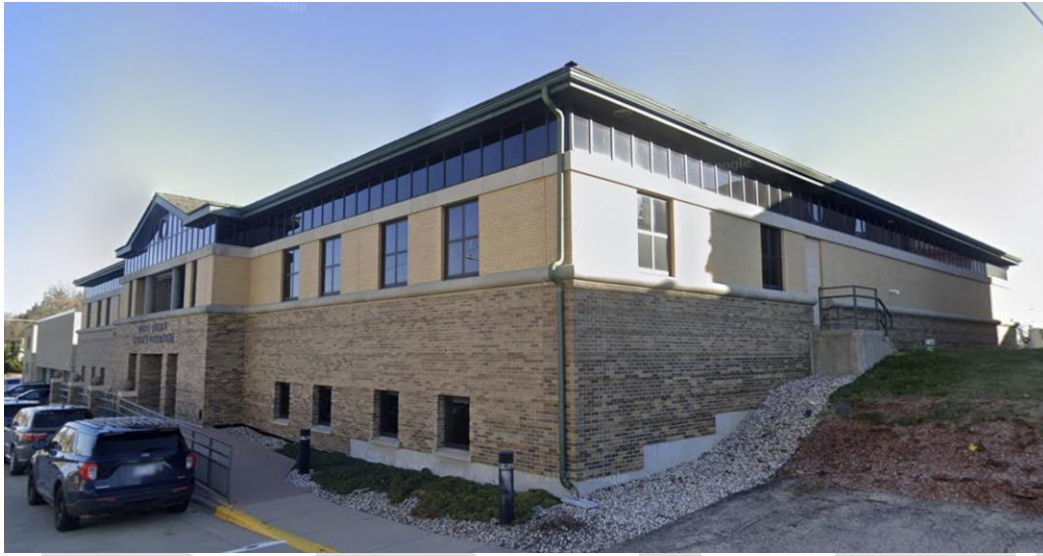
### Sheriff

The Sheriff's staff is making do with the space available but generally appears to have outgrown the approximate 33,400 sf of the facility. There is a shared EOC/Training/Conference/Multipurpose room that is regularly double booked. Additional training space is badly needed. The EOC is used by Emergency Management at least four times each month. For redundancy, there is a backup radio room, but it has no climate control. It should also be noted that the roof needs replacing but it has been temporarily put on hold awaiting results of this master plan. A complete list of the needs, wants, and concerns of the Sheriff's department is attached to the end of this master plan. Many of these needs require additional space that isn't easily addressable in the current location.

Functionally, the Sheriff's Department should be adjacent to the jail so that the staff isn't divided across multiple buildings and the two functions separated by a city block as they are now. While there appears to be ample space adjacent to the jail for the new sheriff's office, it would require space currently in use for parking and / or area being used as part of the stormwater detention. Adding depth to the stormwater to allow shrinking the pond area can be investigated, but a limiting factor will be the depth of the stormwater sewer under the street. It is likely that the current configuration of the stormwater detention is because of a relatively shallow stormwater main under the street.

At the Sheriff's Department, the pneumatic controls system, hot water piping system, and unitary equipment are aging and should be replaced or upgraded to increase occupant comfort and decrease operating costs.

Electrically, the transformer is in reasonable condition. The switchboard is considered obsolete and replacement should be considered if significant renovations are undertaken. The UPS has been in use for 20 years and should be considered for replacement. For an extensive summary of mechanical equipment, see the Mechanical & Electrical Building Assessment attached at the end of this plan report.

Plumbing fixtures, water heater and water softener are generally in good condition. Domestic hot water circulating systems do not appear to meet current codes. The building is fully covered by an automatic fire suppression system.

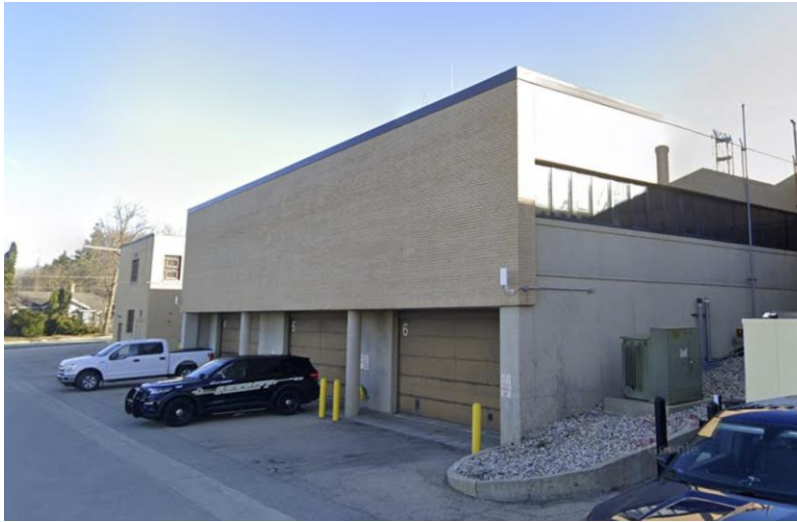
### Sheriff's Vehicle Storage

The Sheriff's Vehicle Storage is located at the lower level of the old jail facility. The storage area is acceptable for how it is being used but insufficiently sized to accommodate all of the vehicles in need of storage. The largest of the department's vehicles are currently being stored at the Highway Department. The vacated upper floor of the building (J-Pod) is periodically used as a tactical training area. While the training is critical, maintaining these buildings may not be the most cost effective for Dodge County.

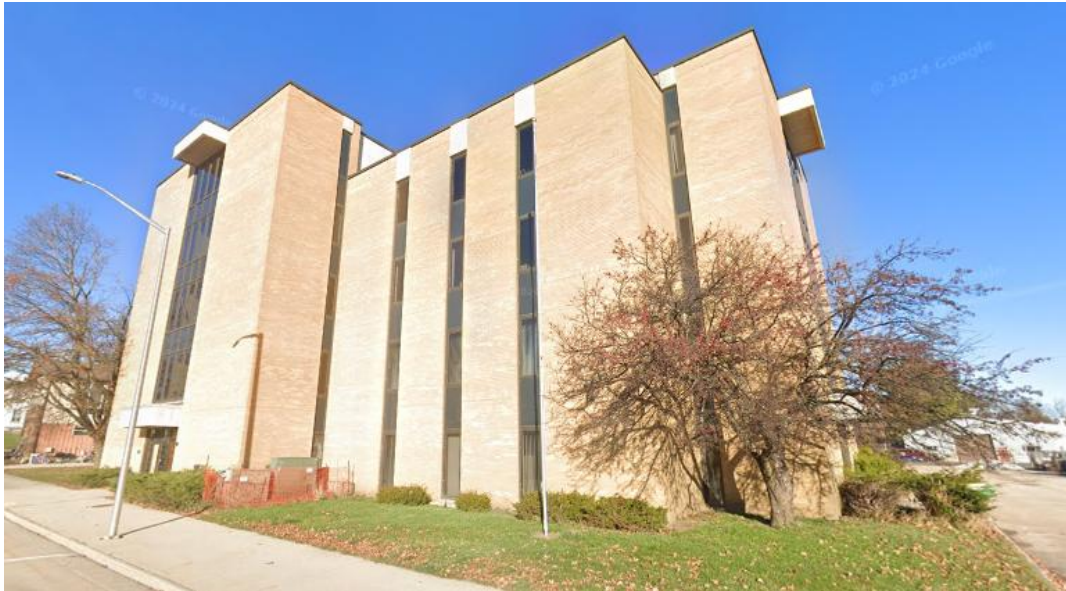
### Dodge County Office Building

Because the discussions regarding how best to remedy a multitude of issues across the campus of buildings often required a space to relocate departments during renovations, the idea of assessing the Dodge County Office Building for potential re-purchase by Dodge County and renovating for re-use was explored. Currently the different floors of the building are in varying stages of demolition by the current owner. The bulk of the interior walls are concrete masonry units. The top floor has been gutted as demolition is proceeding from the top down. The floor structure is precast concrete plank and is supported by precast concrete columns. Precast concrete plank floors can be penetrated at new locations for plumbing, electrical and mechanical needs, but there are significant limitations. The windows may be original to the building and should be replaced with energy efficient windows. The HVAC and electrical systems should be replaced. The plumbing will likely need to be relocated for most efficient layout to meet Dodge County needs. The existing elevator is undersized for an emergency rescue gurney to fit inside.

The building is of an adequate size to accommodate the departments that could be relocated, but there is limited expansion potential, and the most efficient adjacencies won't be optimally accommodated. In general, repurchasing, renovating and re-using this building could have short-term benefits but it is not viewed as a viable long-term solution. It is unlikely that using this building as a short-term solution would provide acceptable return on investment.
