## **Canfield Schools Facilities Assessment 2024**

### **Middle School:**

**Building Pictures - Canfield Local(48314) - Canfield Village Middle School(70417)**

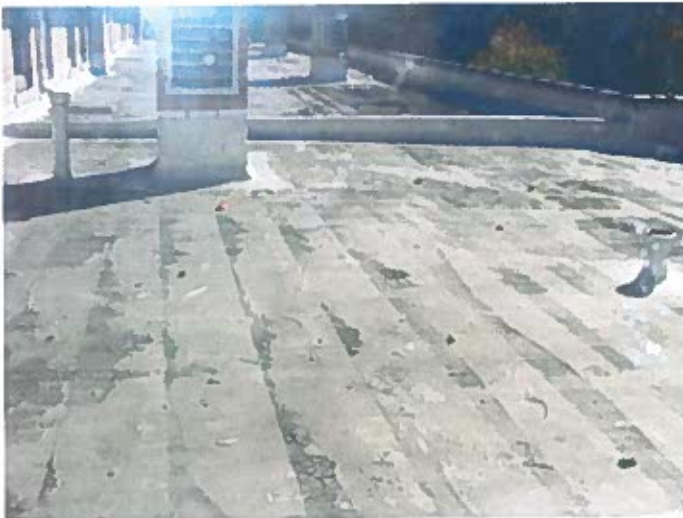
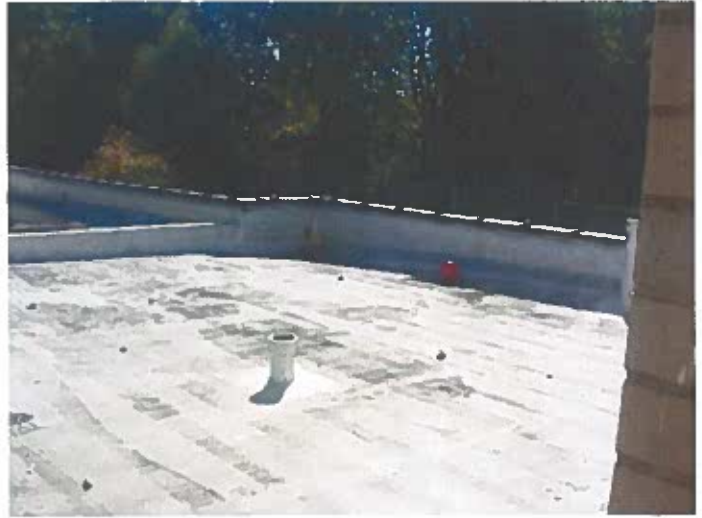
The roof over the overall facility is a EPDM and ballasted membrane system that is in poor condition. There are District reports of current leaking. Signs of past leaking were observed during the physical assessment. Access to the roof was gained by access hatch and ladder that is in fair condition. Fall safety protection cages have not been provided. There were no observations of standing water on the roof. Metal cap flashings and stone copings are in fair condition. Roof storm drainage is addressed through a system of roof drains, which are properly located, and in fair condition. There are gutters and downspouts on the original 1922 building. The roof is not equipped with overflow roof drains, though they are needed on this building. No problems requiring attention were encountered with any roof penetrations. There are not any covered walkways attached to this structure.

3 Needs Replacement

Existing Roof

The roof over the overall facility requires replacement to meet Ohio School Design Manual guidelines for age of system and due to condition. Add gutters, downspouts and overflow drains as required. 2021 UPDATE: Significant update (compare to original).

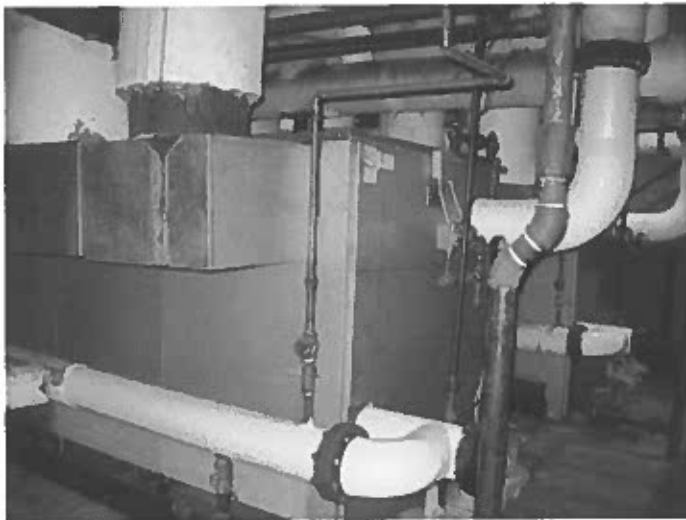
The school is predominately heated with (3) low-pressure, gas-fired steam boilers installed around 2004-2005. The boilers, feedwater system, condensate return units, and other components are in fair-to-poor condition. Steam and condensate return piping is routed throughout the building and serves cast iron radiators, unit ventilators, fan coil units, and heating & ventilating AHUs. Portions of this steam heating system are original to the 1922 building, and some of the units are not operational. There are (19) rooftop HVAC units (RTUs) in the building. Some have gas-fired heat exchangers while others are cooling-only. These will be further addressed in Item C., Air Conditioning, below. The HVAC system does not provide the required outdoor air per OSDM design standards and ASHRAE 62.1. The system temperature controls are pneumatic; however, RTUs are controlled by individual programmable thermostats. There is a Honeywell direct digital Control (DDC) system that controls time-of-day function for the RTUs.

3 Needs Replacement

Steam heating boilers

Replace the steam heating system and most of the packaged rooftop equipment since these systems are not compliant with current OSDM guidelines.

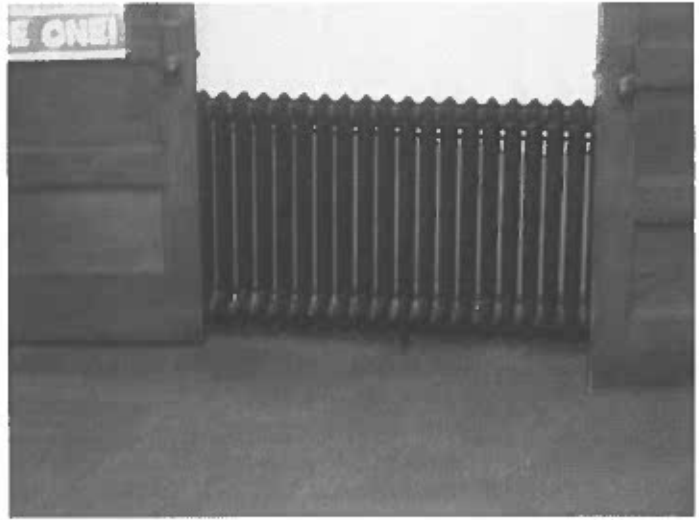
Steam cast iron radiator

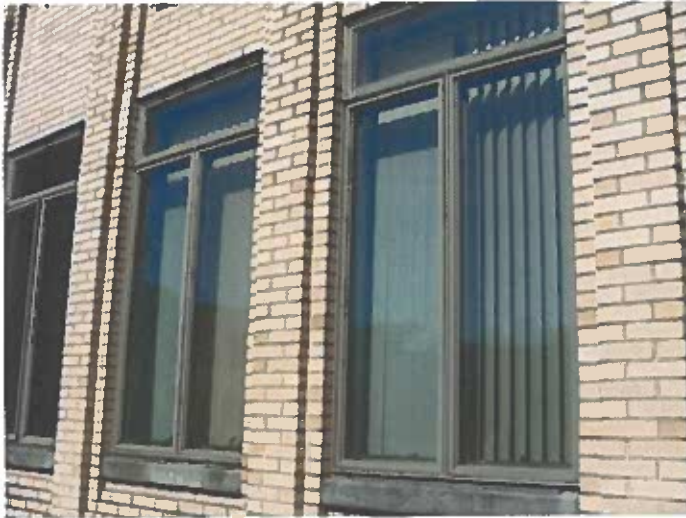
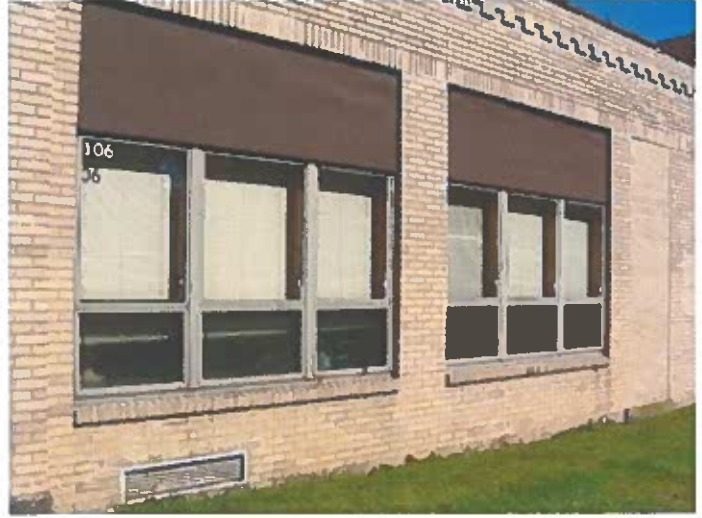
**Description:** The overall facility is equipped with Anderson thermally broken vinyl clad wood windows with double glazed insulated glazing window system, which is in very poor condition. Window system seals are in poor condition, with frequent air and water infiltration being experienced. Window system hardware is in poor condition. The window system features surface mounted blinds, which are in poor condition. There is a greenhouse attached to a 1992 classroom. It was noted to be in a good condition.

**Rating:** 3 Needs Replacement

Typical Classroom Window

Typical Classroom Windows

**Recommendations:** Provide a new insulated window system with integral blinds to meet with Ohio School Design Manual requirements. 2021 UPDATE: Replace skylights due to condition.

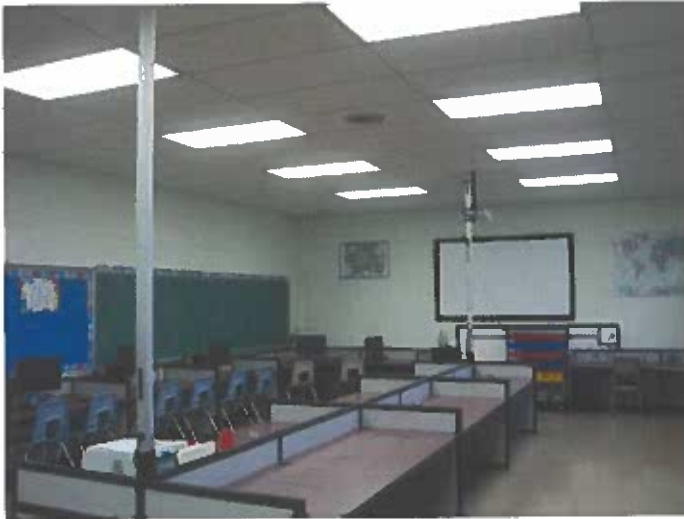
The typical Classrooms in the 1922 Wing are equipped with T-8 2x4 lay-in fluorescent fixtures with dual level switching. Classroom fixtures are in good condition, providing an average illumination of 50-60 FC, thus complying with 50 FC recommended by the OSDM. The typical Classrooms in the 1937 Wing are equipped with T-8 2x4 lay-in fluorescent fixtures with dual level switching. Classroom fixtures are in good condition, providing an average illumination of 40 FC, thus complying with the 50 FC recommended by the OSDM. The typical Classrooms in the 1955 Wing are equipped with T-8 2x4 lay-in fluorescent fixtures with dual level switching. Classroom fixtures are in good condition, providing an average illumination of 40-50 FC, which is less than the 50 FC recommended by the OSDM. The typical Classrooms in the 1992 Wing are equipped with T-8 2x4 lay-in fluorescent fixtures with dual level switching. Classroom fixtures are in good condition, providing an average illumination of 30-60 FC, which is less than the 50 FC recommended by the OSDM. The typical Corridors in the 1937 Wing are equipped with T-8 1x4 lay-in fluorescent fixtures with single level switching. Corridor fixtures are in good condition, providing an average illumination of 25 FC, thus complying with the 20 FC recommended by the OSDM. The typical Corridors in the 1955 Wing are equipped with T-8 1x4 lay-in fluorescent fixtures with single level switching. Corridor fixtures are in good condition, providing an average illumination of 25 FC, thus complying with the 20 FC recommended by the OSDM. The typical Corridors in the 1992 Wing are equipped with T-8 2x4 lay-in fluorescent fixtures with single level switching. Corridor fixtures are in good condition, providing an average illumination of 25 FC, thus complying with the 20 FC recommended by the OSDM. The 1937 Gymnasium space are equipped with 400 watt round recessed metal halide type lighting, in fair condition, providing an average illumination of 25 FC, which is less than the 50 (HS) FC recommended by the OSDM. The 1992 Gymnasium space are equipped with T8 suspended 2x4 LED type lighting, in fair condition, providing an average illumination of 70 FC, thus complying with the 50 (HS) FC recommended by the OSDM. The Media Center 1992 is equipped with 1x4 lay-in T8 fluorescent fixture type lighting in good condition, providing an average illumination of 50 FC, thus complying with the 50 FC recommended by the OSDM. The Student Dining spaces are equipped with 2x2 lay-in 250 watt incandescent fixture type lighting with multi level switching. Student Dining fixtures are in good condition, providing an average illumination of 45 FC, which is less than the 50 FC recommended by the OSDM. The Kitchen spaces are equipped with 2x4 lay-in T8 fluorescent fixture type lighting with single level switching. Kitchen fixtures are in good condition, providing an average illumination of 75-90 FC, thus complying with the 75-80 FC recommended by the OSDM. The Service Areas are equipped with 1x4 surface mount T8 fluorescent fixture and screw-in type lighting in fair condition. The typical Administrative spaces are equipped with 2x4 lay-in T8 fluorescent fixture type lighting in good condition, providing adequate illumination of 35 FC based on OSDM requirements. The overall lighting systems of the facility are not fully compliant with Ohio School Design Manual requirements due to age and condition, inadequate lighting levels, and lack of multi-level switching.

3 Needs Replacement

Typical CR lighting

Provide complete replacement of lighting system due to condition, lighting levels, lack of multilevel switching and installation of new fire suppression and air conditioning systems.

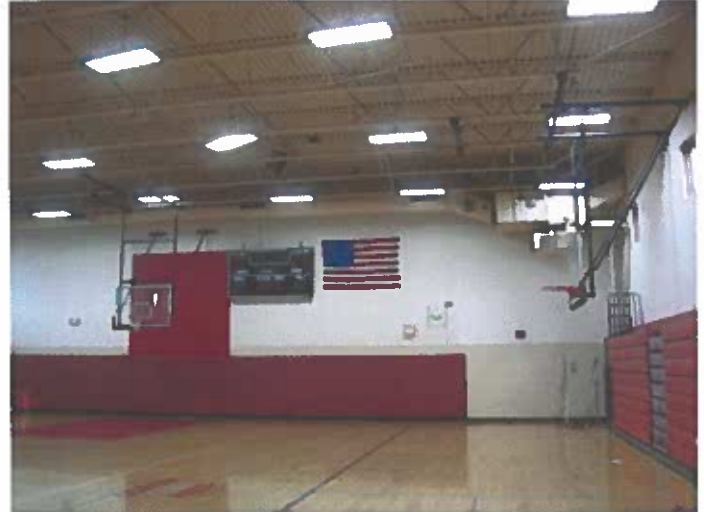
Gym Lighting

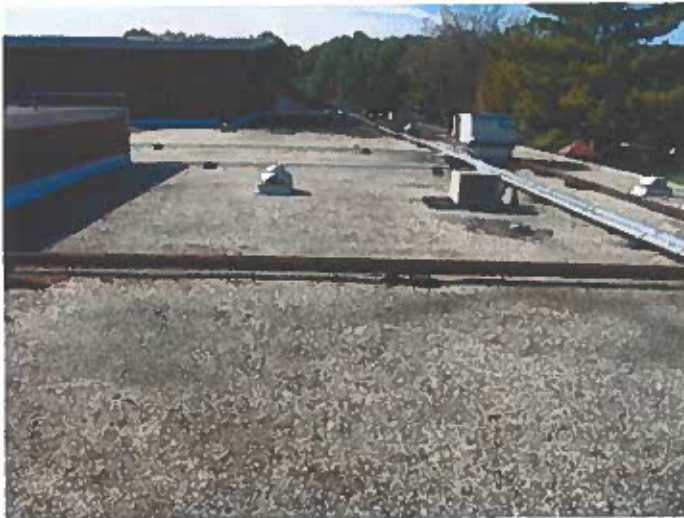
The roofs over the overall facility are EPDM and ballasted membrane systems in poor to fair condition. A new EPDM roof was installed 2 years ago over the Music Area. There are District reports of current leaking. Signs of past leaking were observed during the physical assessment. Access to the roof was gained by a ladder. Fall safety protection cages are not provided. There were observations of standing water on the roof. Metal cap flashings are in fair condition. Roof storm drainage is addressed through a system of roof drains, which are located properly, and in fair condition. The roof is not equipped with overflow roof drains, though they are needed on this building. No problems requiring attention were encountered with any roof penetrations.

3 Needs Replacement

Typical Roof Membrane

The roof over the overall facility requires replacement to meet Ohio School Design Manual guidelines for age of system and due to condition. Also, overflow drains need to be installed. 2021 UPDATE: Add replacement of soffits and fascia due to condition. Add partial roof deck replacement due to rust.

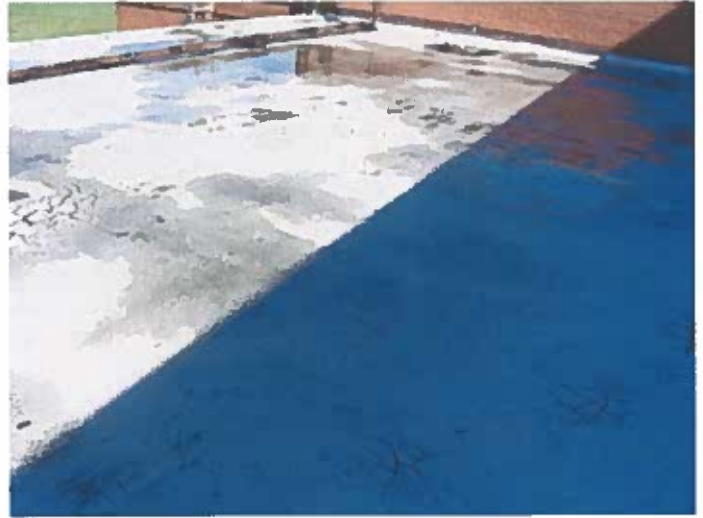
Standing Water on Adhered Membrane

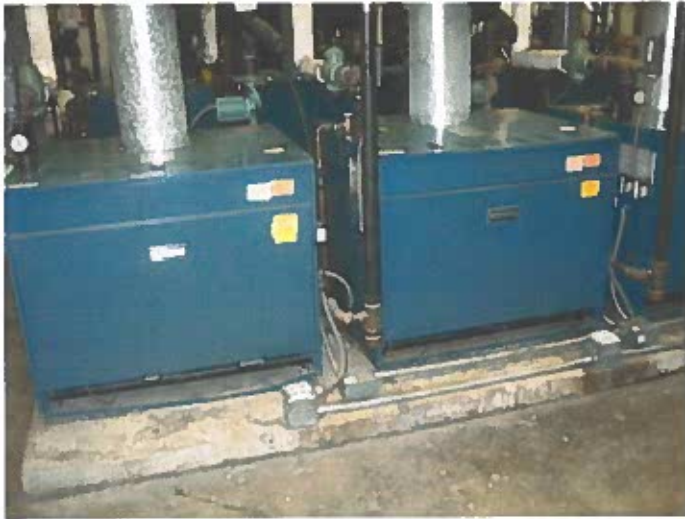
**Description:** The school is heated and cooled by a total of (30) rooftop packaged HVAC units. All are natural gas fired. Units serving classrooms, offices, and other multi-use spaces are variable air volume units, while the gymnasium and cafeteria units are single-zone units. Most units were reportedly installed around 1999. They are in fair condition but approaching the end of a useful life. Gas piping is routed above the roof to each unit and assumed to be low pressure (7-14 in H<sub>2</sub>O). There is a central heating system in the building, consisting of (10) Burnham boilers with an input of 594 MBH each. The boilers were manufactured in 1999 and are in fair-to-good condition. The temperature controls are pneumatic for reheat valves and dampers throughout the building. Controls for the rooftop HVAC units are individual programmable thermostats. There is a Honeywell DDC system that controls time-of-day function for each RTU.

**Rating:** 3 Needs Replacement

Heating Water Boilers

**Recommendations:** Replace all of the packaged rooftop equipment since these systems are not compliant with current OSDM guidelines. 2021 UPDATE: 1 units have been replaced in 2021 and more is scheduled, however, since these are not OSDM compliant, a new system is budgeted.

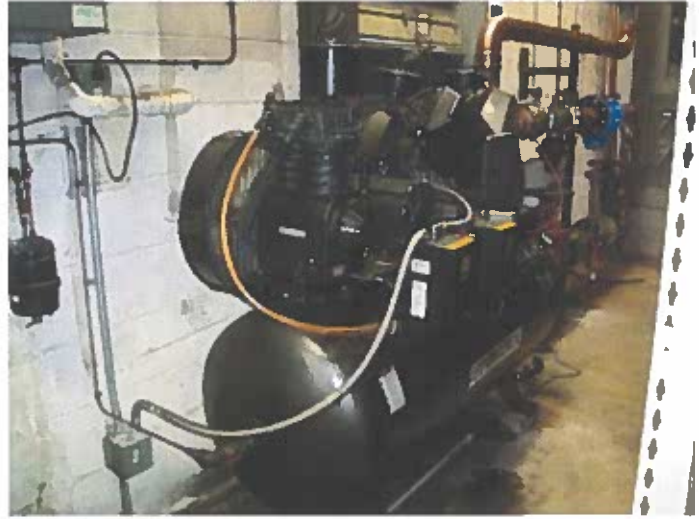
Temperature Control Air Compressor

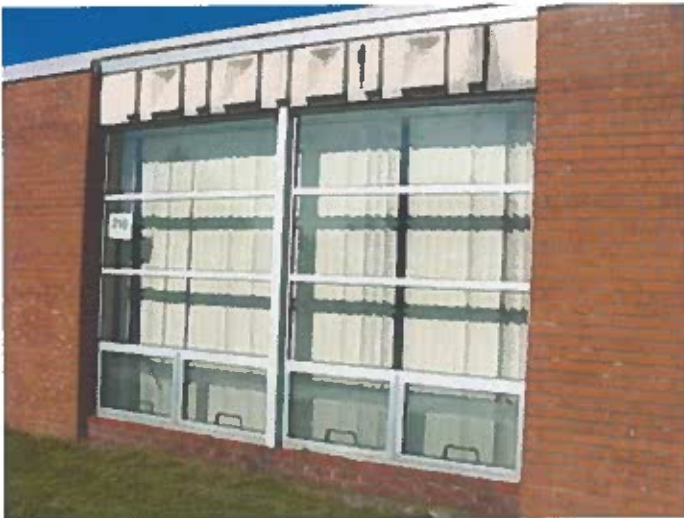
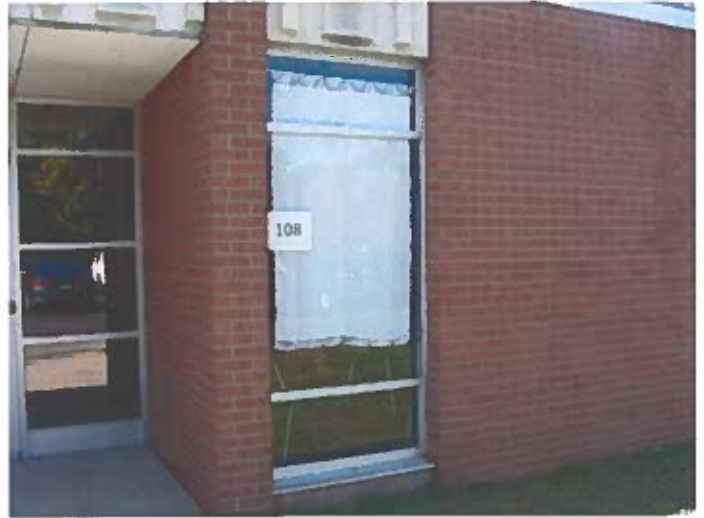
**Description:** The overall facility is equipped with thermally broken aluminum with double glazed insulated glazing window system, which was installed in over 20 years ago. These units are in fair condition. Window system seals are in fair condition, with minimal air infiltration being experienced. Window system hardware is in fair condition. The window system features no blinds.

**Rating:** 3 Needs Replacement

Typical Classroom Window

**Recommendations:** Provide a new insulated window system with integral blinds to meet with Ohio School Design Manual requirements due to age of the windows.  
2021: Adjust sf amounts for window replacement & add skylight replacements.

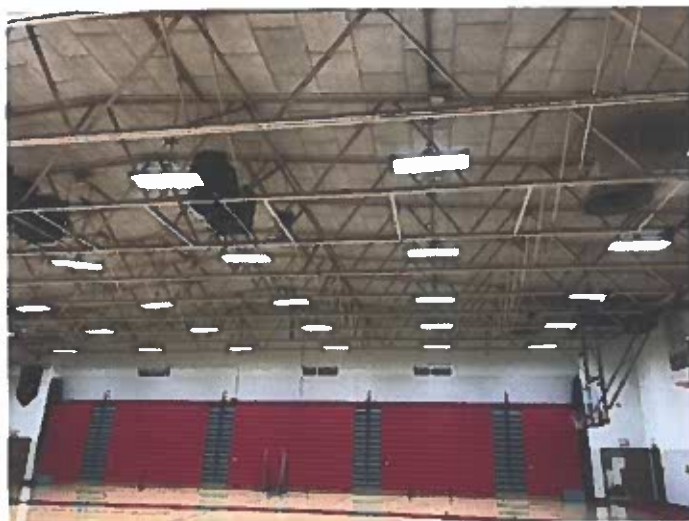
The typical Classrooms in the High School are equipped with T-8 1x4 surface mount fluorescent fixtures with dual level switching. Classroom fixtures are in good condition, providing an average illumination of 40-60 FC, thus complying with the 50 FC recommended by the OSDM. The typical Corridors in the High School are equipped with T-8 2x4 lay-in and 1x4 surface mount fluorescent fixtures with single level switching. Corridor fixtures are in good condition, providing an average illumination of 20 FC, thus complying with the 20 FC recommended by the OSDM. The Gymnasium spaces are equipped with T8 pendant mounted fluorescent fixtures type lighting, in good condition, providing an average illumination of 55 FC, thus complying with the 50 (HS) FC recommended by the OSDM. The Media Center is equipped with 2x4 surface mounted fluorescent fixture type lighting in good condition, providing an average illumination of 50 FC thus complying with the 50 FC recommended by the OSDM. The Student Dining spaces are equipped with 2x2 lay-in LED fixture type lighting with single level switching. Student Dining fixtures are in good condition, providing an average illumination of 30-40 FC, which is less than the 50 FC recommended by the OSDM. The Kitchen spaces are equipped with 2x2 lay-in LED fixture type lighting with single level switching. Kitchen fixtures are in good condition, providing an average illumination of 70 FC, which is less than the 75-80 FC recommended by the OSDM. The Service Areas High School are equipped with 1x4 surface mount T8 fluorescent fixture type lighting in good condition, providing an average illumination of 10-15 FC. The typical Administrative spaces in the High School are equipped with 2x4 lay-in T8 fluorescent fixture type lighting in good condition, providing adequate illumination of 40-55 FC. The overall lighting systems of the facility are not fully compliant with Ohio School Design Manual requirements due to age and condition, inadequate lighting levels, and lack of multi-level switching.

3 Needs Replacement

Gym Lights

Provide complete replacement of lighting system due to condition, lighting levels, lack of multilevel switching and installation of new fire suppression and air conditioning systems.

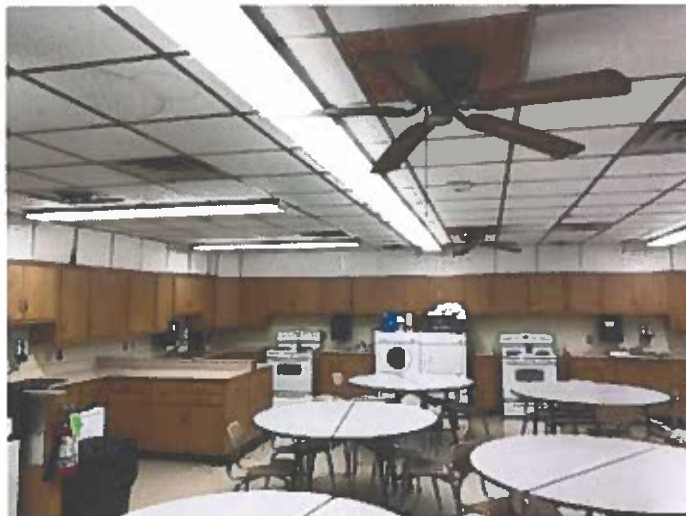
CR Lights

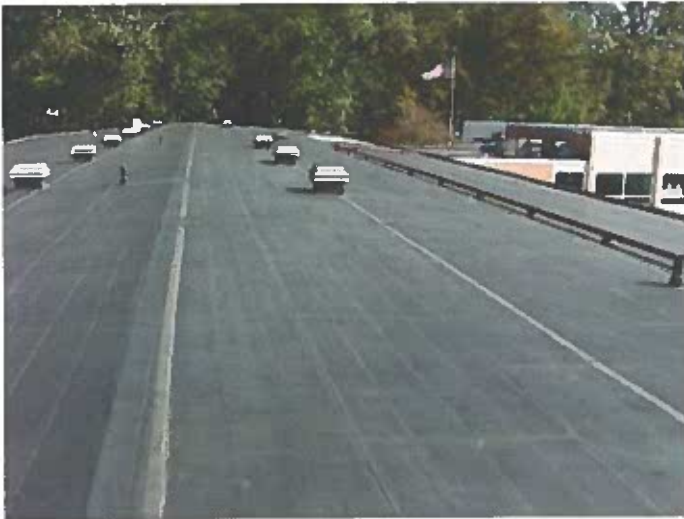
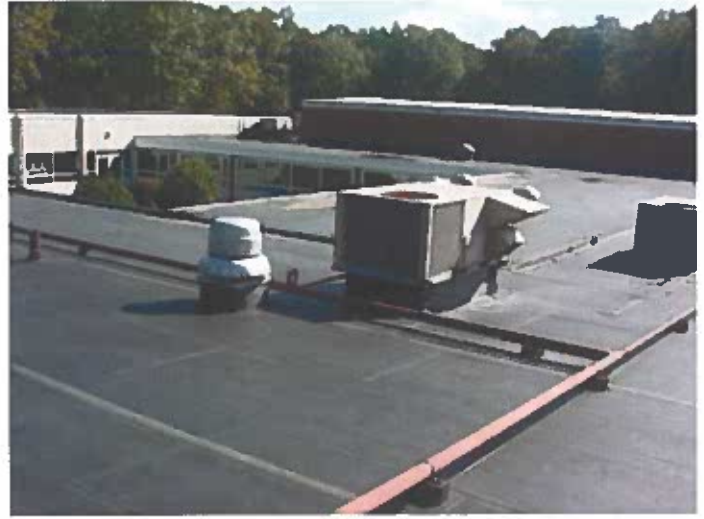
**Description:** The roof over the overall facility is a adhered EPDM system that is in fair condition. There are no District reports of current leaking. No signs of past leaking were observed during the physical assessment. Access to the roof was gained by a ladder. There were no observations of standing water on the roof. Metal cap flashings are in fair condition. Roof storm drainage is addressed through a system of roof drains, which are properly located, and in fair condition. The roof is not equipped with overflow roof drains through they will be required in areas of roof replacement. No problems requiring attention were encountered with any roof penetrations. There is a covered walkway attached to this structure.

**Rating:** 3 Needs Replacement

Existing EPDM Roofing

**Recommendations:** The roof over the overall requires replacement to meet Ohio School Design Manual guidelines for age of system and due to condition. Provide overflow roof drains as well.

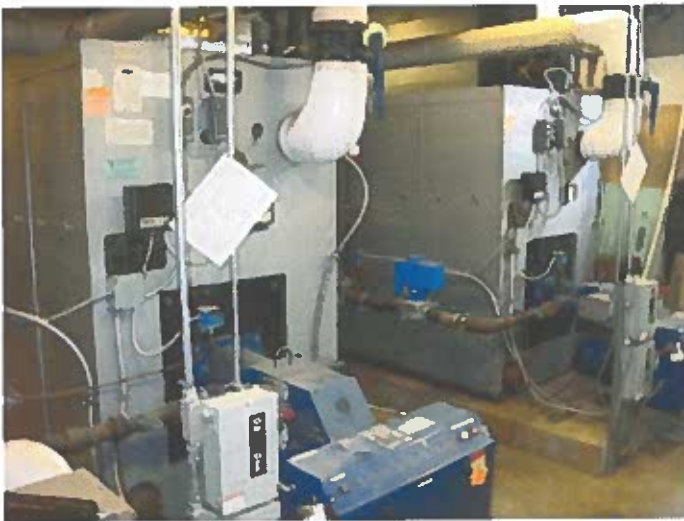
The existing system for the overall structure consists of two Peerless gas-fired boilers installed around 2003 and (3) base-mounted pumps which are in good condition. The boilers supply water to unit ventilators (UVs) in each classroom, and unit heaters/cabinet unit heaters and finned radiation in various locations in the building. The boilers and UVs are in fair condition. The classrooms are not air conditioned. The gymnasium is heated and ventilated by a separate air handler. There are (7) rooftop units (RTUs) that serve various areas of the building. These are described further in Item C. The HVAC system does not provide the required CFM as per OSDM design standards. The system temperature controls for the UVs are pneumatic. Controls for the rooftop HVAC units are individual programmable thermostats. There is a Honeywell direct digital control (DDC) system that controls time-of-day function for each RTU.

3 Needs Replacement

Heating water boilers

Provide new overall HVAC System and ductwork to meet OSDM guidelines including full air conditioning.

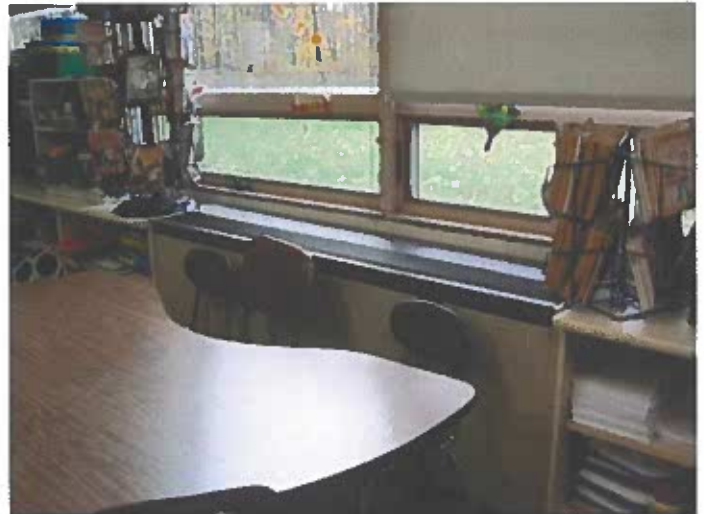
Classroom Univ Ventilator

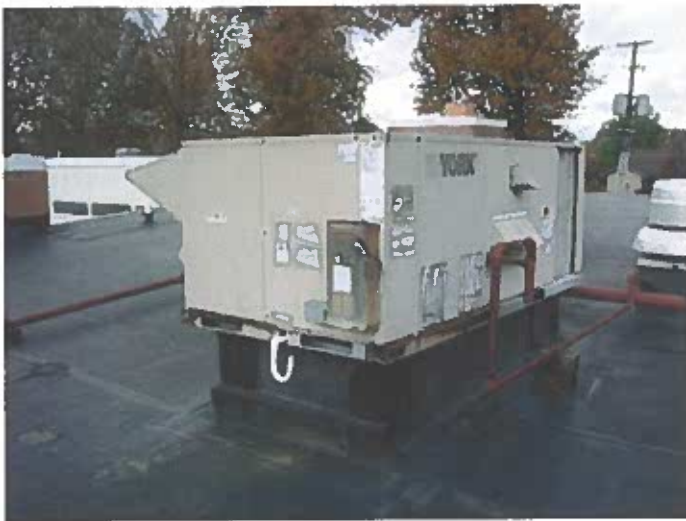
**Description:** The building is partially air conditioned by (7) gas-fired RTUs. (3) serve the library, (1) serves the computer lab, (1) serves the school office and lobby, and (2) serve the cafeteria/kitchen. Most of the RTUs were manufactured in 1999 and are in fair condition. There appears to be adequate space above ceilings for ductwork. It was not determined if the RTU's supply the required minimum outdoor ventilation to the spaces served. The UVs do not supply sufficient outdoor air to the classrooms; however, there are operable windows.

Library RTU

**Recommendations:** Due to the age of the rooftop units and duct distribution systems, and the condition of some air distribution devices, provide a new air conditioning system throughout that meets OSDM design standards. Cost for replacement included in Plate A - Heating System.

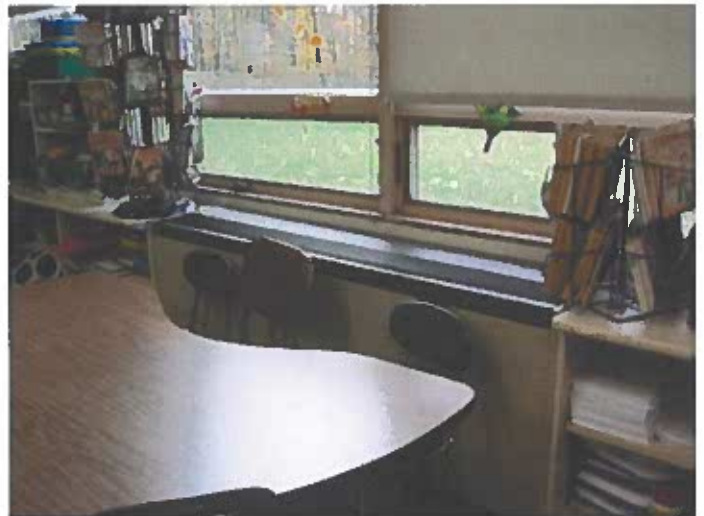
Classroom Univ Ventilator

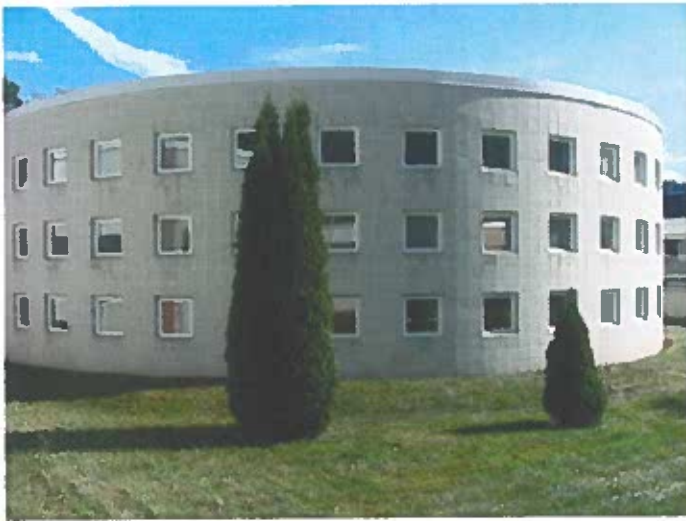
| Description: | The overall facility is equipped with poor Anderson thermally broken vinyl frame windows, double glazed insulated glazing windows. They are in very poor condition. Window system seals are in poor condition, with frequent air and water infiltration being experienced. Window system hardware is in poor condition. The window system features surface mounted blinds. |
| Rating: | 3 Needs Replacement |

Media Center Windows

| Recommendations: | Provide a new insulated window system with integral blinds to meet with Ohio School Design Manual requirements. 2021 UPDATE: Adjust area of window replacement. Add shades to newly replaced windows. 10-13-2022: Per Then Design's assessment validation, updated the cost of the window blinds from \$1800/each to \$2100/each. |

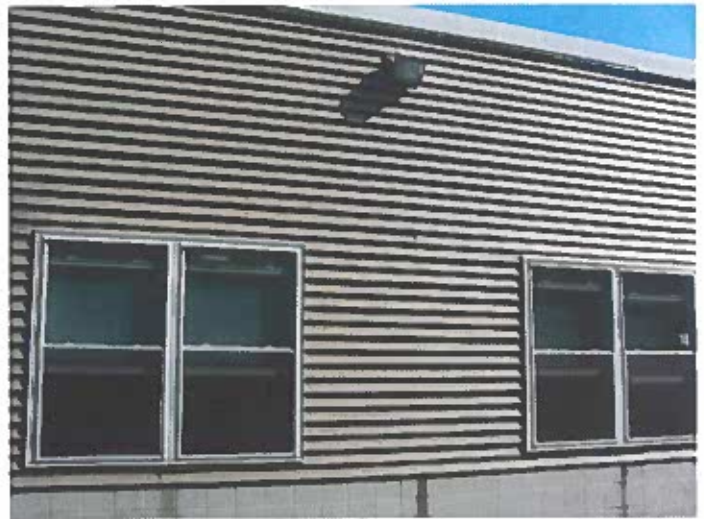
Typical Classroom Windows

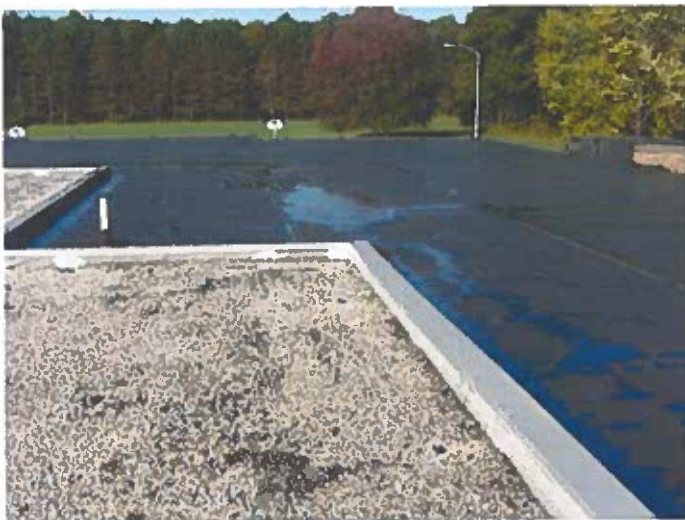
**Description:** The roof over the overall facility is a EPDM and ballasted membrane system that was installed over 7 years ago, and is in poor condition. There are District reports of current leaking. Signs of past leaking were observed during the physical assessment. Access to the roof was gained by access hatch and access ladder that are in good condition. Fall safety protection cages are not required. There were observations of standing water on the roof. Metal cap flashings are in fair condition. Roof storm drainage is addressed through a system of roof drains, which are properly located, and in fair condition. The roof is not equipped with overflow roof drains, though they are needed on this building.

**Rating:** 3 Needs Replacement

Existing EPDM Roofing

**Recommendations:** The roof over the overall facility requires replacement to meet Ohio School Design Manual guidelines for age of system and due to condition. Add roof overflow drains as required.

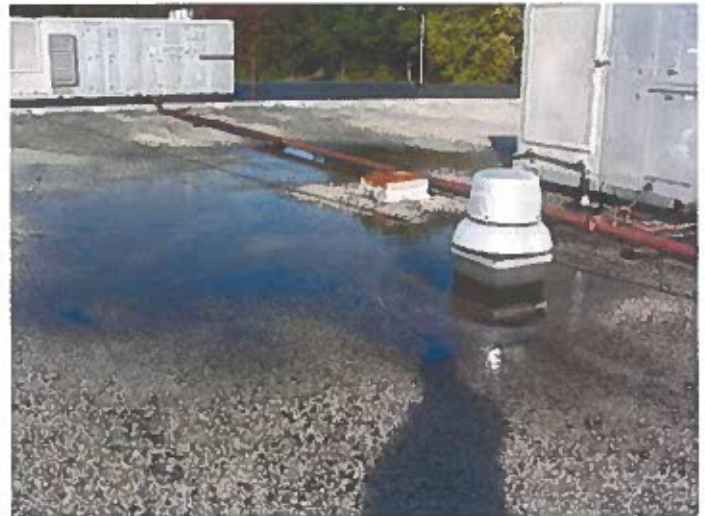
Standing Water on Ballasted Membrane

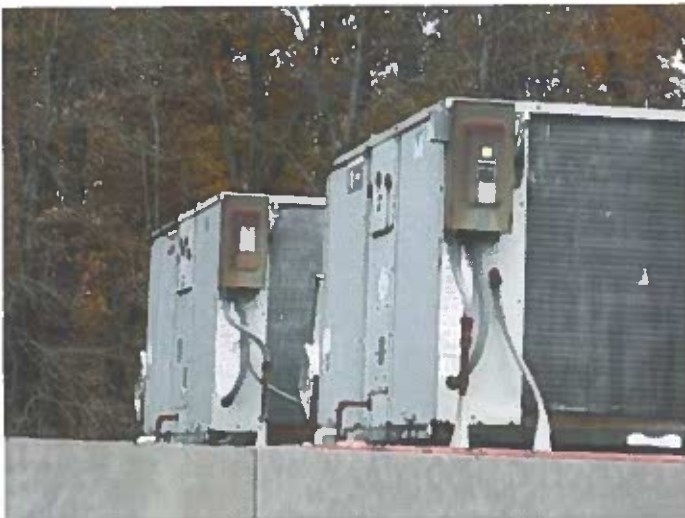
The school is heated and cooled by a total of (9) rooftop packaged HVAC units. (5) units are Seasons-4, which serve various sections of the classrooms, the computer lab, and the library. (4) units are Trane, which serve the central office, cafeteria, and gymnasium. All RTU's were manufactured in 1999 and are in fair condition. All are natural gas fired, with gas piping routed above the roof to each unit. There are electric convectors on the outside wall in each exterior classroom. Each RTU is controlled by a programmable electric thermostat; however, there is a Honeywell direct digital control (DDC) system that controls the time-of-day function for each RTU, plus has the capability to read individual zone temperature throughout the building.

3 Needs Replacement

Seasons 4 RTU's

Provide new overall HVAC System and ductwork to meet OSDM guidelines including air conditioning.

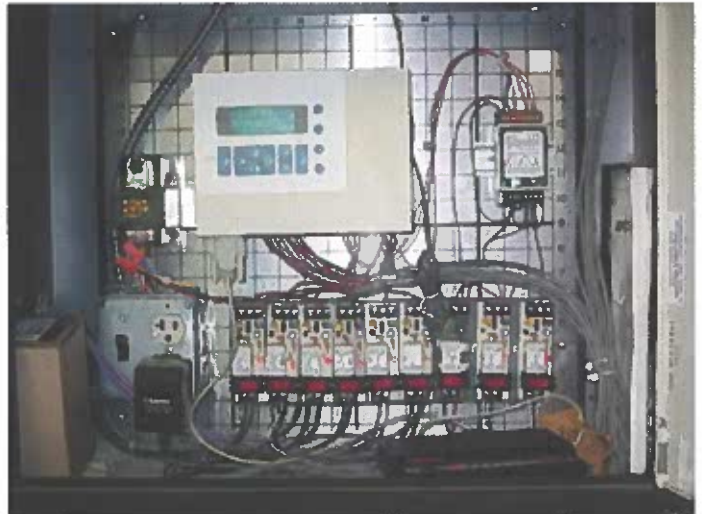
Direct Digital Controls

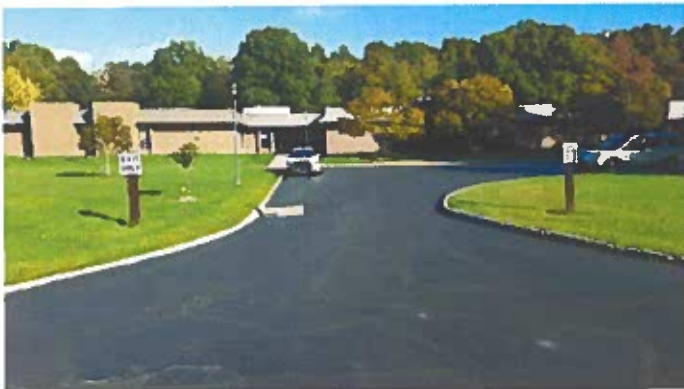
3 Needs Replacement

Typical Pavement Condition

Concrete sidewalk should be replaced where cracked or heaving. Concrete curb should be replaced where crumbling and at points where cars frequently hit it attempting to make sharp turns. The concrete dumpster pad should be removed and replaced with a heavy duty reinforced concrete pavement. The brick retaining wall on the north face of the building should also be replaced with a short, segmental retaining wall. Pavement should be sealed due to mild cracking that does not justify complete removal and replacement. 2021 UPDATE: Add new playground equipment (remove old); provide playground surface; add loading dock repairs; provide asphalt replacement due to condition; delete asphalt sealing; add partial site drainage. 10-13-2022: Per Then Design's assessment validation, updated the cost of the loading dock to \$11,700 and the site drainage to \$35,100

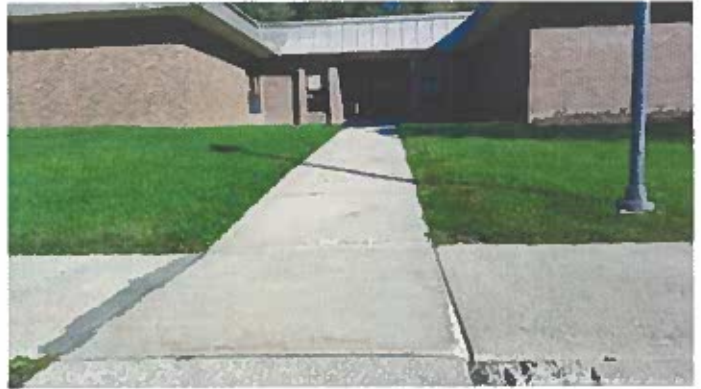
Typical Sidewalk Condition

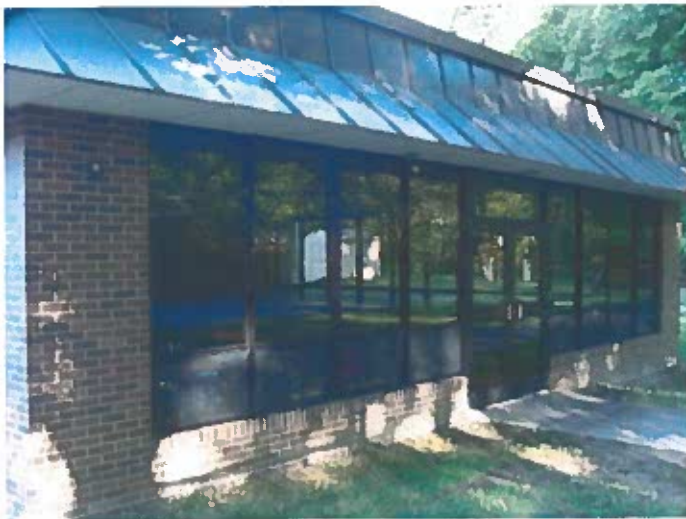
**Description:** The overall facility is equipped with thermally broken aluminum, double-glazed insulated glazing windows, which was installed over 15 years ago, and is in fair condition. Window system seals are in fair condition, with minimal air infiltration being experienced. Window system hardware is in fair condition. The window system features surface mounted blinds, which are in fair condition. The window system is not equipped with insect screens.

**Rating:** 3 Needs Replacement

East End Cafeteria Windows

**Recommendations:** Provide a new insulated window system with integral blinds to meet with Ohio School Design Manual requirements due to age and condition.

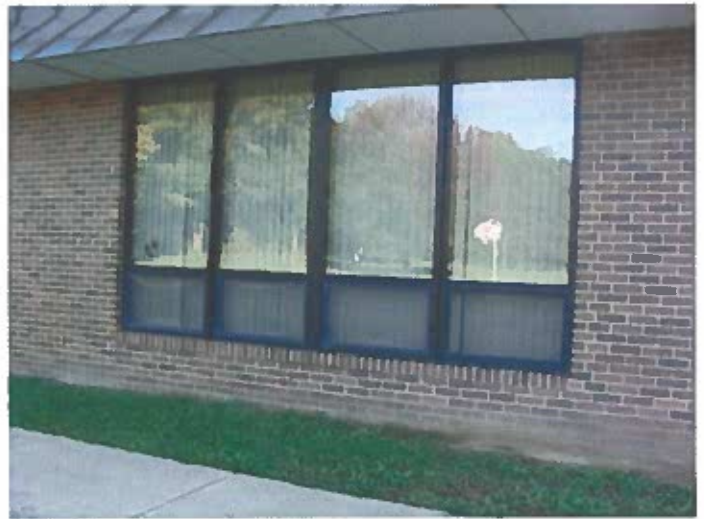
Typical Exterior Window

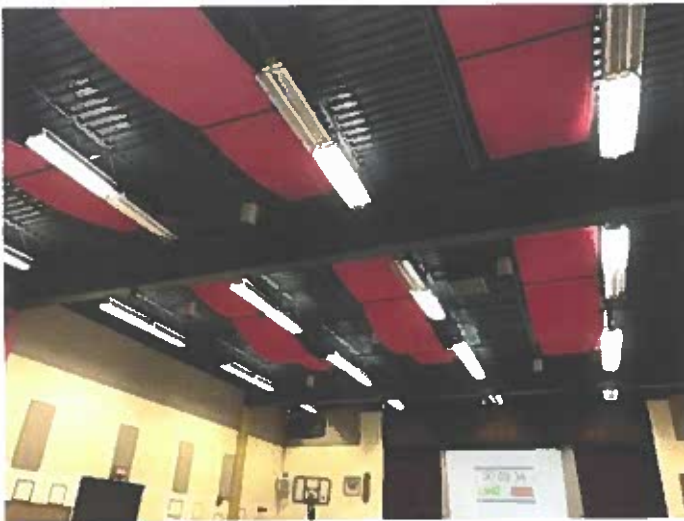
The typical Classrooms in the Hilltop E.S. are equipped with T-8 2x4 lay-in fluorescent fixtures with single level switching. Classroom fixtures are in good condition, providing an average illumination of 31-34 FC, which is less than the 50 FC recommended by the OSDM. The 1999 Addition has 2x4 lay-in T-8 with dual level switching and average illumination of 50-55 FC. The typical Corridors in the Hilltop E.S. are equipped with T-8 1x4 lay-in fluorescent fixtures with single level switching. Corridor fixtures are in good condition, providing an average illumination of 33 FC, thus complying with the 20 FC recommended by the OSDM. The Gymnasium spaces are equipped with T8 1x4 surface mount fluorescent fixtures type lighting, in fair condition, providing an average illumination of 21 FC, which is less than the 50 (ES) FC recommended by the OSDM. The Media Center is equipped with 2x4 lay-in T8 fluorescent fixture type lighting in good condition, providing an average illumination of 50 FC, thus complying with the 50 FC recommended by the OSDM. The Student Dining spaces are equipped with 2x4 lay-in T8 fluorescent fixture type lighting with single level switching. Student Dining fixtures are in good condition, providing an average illumination of 30-40 FC, which is less than the 50 FC recommended by the OSDM. The Kitchen spaces are equipped with 2x4 lay-in T8 fluorescent fixture type lighting with single level switching. Kitchen fixtures are in good condition, providing an average illumination of 75-90 FC, thus complying with the 75-80 FC recommended by the OSDM. The Service Areas in the Hilltop E.S. are equipped with 2x4 surface mount T8 fluorescent fixture type lighting in good condition, providing an average illumination of 10-15 FC. The typical Administrative spaces in the Hilltop E.S. are equipped with 2x4 lay-in T8 fluorescent fixture type lighting in good condition, providing adequate illumination of 35 FC based on OSDM requirements. The overall lighting systems of the facility are not fully compliant with Ohio School Design Manual requirements due to age and condition, inadequate lighting levels, and lack of multi-level switching.

3 Needs Replacement

Gym T8 lights

Provide complete replacement of lighting system due to condition, lighting levels, lack of multilevel switching and installation of new fire suppression and air conditioning systems. 2021 UPDATE: Remove new lighting budget for gym (recently completed).

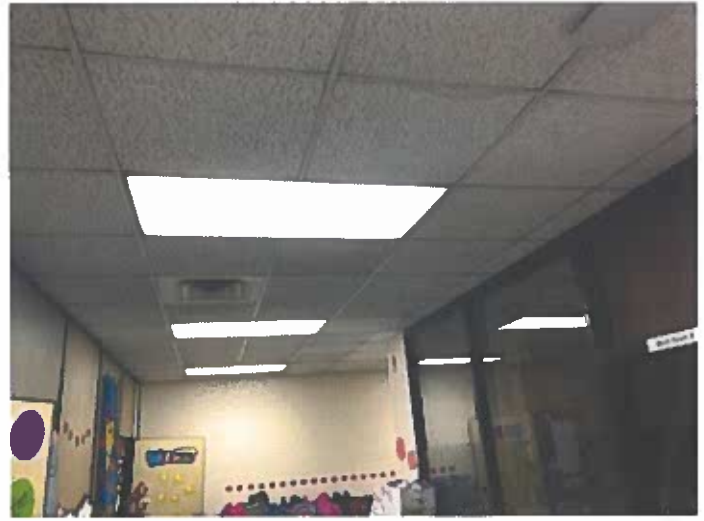
Typical 2x4 lay-in
