# Hazardous Materials Inspection Report

James B. Edwards Elementary School

855 Von Kolnitz Road, Mount Pleasant, South Carolina

November 19, 2025 | Report Number: EN257263

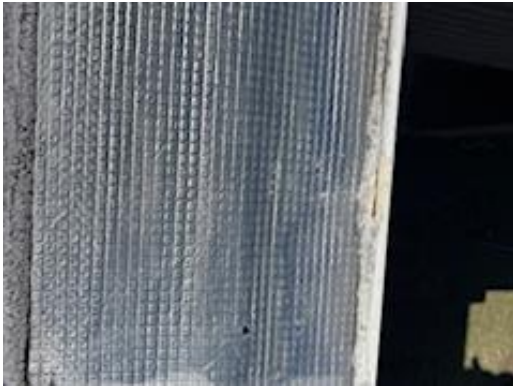
**#1** View of HA-01: White Flashing Sealant

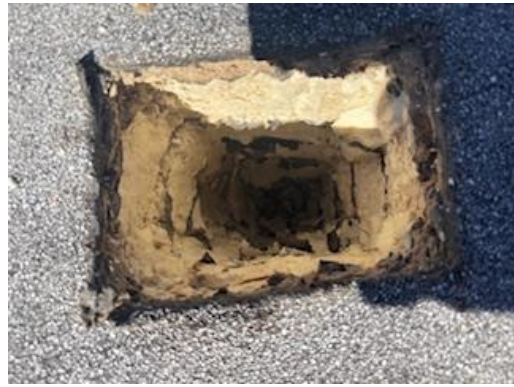
**#2** View of HA-02: Annex Roof Core

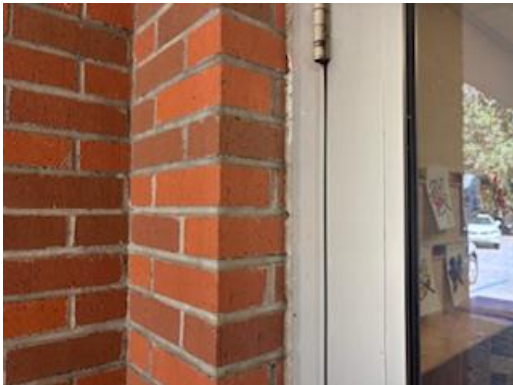
**#3** View of HA-03: Grey Exterior Door Caulk

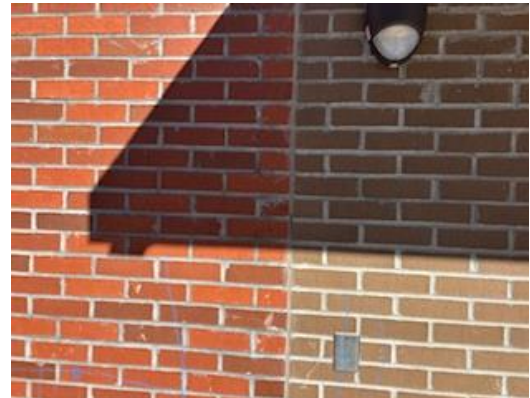
**#4** View of HA-06: Grey Exterior Expansion Joint Caulk

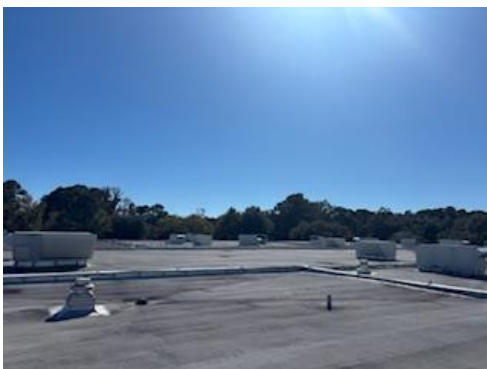
**#5** View of HA-07: Main Building Roof

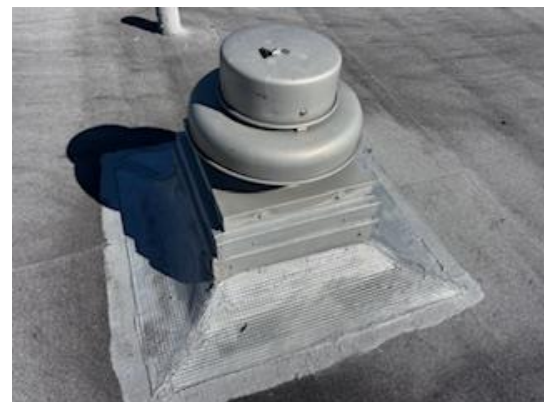
**#6** View of HA-08: Grey Exhaust Hood Sealant

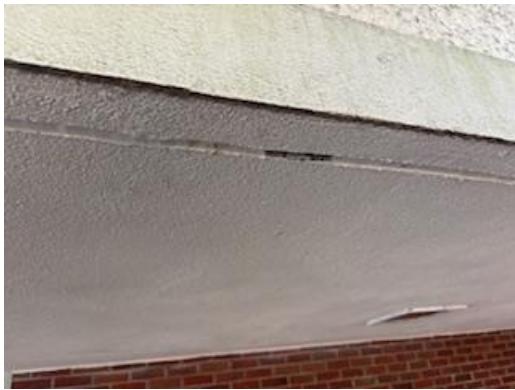
**#7** View of HA-10: White Textured Soffit and HA-11: and associated Sealant

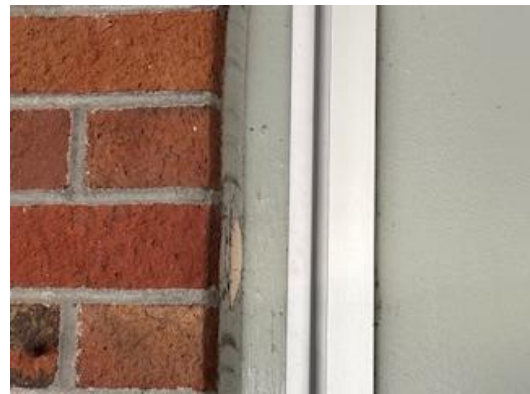
**#8** View of HA-13: Grey Exterior Door Caulk and PC-06 Light Green Paint on Metal Door

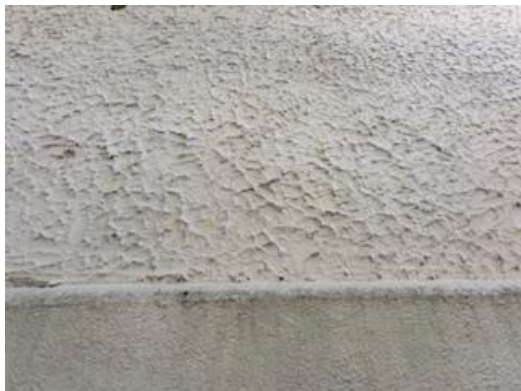
**#9** View of HA-14: White textured Cementous Facade

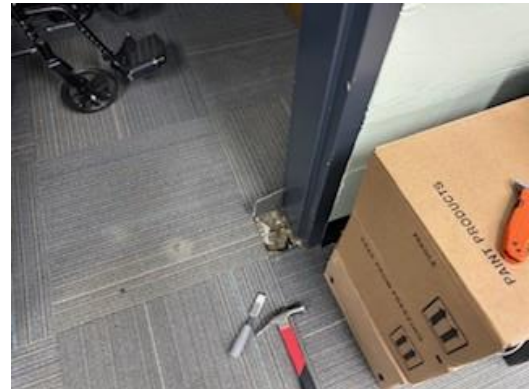
**#10** View of HA-16: Carpet Mastc and HA-17: Vinyl Floor Tile and Mastic and PC-08 Navy Blue Paint on Metal Door Frame

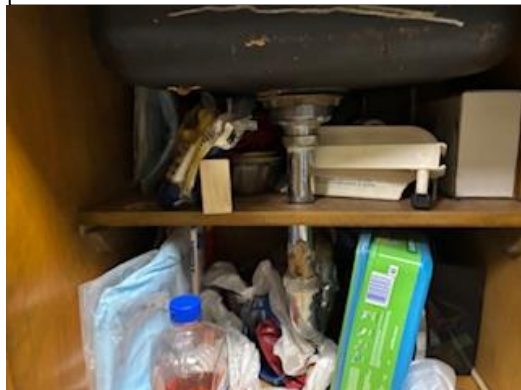
**#11** View of HA-19: Brown Sink Undercoat

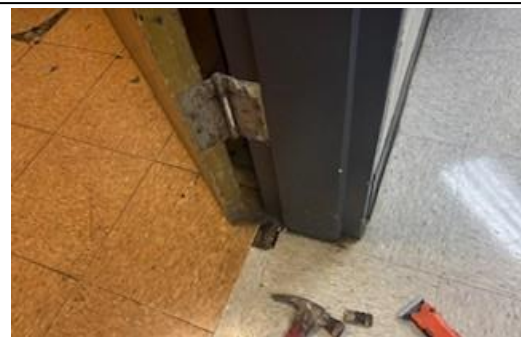
**#12** View of HA-23: 12"x12" Brown Mottled Vinyl Floor Tile and associated asbestos containing Mastic (4% Chrysotile) and HA-25: 12"x12" Light Grey Mottled Vinyl Floor Tile and associated asbestos- containing Mastic (4% Chrysotile)

- Terracon recommends removal of the asbestos-containing materials by a South Carolina licensed asbestos abatement contractor.
- Terracon recommends conducting a destructive survey to delineate the mastic associated with the 12" x 12" light grey mottled vinyl floor tiles in order to quantify the extent of asbestos-containing material. Due to the invasive nature of this survey, Terracon advises that the building be vacated and prepared for demolition prior to performing the assessment.

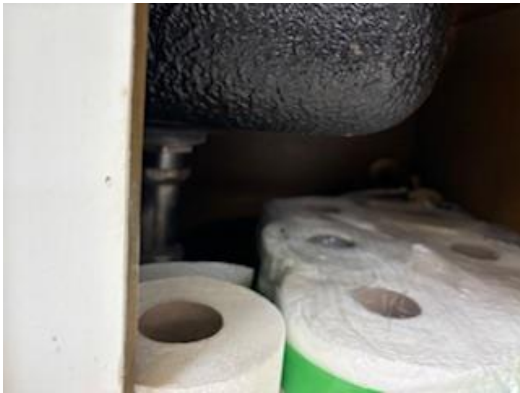
**#13** View of HA-24: Asbestos-containing Black Sink undercoat (6% Chrysotile)

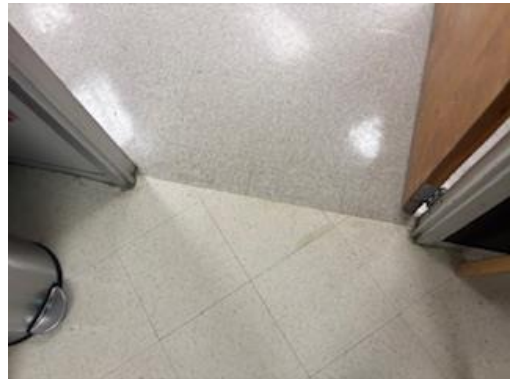
**#14** View of HA-26: 12"x12" White with Light Grey Speck Vinyl Floor Tile and associated Mastic

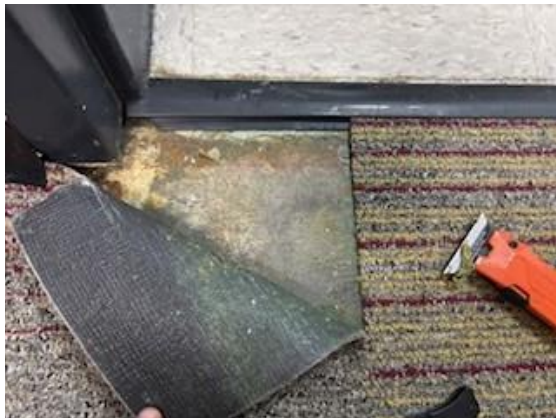
**#15** View of HA-30: Green Carpet Mastic

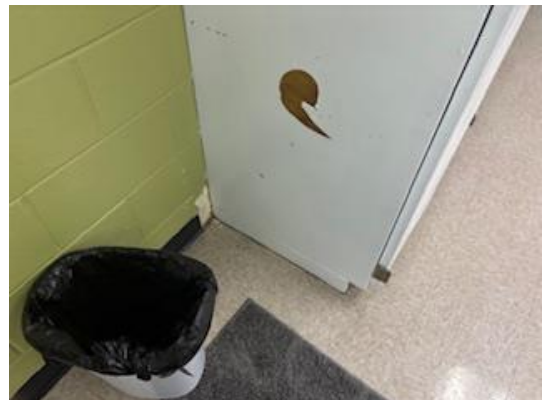
**#16** View of HA-31 and HA-32: Non-ACM Components and PC-13 and PC-14: Painted Wood and CMU Components

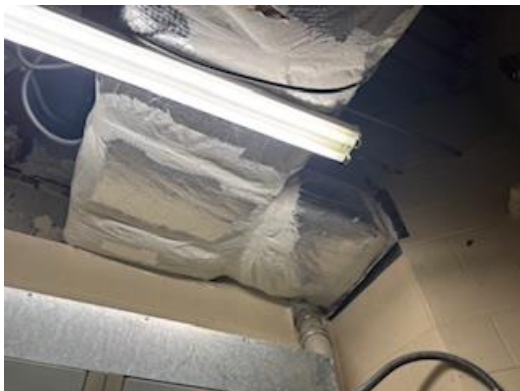
**#17** View of HA-33: White HVAC Duct Seam Mastic

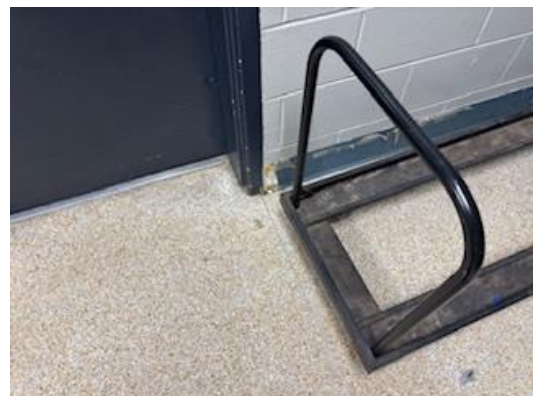
**#18** View of HA-36 and HA-38: Non-ACM Vinyl Cove base and Terrazzo flooring

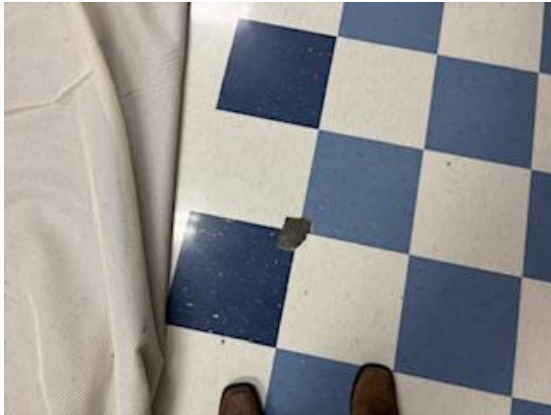
**#19** View of HA-40, HA-41, and HA-42:  
Vinyl Floor Tiles

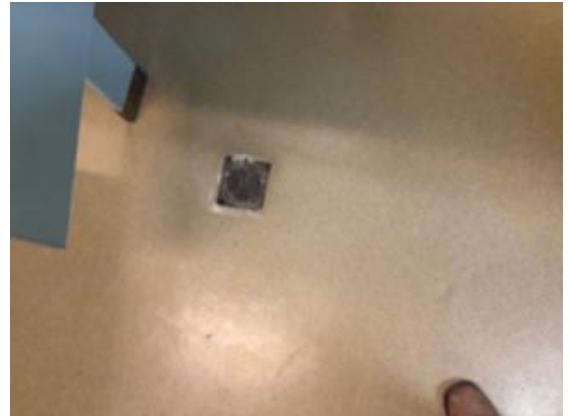
**#20** View of HA-43 Epoxy Flooring

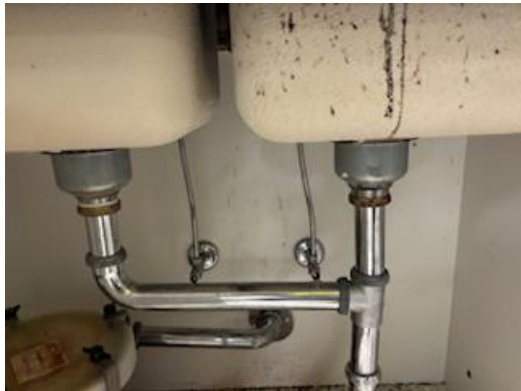
**#21** View of HA-44 White Sink Undercoat

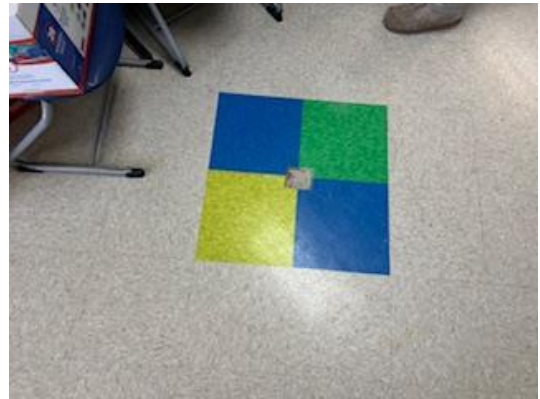
**#22** View of HA-48, HA-49, and HA-50:  
Vinyl Floor Tiles

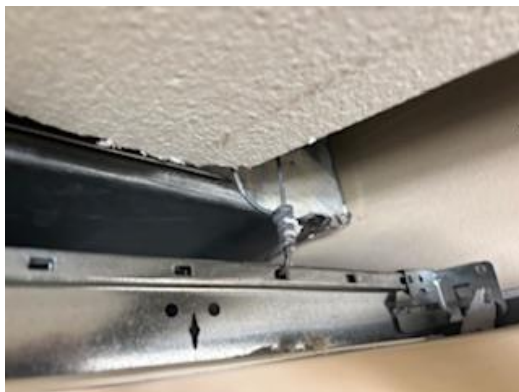
**#23** View of HA-52 2' x 2' Ceiling Tile and  
HA-55 White HVAC Duct Seam Mastic  
and PC-22 White Paint on Gypsum Walls

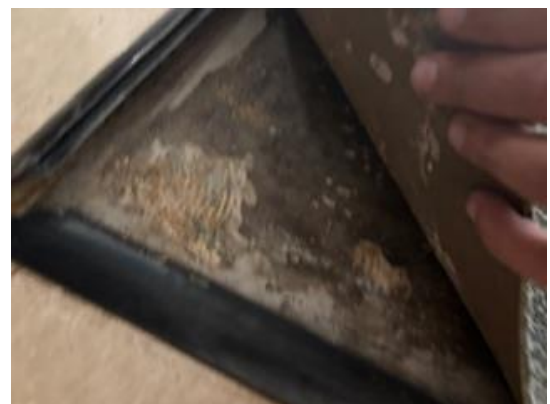
**#24** View of HA-57 Grey Carpet Mastic

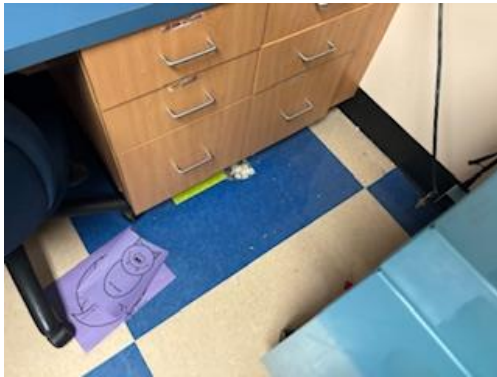
**#25** View of HA-56, HA-58, HA-61 and HA-62 Annex Flooring Materials

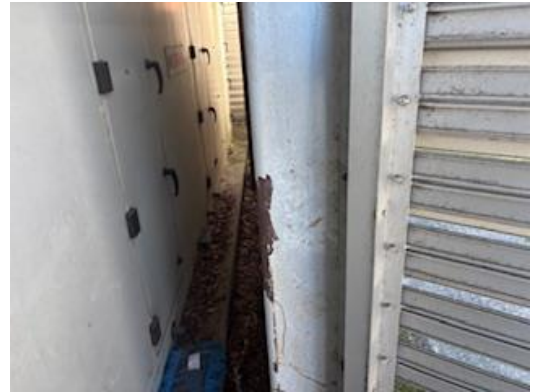
**#26** View of PC-01 Grey/Silver Paint on Metal Gate

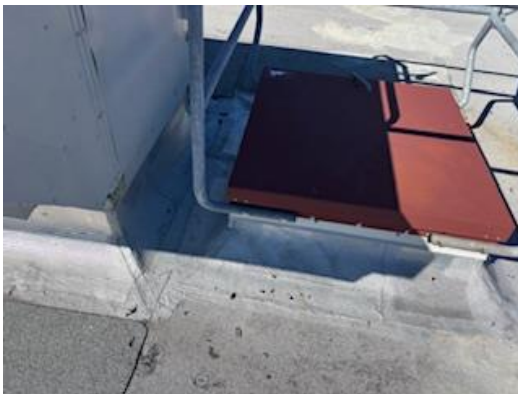
**#27** View of PC-03 Red Paint on Metal Roof Hatch

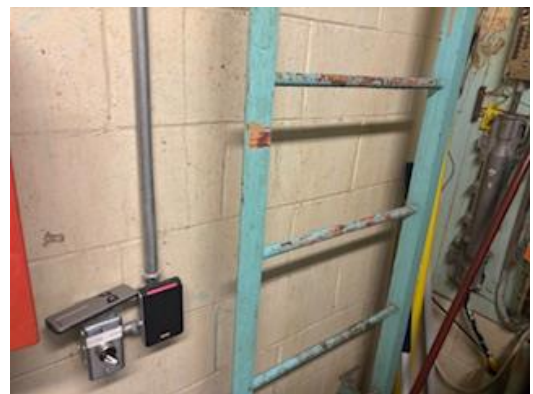
- Blue Paint (1.4% wt.) associated with interior metal ladder.

**#28** View of PC-10 Lead- Based Blue Paint on Metal Ladder (1.4%)

- SCDES regulations require that lead-painted demolition debris be disposed in a permitted Class II landfill. Landfills should be contacted to determine their specific disposal requirements. Metal components painted with lead paint may be recycled however the recycler should be contacted to determine their specific requirements.

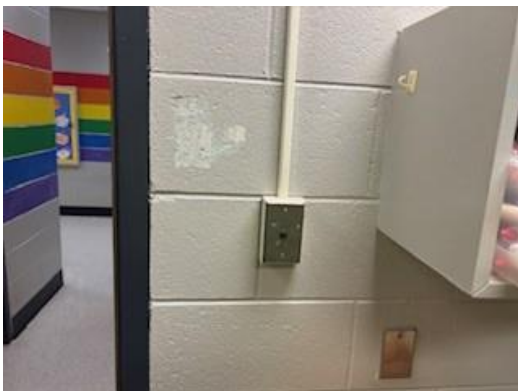
**#29** View of PC-12 Light Grey Paint on CMU Walls

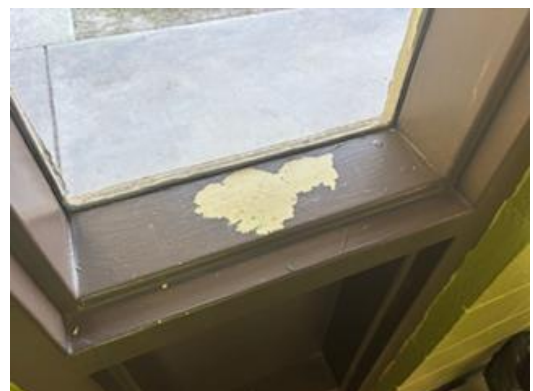
**#30** View of PC-15 Brown Paint on Metal Window Frame

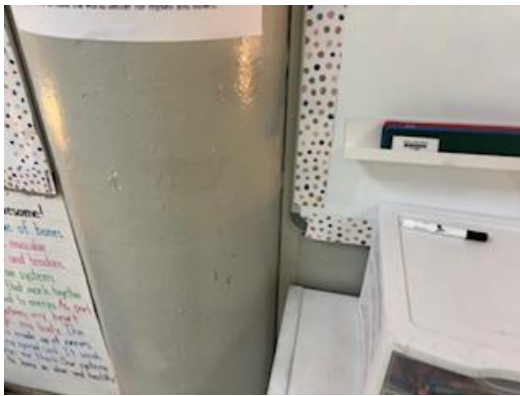
**#31** View of PC-16 Grey Paint on Concrete Column

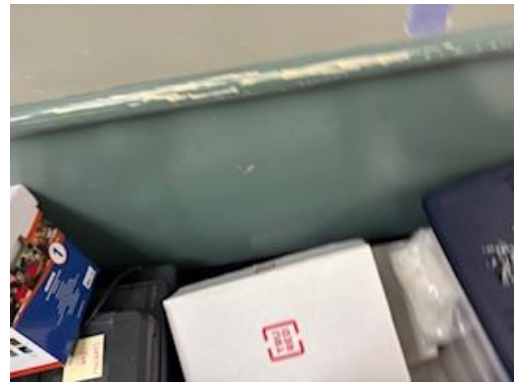
**#32** View of PC-17 Green Paint on Wood Chair Rail

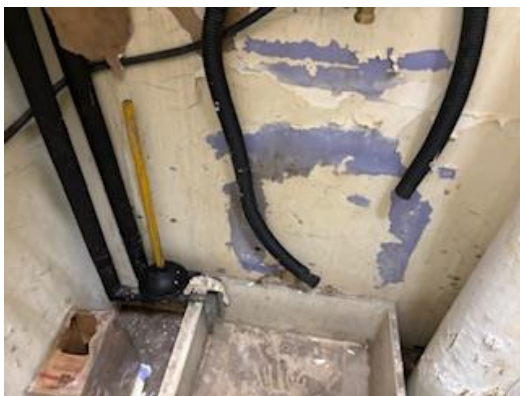
**#33** View of PC-18 White Paint on Gypsum Wall

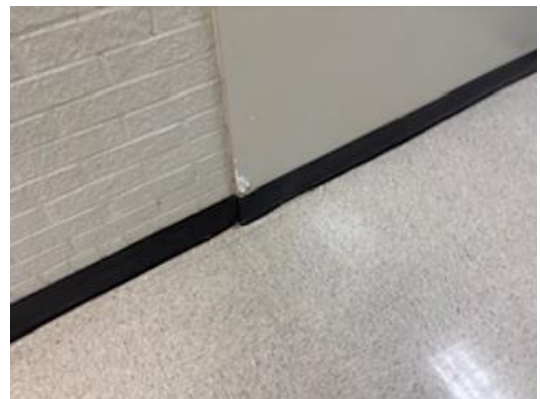
**#34** View of PC-19 Light Grey Paint on Brick Wall

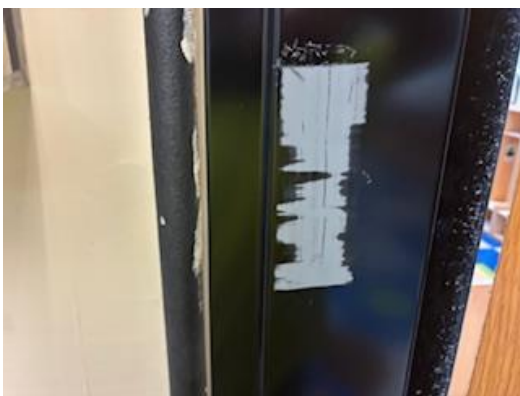
**#35** View of PC-21 Black Paint on Metal Door Frame

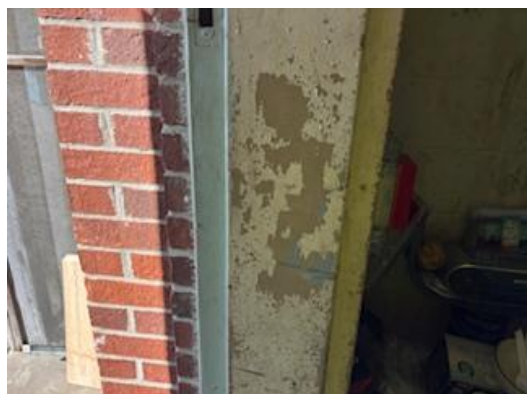
**#36** View of PC-24 Tan Paint on Metal Door Frame
