**Building Information - Northmont City (48728) - Northmoor Elementary**

| Assessment Name | Northmoor Elementary with EEHA & 2026 Costs - OFCC Desktop Update |
| Assessment Date (on-site; non-EEA) | 2011-04-07 |

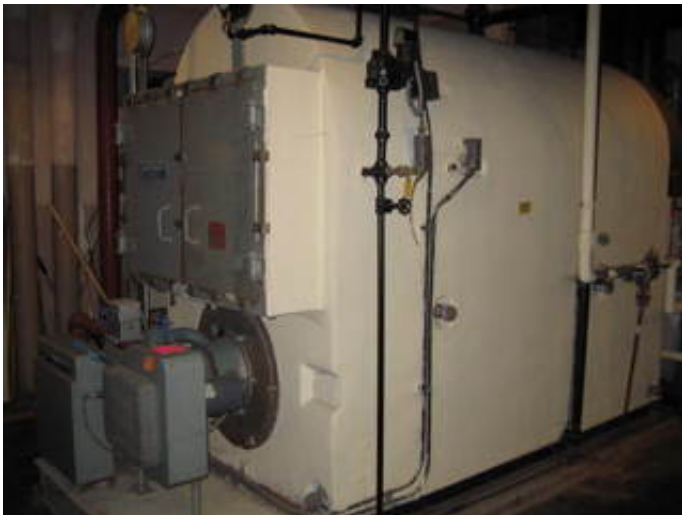
**Description:** The existing system for the 1965 Original Construction is a natural gas fired heated water boiler type system, installed in 1965, and is in fair to poor condition. The systems in the 1968 and 1973 Additions are an extension of that found in the 1965 Original Construction. 2-pipe vs. 4-pipe designations are not applicable in the 1965 Original Construction and 1968 Addition, as no central air conditioning is provided. 2-pipe vs. 4-pipe designations are not applicable in the 1973 Addition, as the central air conditioning provided is a through-wall unit ventilator with electric DX cooling condensers type system. The Kewanee Type C boiler, manufactured by American Standard Products, was installed in 1965 and is in fair to poor condition. Heating water is distributed to terminal units consisting of unit ventilators, cabinet heaters, unit heaters, fin tubes, and air handlers. The terminal equipment is original to each addition and is in fair to poor condition. The system does not comply with the 15 CFM per person fresh air requirements of the Ohio Building Code mechanical code and Ohio School Design Manual. The pneumatic type system temperature controls are original to each addition and are in fair condition. The system does not feature individual temperature controls in all spaces required by the OSDM. The overall system does not feature any central energy recovery systems. The facility is equipped with wood louvered interior doors with glass transom above to facilitate Corridor utilization as return air plenums. See Items J and O for replacement of doors. The existing system is not ducted, and floor to structural deck heights will not accommodate the installation of properly sized ductwork for a future Ohio School Design Manual approved system. The overall heating system is evaluated as not being in safe and efficient working order, and long term life expectancy of the existing system is not anticipated. The overall facility, except for the 1973 Addition, is not equipped with a central air conditioning system. The site does not contain underground fuel storage tanks.

**Rating:** 3 Needs Replacement

Natural Gas Fired Heated Water Boiler

**Recommendations:** Provide new overall heating, ventilating, and air conditioning system to achieve compliance with Ohio Building Code and Ohio School Design Manual standards. Convert the overall facility to a ducted system to facilitate efficient exchange of conditioned air. Provide architectural soffits to accommodate the installation of ductwork, with funding provided in conversion to ducted system replacement.

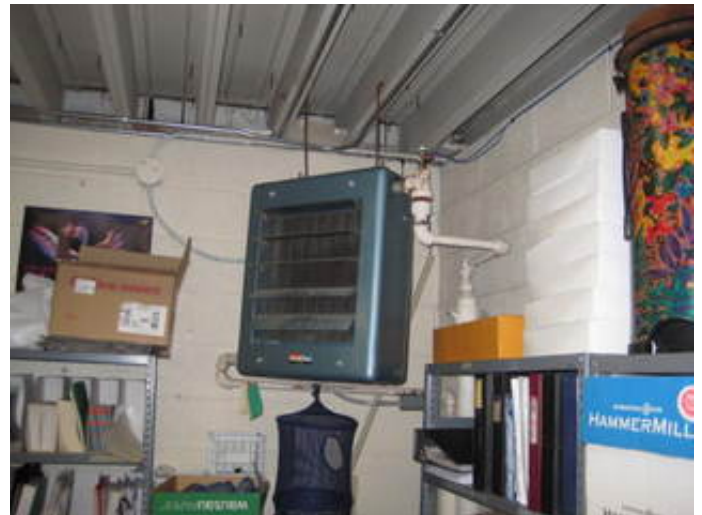
Heating Water Unit Heater

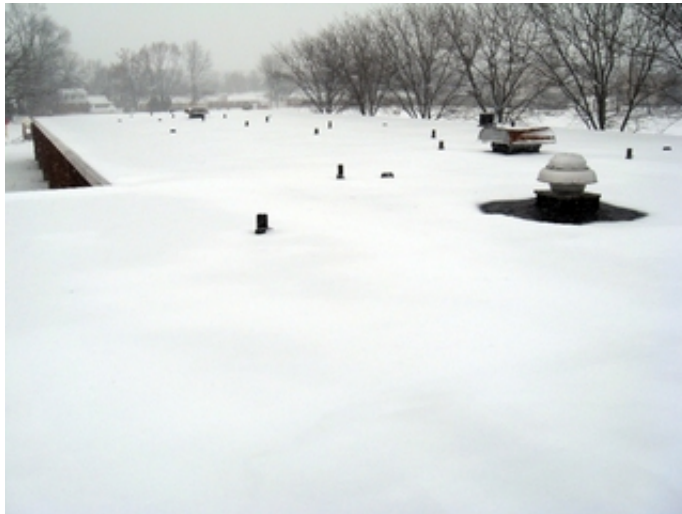
**Description:** The roof over the overall facility, except over the Mechanical Room and Multi-Purpose Room, is an EPDM fully adhered single ply membrane system that was installed in 2000, and is in good condition. The roof over the Mechanical Room and Multi-Purpose Room is an EPDM single ply membrane with gravel ballast system that was installed in 2000, and is in good condition. There are no District reports of current leaking. Signs of past leaking were observed during the physical assessment. Access to the roof was gained by an extension ladder that is in good condition. Fall safety protection cages are not required, and are not provided. There were observations of standing water on the roof. Metal cap flashings are in good condition. Roof storm drainage is addressed through a system of roof drains, which are properly located, and in good to fair condition. Three roof drain strainers are broken or missing. The roof is not equipped with overflow roof drains, though they are not required. No problems requiring attention were encountered with any roof penetrations. There are not any covered walkways attached to this structure. **June 2026 Desktop Update - OFCC - Under Contract Deduction Partial Roof Replacement (Boiler Room & Gym) FY '23. This reduced the scope of work required. The partial roof replacement of the west side of the building does not reduce required scope of work per OSDM assessment cost guidelines and judgement of OFCC staff.**

**Rating:** 3 Needs Replacement

Roof Over Classroom Wing Of The 1965 Original Construction

**Recommendations:** The roof over the overall facility requires replacement to meet Ohio School Design Manual guidelines for age of system. Provide new Roof hatch and ladder for roof access. Replace 3 broken or missing roof drain strainers. **June 2026 Desktop Update - OFCC - Under Contract Deduction Partial Roof Replacement (Boiler Room & Gym) FY '23. This reduced the scope of work required. The partial roof replacement of the west side of the building does not reduce required scope of work per OSDM assessment cost guidelines and judgement of OFCC staff.**

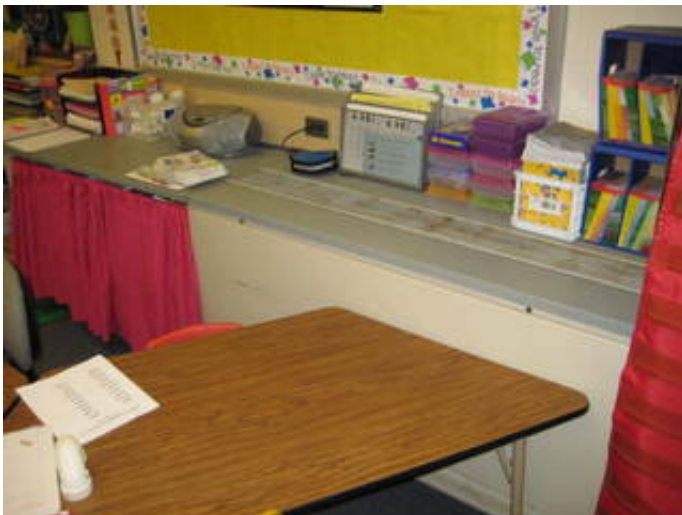
**Description:** The overall facility, except for the 1973 Addition, is not equipped with a central air conditioning system. The 1973 Addition is equipped with through-wall unit ventilators with electric DX cooling condensers located on the roof. The system was installed in 1973 and is in fair condition. Window units are provided in the Administrative Offices. Isolated room systems consisting of ductless split AC units with condensers located on the roof are provided in Media Center, Teacher's Lounge, and Teacher's Workroom locations. The ventilation system in the overall facility consists of unit ventilators, original to each addition and in fair condition, providing fresh air to Classrooms, and air handlers, installed in 1965 and in poor condition, providing fresh air to other miscellaneous spaces such as the Multi-Purpose Room (Student Dining / Gymnasium). Relief air venting is provided by louvered interior doors, unit ventilators, air handlers, and central relief fans. The ventilation system does not meet the Ohio Building Code 15 CFM per occupant fresh air requirement. The overall system is not compliant with Ohio Building Code and Ohio School Design Manual requirements. Dust collection systems are not required in this facility. Exhaust systems for Restrooms, Storage Rooms, Custodial Closets, Maintenance Workrooms, Locker Rooms, Kitchen Dry Food Storage, and Art Rooms are inadequately placed, and in fair to poor condition. The Art Program is not equipped with a kiln.

**Rating:** 2 Needs Repair

Typical Classroom Unit Ventilator

**Recommendations:** Provide an air conditioning system to meet with Ohio Building Code and Ohio School Design Manual requirements. Pricing included in Item A. Replace the existing general building exhaust system. Provide the existing Art Program the required kiln ventilation system, with kiln pricing to be included in Item J.

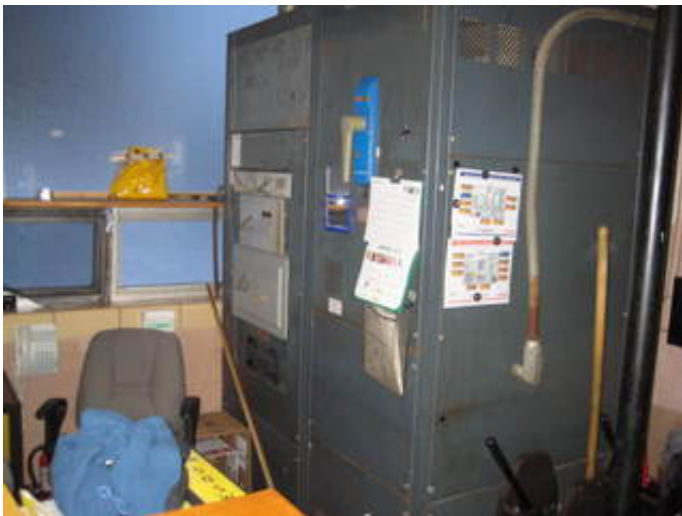
**Description:** The electrical system provided to the overall facility is a 120/208 volts, 1200 amp, 3 phase and 4 wire system installed in 1965, and is in fair condition. The systems in the 1968 and 1973 Additions are an extension of that found in the 1965 Original Construction. Power is provided to the school by multiple utility owned, pad-mounted transformers located outside the Mechanical Room, and in fair to poor condition. The General Electric panel system, installed in 1965, is in fair condition, but cannot be expanded to add additional capacity. The Classrooms are not equipped with adequate electrical outlets. The typical Classroom contains four (4) general purpose outlets, two (2) dedicated outlets for each Classroom computer, and zero (0) dedicated outlet for each Classroom television. Some Classrooms are equipped with as many as five (5) general purpose outlets, while others are equipped with as few as three (3) general purpose outlets. There are not any spaces that have no electrical outlets. The Corridors are not equipped with adequate electrical outlets for servicing. Adequate GFI protected exterior outlets are not provided around the perimeter of the building. The facility is not equipped with an emergency generator. Adequate lightning protection safeguards are not provided. The facility is not equipped with Stage spaces. The overall electrical system does not meet Ohio School Design Manual requirements in supporting the current needs of the school, and will be inadequate to meet the facility's future needs.

**Rating:** 3 Needs Replacement

Main Electrical Distribution Panel

**Recommendations:** The entire electrical system requires replacement to meet Ohio School Design Manual guidelines for overall capacity and Classroom capacity due to age, condition, lack of OSDM-required features, and to accommodate the addition of an air conditioning system. Provide new transformer due to age, condition, and possible hazardous materials, with funding to be coordinated with the utility company. Provide an emergency generator, with funding included in the electrical system replacement. Provide adequate lightning protection safeguards in the overall facility, including associated grounding system, with funding included in the electrical system replacement.

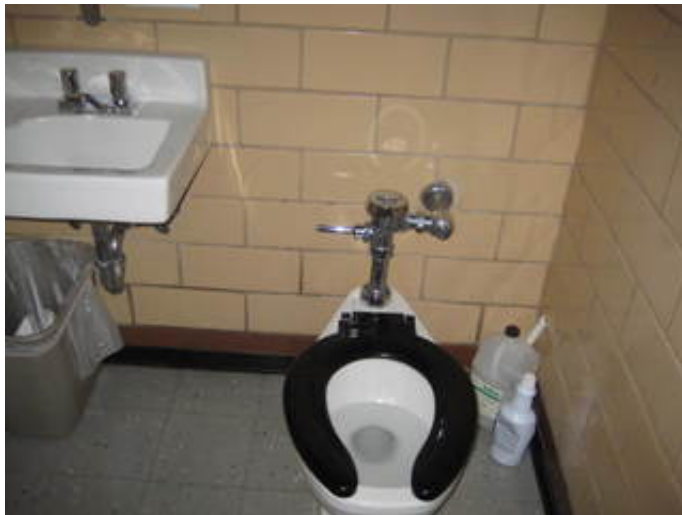
| Description: | <p>The service entrance is not equipped with a reduced pressure backflow preventer. A water treatment system is not provided, though none is needed. The domestic water supply piping in the overall facility is galvanized and copper, is original to each addition, and is in fair condition. The waste piping in the overall facility is cast iron and galvanized, is original to each addition, and is in fair condition. The facility is equipped with one (1) A.O. Smith 80 gallon natural gas water heater, installed in 2005, and in good condition, with one (1) separate 250 gallon storage tank, installed in 1965, and in poor condition. The overall facility contains 2 Large Group Restrooms for boys, 2 Large Group Restrooms for girls, 1 Kitchen Restroom, 1 Health Clinic Restroom, 2 Restrooms associated with Kindergarten Classrooms, and 2 Restrooms for staff. Boys' Large Group Restrooms contain 6 non-ADA wall mounted flush valve toilets, 2 ADA and 11 non-ADA wall mounted infra-red urinals, as well as 9 non-ADA wall mounted lavatories. Girls' Large Group Restrooms contain 13 non-ADA wall mounted flush valve toilets, as well as 9 non-ADA wall mounted lavatories. Staff Restrooms contain 2 non-ADA floor mounted flush valve toilets, as well as 2 non-ADA wall mounted lavatories. Condition of fixtures is fair. The facility is equipped with 6 non-ADA electric water coolers, in fair condition. Elementary Classrooms are equipped with required lavatory mounted type drinking fountains, which are not ADA compliant, and are in fair to poor condition. Special Education Classroom is not equipped with the required Restroom facilities. Kitchen is equipped with the required Restroom which contains 1 non-ADA floor mounted flush valve toilet, as well as 1 non-ADA wall mounted lavatory, and fixtures are in fair condition. Health Clinic is equipped with the required Restroom which contains 1 non-ADA floor mounted flush valve toilet, as well as 2 non-ADA wall mounted lavatories, and fixtures are in fair condition. Kindergarten / Pre-K Classrooms are equipped with two (2) Restroom facilities which contain 2 (total) non-ADA floor mounted flush valve toilets, as well as 2 (total) non-ADA wall mounted lavatories, and fixtures are in fair condition. Kitchen fixtures consist of one (1) single-compartment sink, one (1) double compartment sink, one (1) hand sink, one (1) dishwashing unit, and one (1) disposal unit, which are in good to fair condition. The Kitchen is not equipped with a grease interceptor. The Kitchen is not provided the required 140 degree hot water supply. The school meets the OBC requirements for fixtures, but does not meet the OBC requirements for drinking fountains. Per OBC and OSDM requirements this facility should be equipped with 18 toilets, 3 urinals, 18 lavatories, and 7 electric water coolers, and at present it is equipped with 25 toilets, 13 urinals, 25 lavatories, and 6 electric water coolers. ADA requirements are not met for fixtures and drinking fountains (see Item O). Custodial Closets are not properly located and are not adequately provided with required service sinks or floor drain sinks, which are in fair condition. Science Classrooms / Labs are not equipped with required utility sink, gas / compressed air connections, and safety shower / eyewash stations. Due to existing grade configuration, no Biology or Chemistry Classroom acid waste systems are required. Adequate exterior wall hydrants are not provided.</p> |
| Rating: | 3 Needs Replacement |

Non-ADA Wall Hung Lavatory and Floor Mounted Flush Valve Toilet

| Recommendations: | <p>Replace water supply piping in the overall facility with copper piping due to age and condition. Replace sanitary waste piping in the overall facility due to age and condition. To facilitate the school's compliance with OBC and OSFC requirements, provide 1 new electric water cooler. Due to age, condition, and OSFC standards, replace 27 lavatory mounted type drinking fountains, 44 faucets and valves, and 6 toilets. See Item O for replacement of fixtures related to ADA requirements. Provide the service entrance with a reduced pressure back flow preventer. Replace the 250 gallon domestic hot water heater storage tank due to age and condition. Provide the Kitchen with a grease trap interceptor. Provide the Kitchen with a water booster heater. Provide 2 additional exterior wall hydrants. Provide additional Custodial Closet service sinks / floor drain sinks. Replace the existing Custodial Closet floor drain sinks due to age and condition. Provide the Science Classrooms with the required gas connection. Provide the Science Classrooms with the required compressed air connection. Provide the Science Classrooms with the required safety shower / eyewash station. Provide the Science and Art Classrooms with the required utility sink.</p> |

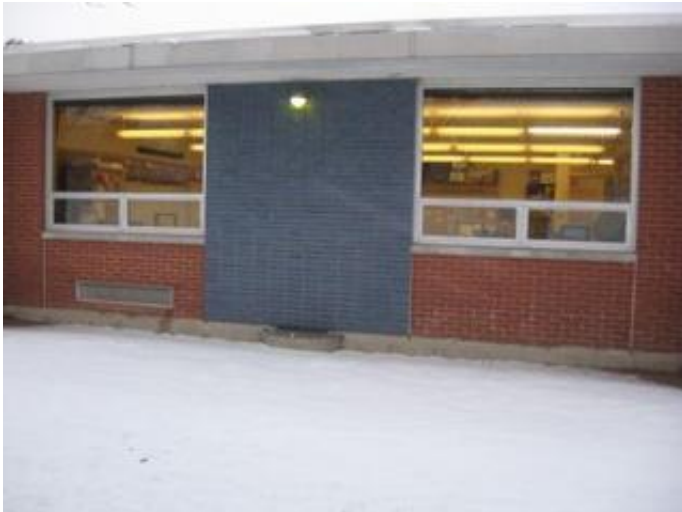
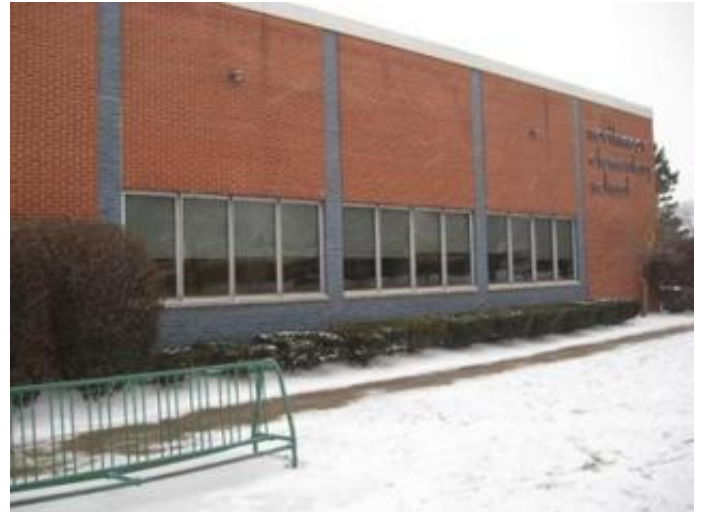
**Description:** The overall facility is equipped with aluminum frame windows with single glazed type window system, which was installed at time of construction, and is in fair condition. The window system features operable windows throughout the building, and operable windows are not equipped with opening limiters. The windows are equipped with insect screens in good condition. Window system seals are in good to fair condition, with minimal air and water infiltration being experienced. Window system hardware is in good to fair condition. The window system features surface mounted blinds and shades, which are in good to fair condition. This facility is not equipped with any curtain wall systems. This facility does not feature any glass block windows. The exterior doors in the overall facility are equipped with aluminum and hollow metal frame sidelights and transoms with single pane glazing in fair condition. Exterior door vision panels are tempered single pane glazing. The school does not contain skylights. The school does not contain clerestories. Interior glass is not OSDM-compliant due to lack of code compliant safety glazing. Window security grilles are not provided for ground floor windows. There is not a Greenhouse associated with this school.

**Rating:** 3 Needs Replacement

Typical Classroom Windows

1965 Original Construction Multi Purpose Room Windows

**Recommendations:** Provide a new insulated window system with integral blinds to meet with Ohio School Design Manual requirements. Replace window transoms and sidelights at exterior doors of the overall facility. Exterior door vision panel replacement is addressed in Item S in exterior door replacement scope. Replace non compliant interior glazing.

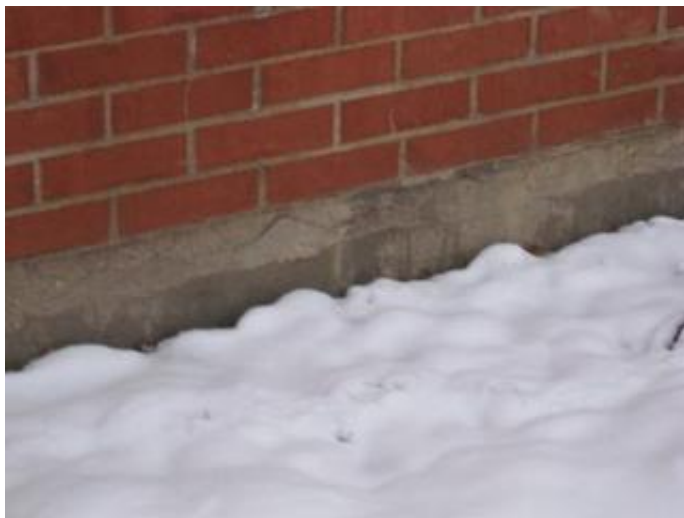
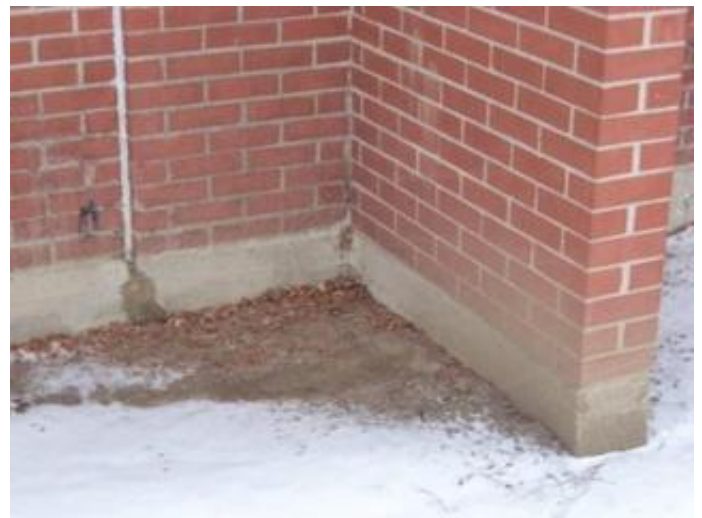
**Description:** The overall facility is equipped with concrete foundation walls on concrete footings which displayed no locations of significant differential settlement, cracking, or leaking, and are in good to fair condition. Areas of minor cracking and spalling were observed through the overall facility. The District reports that there has been no past leaking. No grading or site drainage deficiencies were noted around the perimeter of the structure that are contributing or could contribute to foundation / wall structural deterioration.

**Rating:** 3 Needs Replacement

Typical Exposed Concrete Foundation Wall Condition

Exposed Concrete Foundation at Control Joint and Wing Wall

**Recommendations:** Repair areas of cracking and spalling through the overall facility.

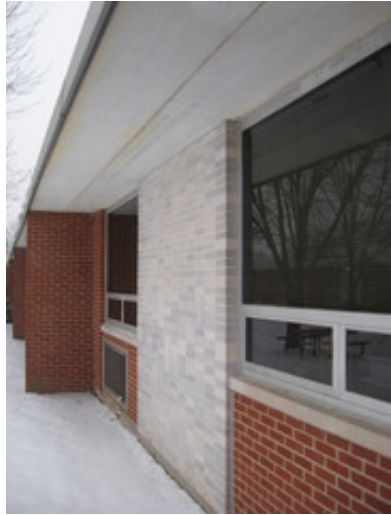
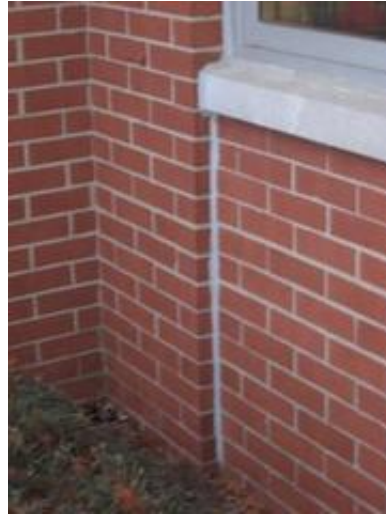
**Description:** The overall facility has a brick veneer on load bearing masonry wall system which displayed minor locations of deterioration, and is in good to fair condition. The exterior masonry appears to have appropriately spaced and inadequately caulked control joints in fair condition. Control joints are provided at lintel locations, at doors and windows and wall offsets and are in fair condition. The school does have sufficient expansion joints, and they are in good condition. Brick veneer masonry walls are cavity walls. Weep holes are provided but not in sufficient quantity at 48" on center at lintels, below sills, and the base of masonry cavity walls, and are in fair condition. Weep holes are plastic tube type weeps. Vents are not provided. The exterior masonry has not been cleaned and sealed in recent years, and shows evidence of mortar deterioration. Architectural exterior accent materials consist of glazed brick and stone, which are in good to fair condition. Installation of new HVAC systems will result in removal of any existing unit ventilators, necessitating the exterior masonry infill of associated exterior wall voids. Interior walls are concrete masonry units, glazed block, brick, operable partitions and wood framed partitions with wood paneling and are in good to fair condition. Some minor cracking was observed in the corridor CMU walls. Interior masonry appears to have adequately spaced and caulked control joints in good condition. The window sills are stone, and are in good to fair condition. The exterior lintels are steel, and are rusting, in good to fair condition. Chimney is in fair condition, requiring some masonry repair work and tuckpointing. There are no canopies over entrances. Exterior soffits are painted precast concrete, and in fair condition. The school is not equipped with a loading dock.

**Rating:** 2 Needs Repair

Typical Exterior Soffit Condition

Typical Control Joint at Window Sill

**Recommendations:** Provide tuckpointing in all areas of mortar deterioration as required through the overall facility. Provide masonry cleaning, sealing and caulking as required through the overall facility. Recaulk existing control joints. Repoint stone window sills through the overall facility. Prep and paint exposed steel lintels through the overall facility. Repair exterior masonry as required through the overall facility. Repair minor cracks in interior masonry as required through the overall facility. Repair chimney masonry as required. Repair and paint exterior precast concrete soffits. Replace wood framed partitions with code compliant construction. Provide masonry infill for unit ventilator openings in exterior walls.

| Item | Cost | Unit | Whole Building | Original Construction (1965)<br>26,228 ft <sup>2</sup> | Classroom Addition (1968)<br>7,954 ft <sup>2</sup> | Classroom Addition (1973)<br>8,099 ft <sup>2</sup> | Sum | Comments |
|---|---|---|---|---|---|---|---|---|
| <b>Other:</b> Repair and Paint Exterior Soffits | \$8.00 | sq.ft.<br>(Qty) | | 2,070 Required | 1,160 Required | 240 Required | \$27,760.00 | Repair and paint exterior precast concrete soffits. |

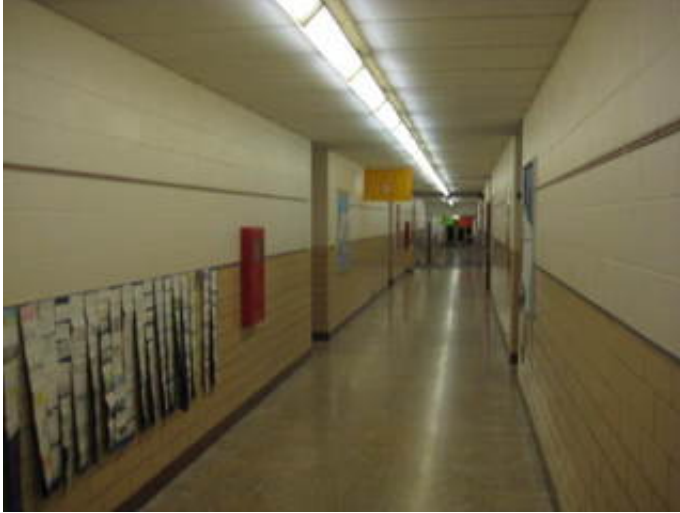
The overall facility features conventionally partitioned Classrooms with carpet flooring, acoustical tile type ceilings, as well as brick, painted block, and glazed block wall finishes, and they are in fair condition. The 1965 Original Construction also features wood panel walls and operable partitions, which are in fair condition. The overall facility has Corridors with terrazzo flooring, acoustical tile ceilings, as well as brick, painted block, and glazed block wall finishes, and they are in fair condition. The 1965 Original Construction and 1968 Addition have Restrooms with terrazzo or ceramic tile flooring, plaster ceilings, as well as brick and glazed block wall finishes, and they are in fair condition. Toilet partitions are metal and painted block, and are in fair to poor condition. Classroom casework in the overall facility is wood or metal construction with plastic laminate tops, is inadequately provided, and in poor condition. The typical Classroom contains 12 lineal feet of casework, and Classroom casework provided ranges from 8 to 20 feet. Classrooms are provided adequate chalkboards, markerboards, tackboards, which are in fair condition. The lockers, located in the Classrooms, are adequately provided, and in fair condition. The Art program is not equipped with a kiln. The facility is equipped with wood louvered interior doors that are flush mounted without proper ADA hardware and clearances, and in fair to poor condition. The Multi-Purpose spaces have VAT flooring, exposed metal deck and joist with acoustical spray ceilings, as well as brick, painted block, glazed block, and acoustical spray wall finishes, and they are in fair to poor condition. Multi-Purpose Room is not equipped with seating. Multi-Purpose Room basketball backboards are fixed type, and are in fair to poor condition. The Media Center, located in the 1965 Original Construction, has carpet flooring, acoustical tile ceilings, as well as painted block wall finishes, and they are in fair condition. Student Dining shares the Gymnasium space. There is no stage featured in the Multi-Purpose Room. Existing Multi-Purpose Room and Media Center spaces are inadequately provided with appropriate sound attenuation acoustical surface treatments. The existing Kitchen is full service, is undersized based on current enrollment, and the existing Kitchen equipment, installed within the last 10 years, and is in good to fair condition. The Kitchen hood is in poor condition, and is equipped with the required UL 300 compliant wet chemical fire suppression system. The required 6" overhang on all three exposed sides of the cooking equipment is not provided by the hood. Kitchen hood exhaust ductwork is not of proper construction material and/or installed as required by the OSDM and OBCMC. Reach-in coolers and freezers are located within the Kitchen spaces, and are in fair condition. **June 2026 Desktop Update - OFCC - VAT flooring was replaced with NORA/FORBO flooring in the multi-purpose spaces. The acoustical spray wall finishes have been removed. After, the walls were painted. Does not reduce required scope of work per OSDM assessment cost guidelines and judgement of OFCC staff.**

3 Needs Replacement

Typical Corridor Finishes

Provide complete replacement of finishes and casework due to installation of systems outlined in Items A, C, D, E, K, L, M, N, T, U, W, and due to condition. Provide for the replacement of interior doors due to condition, louvers, and work in Item O. Provide a kiln for the Art Program with funding for the heat removal hood provided in Item C. Provide for replacement of reach-in cooler/freezer as required due to condition. Provide for the replacement of the Kitchen exhaust hood to meet OSDM requirements. Provide for repairs to terrazzo flooring due to condition. Provide for the replacement of toilet partitions due to condition. Provide for the replacement of toilet accessories. Provide additional acoustical control for the Multi-Purpose Room and Media Center. Provide for the replacement of Multi-Purpose Room basketball goals due to condition. Provide seating for the Multi-Purpose Room. Provide for the replacement of hard plaster in the 1965 Original Construction and 1968 Addition due to work in Item T. **June 2026 Desktop Update - OFCC - VAT flooring was replaced with NORA/FORBO flooring in the multi-purpose spaces. The acoustical spray wall finishes have been removed. After, the walls were painted. Does not reduce required scope of work per OSDM assessment cost guidelines and judgement of OFCC staff.**

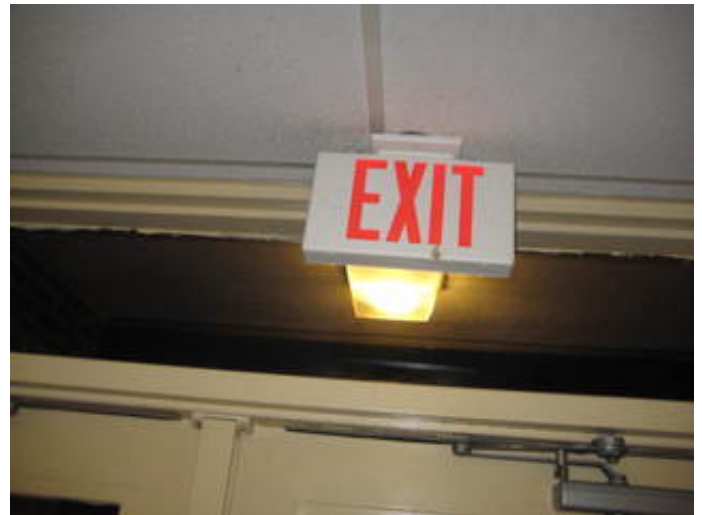
**Rating:** 3 Needs Replacement

Non-compliant Exit Sign

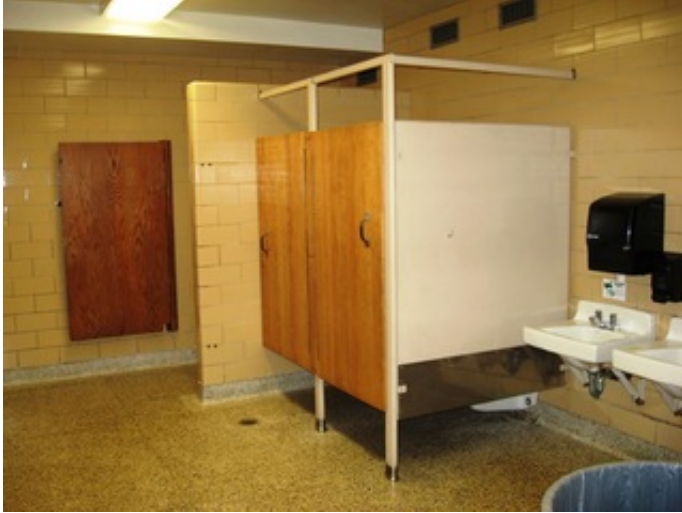
Typical Boys Group Restroom

| Item | Cost | Unit | Whole Building | Original Construction (1965) | Classroom Addition (1968) | Classroom Addition (1973) | Sum | Comments |
|---|---|---|---|---|---|---|---|---|
| <b>Other:</b> Reconfigure Toilet Rooms for ADA Accessibility | \$10,000.00 | each | | 4 Required | 1 Required | | \$50,000.00 | Enlarge and reconfigure existing Toilet Room to meet ADA requirements (includes fixtures, walls, door and hardware, floor drain, and supply lines from existing Restroom). |

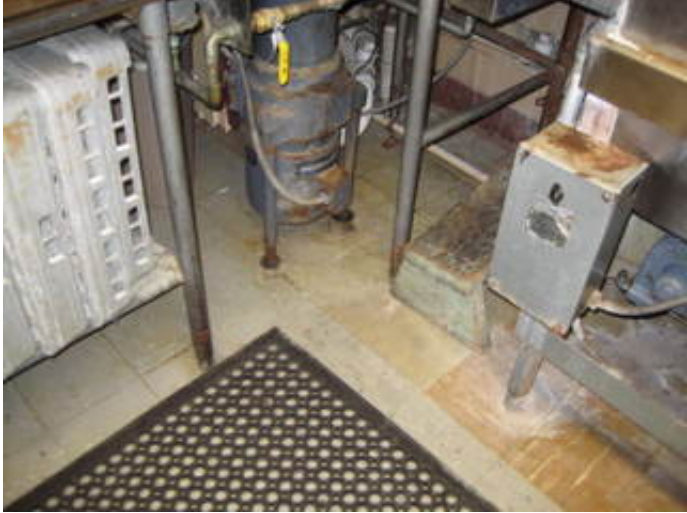
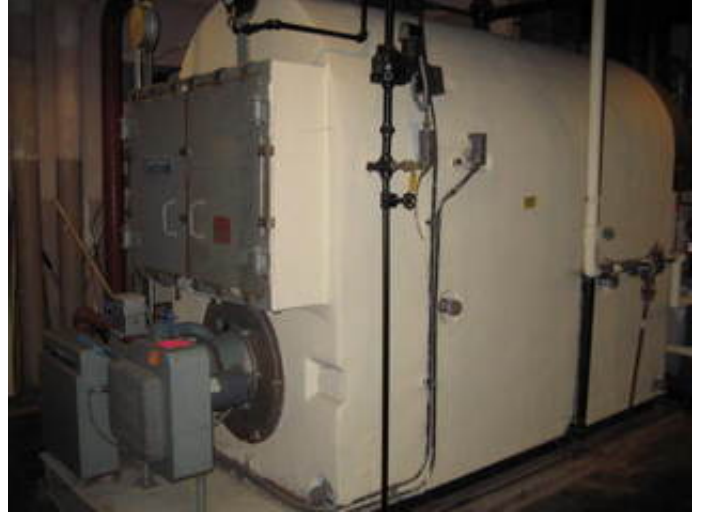
VAT in Kitchen

Boiler Insulation
