**Building Information - Northmont City (48728) - Northmont Middle**

| Assessment Name | Northmont Middle with EEHA & 2026 Costs - OFCC Desktop Update |
| Assessment Date (on-site; non-EEA) | 2011-04-07 |

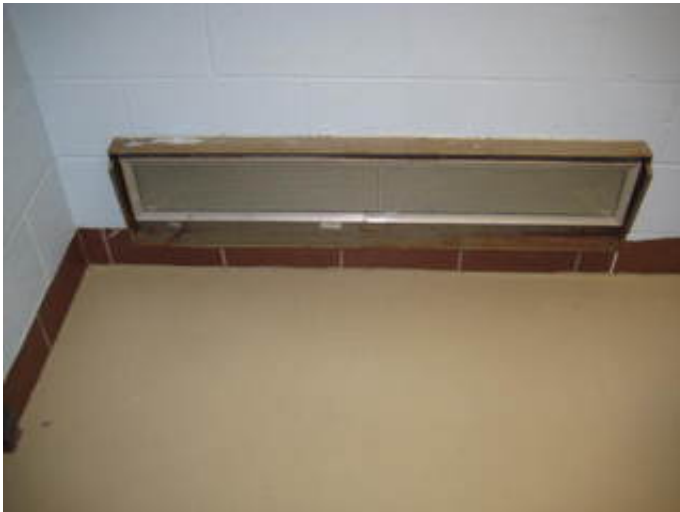
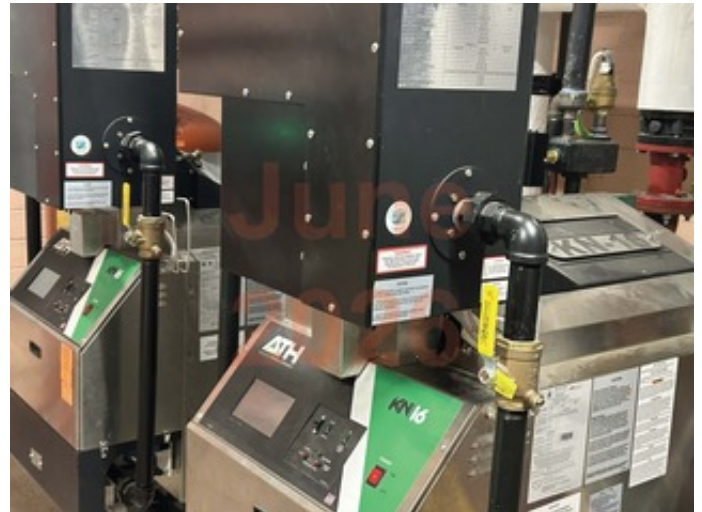
**Description:** The existing system for the overall facility is a natural gas fired heated water boiler type system, installed in 1967, and is in fair condition. The heating water system in the overall facility is a 2-pipe system and the cooling system is a ducted split DX condenser type system, without a capacity for simultaneous heating and cooling operation, which is not compliant with the OSDM requirements for basic system type. The one (1) heated water boiler, manufactured by Columbia Boiler Company, was installed in 1967 and is in fair to poor condition. Heating water is distributed to terminal units consisting of multiple CAV Trane air handlers. Electric fired wall hung radiant glass heaters are also provided throughout the overall facility. The terminal equipment was installed in 1967 and is in fair to poor condition. The system does not comply with the 15 CFM per person fresh air requirements of the Ohio Building Code mechanical code and Ohio School Design Manual. The pneumatic type system temperature controls were installed in 1967 and are in poor condition. The system does not feature individual temperature controls in all spaces required by the OSDM. The overall system does not feature any central energy recovery systems. The facility is equipped with louvered interior doors to facilitate Corridor utilization as return air plenums. See Items J and O for replacement of doors. The existing system is ducted, but the ductwork cannot be integrated into a possible future system due to arrangement, air volume, and routing of existing ductwork. The overall heating system is evaluated as not being in safe and efficient working order, and long term life expectancy of the existing system is not anticipated. The overall facility, except for the Student Dining and Kitchen, is equipped with a central air conditioning system. The site does not contain underground fuel tanks. **June 2026 Desktop Update - OFCC - A contract deduction is provided for the air handling units installed between 2014 and 2017 and the chiller replacement.**

**Rating:** 3 Needs Replacement

Electric Fired Radiant Glass Heater

New Boiler (2026 Photo)

**Recommendations:** Provide new overall heating, ventilating, and air conditioning system to achieve compliance with Ohio Building Code and Ohio School Design Manual standards. Replace existing ductwork in the overall facility to facilitate efficient exchange of conditioned air, with pricing included in conversion to ducted system replacement. **June 2026 Desktop Update - OFCC - A contract deduction is provided for the air handling units installed between 2014 and 2017 and the chiller replacement.**

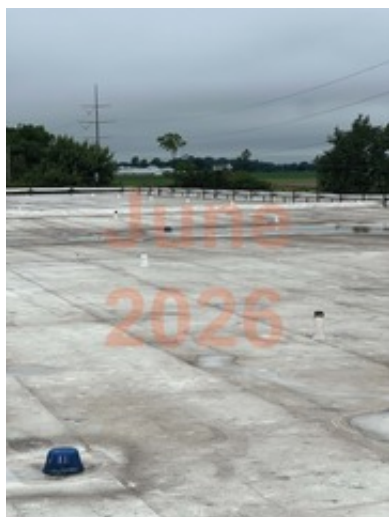
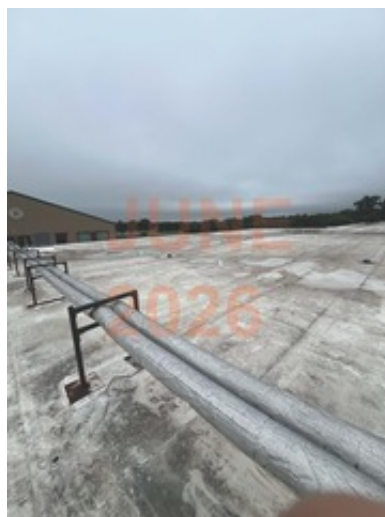
**Description:** The roof over the overall facility is a built-up asphalt with granular wear coat system that was installed in 1991, and is in fair condition. There are no District reports of current leaking. Signs of past leaking were observed during the physical assessment. Access to the roof was gained by an access hatch over the Student Dining Area that is in fair condition, an access door over the second story portion that is in good condition, one access stair over piping that is in good condition, and two access ladders between roof levels that are in fair condition due to lack of attachment at the upper portions of the ladders. Fall safety protection cages are not required, are not provided. There were observations of standing water on the roof. Metal cap flashings are in good to fair condition. Roof storm drainage is addressed through a system of roof drains, which are properly located, and in good condition. The roof is not equipped with overflow roof drains though they are not required on this building. No problems requiring attention were encountered with any roof penetrations. Wall flashings are cracked in some areas and are in fair condition. There are not any covered walkways attached to this structure. **June 2026 Desktop Update - OFCC - The lower sections of the roof were replaced in 2014. The upper sections of the roof were replaced in 2015. Neither reduce scope of work required per OSDM assessment cost guidelines and judgement of OFCC staff.**

**Rating:** 3 Needs Replacement

New Membrane Roof (2026 Photo)

**Recommendations:** The roof over the overall facility requires replacement to meet Ohio School Design Manual guidelines for age of system and due to condition. Replace two exterior roof ladders. Exterior roof doors are corrected in Item S. **June 2026 Desktop Update - OFCC - The lower sections of the roof were replaced in 2014. The upper sections of the roof were replaced in 2015. Neither reduce scope of work required per OSDM assessment cost guidelines and judgement of OFCC staff.**

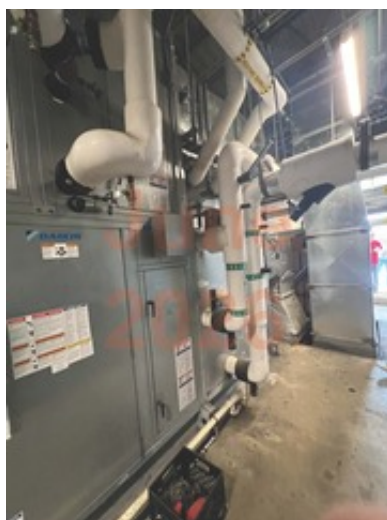
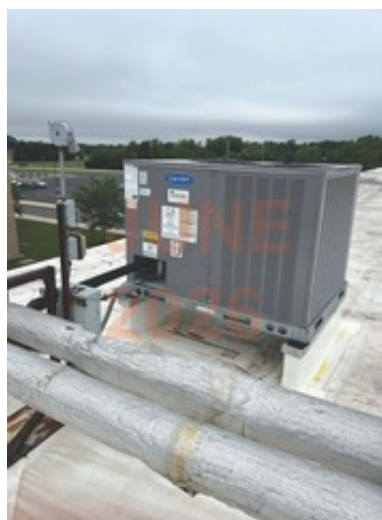
**Description:** The overall facility, except for the Student Dining and Kitchen, is equipped with a ducted split DX condenser type central air conditioning system with multiple CAV air handlers, which was installed in 1967, and is in fair to poor condition. The roof mounted DX condensers and CAV air handlers provide cooled air to the overall facility, were installed in 1967, and are in poor condition. An isolated room system consisting of a ductless split HVAC system (with the condensing unit located on the exterior of the facility) is provided in Guidance Offices and Computer Lab locations. The overall facility is not equipped with any window units. The ventilation system in the overall facility consists of air handlers, installed in 1967 and in poor condition, providing fresh air to Classrooms and providing fresh air to other miscellaneous spaces such as the Gymnasium, Student Dining, and Media Center. Relief air venting is provided by louvered interior doors, air handlers, and central relief fans. The ventilation system does not meet the Ohio Building Code 15 CFM per occupant fresh air requirement. The overall system is not compliant with Ohio Building Code and Ohio School Design Manual requirements. Dust collection systems are not required in this facility. Exhaust systems for Restrooms, Storage Rooms, Custodial Closets, Maintenance Workrooms, Locker Rooms, Kitchen Dry Food Storage, Art Rooms, and Loading & Receiving Areas are inadequately placed, and in fair to poor condition. The Art Program is equipped with a kiln, but is not equipped with a kiln ventilation system. **June 2026 Desktop Update - OFCC - The Split DX condenser type central air conditioning system installed in 1967 has been replaced but does not reduce scope of work per OSDM assessment cost guidelines and judgement of OFCC staff.**

**Rating:** 2 Needs Repair

New HVAC Units (2026 Photo)

Rooftop Unit (2026 Photo)

**Recommendations:** Provide an air conditioning system to meet with Ohio Building Code and Ohio School Design Manual requirements. Pricing included in Item A. Replace the existing general building exhaust system. Provide the existing Art Program kiln with the required ventilation system. **June 2026 Desktop Update - OFCC - The Split DX condenser type central air conditioning system installed in 1967 has been replaced but does not reduce scope of work per OSDM assessment cost guidelines and judgement of OFCC staff.**

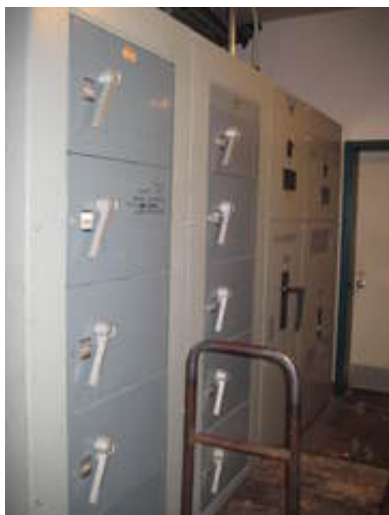
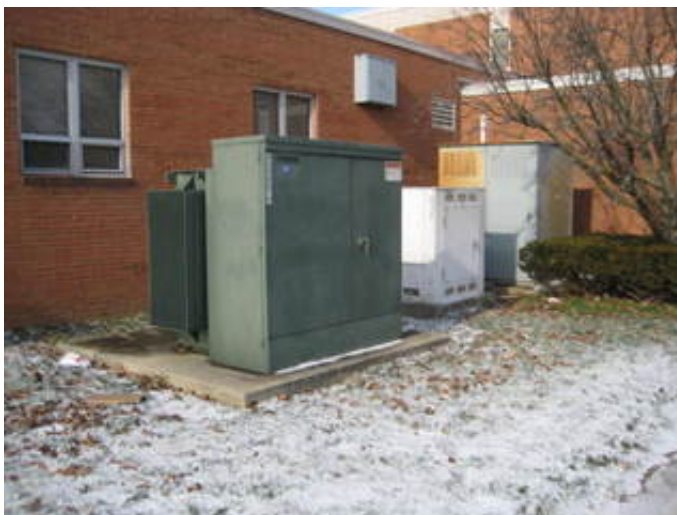
**Description:** The electrical system provided to the overall facility is a 480/277 volts, 4000 amp, 3 phase and 4 wire system installed in 1967, and is in fair condition. Power is provided to the school by a single utility owned, pad-mounted transformer located outside the Guidance Offices, and in fair condition. The panel system, installed in 1967, is in fair condition, and cannot be expanded to add additional capacity. The Classrooms are not equipped with adequate electrical outlets. The typical Classroom contains three (3) general purpose outlets, three (3) dedicated outlets for each Classroom computer, and one (1) dedicated outlet for each Classroom television. Some Classrooms are equipped with as many as six (6) general purpose outlets, while others are equipped with as few as two (2) general purpose outlets. There are not any spaces that have no electrical outlets. The Corridors are not equipped with adequate electrical outlets for servicing. Adequate GFI protected exterior outlets are not provided around the perimeter of the building. The facility is not equipped with an emergency generator. Adequate lightning protection safeguards are provided. The facility is not equipped with Stage spaces. The overall electrical system does not meet Ohio School Design Manual requirements in supporting the current needs of the school, and will be inadequate to meet the facility's future needs.

**Rating:** 3 Needs Replacement

Main Electrical Distribution Panel

Pad Mounted Transformer

**Recommendations:** The entire electrical system requires replacement to meet Ohio School Design Manual guidelines for overall capacity and Classroom capacity due to age, condition, lack of OSDM-required features, and to accommodate the addition of an air conditioning system. Provide an emergency generator, with funding included in the electrical system replacement.

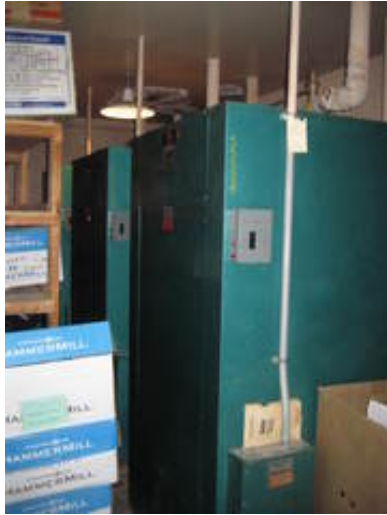
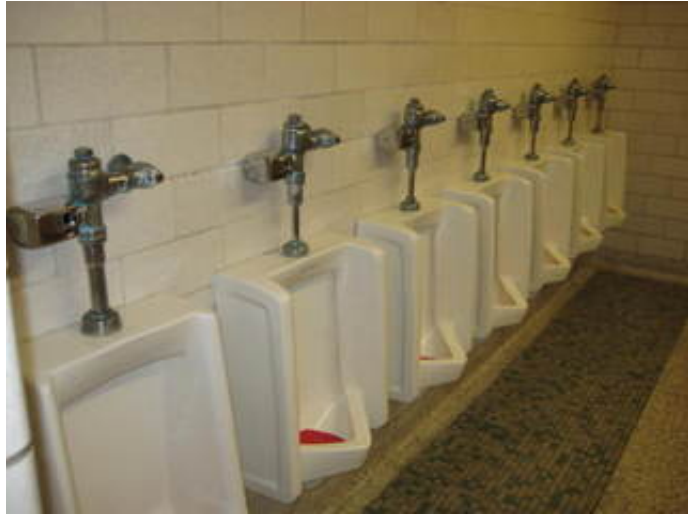
The service entrance is not equipped with a reduced pressure backflow preventer. A water treatment system is not provided, though none is needed. The domestic water supply piping in the overall facility is galvanized and copper, was installed in 1967, and is in fair condition. The waste piping in the overall facility is cast iron with some galvanized and PVC, was installed in 1967, and is in fair to poor condition. The facility is equipped with 3 Coates 300 gallon electric water heaters, installed in 1967, and in fair to poor condition. The overall facility contains 4 Large Group Restrooms for boys, 4 Large Group Restrooms for girls, 1 Locker Room Restroom for boys, 1 Locker Room Restroom for girls, 2 Locker Room Restrooms for staff, 1 Kitchen Restroom, 1 Health Clinic Restroom, 0 Restrooms associated with Specialty Classrooms, and 2 Restrooms for staff. Boys' Large Group Restrooms contain 12 non-ADA floor mounted flush valve toilets, 28 non-ADA wall mounted infra-red urinals, as well as 4 ADA and 8 non-ADA floor mounted group lavatories. Girls' Large Group Restrooms contain 24 non-ADA floor mounted flush valve toilets, as well as 4 ADA and 8 non-ADA floor mounted group lavatories. Boys' Locker Room Restroom contains 1 non-ADA floor mounted flush valve toilet, 2 non-ADA wall mounted infra-red urinals, 1 non-ADA wall mounted lavatory, as well as 29 non-ADA showers. Girls' Locker Room Restroom contains 2 non-ADA floor mounted flush valve toilets, 1 non-ADA wall mounted lavatory, as well as 24 non-ADA showers. Staff Locker Room Restrooms contain 2 non-ADA floor mounted flush valve toilets, 2 non-ADA wall mounted lavatories, as well as 2 non-ADA showers. Staff Restrooms contain 2 non-ADA floor mounted flush valve toilets, as well as 2 non-ADA wall mounted lavatories. Condition of fixtures is fair. The facility is equipped with 2 ADA and 10 non-ADA electric water coolers, in fair condition. Due to existing grade configuration, there are no Elementary Classrooms. Special Education Classroom is not equipped with the required Restroom facilities. Kitchen is equipped with the required Restroom which contains 1 non-ADA floor mounted flush valve toilet, as well as 1 non-ADA wall mounted lavatory, and fixtures are in fair condition. Health Clinic is equipped with the required Restroom which contains 1 non-ADA floor mounted flush valve toilet, as well as 1 non-ADA wall mounted lavatory, and fixtures are in fair condition. Due to existing grade configuration, there are no Kindergarten / Pre-K Classrooms. Kitchen fixtures consist of 3 hand sinks, 1 single-compartment sink, 1, double-compartment sink, 1 triple-compartment sink, 4 garbage disposal units, and 1 dishwashing unit, which are in fair condition. The Kitchen is equipped with an unsatisfactory grease interceptor due to age, condition, and insufficient capacity. The Kitchen is provided the required 140 degree hot water supply, via 2 Coates 300 gallon electric water heaters, installed in 1967, and in poor condition. The school meets the OBC requirements for fixtures. Per OBC and OSDM requirements this facility should be equipped with 22 toilets, 5 urinals, 22 lavatories, and 9 electric water coolers, and at present it is equipped with 45 toilets, 28 urinals, 32 lavatories, and 12 electric water coolers. ADA requirements are not met for fixtures and drinking fountains (see Item O). Custodial Closets are properly located and are adequately provided with required service sinks or floor drain sinks, which are in good to fair condition. Science Classrooms / Labs are equipped with required gas connections in fair condition, but are not equipped with required utility sinks, compressed air connections, and safety shower / eyewash stations. Due to existing grade configuration, no Biology or Chemistry Classroom acid waste systems are required. Adequate exterior wall hydrants are not provided.

3 Needs Replacement

Electric Fired Domestic Water Heaters

Wall Mounted Infra-red Urinals

Replace water supply piping in the overall facility with copper piping due to age and condition. Replace sanitary waste piping in the overall facility due to age and condition. Due to age, condition, and OSFC standards, replace 60 faucets and valves, 22 lavatories, 45 toilets, 5 urinals and 5 electric water coolers. See Item O for replacement of fixtures related to ADA requirements. See Item J for provisions on Kitchen related equipment. Provide the service entrance with a reduced pressure back flow preventer. Replace the 3 Coates 300 gallon domestic hot water heaters due to age and condition. Replace the Kitchen grease trap interceptor due to age and condition. Replace the 2 Coates 300 gallon electric Kitchen water booster heaters due to age and condition. Provide the Science Classrooms with the required compressed air connection. Provide the Science Classrooms with the required safety shower / eyewash station. Provide the Science and Art Classrooms with the required utility sink. Provide 3 additional exterior wall hydrants.

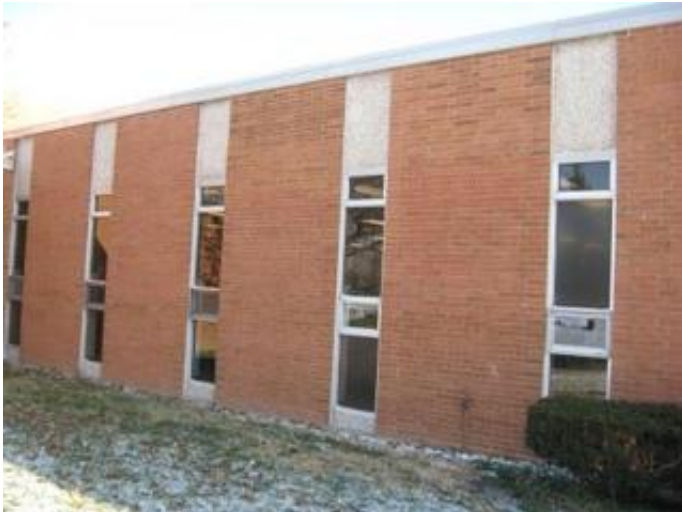
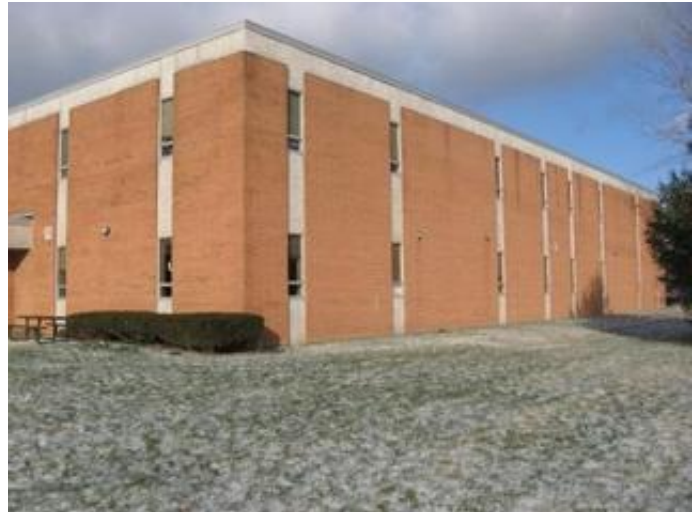
**Description:** The overall facility is equipped with aluminum frame windows with single glazed type window system, which was installed in 1967, and is in fair to poor condition. The window system features operable and inoperable windows throughout the building, and the operable windows are equipped with opening limiters in fair condition and partially equipped with insect screens in poor condition. Window system seals are in fair condition, with minimal air and water infiltration being experienced. Window system hardware is in fair condition. The window system features surface mounted blinds, which are in fair to poor condition. This facility is not equipped with any curtain wall systems. This facility does not feature any glass block windows. The exterior doors in the overall facility are equipped with aluminum frame sidelights and transoms with single pane glazing provided with internal wire mesh, in fair condition. Exterior door vision panels are single pane provided with internal wire mesh. The school does not contain skylights. The school does not contain clerestories. Interior glass is not OSDM-compliant due to lack of code compliant safety glazing. Window security grilles are not provided for ground floor windows. There is not a Greenhouse associated with this school.

**Rating:** 3 Needs Replacement

1967 Original Construction Cafeteria Windows

1967 Original Construction Classroom Windows

**Recommendations:** Provide a new insulated window system with integral blinds to meet with Ohio School Design Manual requirements. Replace window transoms and sidelights at exterior doors of the overall facility. Exterior door vision panel replacement is addressed in Item S in exterior door replacement scope. Replace non compliant interior glazing.

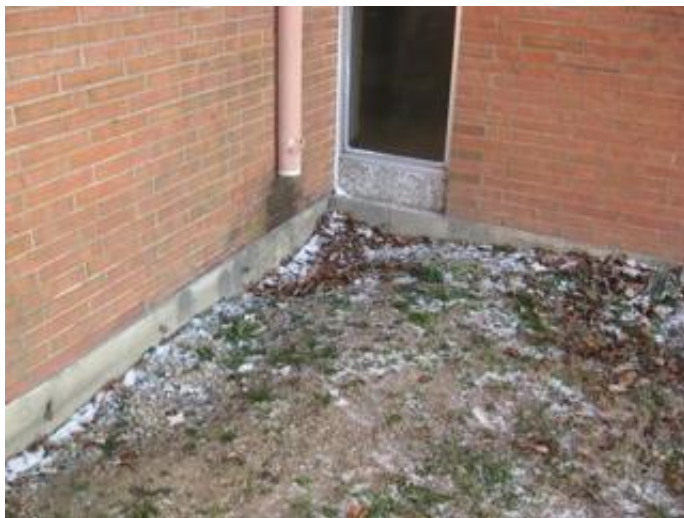
**Description:** The overall facility is equipped with concrete foundation walls on concrete spread footings, which displayed no locations of significant differential settlement, cracking, or leaking, and are in good condition. No significant issues related to foundation cracking or spalling were encountered. The District reports that there has been no past leaking. Drainage deficiencies were noted at the perimeter of the structure at roof downpipe locations that could contribute to foundation / wall structural deterioration.

**Rating:** 2 Needs Repair

Condition of Grade at Foundation and Roof Drain Location

**Recommendations:** Repair deteriorated roof drain pipes, add fill as required to depressions and provide concrete splash blocks at all roof downspouts.

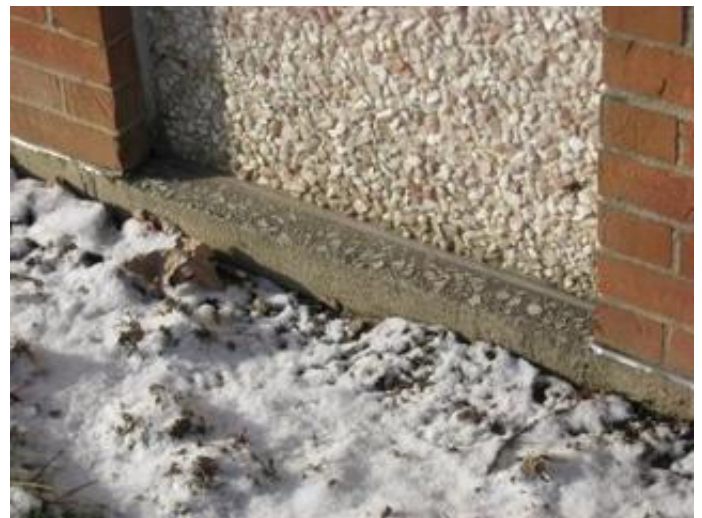
Exposed Concrete Foundation at Window Location

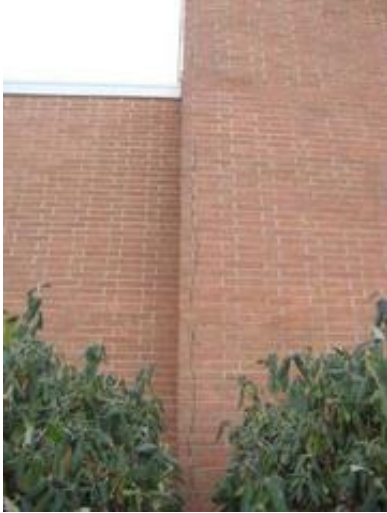
**Description:** The overall facility has a brick veneer on load bearing masonry wall system which displayed locations of deterioration, and is in good to fair condition. The exterior masonry appears to have inappropriately spaced and inadequately caulked control joints in fair to poor condition. Control joints are not provided at lintel, doors, windows, building corners, and wall offset locations. The school does not contain expansion joints and none are needed, as there is no indication of exterior masonry cracking or separation. Brick veneer masonry walls are cavity walls. Weep holes and vents are not provided. The exterior masonry has not been cleaned and sealed in recent years, and shows evidence of mortar deterioration at lintel, sill and building offset locations. Architectural exterior accent materials consist of precast exposed aggregate panels, which are in fair condition. Interior walls are brick, concrete masonry units, glazed block, metal stud framed partitions with gypsum board, demountable partitions, operable partitions and interior glazed store front partitions which are in fair condition. Interior masonry appears to have adequately spaced and caulked control joints in good condition. Interior soffits are a plaster type construction, and in good to fair condition. The window sills are brick and an element of the aluminum window system, and are in fair condition. The exterior lintels are steel, and are sagging and rusting, in fair to poor condition. There is one chimney in fair condition and requires masonry repairs. A canopy over the service entrances is metal type construction, and is in fair condition. Exterior soffits are of plaster type construction, and in fair condition. The school is not equipped with a loading dock.

**Rating:** 2 Needs Repair

Masonry Cracks at Building Offset

**Recommendations:** Provide tuckpointing in all areas of mortar deterioration as required through the overall facility. Provide masonry repairs as required through the overall facility. Provide masonry cleaning, sealing and caulking as required through the overall facility. Saw cut and caulk new appropriately spaced control joints in existing masonry at all building offsets and corners through the overall facility. Recaulk existing control joints. Repoint brick window sills through the overall facility. Prep and paint exposed steel lintels through the overall facility. Repair and paint exterior plaster soffits through the overall facility. Repair and paint metal service area canopy. Repair existing chimney masonry as required. Repair and paint interior plaster soffits as required through the overall facility. Repair interior masonry walls as required through the overall facility. Provide new weep holes and vents in exterior masonry walls through the overall facility. Prep and paint roof top metal mechanical equipment enclosures. Recaulk precast exposed aggregate panel joints.

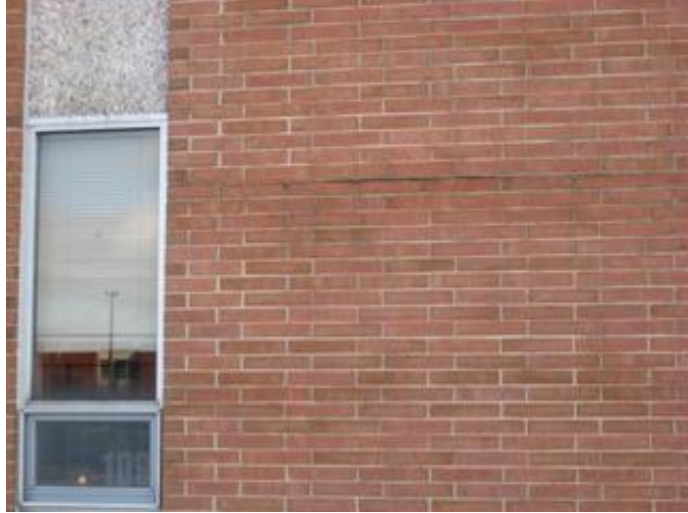
Horizontal Joint Cracking in Exterior Masonry

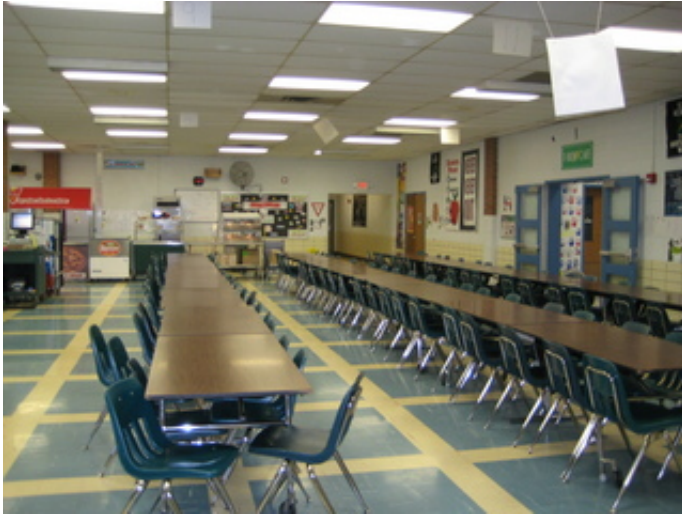
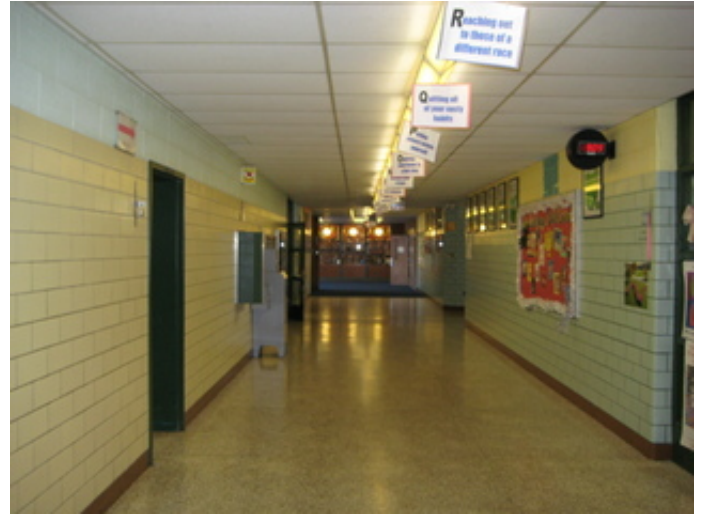
The overall facility features conventionally partitioned Classrooms with VAT and VCT flooring, acoustical tile ceilings, as well as glazed and painted block wall finishes, and they are in fair to poor condition. The overall facility has Corridors with terrazzo flooring, acoustical tile ceilings, as well as brick, glazed block and painted block wall finishes, and they are in fair condition. The overall facility has Restrooms with terrazzo flooring, acoustical tile ceilings, as well as glazed block wall finishes, and they are in fair condition. Toilet partitions are metal, and are in fair condition. Casework is provided in the Art Rooms, Science Room and former Home Economic Rooms, and is plastic laminate construction with plastic laminate tops, is inadequately provided, and in poor condition. The typical Classroom does not contain casework, and is provided with miscellaneous wood bookshelves in poor condition. Classrooms are not provided adequate chalkboards, markerboards, or tackboards which are in good to fair condition. The lockers, located in the Corridors, are adequately provided, and in poor condition. The Art program is equipped with a kiln in poor condition, and existing kiln ventilation is inadequate. The facility is equipped with wood louvered interior doors that are partially recessed without proper ADA hardware and clearances, and in fair to poor condition. The Gymnasium spaces have wood flooring, exposed metal deck ceilings, as well as brick, gypsum partitions, painted block, and glazed block wall finishes, and they are in fair condition. Wood Gymnasium flooring has been well maintained, will accommodate a few future sandings and refinishings, and is rated at a median stage of its product lifecycle. Gymnasium telescoping stands are metal construction in fair to poor condition. Gymnasium basketball backboards are electrically operated, and are in good condition, with two in poor condition. The Media Center has carpet flooring, acoustical tile ceilings, as well as painted block wall finishes, and they are in fair condition. Student Dining has VAT and VCT flooring, acoustical tile ceilings, as well as brick, glazed block and painted block wall finishes, and they are in fair condition. The stage has been converted to a storage room. Existing Gymnasium, Student Dining, Media Center, and Music spaces are inadequately provided with appropriate sound attenuation acoustical surface treatments. The existing Kitchen is full service, is oversized based on current enrollment, and the existing Kitchen equipment, installed in 1967 with renovations in 1997, is in fair condition. The Kitchen hood is in fair to poor condition, and is not equipped with the required UL 300 compliant wet chemical fire suppression system. The required 6" overhang on all three exposed sides of the cooking equipment is provided by the hood. Kitchen hood exhaust ductwork is not of proper construction material and/or installed as required by the OSDM and OBCMC. Walk-in cooler and freezer are located within the Kitchen spaces, and are in fair condition.

3 Needs Replacement

Student Dining Finishes

Typical Corridor Finishes

Provide complete replacement of finishes and casework due to installation of systems outlined in Items A, C, D, E, I, K, L, M, N, T, U, W, and due to condition. Provide for the replacement of interior doors due to condition and louvers, with the exceptions of those replaced in Item O. Provide for replacement of walk-in cooler/freezer. Provide for repairs to terrazzo flooring due to condition. Provide for the replacement of the Art program kiln, with funding for the heat removal hood provided in Item C. Provide for the replacement of Kitchen exhaust hood due to condition and lack of a fire suppression system. Provide for the replacement of toilet partitions due to condition. Provide for the replacement of toilet accessories. Provide for the replacement of damage glazed block walls near the restrooms. Provide for the replacement of demountable partitions. Provide for the replacement of laboratory table tops due to work in Item T. Provide for the replacement of hard plaster due to work in Item T. Provide for the replacement of Gymnasium telescoping seating due to age and condition. Provide for the replacement of electric basketball goals due to condition. Provide for the replacement of interior glazing systems due to condition and OSDM compliance. Provide sound attenuation acoustical surface treatments for Gymnasium, Student Dining, Media Center, and Music spaces.

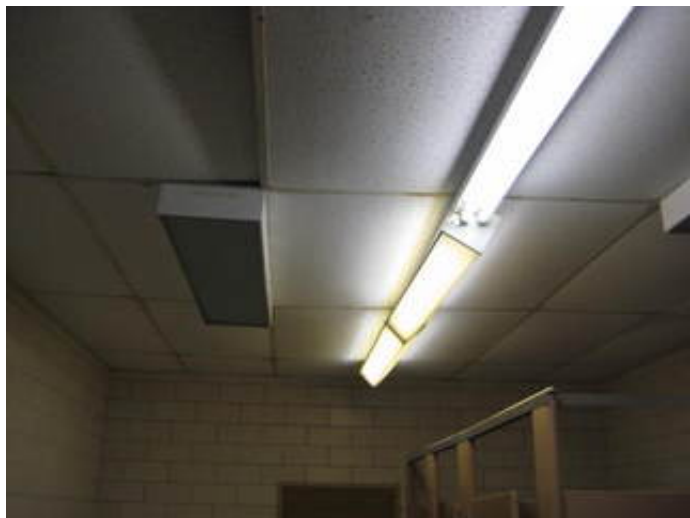
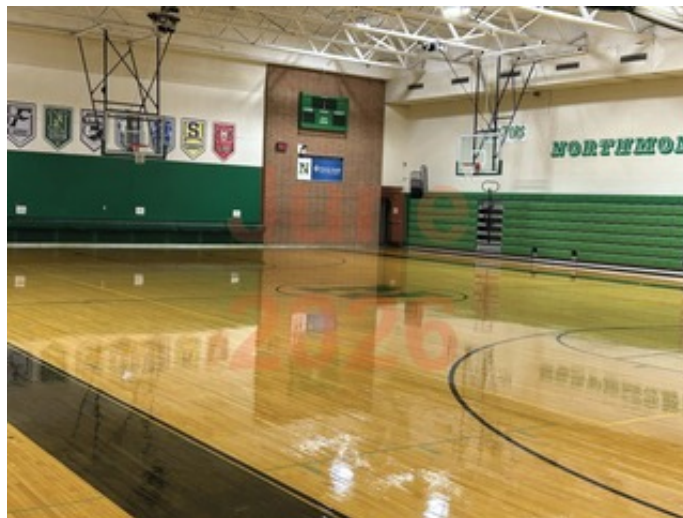
**Description:** The typical Classrooms in the overall facility are equipped with T-8 1x4 surface mount fluorescent fixtures with multi-level switching. Classroom fixtures are in fair condition, providing an average illumination of 60 FC, thus complying with the 50 FC recommended by the OSDM. The typical Corridors in the overall facility are equipped with T-8 1x4 surface mount fluorescent fixtures with single level switching. Corridor fixtures are in fair to poor condition, providing an average illumination of 12 FC, which is less than the 20 FC recommended by the OSDM. The Gymnasium spaces are equipped with pendant metal halide type lighting, in good to fair condition, providing an average illumination of 48 FC, which is less than 50 FC recommended by the OSDM. The Media Center is equipped with T-8 1x4 surface mount fluorescent fixture type lighting in fair condition, providing an average illumination of 58 FC, thus complying with the 50 FC recommended by the OSDM. The Student Dining spaces are equipped with T-8 2x4 lay-in direct fluorescent fixture type lighting with single level switching. Student Dining fixtures are in good to fair condition, providing an average illumination of 63 FC, thus complying with the 50 FC recommended by the OSDM. The Kitchen spaces are equipped with T-8 1x4 surface mount fluorescent fixture type lighting with single level switching. Kitchen fixtures are in fair condition, providing an average illumination of 59 FC, which is less than the 75-80 FC recommended by the OSDM. The Service Areas in the overall facility are equipped with pendant incandescent, T-8 1x4 suspended, and T-8 2x4 lay-in direct fluorescent fixture type lighting in poor condition, providing inadequate illumination. The typical Administrative spaces in the overall facility are equipped with T-8 1x4 surface mount fluorescent fixture type lighting in fair condition, providing adequate illumination based on OSDM requirements. The overall lighting systems of the facility are not fully compliant with Ohio School Design Manual requirements due to age, condition, inadequate lighting levels, lack of multi-level switching, and the utilization of incandescent fixtures. **June 2026 Desktop Update: Gym lighting has been replaced. Media Center lighting has been replaced. Both use flat panel RAAB LED lighting. Lamps have been replaced but fixtures still need replacement.**

**Rating:** 3 Needs Replacement

Surface Mounted Fluorescent Light Fixtures

LED Lighting Fixtures in Gym (2026 Photo)

**Recommendations:** Provide complete replacement of lighting system due to age, condition, inadequate lighting levels, lack of multilevel switching, the utilization of incandescent fixtures, and installation of systems outlined in Items A, C, J, and U. **June 2026 Desktop Update: Gym lighting has been replaced. Media Center lighting has been replaced. Both use flat panel RAAB LED lighting. Lamps have been replaced but fixtures still need replacement.**

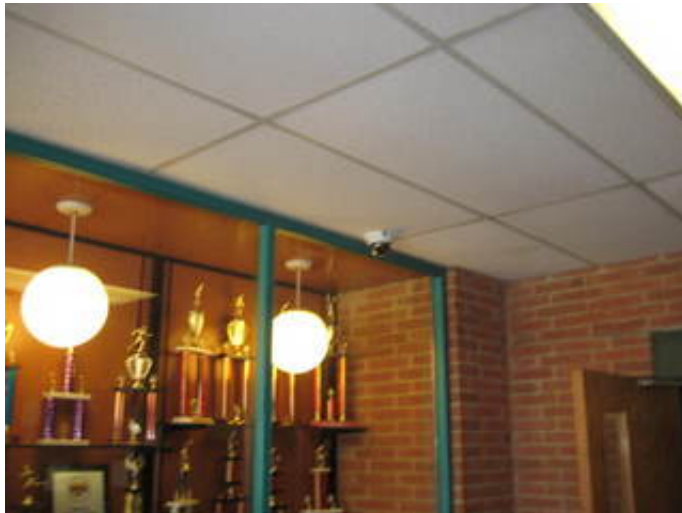
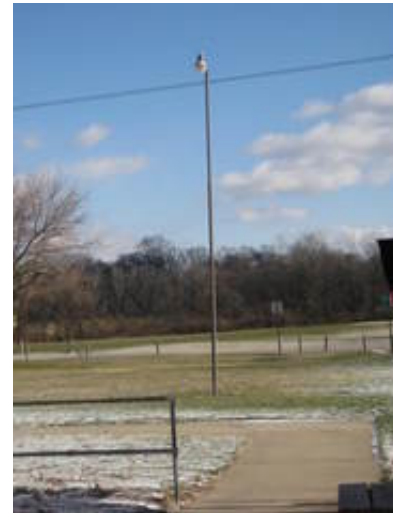
**Description:** The overall facility contains a CCTV camera type security system in good to fair condition. Motion detectors are not provided in main entries, central gathering areas, offices, main Corridors, and spaces where 6 or more computers are located. Exterior doors are not equipped with door contacts. An automatic visitor control system is not provided. Compliant color CCTV cameras are inadequately provided at main entry areas, parking lots, central gathering areas, and main Corridors. CCTV is monitored in Administrative Area with the use of TV and VCR. A compliant computer controlled access control system integrating alarms and video signals, with appropriate UPS backup, is not provided. The system is not equipped with card / biometric readers. The security system is inadequately provided throughout, and the system is not fully compliant with Ohio School Design Manual guidelines. There are no existing playground fencing issues. The exterior site lighting system is equipped with recessed incandescent entry lights in fair condition. Parking and bus pick-up / drop off areas are illuminated by pole mounted HID high pressure sodium fixtures in fair condition. The exterior site lighting system provides inadequate coverage. **June 2026 Desktop Update: Parking and bus lot areas are illuminated with LED lighting. Lamps have been replaced but fixtures still need replacement.**

**Rating:** 3 Needs Replacement

Main Corridor CCTV Camera

Pole-mounted LED light fixture (formerly HID high-pressure sodium)

**Recommendations:** Provide complete replacement of security system to meet Ohio School Design Manual guidelines. Provide complete replacement of exterior site lighting system to meet Ohio School Design Manual guidelines. **June 2026 Desktop Update: Parking and bus lot areas are illuminated with LED lighting. Lamps have been replaced but fixtures still need replacement.**

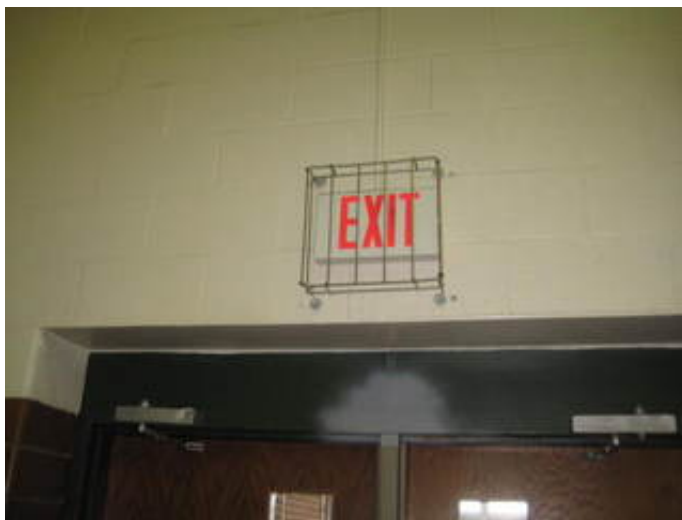
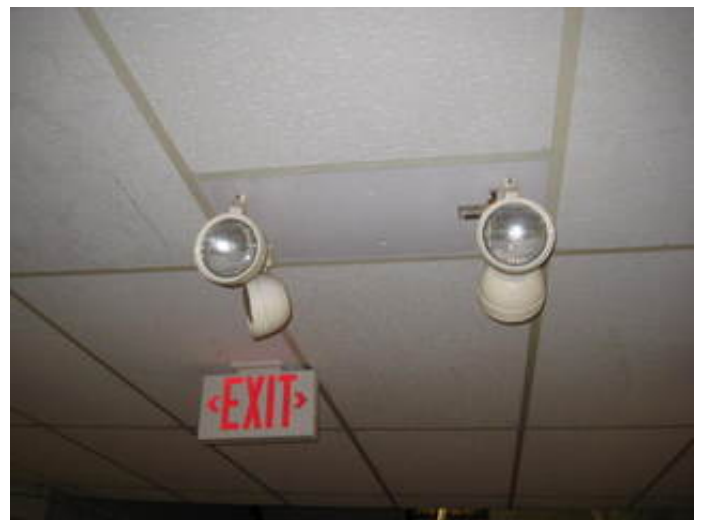
**Description:** The overall facility is equipped with an emergency egress lighting system consisting of non compliant plastic construction exit signs, as well as OSDM compliant red lettered and LED illuminated exit signs and the system is in fair condition. The facility is not adequately equipped with emergency egress floodlighting and the system is in fair to poor condition. The system is not provided with appropriate battery backup or emergency generator on separate circuits. The system is inadequately provided throughout, and does not meet Ohio School Design Manual and Ohio Building Code requirements.

Illuminated Exit Sign

Emergency Egress Light Fixture

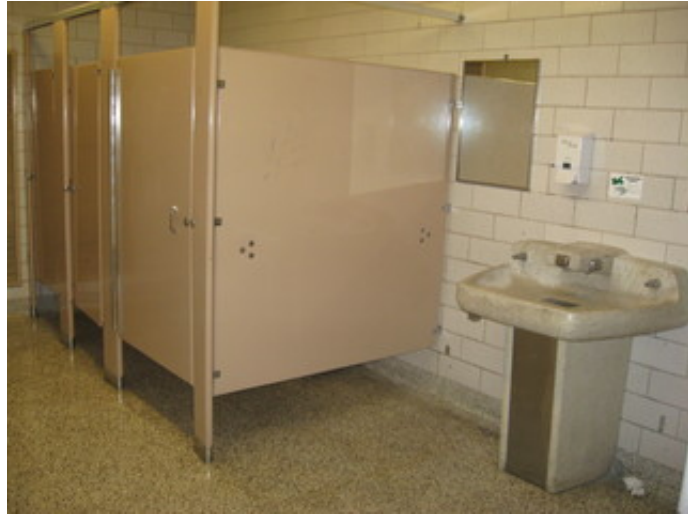
Typical Boy's Restroom With Non-Compliant ADA Toilet Stall

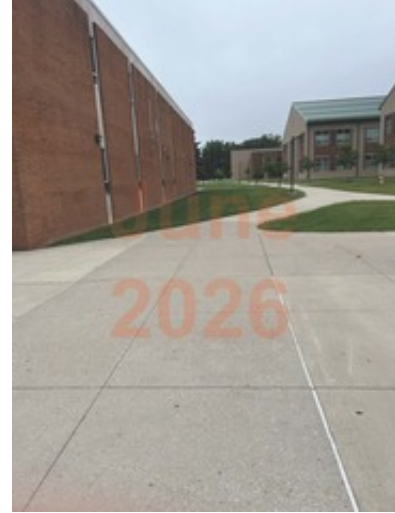
Concrete Sidewalk Conditions (2026 Photo)

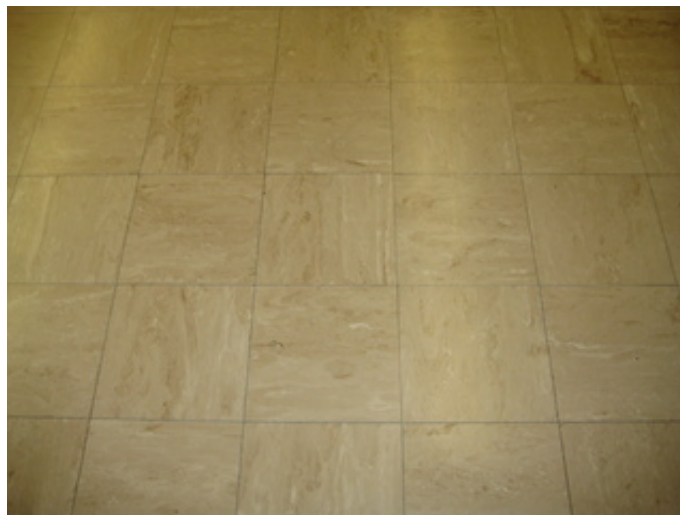
VAT in Classrooms

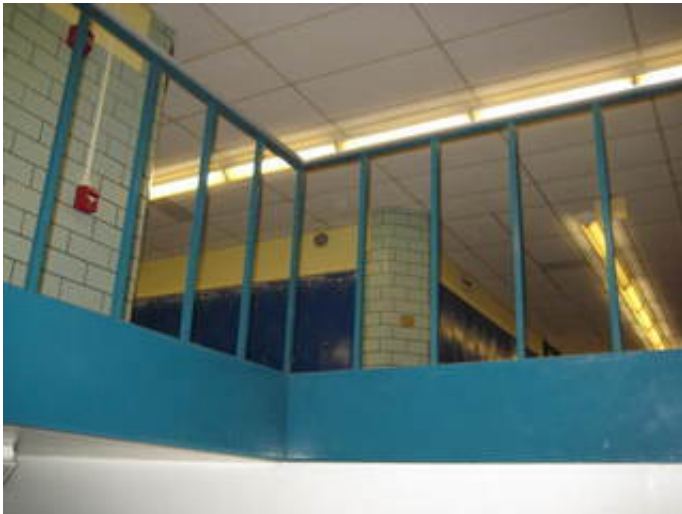
Non-compliant Guardrail

| Item | Cost | Unit | Whole Building | Original Construction (1967) | Sum | Comments |
|---|---|---|---|---|---|---|
| Other: Guardrails | \$42.50 | n.ft. | | 75 Required | \$3,187.50 | Provide new guardrails to meet the requirements of the Ohio Building Code. |

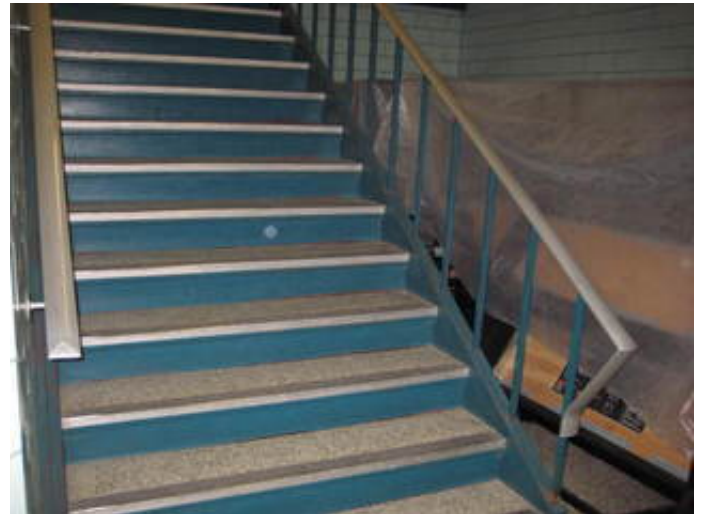
Non-compliant Handrail

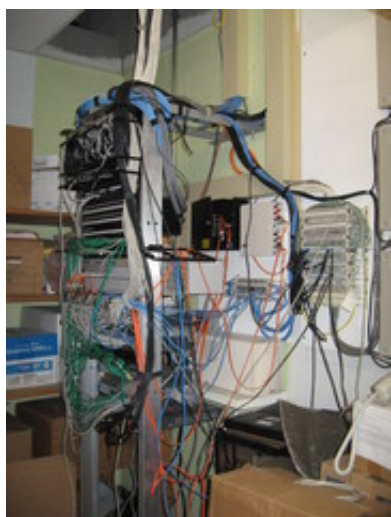
OSDM Non-Compliant Computer Network Infrastructure
