# 2025 FACILITY MASTER PLAN REPORT

FACILITY CONDITION / NEEDS ASSESSMENT - LIST & PHOTOS

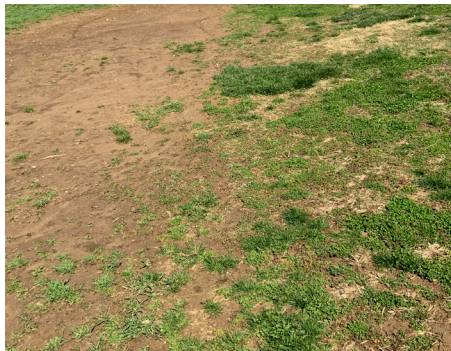
Building Site - Turf Grass

| 1. Building Site, Landscaping etc. | | |
|---|---|---|
| | Turf Grass | Several areas of sparse or no grass. Seeding or sodding is recommended. |

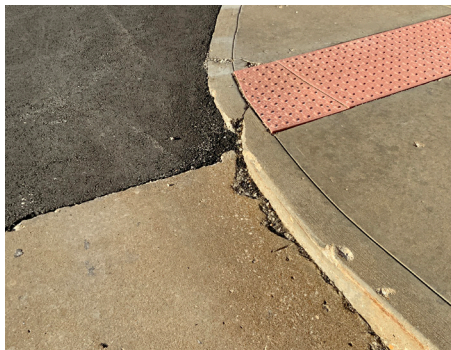
Building Site - Curbs

| 1. Building Site, Landscaping etc. | | |
|---|---|---|
| | <b>Curbs</b> | The curb is generally in good condition overall; however, a few segments exhibit larger cracks and should be replaced concurrently with adjacent sidewalk repairs to maintain continuity and structural integrity. |

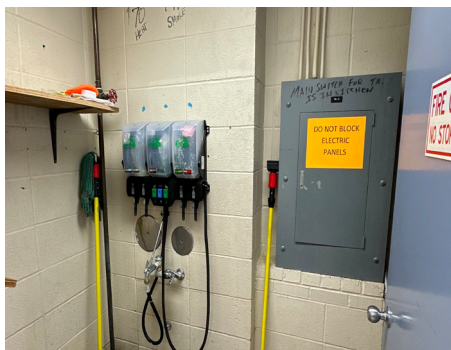
Building Systems - Main Electrical System

| 1. Building Site, Landscaping etc. | | |
|---|---|---|
| | <b>Main Electrical Service</b> | No additional capacity in main switchboard. Existing gear will not be able to be expanded for future additional needs. Existing gear is old and utilizes fuse buckets, which are difficult to replace if needed. Existing gear does appear to be in an operational condition. |

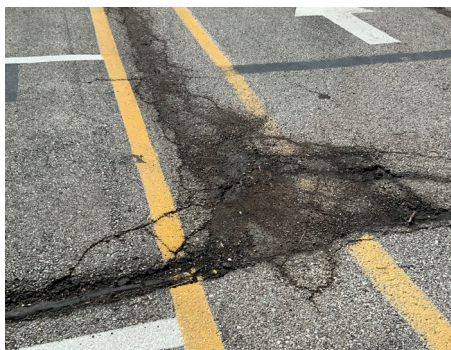
Building Site - Drive Surface

| 1. Building Site, Landscaping etc. | | |
|---|---|---|
| | Drive Surface | The driveway pavement exhibits significant longitudinal and transverse cracking, alligator cracking, and surface weathering, indicating structural fatigue and aging of the pavement. |

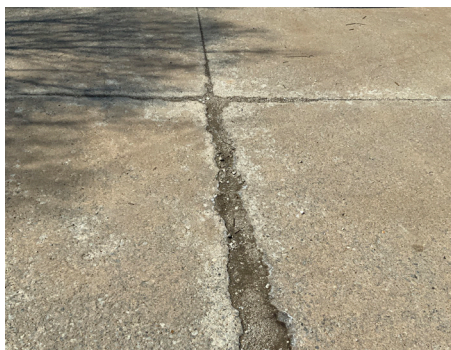
Building Site - Sidewalk

| 1. Building Site, Landscaping etc. | | |
|---|---|---|
| | Sidewalk | Sidewalks are in mostly good condition. There is one section on the east side near the playground that has deteriorating joints. |

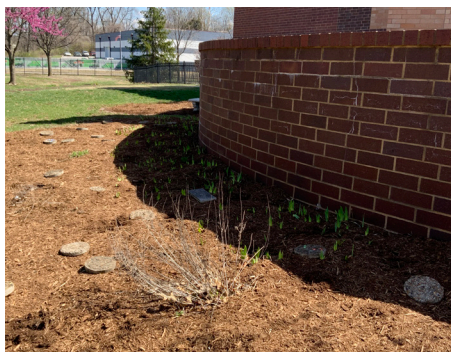
Building Site - Landscaping

| 1. Building Site, Landscaping etc. | | |
|---|---|---|
| | Landscaping | Site landscaping is in good condition and recently mulched. There are a couple of stumps on site that need to be removed. |

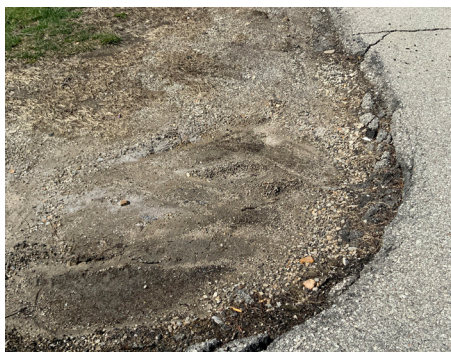
Building Site - Turf Grass

| 1. Building Site, Landscaping etc. | | |
|---|--|---|
| Turf Grass | | Several areas around the school require seeding. Evidence of recent seeding—likely associated with the new playground construction—was observed. Given the timing of the site visit, it is possible that grass establishment has since improved. |
