**Arborist Inspection & Report · Tree Service**

**Elias Najjar**

Air excavation and root-zone inspection were conducted from August 24th through August 26th, 2026, at Longfellow School.

## Tree Risk Assessment and Arborist Report

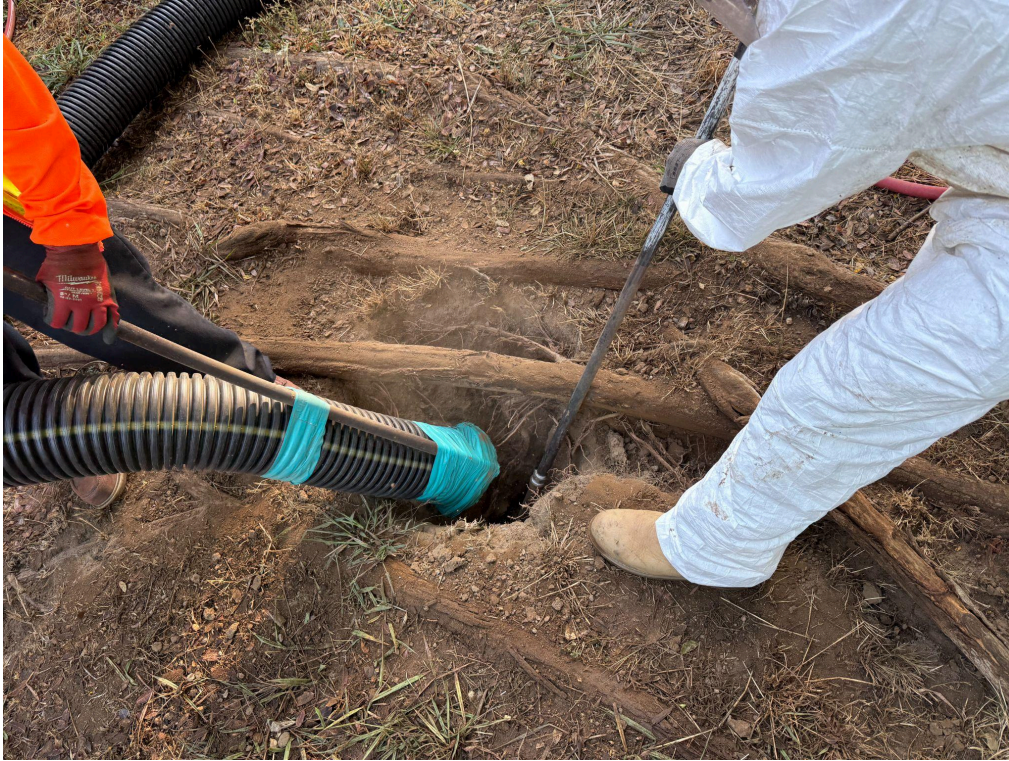
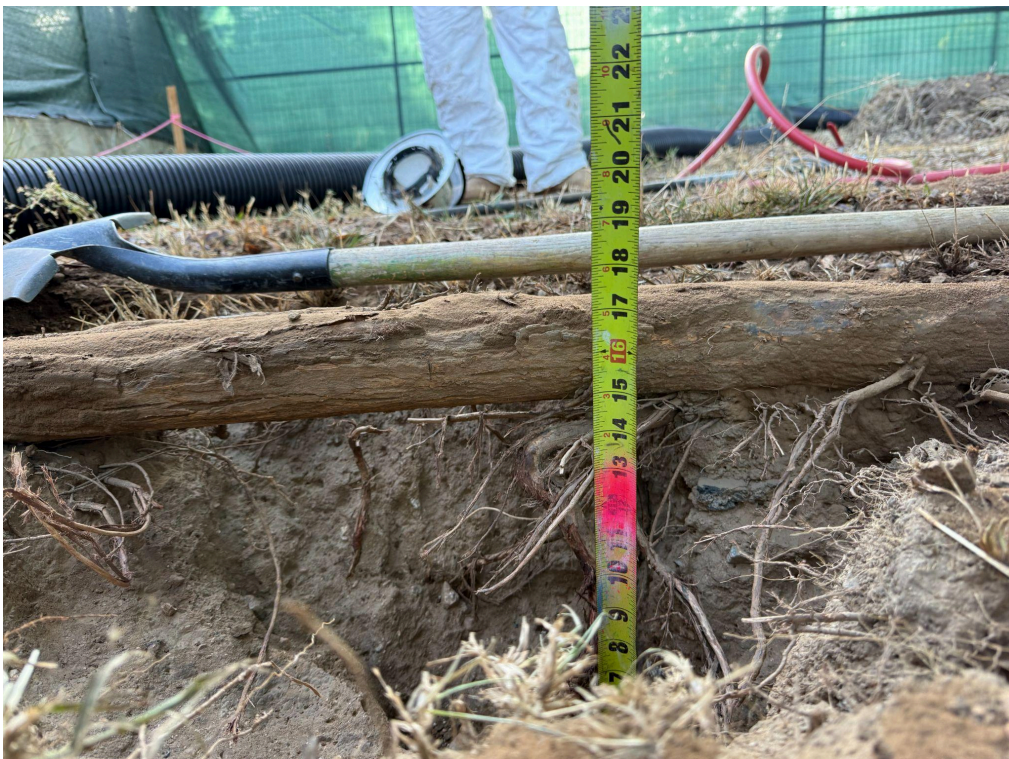
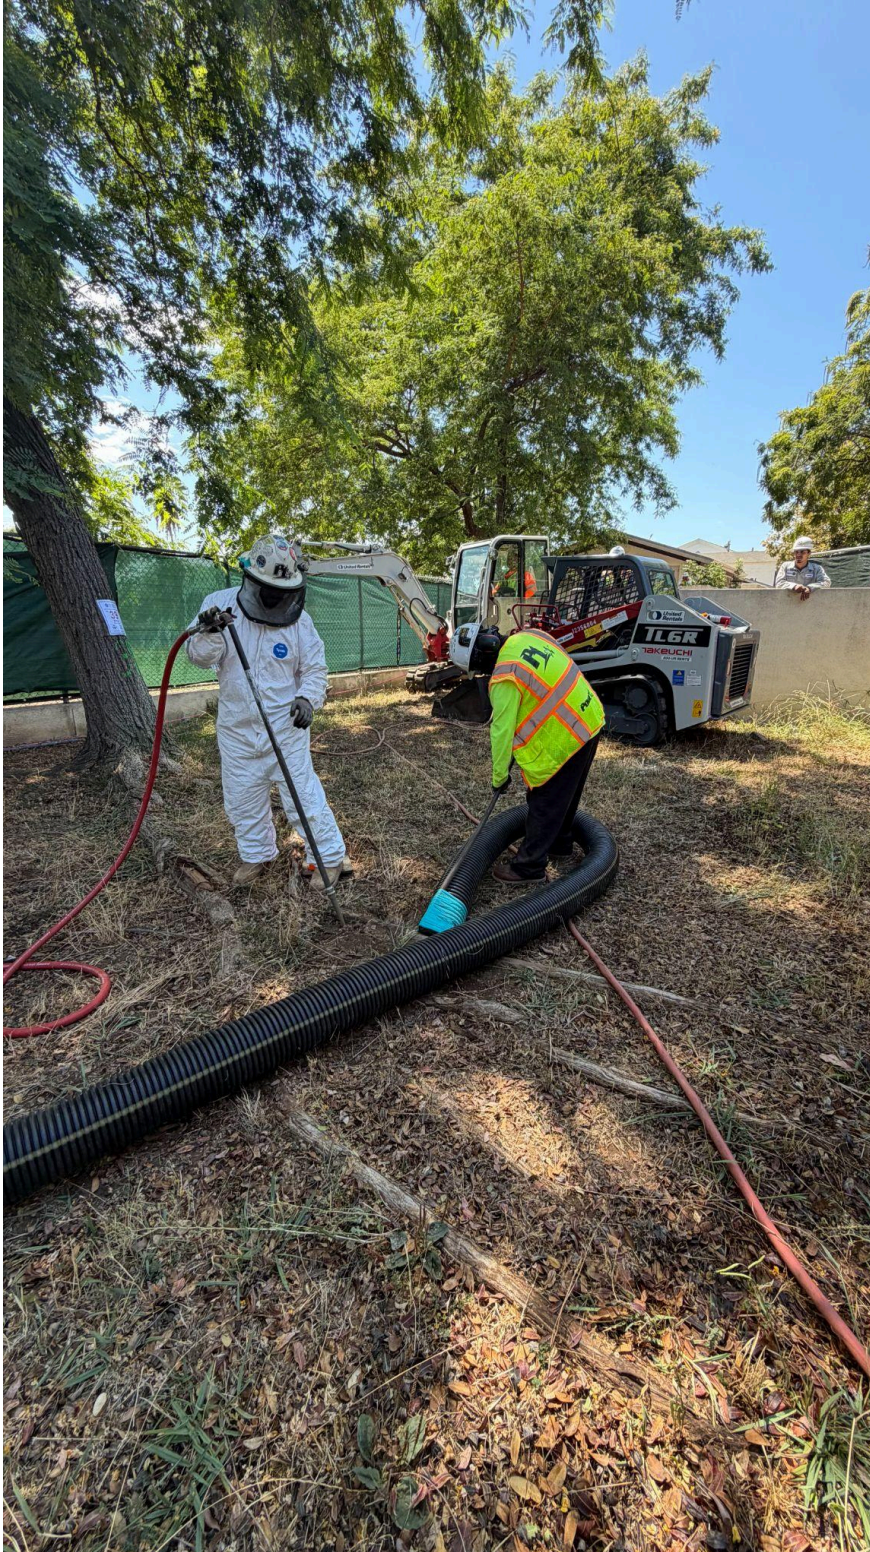
### Tree #39 — Tipuana tree (Tipuana tipu)

Tree #39 (subsequently removed by contractor) exhibits a southerly lean, approximately 28 degrees, with no corrective counter lean present. Several structural roots are already exposed due to soil displacement and compaction. The lean has resulted in partial loss of soil cover over the primary structural roots on the north side.

Air-knifing performed on the north side of the tree to a depth of 18 inches revealed structural and anchor roots beginning at approximately 9 inches below grade. These roots provide essential mechanical support and are responsible for resisting overturning forces associated with the tree's existing lean.

Excavation to 24 inches will expose the majority of the tree's structural and anchor root system. Based on International Society of Arboriculture (ISA) Best Management Practices (BMPs) for Tree Risk Assessment and Root Management, removal of soil to this depth within the CRZ will imminently compromise the tree's mechanical stability. Given the tree's existing lean and the depth at which critical roots occur, further excavation will likely result in loss of structural support and may lead to tree failure.

Tree #39 cannot maintain structural stability if excavation proceeds to the proposed depth. The contaminated soil removal will expose and destabilize all major structural roots on the north side, creating a high likelihood of failure once root support is compromised.

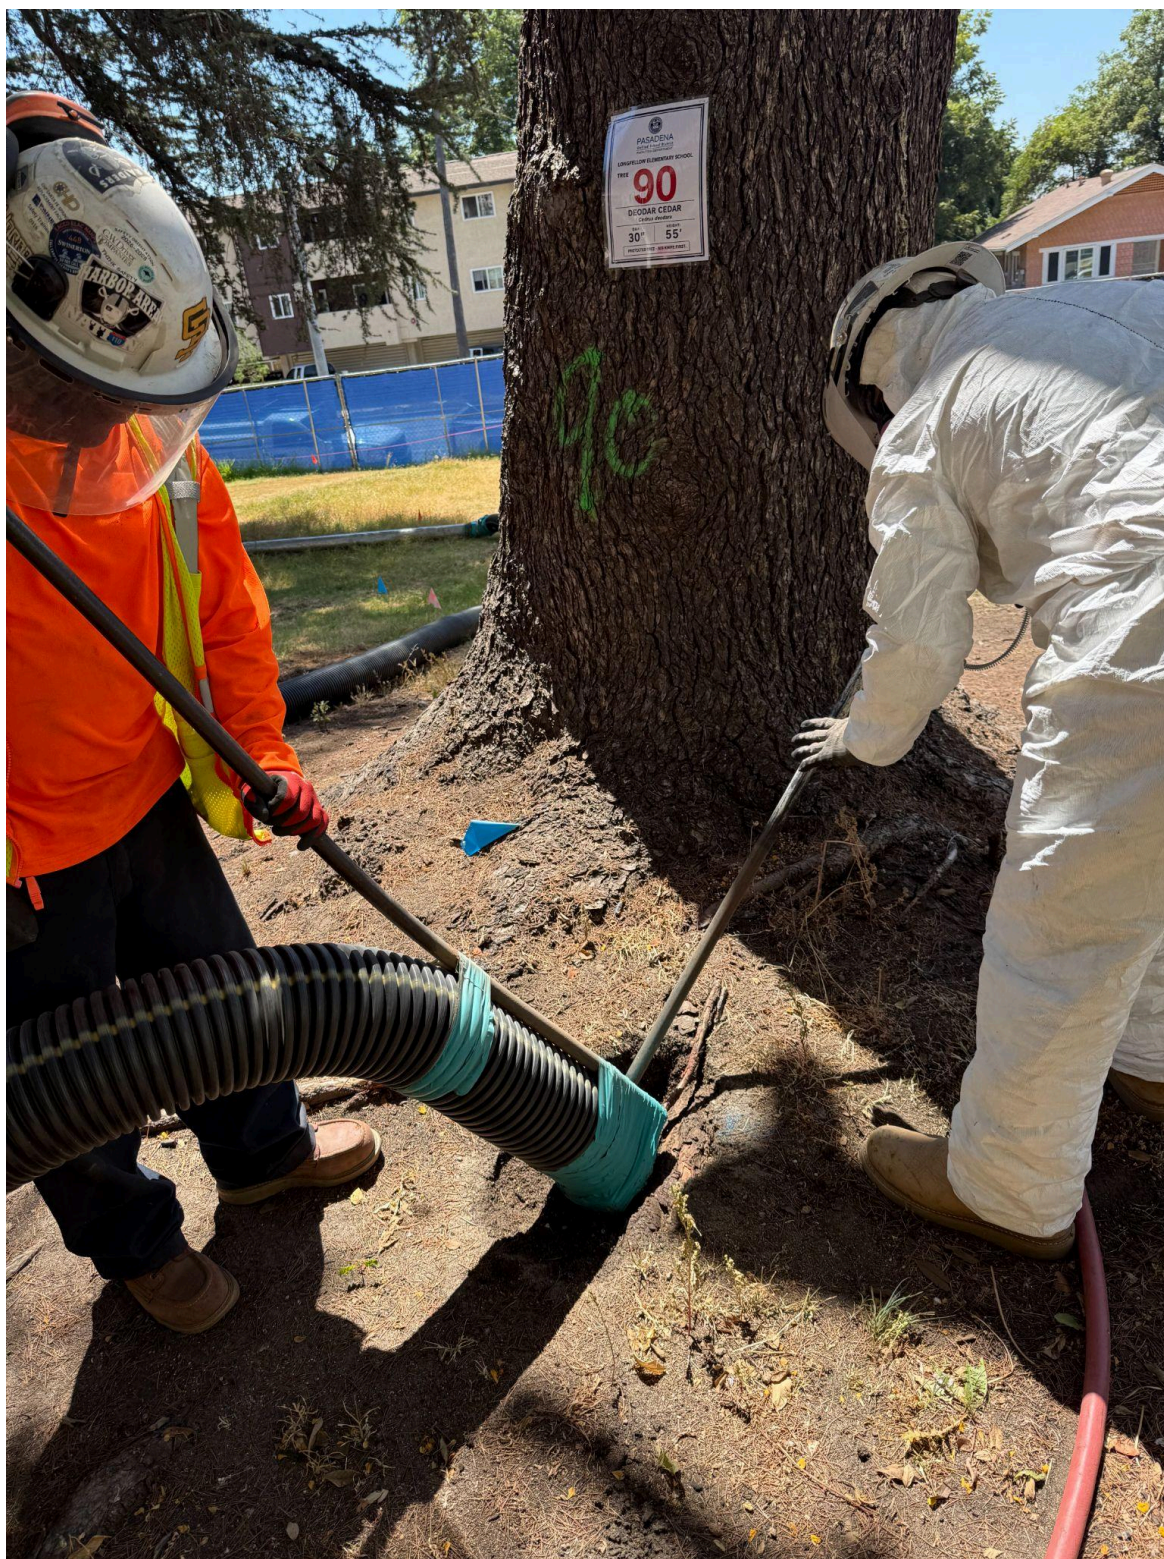
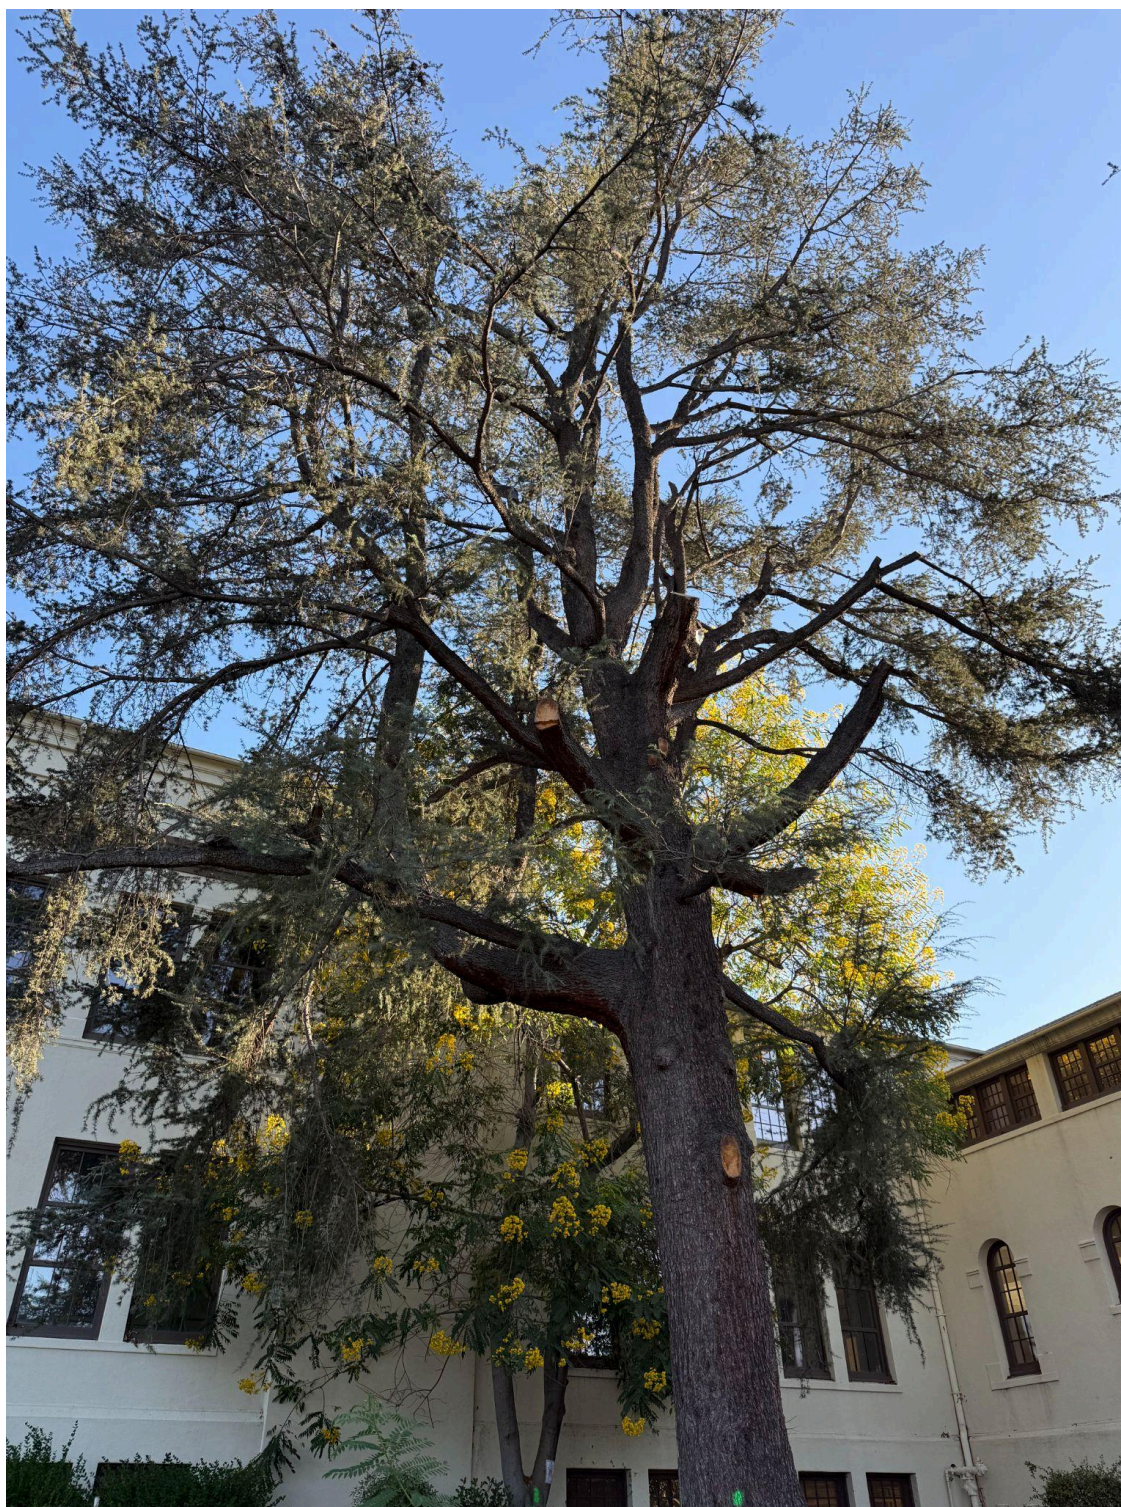
### Tree #90 — Deodar tree (*Cedrus deodara*)

Tree #90 exhibits a slight southerly lean, approximately at a 20 degree angle. No corrective counter lean present. Several structural roots are already exposed due to soil displacement and uncompaction. The lean has resulted in partial loss of soil cover over the primary structural roots on the north side. Several branches were damaged, creating an unbalanced canopy.

Air-knifing was performed on the north and east sides to a depth of 12 inches revealed structural and anchor roots beginning at approximately 10 inches below grade. These roots provide essential mechanical support and are responsible for resisting overturning forces associated with the tree's existing lean.

Excavation to 12 inches will expose the majority of the tree's structural and anchor root system. Based on ISA BMPs for Tree Risk Assessment and Root Management, removal of soil to this depth within the CRZ will imminently compromise the mechanical stability. Given the tree's existing lean and the depth at which critical roots occur, further excavation will likely result in loss of structural support and may lead to tree failure.

Tree #90 cannot maintain structural stability if excavation proceeds to the proposed depth 1 foot below grade. The planned contaminated soil removal will expose and destabilize all major structural roots on all sides of the tree, creating a high likelihood of failure once root support is compromised.

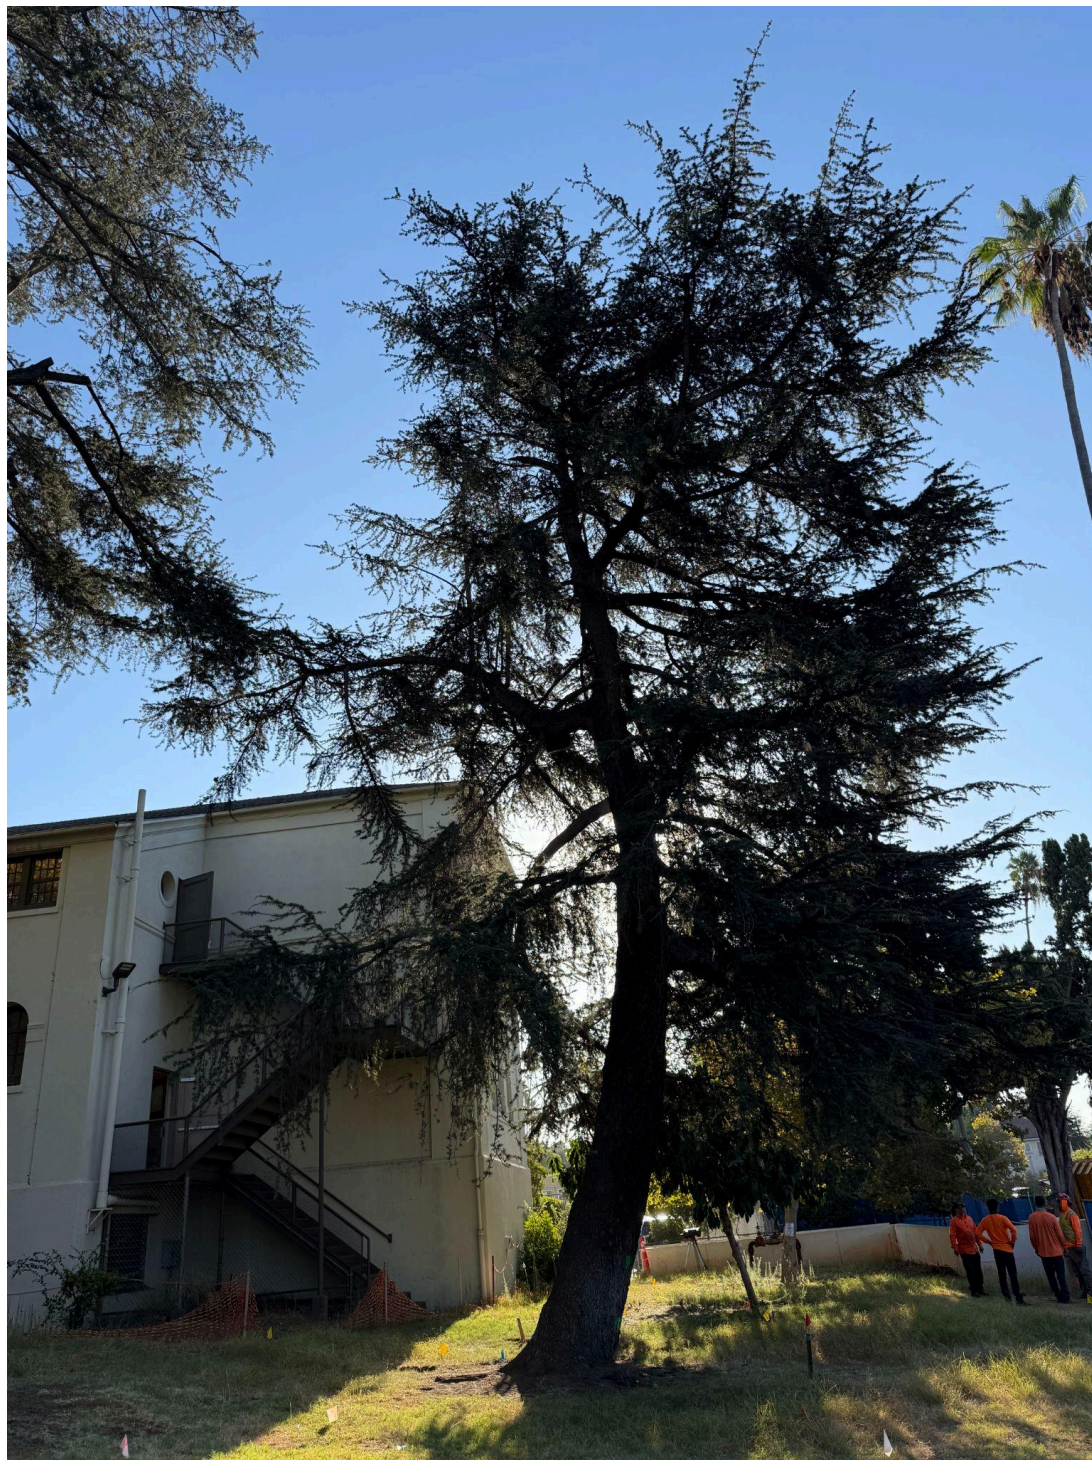
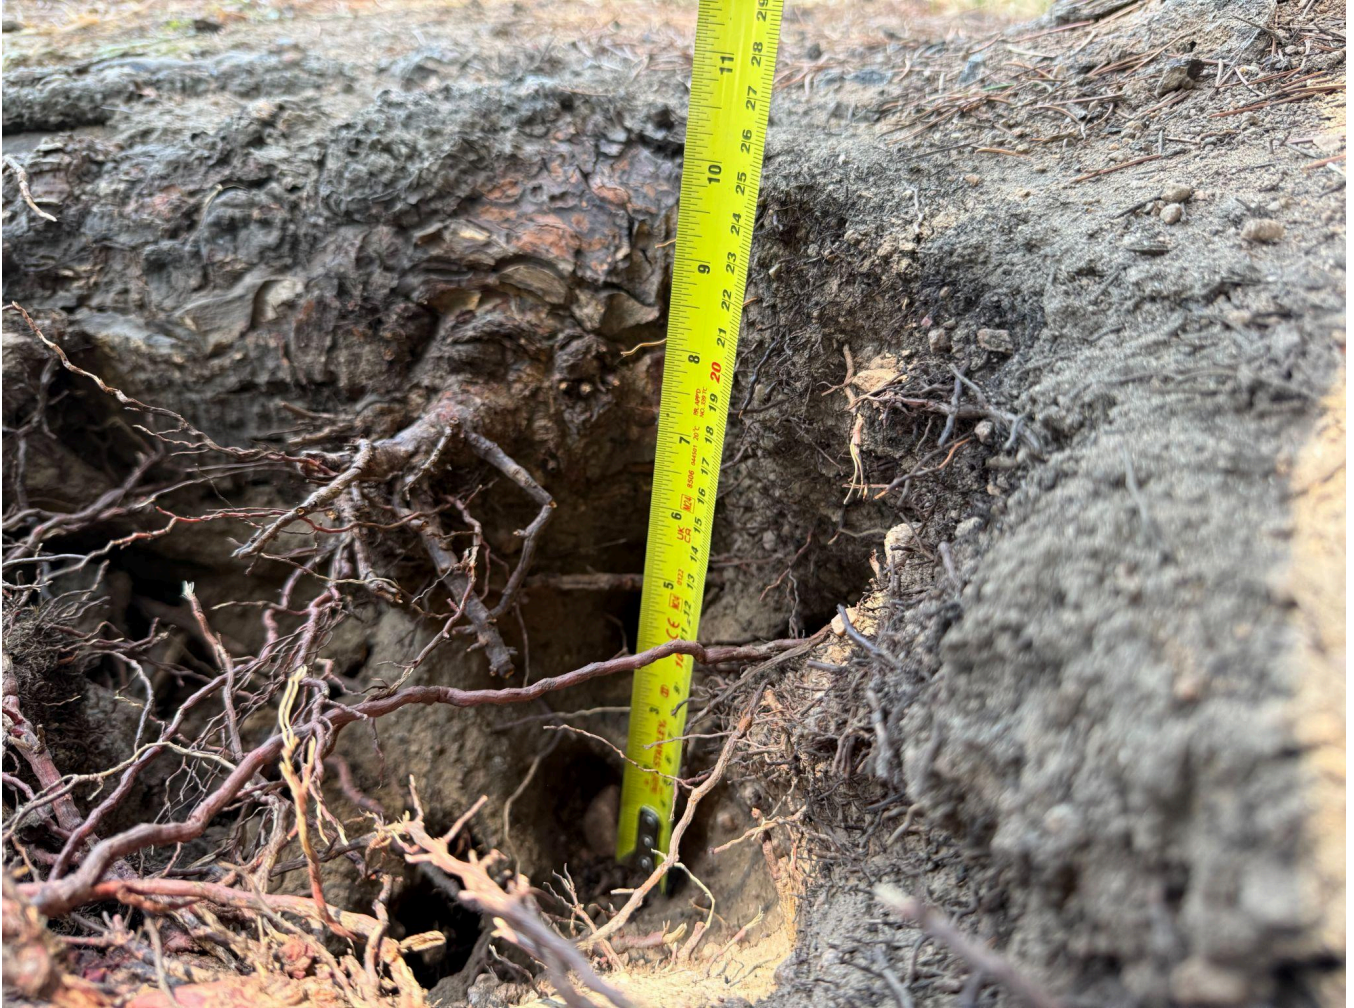
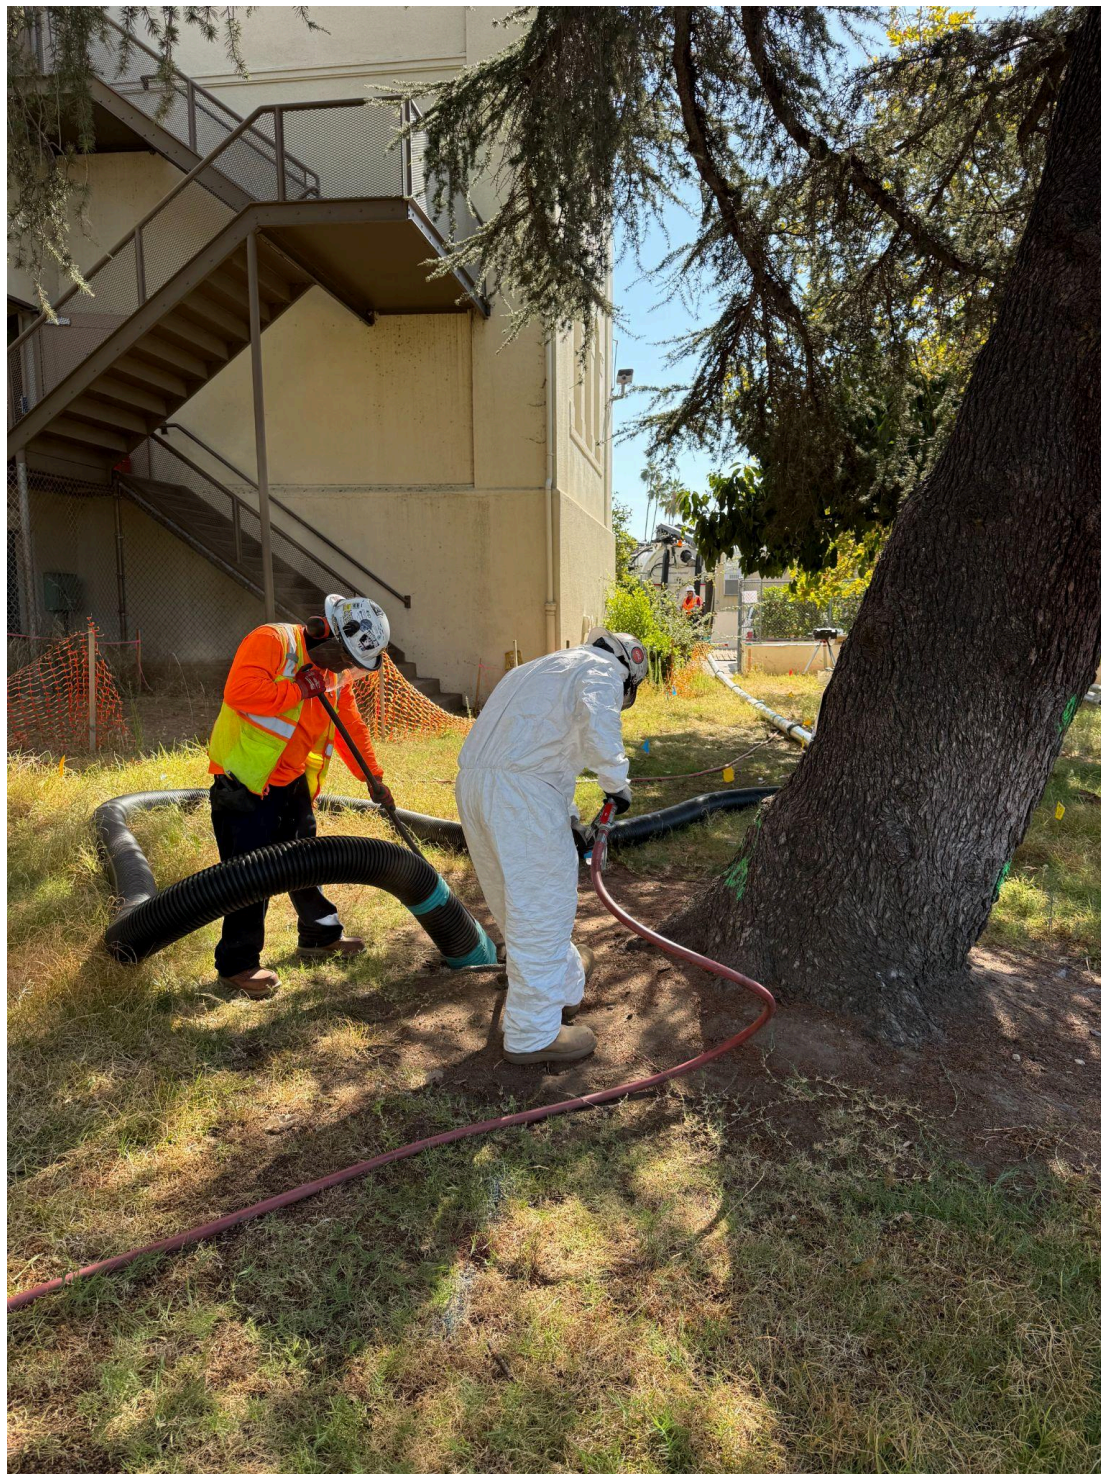
### Tree #92 — Deodar tree (*Cedrus deodara*)

Tree #92 exhibits a southerly lean, approximately at a 25 degree angle, with corrective counter lean to the east side of the tree. Several structural roots are already exposed due to soil displacement and uncompaction. The lean has resulted in partial loss of soil cover over the primary structural roots on the north side. Several branches were damaged, creating an unbalanced canopy.

Air-knifing was performed on the north, south, east, and west sides of the tree to a depth of 12 inches. Investigation revealed structural and anchor roots beginning at approximately 10 inches below grade. These roots provide essential mechanical support and are responsible for resisting overturning forces associated with the tree's existing lean.

Excavation to 12 inches will expose the majority of the tree's structural and anchor root system. Based on ISA BMPs for Tree Risk Assessment and Root Management, removal of soil to this depth within the CRZ will imminently compromise the tree's mechanical stability. Given the tree's existing lean and the depth at which critical roots occur, further excavation will likely result in loss of structural support and may lead to tree failure.

Tree #92 cannot maintain structural stability if excavation proceeds to the proposed depth of 1 foot below grade. The planned contaminated soil removal will expose and destabilize all major structural roots on all sides, creating a high likelihood of failure once root support is compromised.

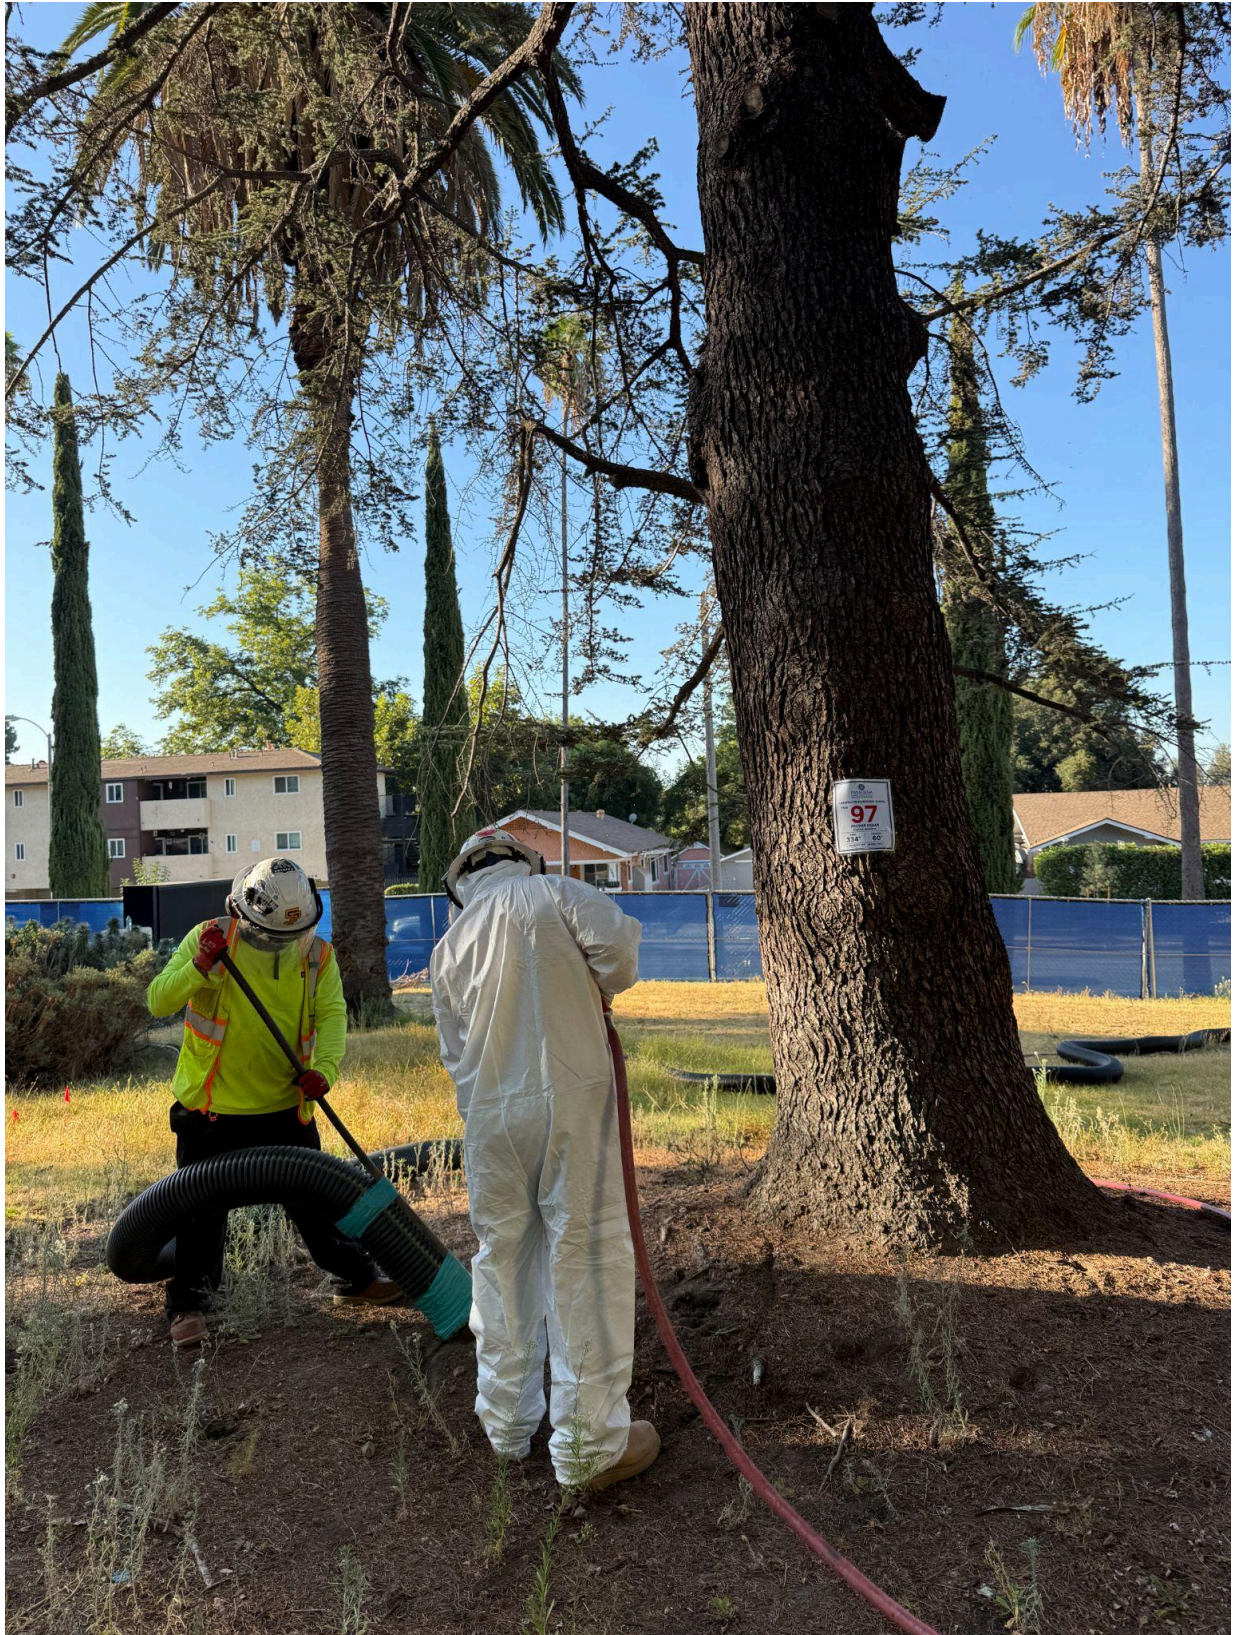
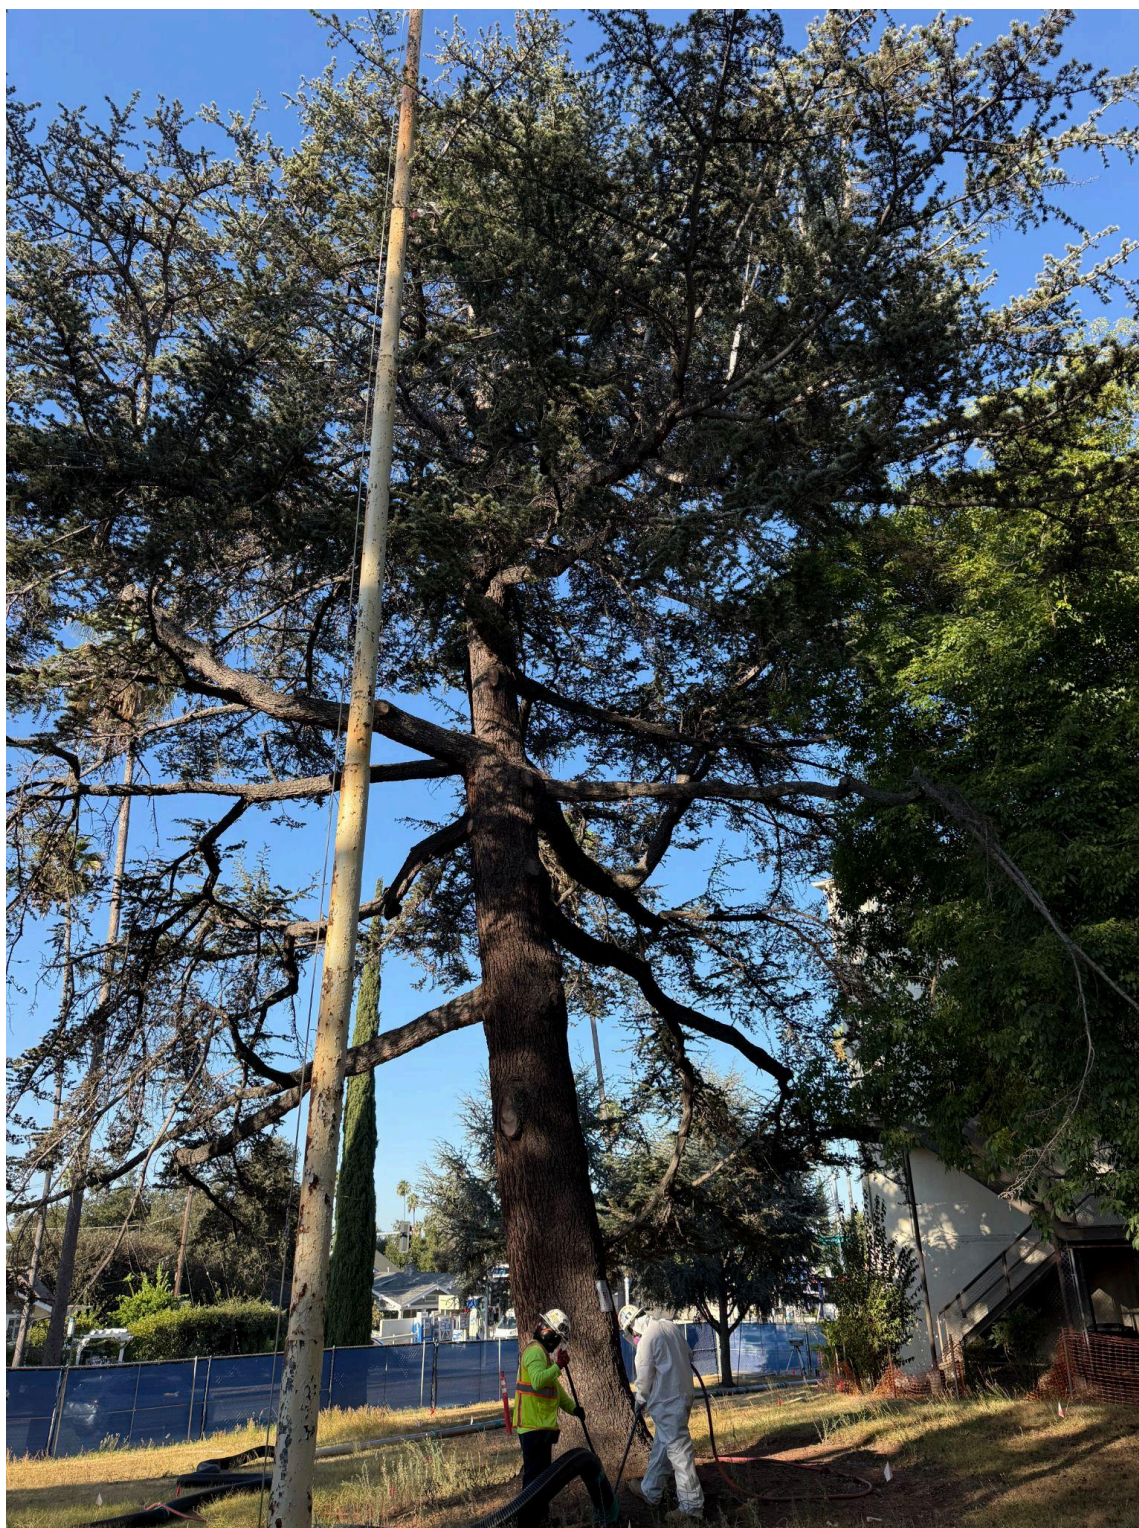
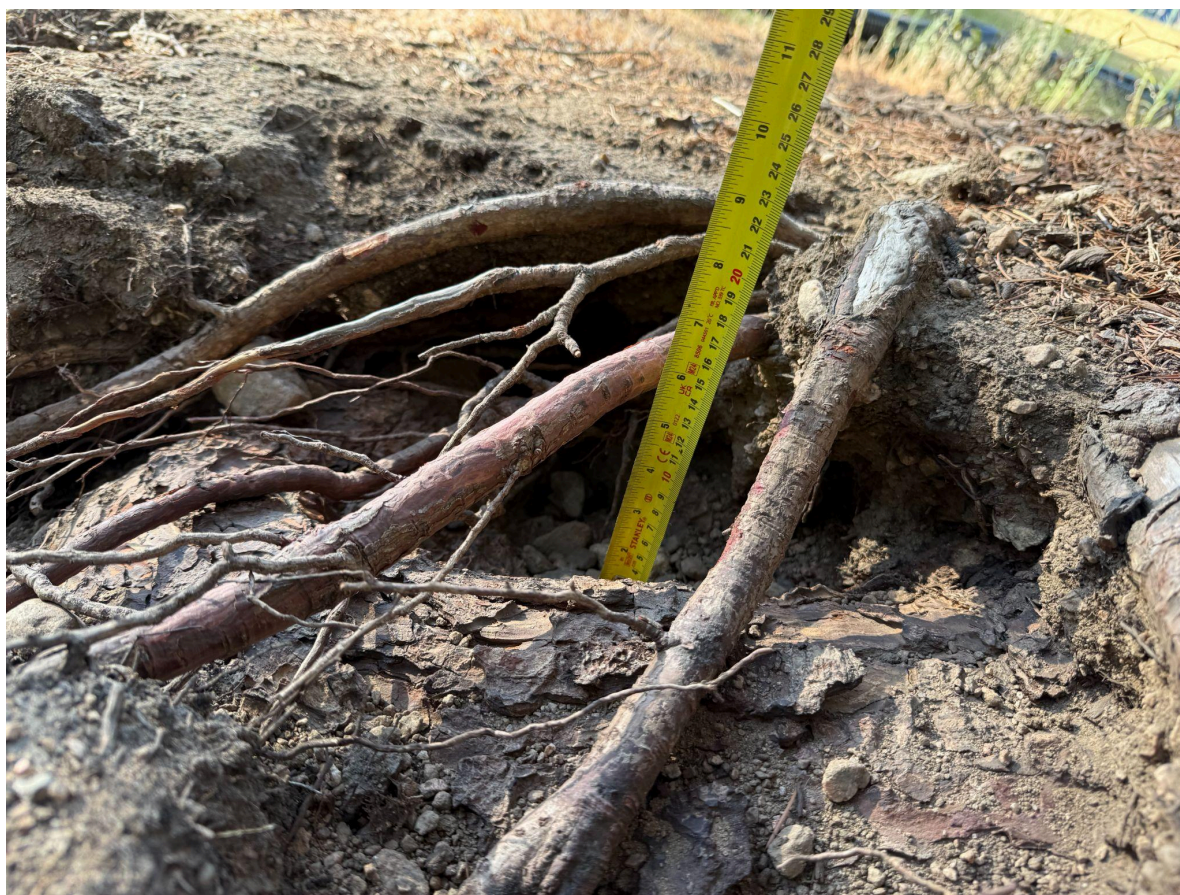
### Tree #97 — Deodar tree (*Cedrus deodara*)

Tree #97 exhibits a slight southerly lean at an approximate 20 degree angle, with no corrective counter lean present. Several structural roots are already exposed due to soil displacement and uncompaction. The lean has resulted in partial loss of soil cover over the primary structural roots on the north side. Several branches were damaged, creating an unbalanced canopy.

Air-knifing was performed on the north, south, east, and west sides of the tree to a depth of 12 inches. Investigation revealed structural and anchor roots beginning at approximately 8 inches below grade. These roots provide essential mechanical support and are responsible for resisting overturning forces associated with the tree's existing lean.

Excavation to 12 inches will expose the majority of the tree's structural and anchor root system. Based on ISA BMPs for Tree Risk Assessment and Root Management, removal of soil to this depth within the CRZ will imminently compromise the tree's mechanical stability. Given the tree's existing lean and the depth at which critical roots occur, further excavation will likely result in loss of structural support and may lead to tree failure.

Tree #97 cannot maintain structural stability if excavation proceeds to the proposed depth of 1 foot below grade. The planned contaminated soil removal will expose and destabilize all major structural roots on all sides, creating a high likelihood of failure once root support is compromised.

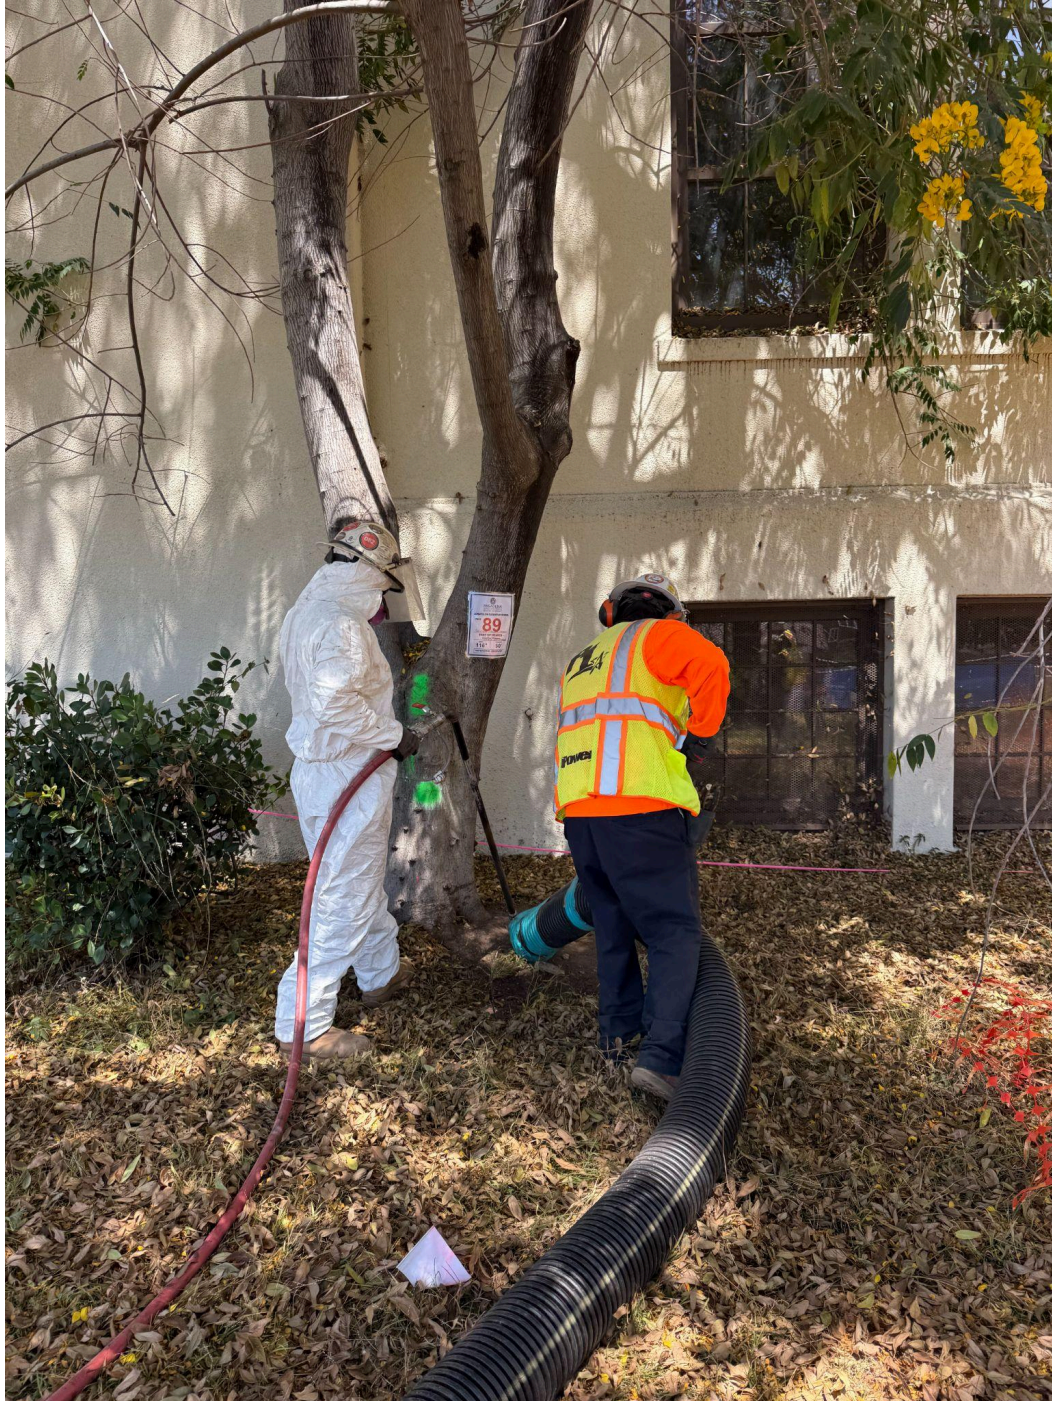
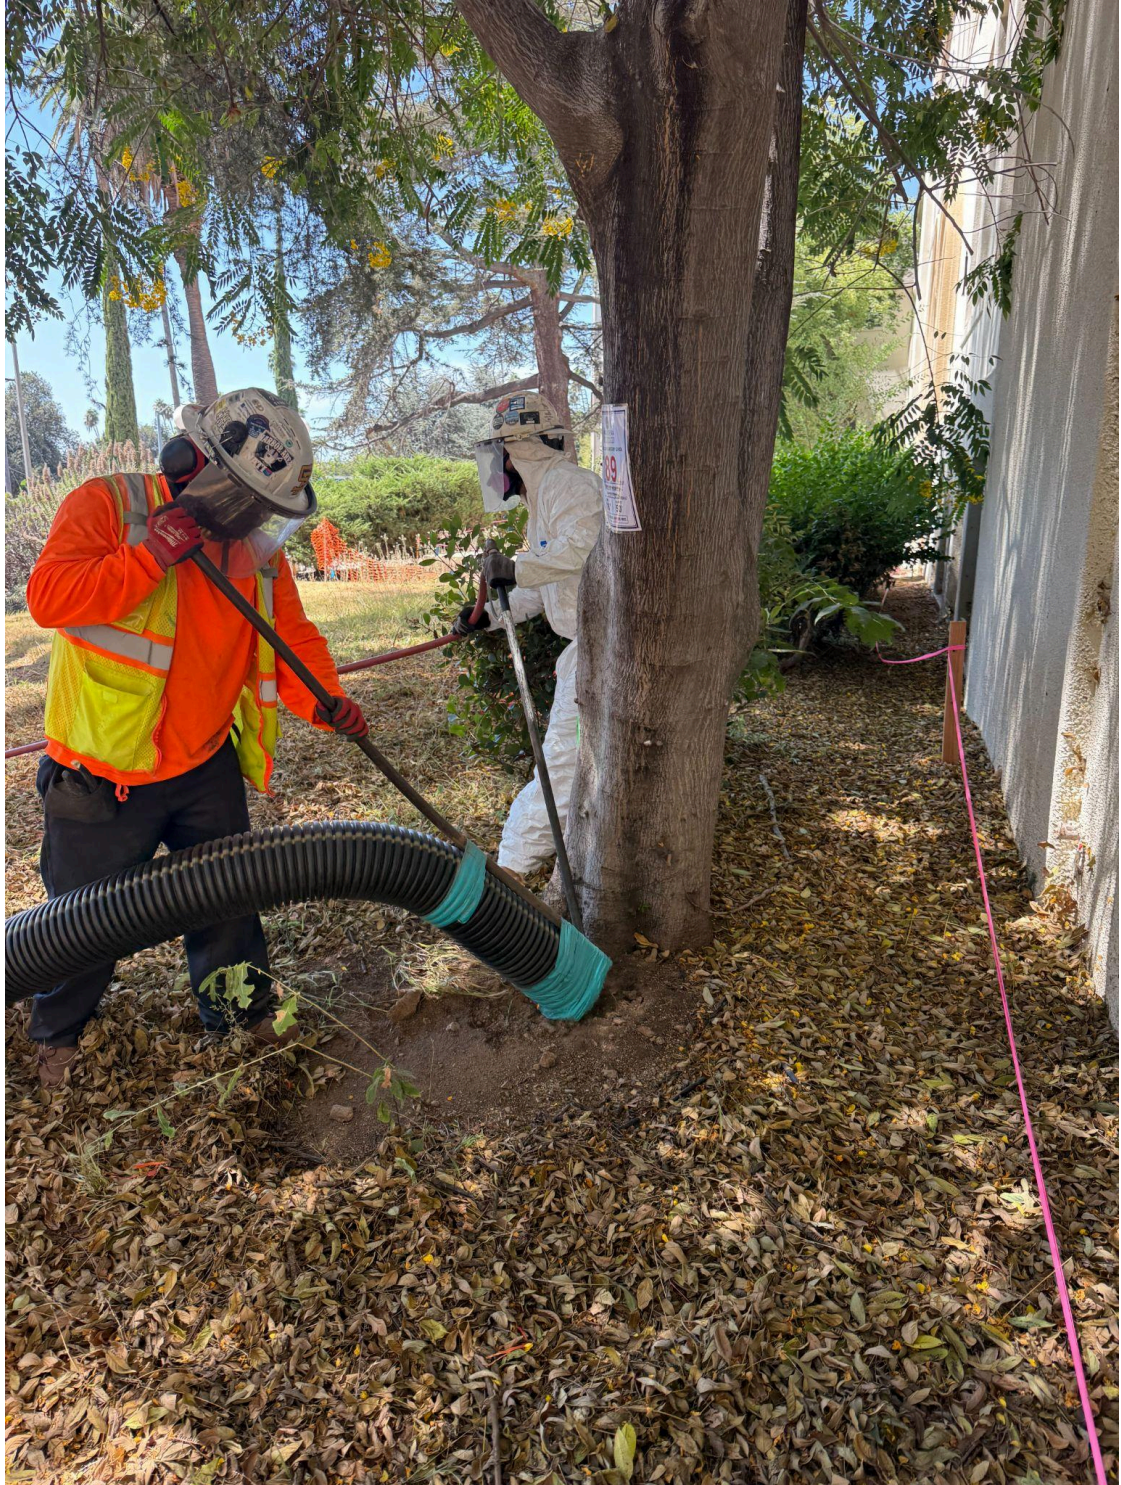
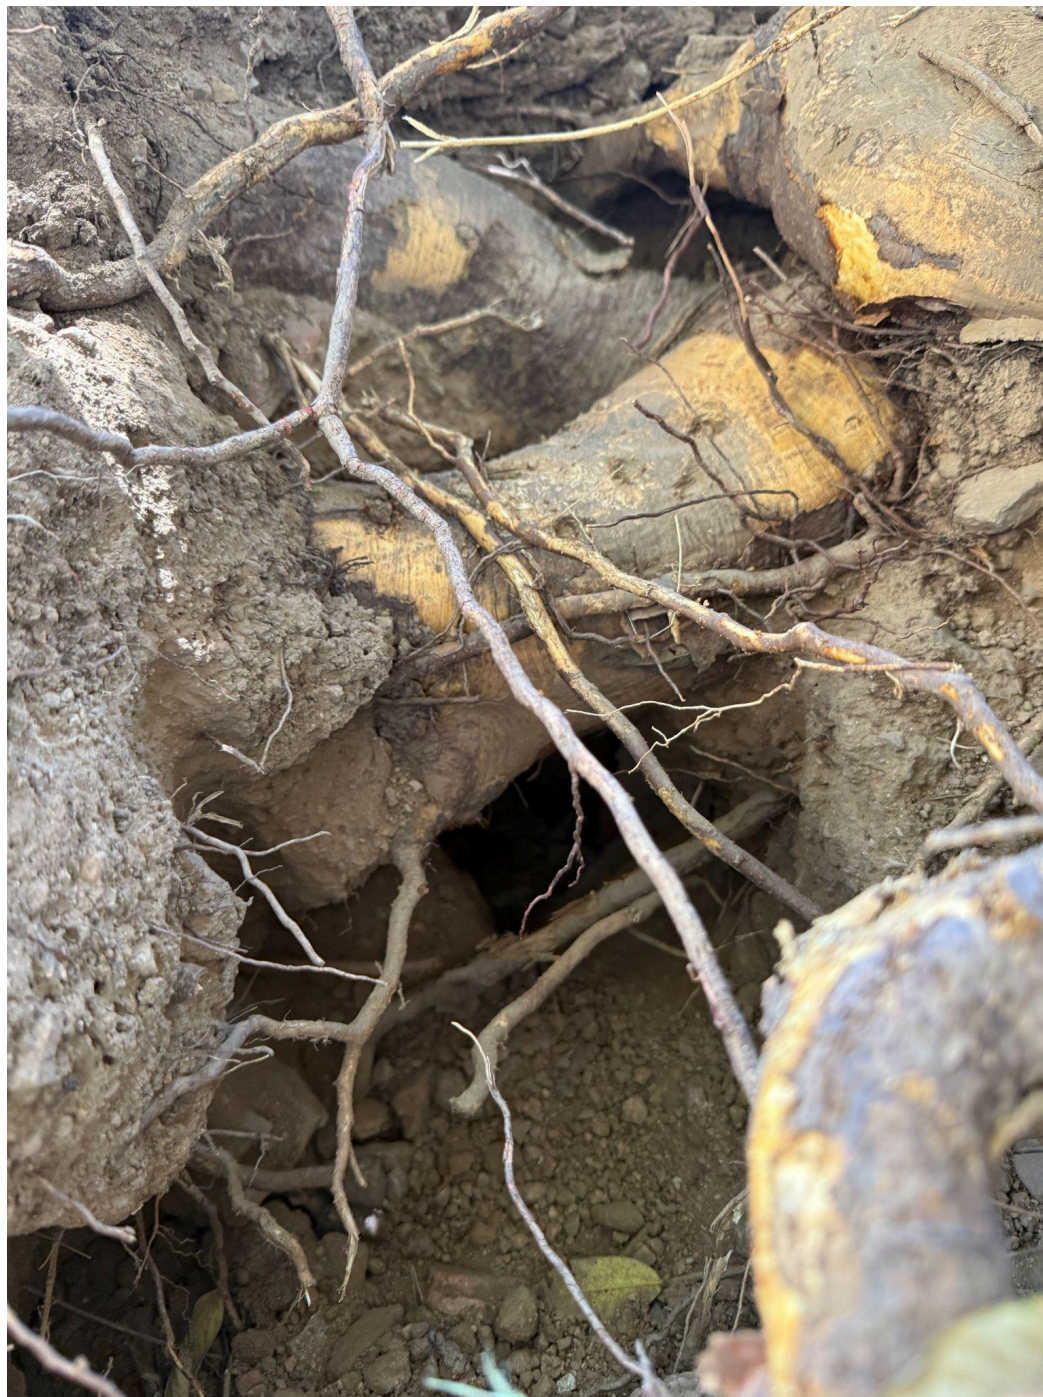
Tree #89 exhibits a slight southerly lean to an approximate 20 degree angle, without correctional lean. Several structural roots are already exposed due to soil displacement and uncompaction. The lean has resulted in partial loss of soil cover over the primary structural roots on the south side. Several branches were damaged, creating an unbalanced canopy.

Air-knifing was performed on the east and north side of the tree to a depth of 24 inches revealed structural and anchor roots beginning at approximately 12 inches below grade. These roots provide essential mechanical support and are responsible for resisting overturning forces associated with the tree's existing lean.

Excavation to 12 inches will expose the majority of the tree's structural and anchor root system. Based on ISA BMPs for Tree Risk Assessment and Root Management, removal of soil to this depth within the CRZ will imminently compromise mechanical stability. Given the tree's existing lean and the depth at which critical roots occur, further excavation will likely result in loss of structural support and may lead to tree failure.

Tree #89 cannot maintain structural stability if excavation proceeds to the proposed depth. The planned contaminated soil removal will expose and destabilize all major structural roots on the east and north side, creating a high likelihood of failure once root support is compromised.
