**Arborist Inspection & Report · Tree Service**

**Elias Najjar**

Air excavation and root-zone inspection were conducted from August 24th through August 26th, 2026, at Longfellow School.

## Tree Risk Assessment and Arborist Report

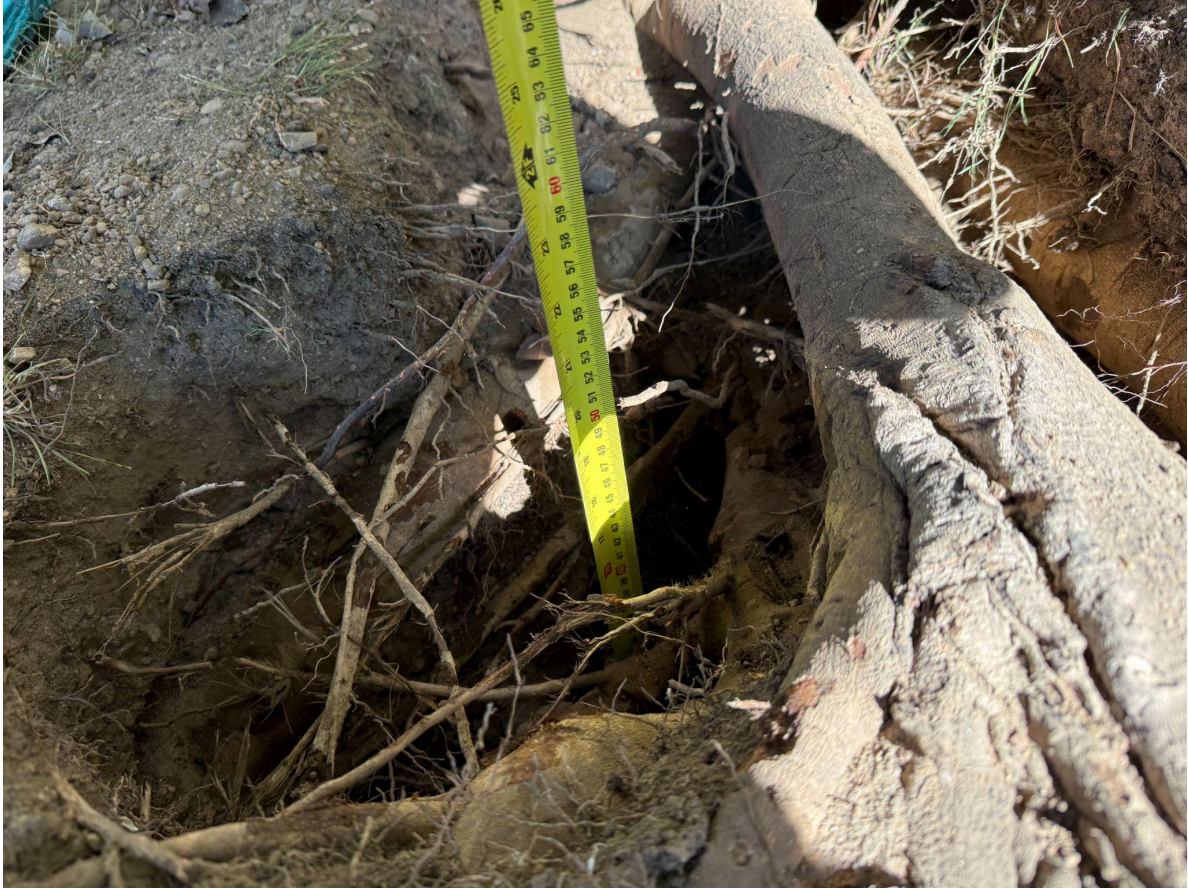
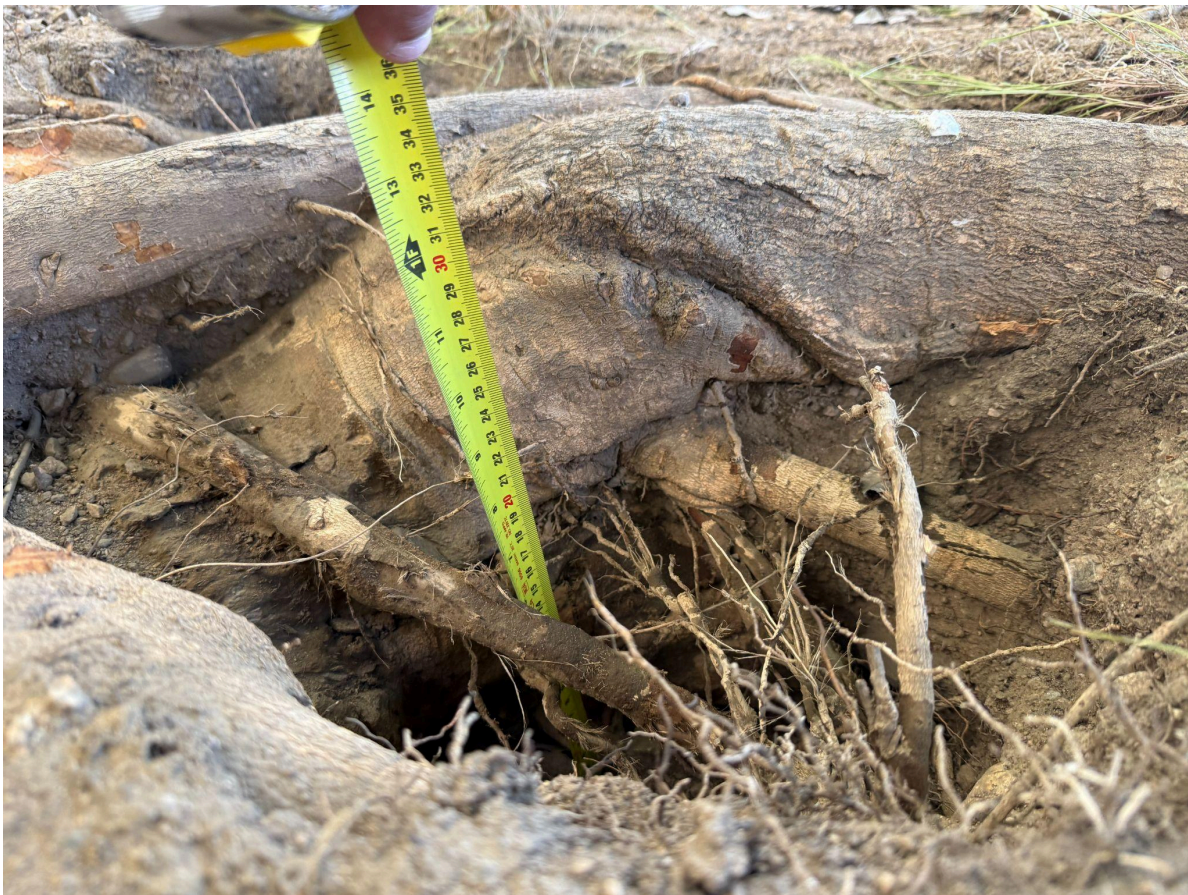
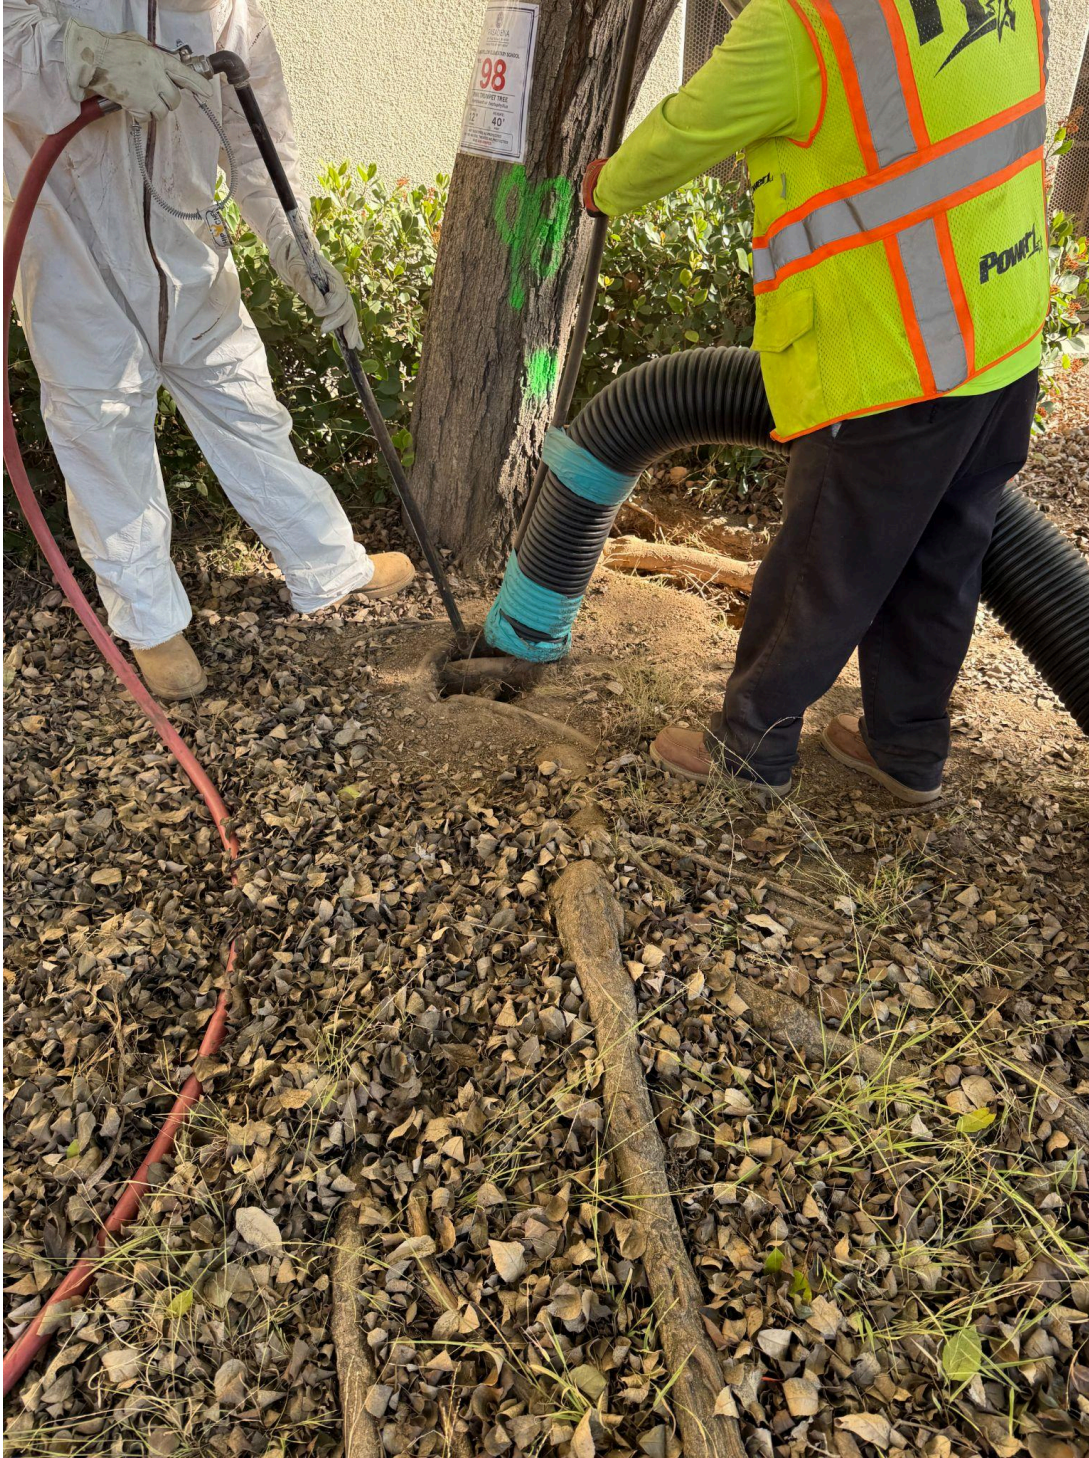
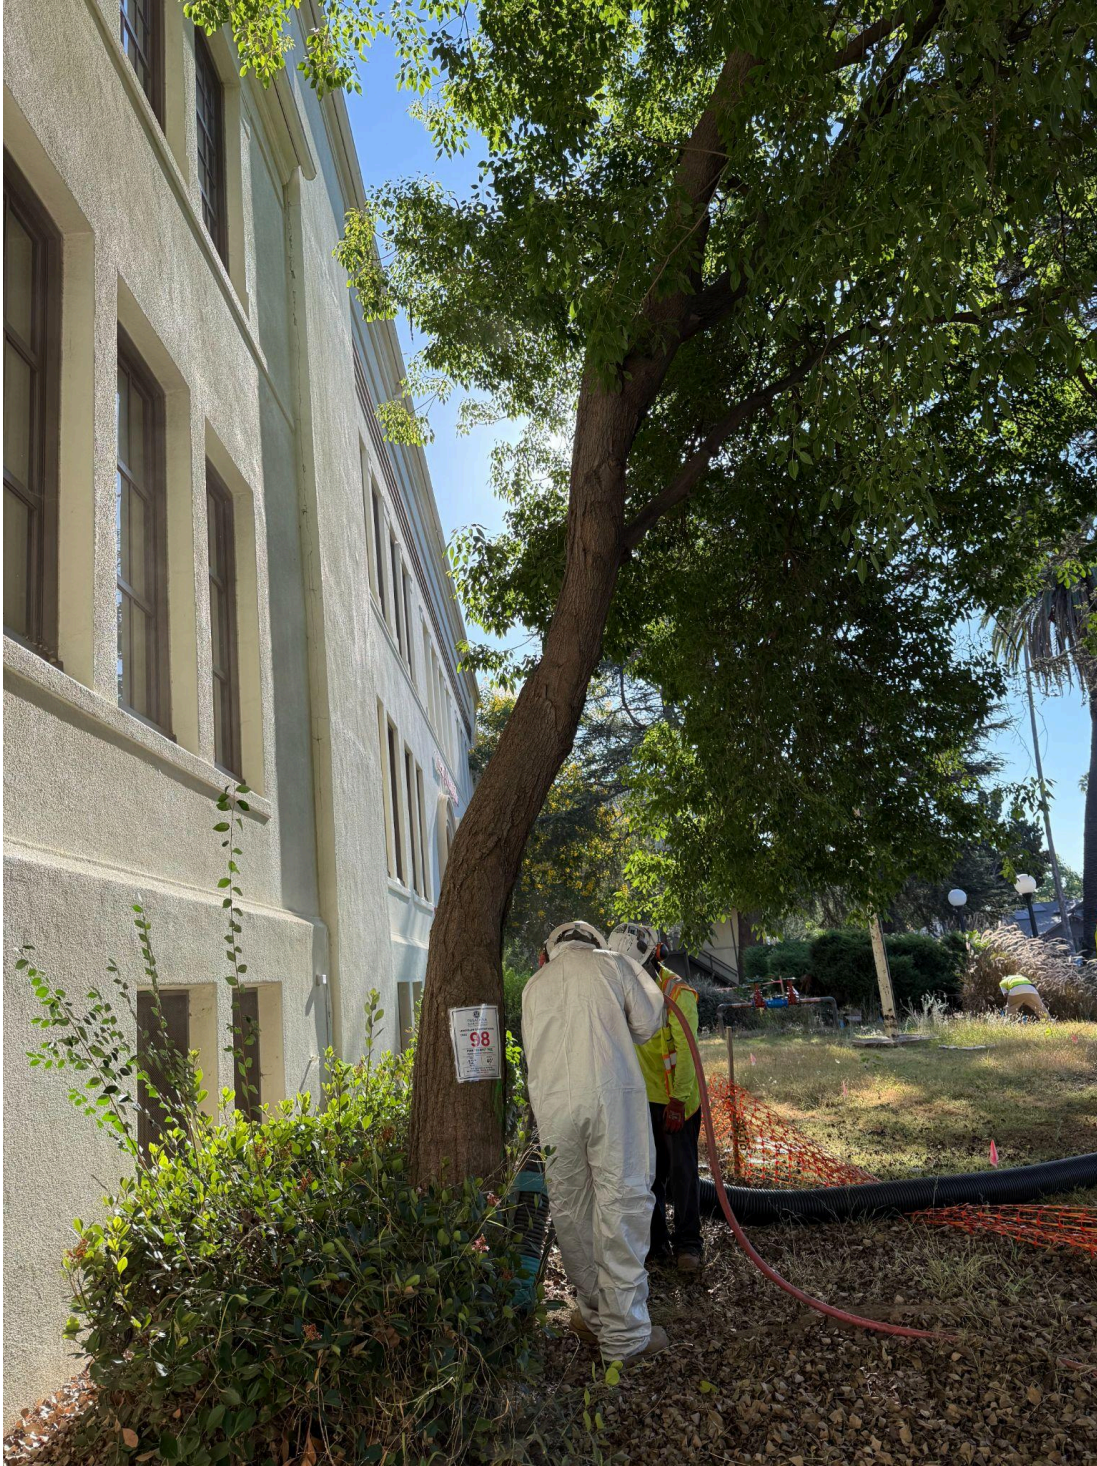
### Tree #98 — Pink trumpet (*Handroanthus heptaphyllus*)

Tree #98 exhibits a slight southerly lean, with several structural roots already exposed due to soil displacement and uncompaction. The lean has resulted in partial loss of soil cover over the primary structural roots on the south side. Several branches were damaged, creating an unbalanced canopy.

Air-knifing was performed on the east, and south side of the tree to a depth of 24 inches revealed structural and anchor roots beginning at approximately 12-18 inches below grade. These roots provide essential mechanical support and are responsible for resisting overturning forces associated with the tree's existing lean.

Excavation to 24 inches will expose the majority of the tree's structural and anchor root system. Based on ISA BMPs for Tree Risk Assessment and Root Management, removal of soil to this depth within the CRZ will imminently compromise mechanical stability. Given the tree's existing lean and the depth at which critical roots occur, further excavation will likely result in loss of structural support and may lead to tree failure.

Tree #98 cannot maintain structural stability if excavation proceeds to the proposed depth of 2 feet below grade. The planned soil removal will expose and destabilize all major structural roots on the east and south side, creating a high likelihood of failure once root support is compromised.

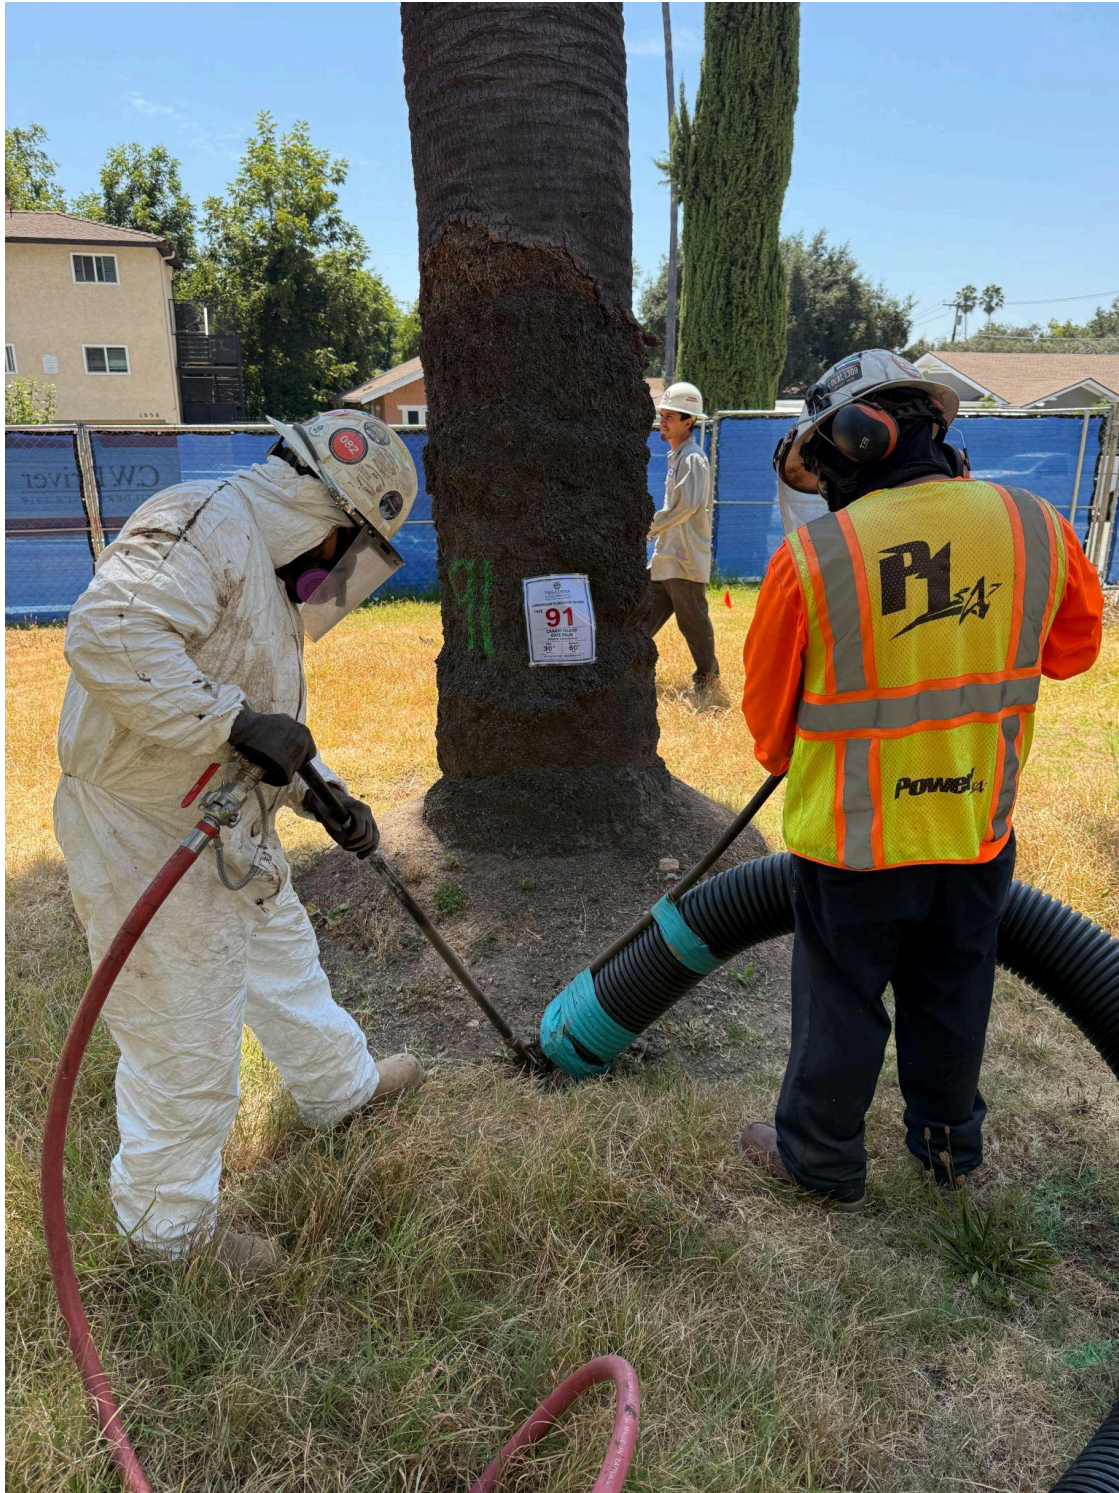
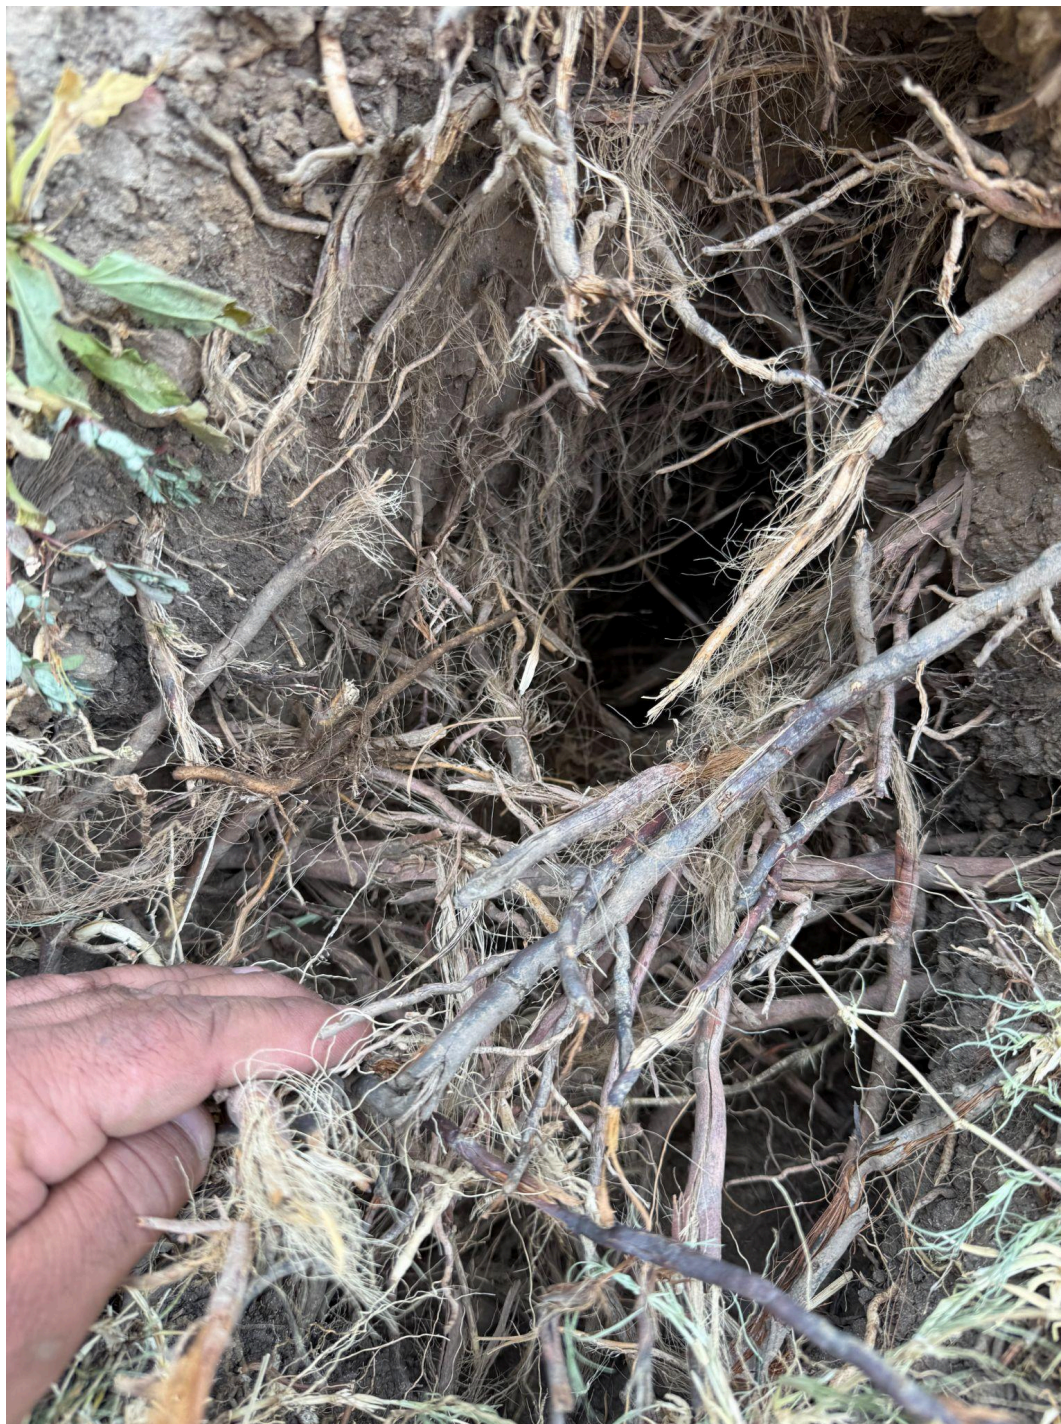
### Tree #91 — Canary island date palm (*Phoenix canariensis*)

The tree #91 exhibits a slight southerly lean, with portions of the older fibrous root system already exposed, consistent with the natural growth habit of date palms. This pre-existing lean reduces structural stability and increases susceptibility to disturbance during air-knife excavation. Date palm fibrous roots were easily deflected, torn, or severed when soil was removed around the root zone, and excavation approximately 12 inches is expected to result in significant root loss, including portions of the structural root plate responsible for anchorage. Such loss will materially compromise the tree's health, stability and physiological function. The tree is unlikely to maintain adequate structural support or long-term health following excavation.

Air-knifing performed on the north and east side of the tree to a depth of 12 inches revealed structural and anchor roots beginning at approximately 2-4 inches below grade. These roots provide essential mechanical support and are responsible for resisting overturning forces associated with the tree's existing lean.

Excavation to 12 inches will expose the majority of the tree's fiber root system. Based on ISA BMPs for Tree Risk Assessment and Root Management, removal of soil to this depth within the CRZ will imminently compromise mechanical stability. Given the tree's existing lean and the depth at which critical roots occur, further excavation will likely result in loss of structural support and may lead to tree failure.

Tree #91 cannot maintain structural stability if contaminated soil excavation proceeds to the proposed level of 1 foot below grade. The planned soil removal will expose and destabilize all major fiber roots, creating a high likelihood of failure once root support is compromised.

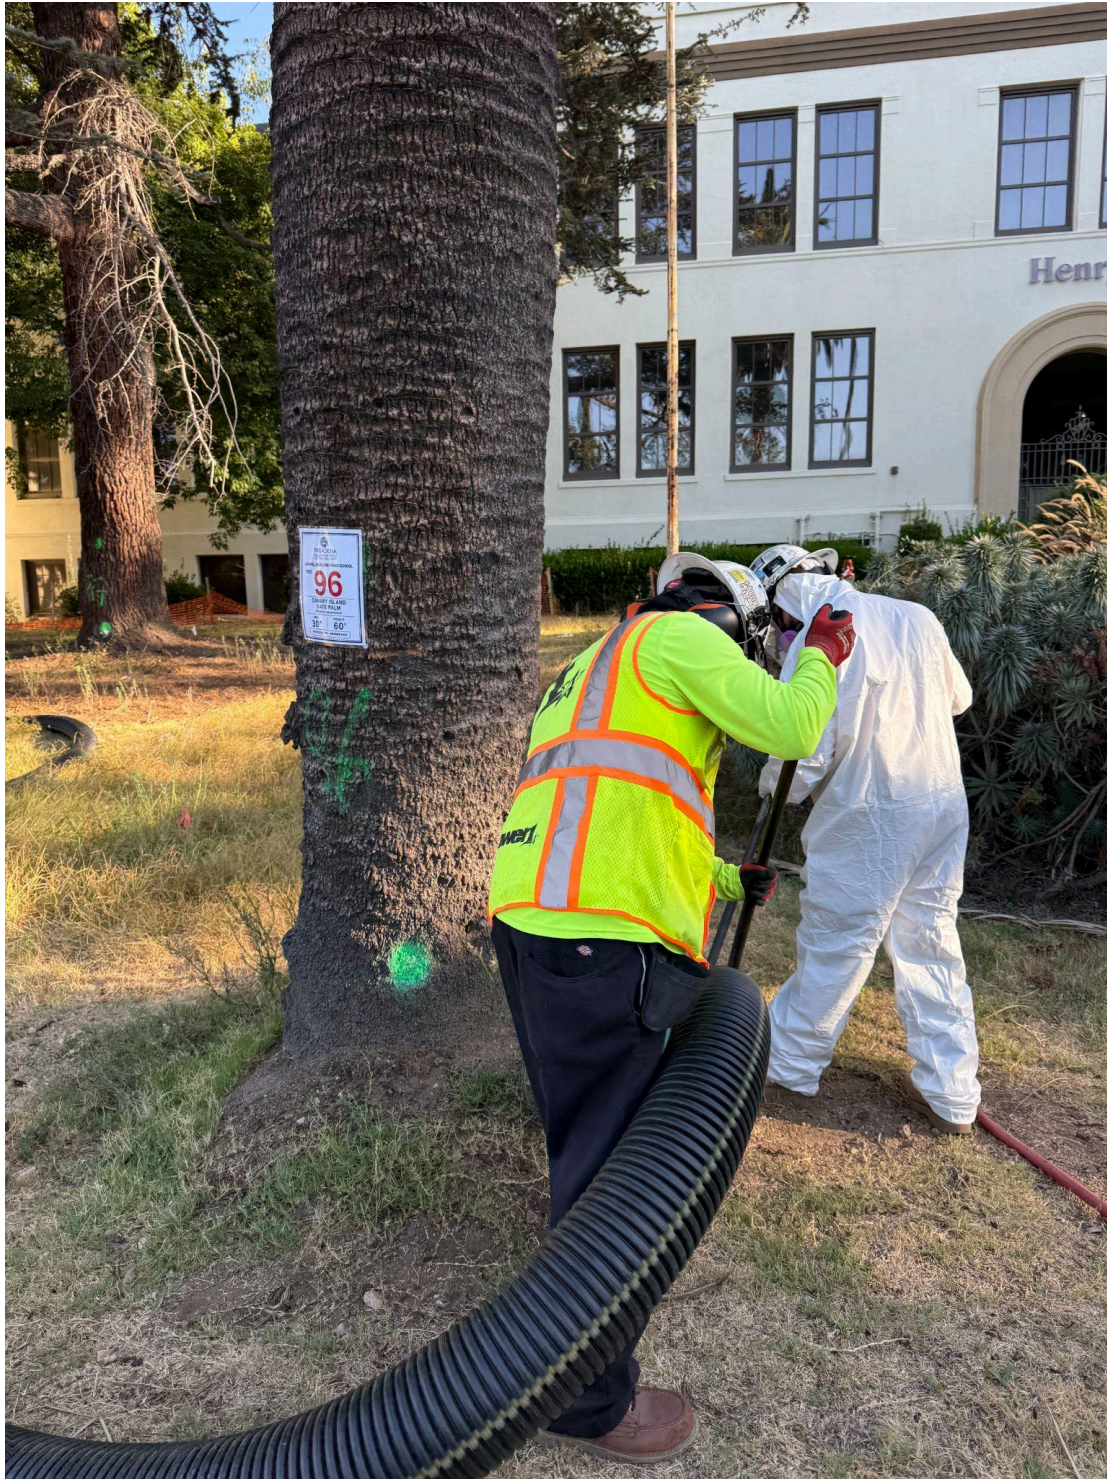
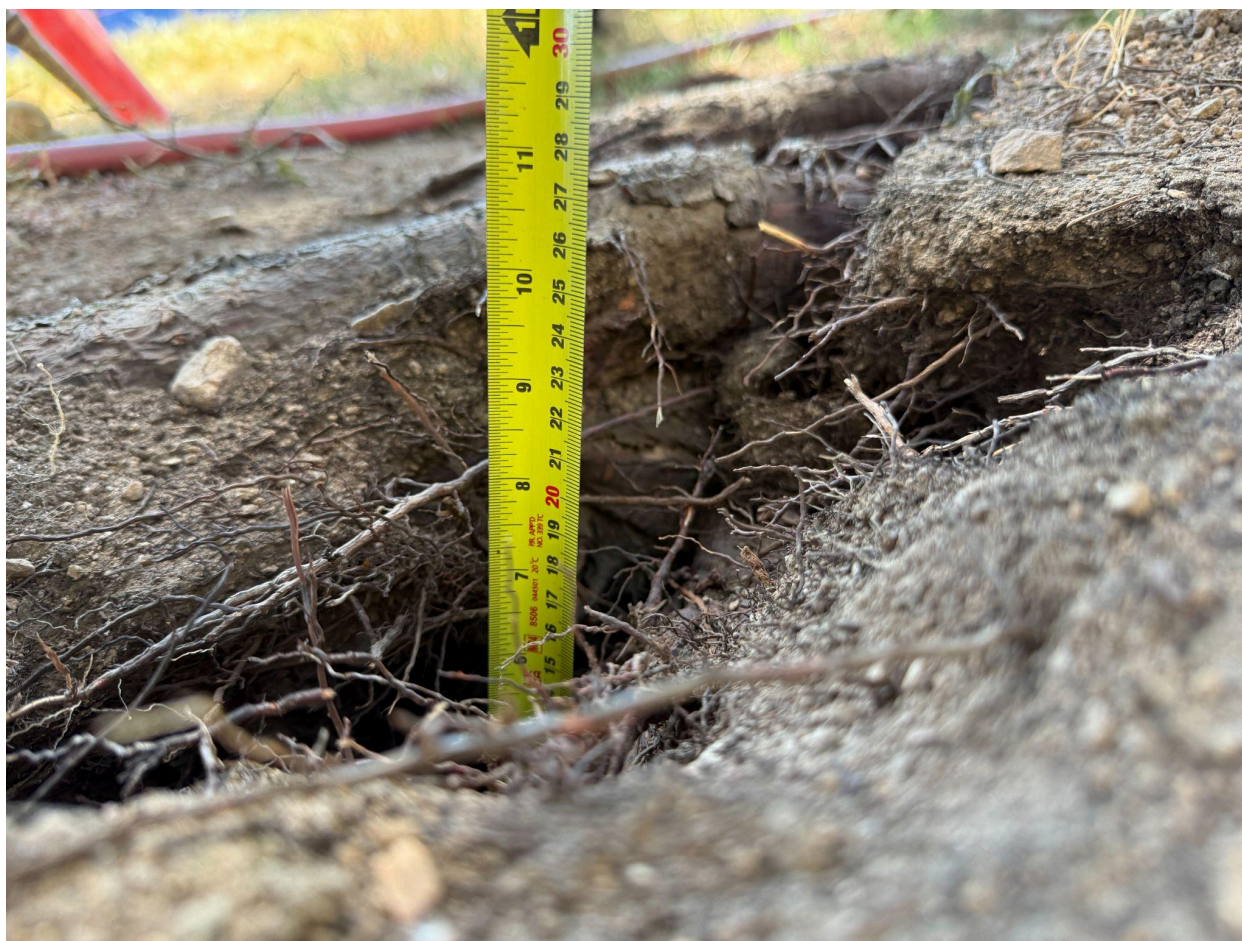
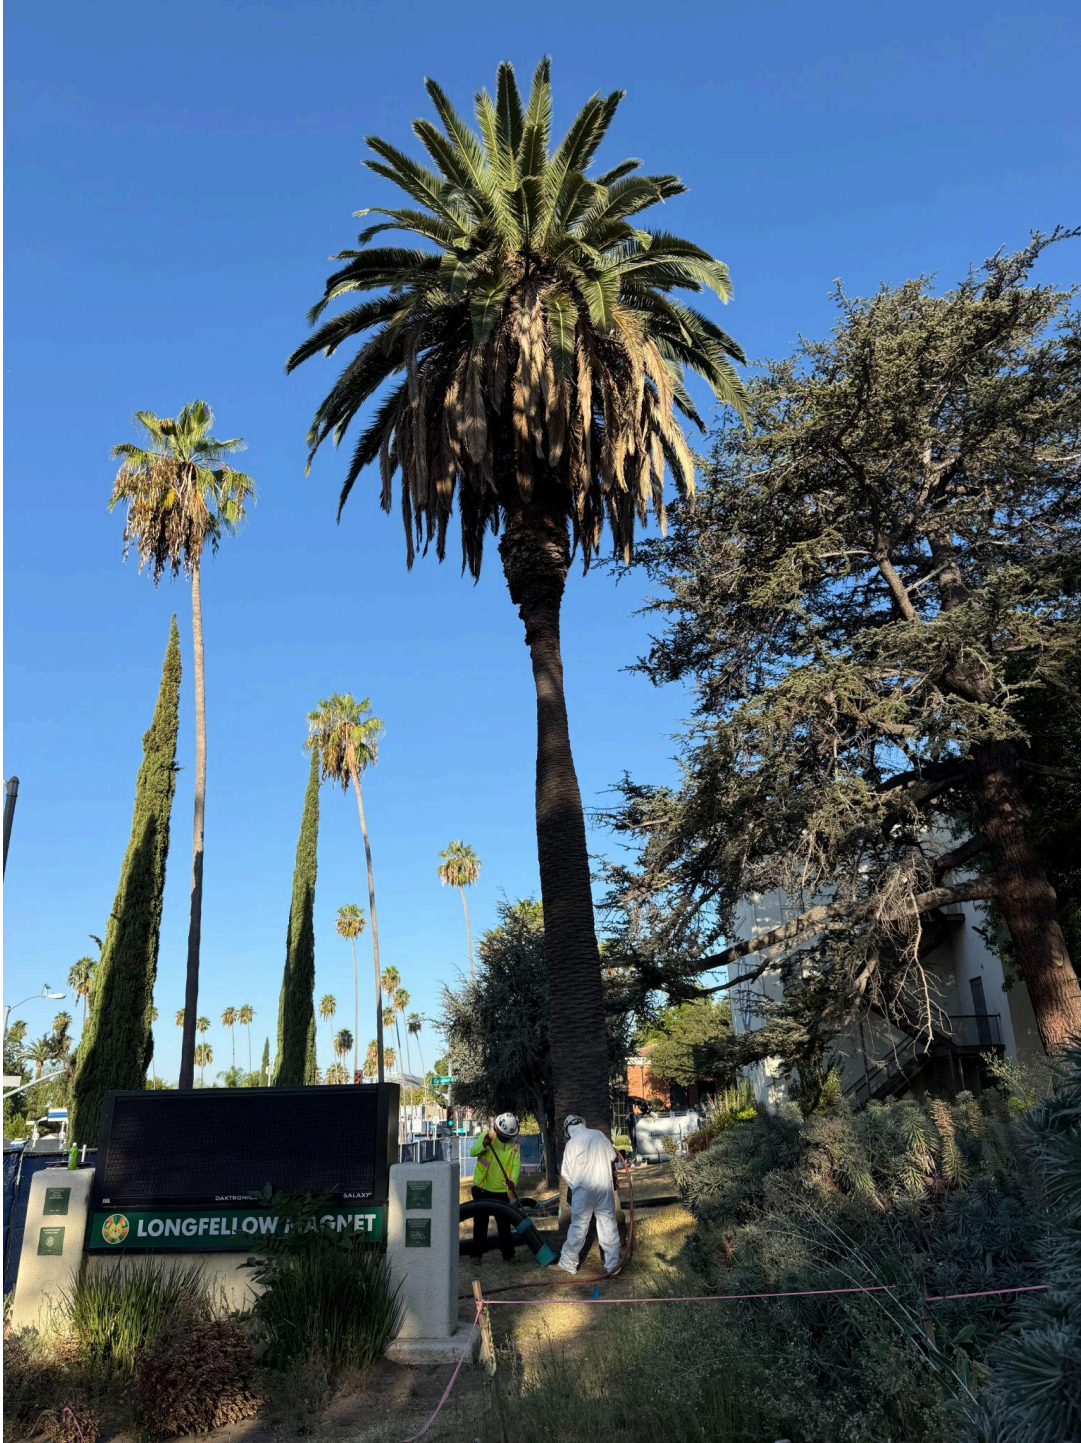
### Tree #96 — Canary island date palm (*Phoenix canariensis*)

The tree #96 exhibits a slight southerly lean, with portions of the older fibrous root system already exposed, consistent with the natural growth habit of date palms. This pre-existing lean reduces structural stability and increases susceptibility to disturbance during air-knife excavation. Date palm fibrous roots were easily deflected, torn, or severed when soil was removed around the root zone, and excavation approximately 12 inches is expected to result in significant root loss, including portions of the structural root plate responsible for anchorage. Such loss will materially compromise the tree's health, stability and physiological function. The tree is unlikely to maintain adequate structural support or long-term health following excavation.

Air-knifing performed on the north, east and west sides of the tree to a depth of 12 inches revealed structural and anchor roots beginning at approximately 2-4 inches below grade. These roots provide essential mechanical support and are responsible for resisting overturning forces associated with the tree's existing lean.

Excavation to 12 inches will expose the majority of the tree's fiber root system. Based on ISA BMPs for Tree Risk Assessment and Root Management, removal of soil to this depth within the CRZ will imminently compromise mechanical stability. Given the tree's existing lean and the depth at which critical roots occur, further excavation will likely result in loss of structural support and may lead to tree failure.

Tree #96 cannot maintain structural stability if contaminated soil excavation proceeds to the proposed level of 1 foot below grade. The planned soil removal will expose and destabilize all major fiber roots, creating a high likelihood of failure once root support is compromised.
