# POUDRE SCHOOL DISTRICT

## BACON ELEMENTARY SCHOOL

### FACILITY CONDITION ASSESSMENT

OCTOBER 2023

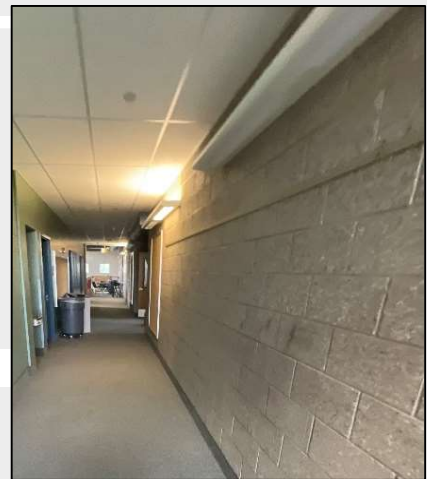
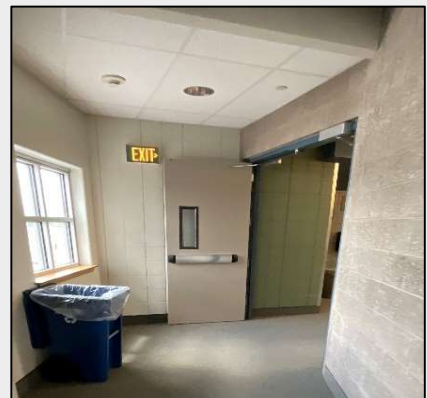
##### 1. Replace outdated Lighting

The following assets are included within this measure:

- Interior Lighting, Fluorescent (FCAID-010124)
- Emergency Back-up Lighting (FCAID-010122)

**Priority Level:** 2  
**Estimated Cost:** \$1,248,520  
**Remaining Life:** 5 years

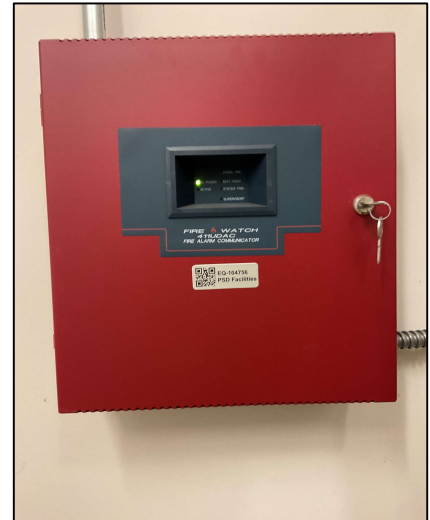
The following assets are included within this measure:

- Fire Alarm System (FCAID-010121)

**Priority Level:** 2  
**Estimated Cost:** \$508,680  
**Remaining Life:** 5 Years

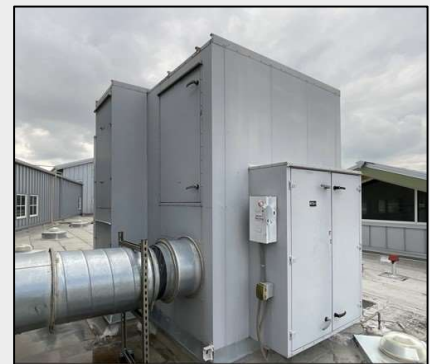
## 3. Replace outdated HVAC (RTU / Package Units)

Eight (8) outdated HVAC (RTU / Package Units) need replacement

The following assets are included within this measure:

- RTU-1 (FCAID-010064)
- RTU-5 (FCAID-010068)
- RTU-4 (FCAID-010067)
- RTU-3 (FCAID-010066)
- RTU-2 (FCAID-010065)
- RTU-6 (FCAID-010069)
- CLRTU-2 (FCAID-010063)
- CLRTU-1 (FCAID-010062)

**Priority Level:** 1  
**Estimated Cost:** \$727,230  
**Remaining Life:** 3 Years
