# POUDRE SCHOOL DISTRICT MCGRAW ELEMENTARY SCHOOL

## FACILITY CONDITION ASSESSMENT

FORT COLLINS, CO

OCTOBER 2023

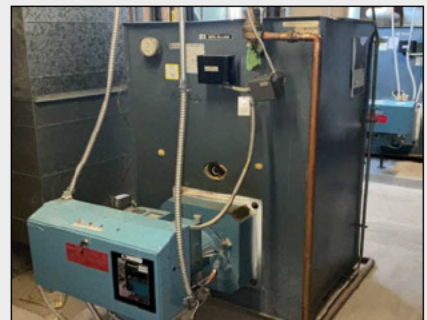
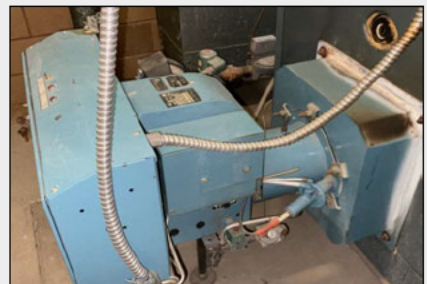
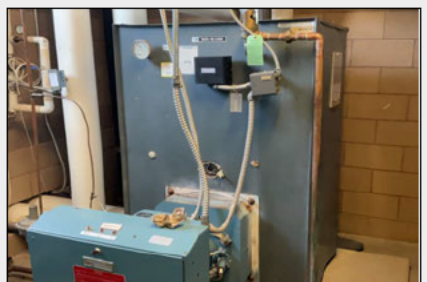
##### 1. Prepare for Boiler Replacements

The building utilizes two natural gas fired hydronic boilers which were installed in 1991. These boilers are expected to reach the end of their lifespan within 3-5 years, and will likely require some level of refurbishment or a full replacement. Plan to address these assets within this period to ensure that the building's heating system is running efficiently, and as reliably as possible.

- Boiler 1 (FCAID-370092)
- Boiler 2 (FCAID-370093)

| Priority Level: | 2 |
| Estimated Cost: | \$157,260 |

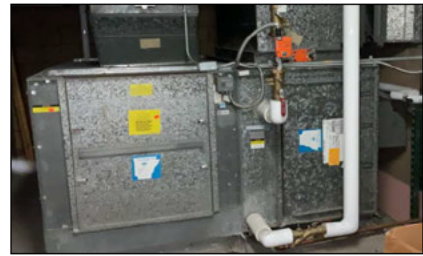
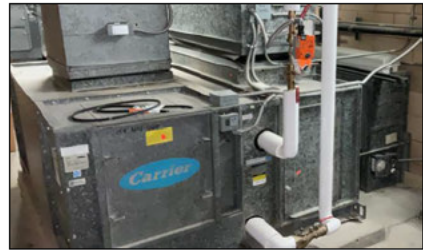
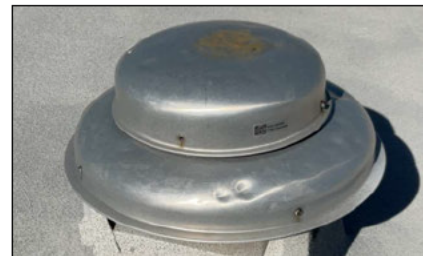
Many of these assets are original to the building's 1991 construction and are due for replacement.

- AHU-1 (FCAID-370040)
- AHU-2 (FCAID-370041)
- CUH-3 (FCAID-370047)
- CUH-4 (FCAID-370048)
- CUH-5 (FCAID-370049)
- CUH-6 (FCAID-370050)
- CUH-7 (FCAID-370051)
- (23) Exhaust Fans (FCAIDs vary)

**Priority Level:** 2  
**Estimated Cost:** \$329,980  
**Remaining Life:** 5 years

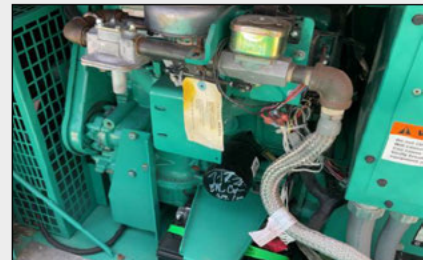
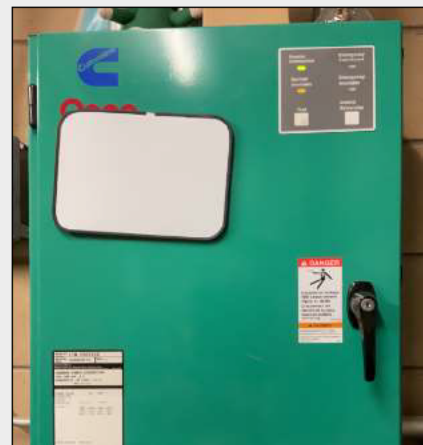
## 3. Replace the Backup Generator

The building's backup generator was installed in 2003 and has a capacity of 20 kW.

- Backup Generator (FCAID-370136)
- ATS (FCAID-370135)

**Priority Level:** 2  
**Estimated Cost:** \$29,050  
**Remaining Life:** 4-5 years

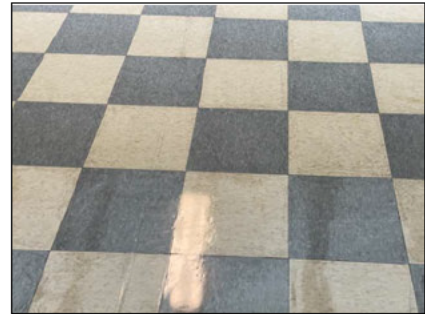
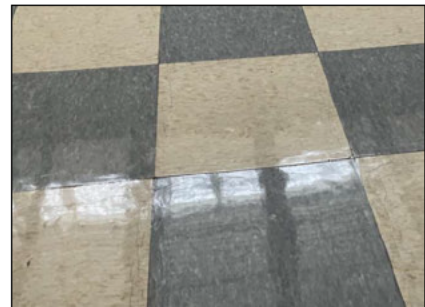
## 4. Replace the Cafeteria (FLEX) VCT Tiling

The VCT tiling in the cafeteria was found [REDACTED], with areas of cracking and peeling tiles identified. Plan to replace this surface in the next 3-5 years to reduce the risk of tripping hazards developing.

- Flooring - VCT (FCAID-370026)

**Priority Level:** 3  
**Estimated Cost:** \$78,260  
**Remaining Life:** 3-5 years

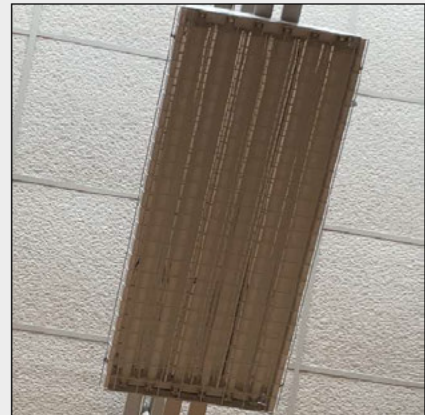
## 5. Replace Fluorescent Lighting

- Interior Lighting, Fluorescent (FCAID-370140)

**Priority Level:** 3  
**Estimated Cost:** \$754,320  
**Remaining Life:** 4 years
