# POUDRE SCHOOL DISTRICT LOPEZ ELEMENTARY SCHOOL

## FACILITY CONDITION ASSESSMENT

FORT COLLINS, CO

OCTOBER 2023

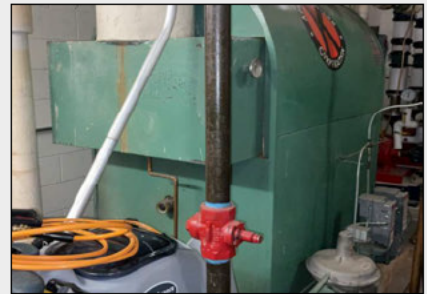
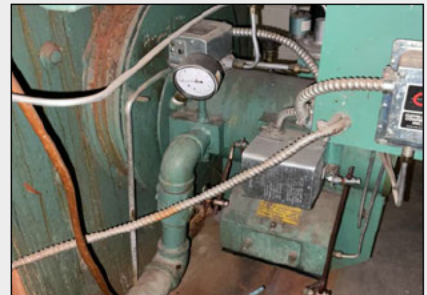
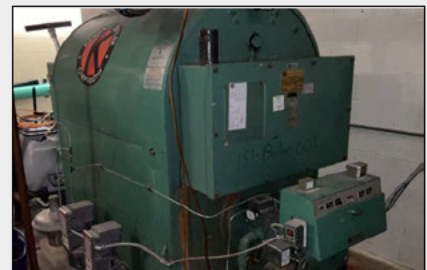
##### 1. Replace the Original Boiler

The original heating water boiler is currently 37 years old, and has surpassed its recommended lifespan [REDACTED] should be prioritized for replacement within the next 3 years. Replacing this unit will ensure that the building has a reliable and efficient heating source.

- Boiler 1 (FCAID-360084)
- Pump P-5 (FCAID-360094)

| Priority Level: | 1 |
| Estimated Cost: | \$98,610 |

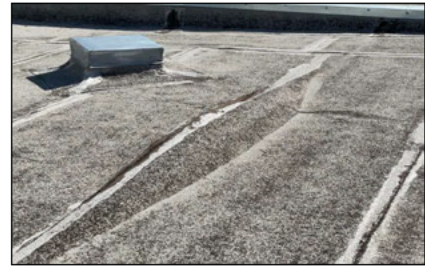
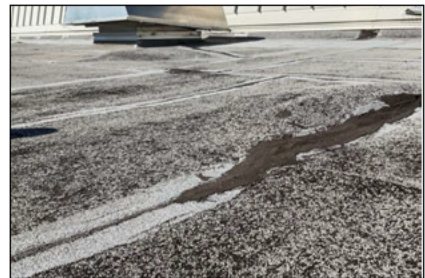
## 2. Replace the Roofing

The flat portions of the building's roofing consist of rolled asphalt sheets. Based on available records, this roofing was installed circa 2010. Severe bubbling of the roofing was noted in numerous locations, likely due to water infiltration or improper adhesion to the roofing substructure. [REDACTED]. There are numerous sloped standing-seam metal accents on the edges of the roof of the original building, and covering the gymnasium addition.

The roofing was found to be in poor condition, with areas of severe bubbling and surface separation. These bubbles are at risk for moisture infiltration into the structure if not addressed, therefore the replacing or refurbishing the roofing should be prioritized in the next 4 years. Based on available documentation, portions of the roofing were replaced in 2010, which may be under warranty.

**Priority Level:** 2  
**Estimated Cost:** \$364,020  
**Remaining Life:** 4 years

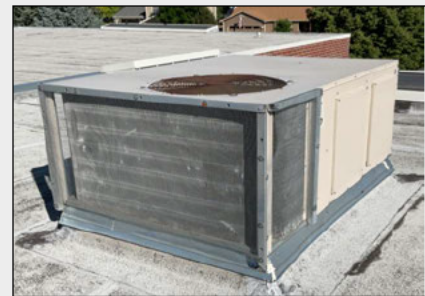
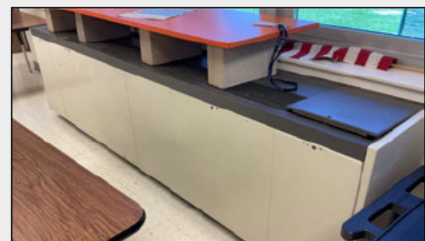
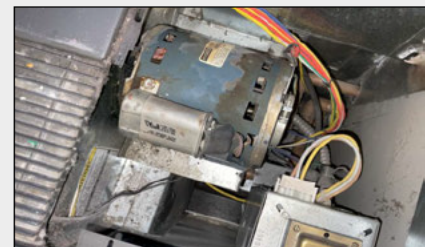
## 3. Replace or Refurbish Outdated HVAC Equipment

Generally, the assets included in this measure were installed between 1980-2001, and have reached the end of their industry recommended lifespan. Plan for replacement of these assets over the next 2-5 years to ensure the systems is functioning as designed.

- AHU-1 (FCAID-360042)
- AHU-2 (FCAID-360043)
- Gym AHU (FCAID-360047)
- RTU-2 (FCAID-360146)
- SF-1 (FCAID-360147)
- UV-54 (FCAID-360149)
- RTU-1 (FCAID-360145)
- EF-13 (FCAID-360061)
- SF-2 (FCAID-360148)
- Kitchen Hood (FCAID-360096)
- CH-1 (FCAID-360051)
- CH-2 (FCAID-360052)
- CH-2 (FCAID-360053)
- CH-4 (FCAID-360054)
- CH-4 (FCAID-360055)
- FCU-1 (FCAID-360057)
- (11) Exhaust Fans (FCAIDs vary)
- Convector (FCAID-360144)

**Priority Level:** 2  
**Estimated Cost:** \$577,850  
**Remaining Life:** 2-5 years

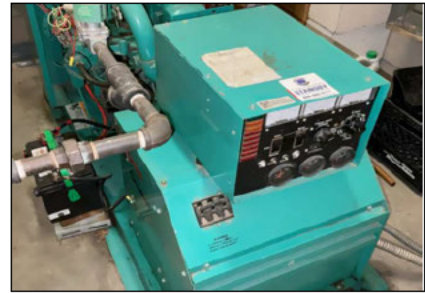
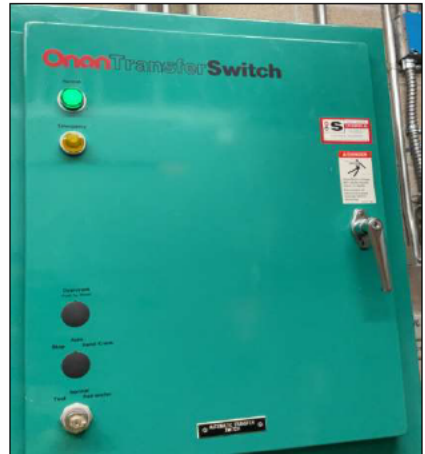
## 4. Replace the Generator

The building's backup power supply is provided by a 23 kVA generator, installed when the building was constructed circa 1986. [REDACTED]

- Backup Generator (FCAID-360151)
- ATS (FCAID-360150)

| Priority Level: | 2 |
| Estimated Cost: | \$29,050 |

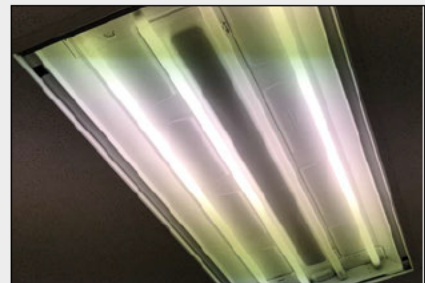
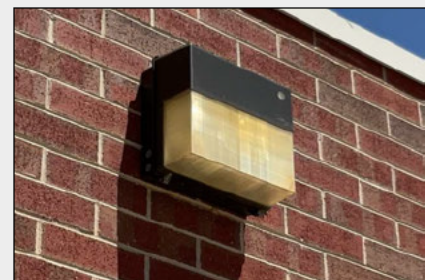
## 5. Replace Fluorescent and HID Lighting

While a portion of the building's lighting has been converted to LED, including the gymnasium and library, portions of the building still utilize fluorescent technology. Additionally, a number of exterior building-affixed lighting fixtures utilize high intensity discharge (HID) lamps. Replacing these fixtures with LED lighting will reduce energy and maintenance costs of the building.

- Interior Lighting: Fluorescent (FCAID-360156)
- Exterior Lighting, HID (FCAID-360152)

| Priority Level: | 3 |
| Estimated Cost: | \$776,770 |
