# POUDRE SCHOOL DISTRICT O'DEA ELEMENTARY SCHOOL

## FACILITY CONDITION ASSESSMENT

FORT COLLINS, CO

OCTOBER 2023

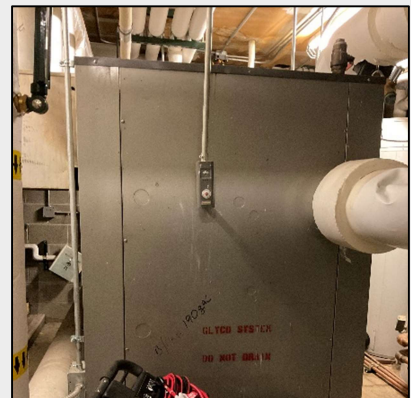
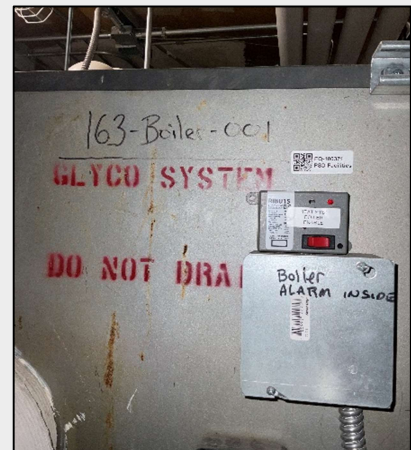
FCAID-390135

#### 1. Replace Boiler 1

The boiler B-1 was installed in 1962, [REDACTED], and has surpassed the end of its life expectancy by nearly 30 years. This boiler should be replaced within the next year.

| Priority Level: | 2 |
| Estimated Cost: | \$127,750 |

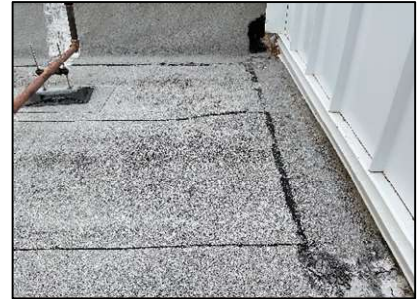
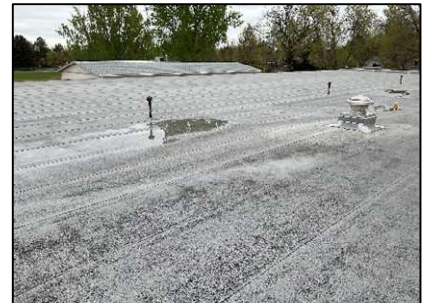
FCAID-390031

## 2. Replace Rolled Asphalt Roofing

The rolled asphalt roofing is in poor condition and is nearing the end of its industry life expectancy. A roof leak was observed in the Annex section during inspection along with lots of standing water, bubbled up areas, and visible cracks. Rolled asphalt roofing should be replaced within the next two years.

**Priority Level:** 2  
**Estimated Cost:** \$292,390  
**Remaining Life:** 2 Years

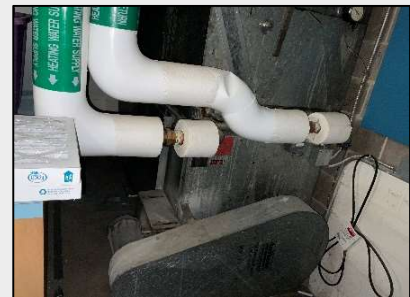
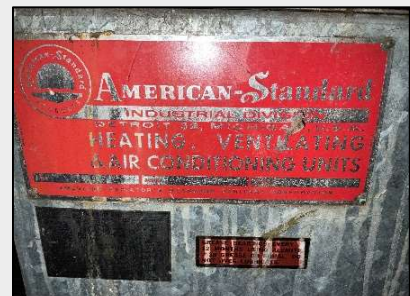
FCAID-390078

## 3. Replace AHU-1

AHU-1 was installed in 1966, [REDACTED], and has surpassed the end of its life expectancy by over 30 years. This air handling unit should be replaced within the next year.

**Priority Level:** 2  
**Estimated Cost:** \$117,170  
**Remaining Life:** 1 Year

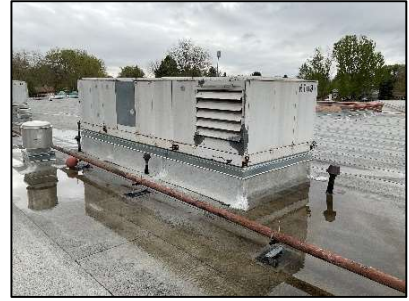
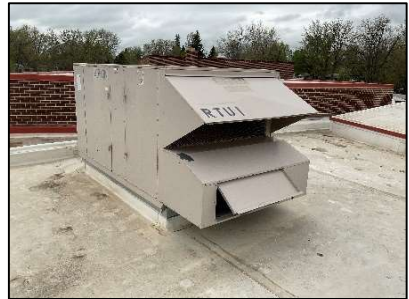
FCAID-390151, FCAID-390152, FCAID-390153

## 4. Replace Rooftop Units

The rooftop units RTU-1, RTU-3, and RTU-4, were installed in 1994, [REDACTED] and have surpassed the end of their life expectancies. These rooftop units should be replaced within the next year.

**Priority Level:** 2  
**Estimated Cost:** \$351,510  
**Remaining Life:** 1 Year

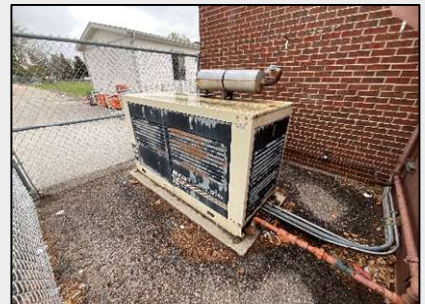
FCAID-390080

## 5. Replace Emergency Generator

The emergency is estimated to have been installed in 1994, [REDACTED] It should be replaced within the next year.

**Priority Level:** 2  
**Estimated Cost:** \$28,150  
**Remaining Life:** 1 Year
