# POUDRE SCHOOL DISTRICT OLANDER ELEMENTARY SCHOOL

## FACILITY CONDITION ASSESSMENT

FORT COLLINS, CO

OCTOBER 2023

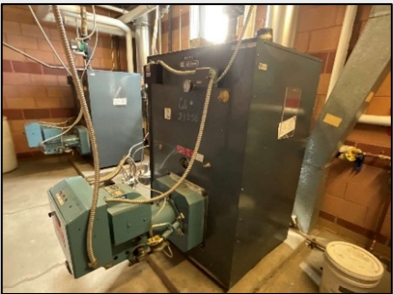
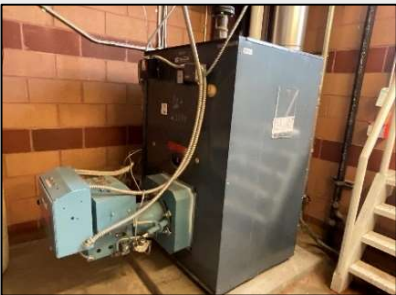
### Replace Boilers

The two existing boilers serving the school's hot water system, are nearing the end of their life expectancy and are anticipated to need replacement within the next five years.

FCAID-400038, FCAID-400039

| Priority Level: | 2 |
| Estimated Cost: | \$157,260 |

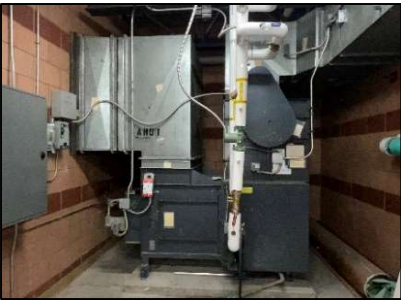
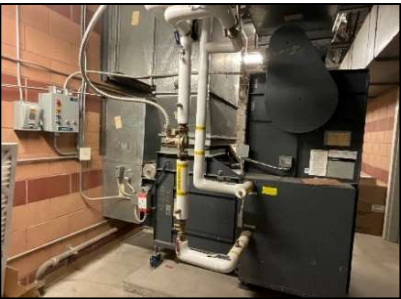
## Replace AHU-1 and AHU-2

The two air handling units in the mechanical mezzanine space, AHU-1 and AHU-2, have surpassed their industry life expectancy by nearly ten years, [REDACTED] [REDACTED] These two units should be replaced within the next three years.

FCAID-400035, FCAID-400036

**Priority Level:** 1  
**Estimated Cost:** \$195,530  
**Remaining Life:** 3 Years

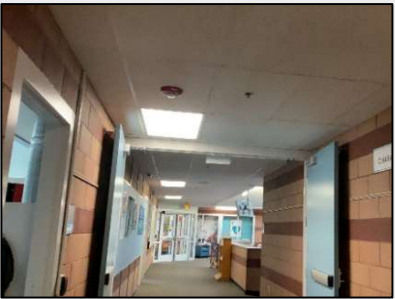
## Replace Interior Fluorescent Lighting

The interior lighting fixtures are nearing the end of their recommended lifespan. Consider upgrading the interior and exterior lighting to light emitting diode (LED) fixtures to reduce energy costs and maintenance needs.

FCAID-400131

**Priority Level:** 2  
**Estimated Cost:** \$786,690  
**Remaining Life:** 4 Years

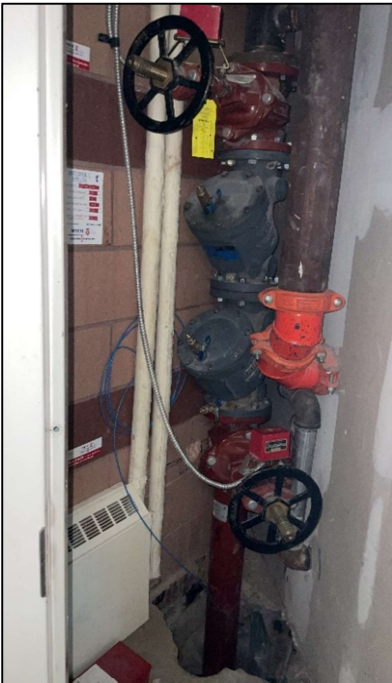
## Replace Wet Sprinkler System

The wet sprinkler system was estimated to have been installed during original construction, this would indicate that it is nearing the end of its industry life expectancy and should be replaced within the next six years.

FCAID-400128

| Priority Level: | 2 |
| Estimated Cost: | \$891,000 |

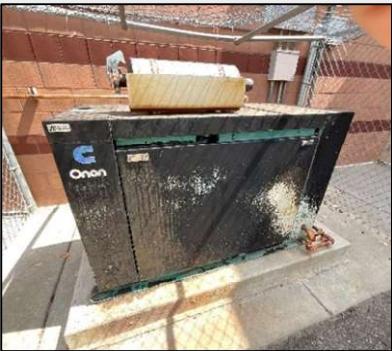
## Replace Emergency Generator

The emergency generator [REDACTED] has surpassed its industry life expectancy. This asset should be replaced within the next four years.

FCAID-400151

| Priority Level: | 2 |
| Estimated Cost: | \$28,150 |

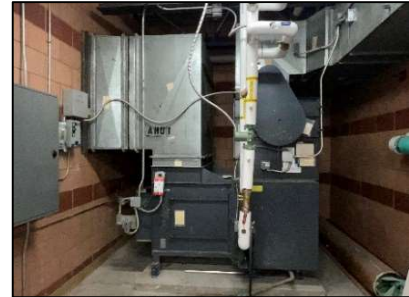
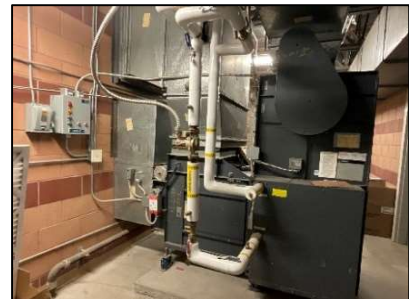
FCAID-400035, FCAID-400036

**Priority Level:** 1  
**Estimated Cost:** \$195,530  
**Remaining Life:** 3 Years

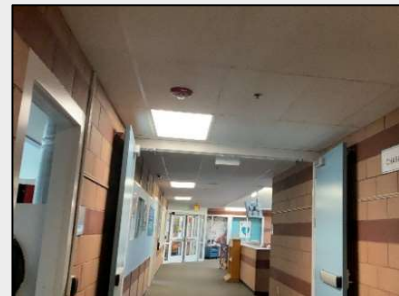
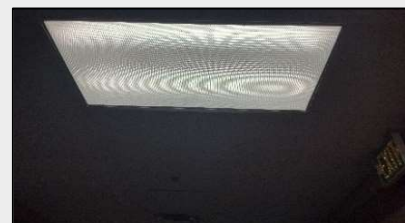
## Replace Interior Fluorescent Lighting

FCAID-400131

**Priority Level:** 2  
**Estimated Cost:** \$786,690  
**Remaining Life:** 4 Years

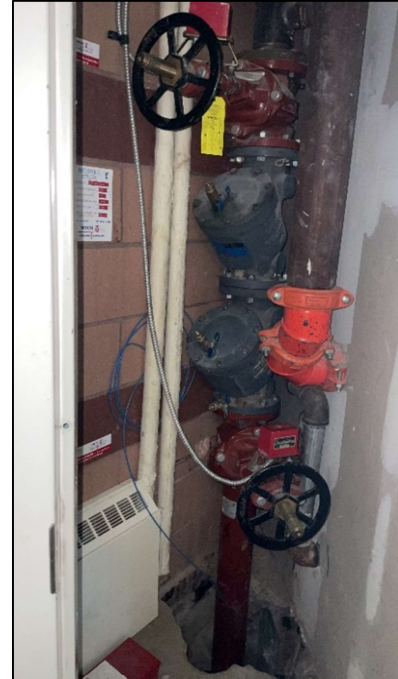
FCAID-400128

**Priority Level:** 2

**Estimated Cost:** \$891,000

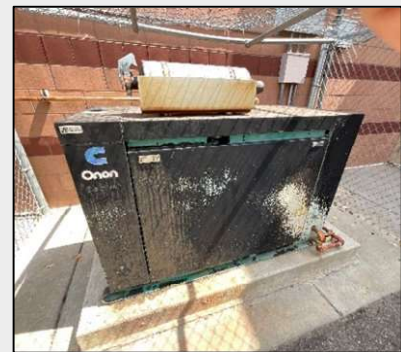
FCAID-400151

**Priority Level:** 2

**Estimated Cost:** \$28,150
