# POUDRE SCHOOL DISTRICT BEATTIE ELEMENTARY SCHOOL

## FACILITY CONDITION ASSESSMENT

FORT COLLINS, CO

OCTOBER 2023

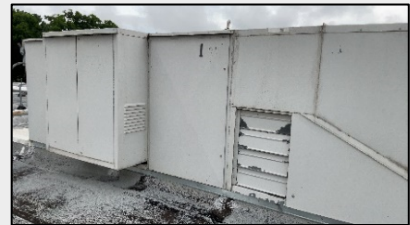
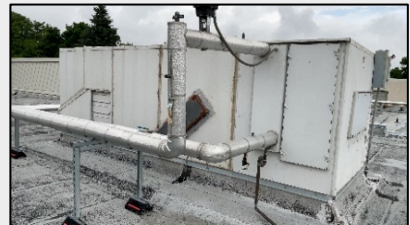
### Replace Rooftop Units

Seven of the rooftop units [REDACTED] have surpassed their life expectancies and should be replaced within the next three years.

FCAID-040094, FCAID-040095, FCAID-040096, FCAID-040097, FCAID-040098, FCAID-040099, FCAID-040100

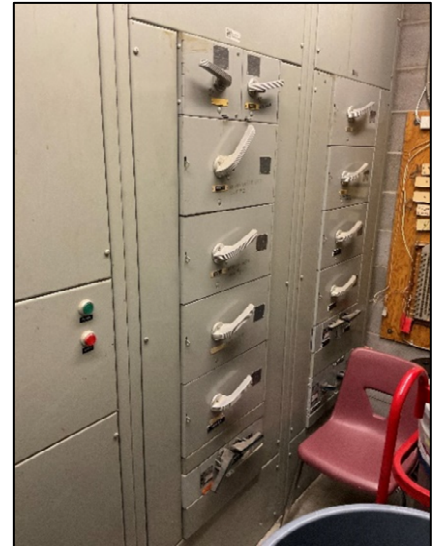
## Replace Switchboard

The three-section switchboard was installed in 1972 [REDACTED] This asset has surpassed its life expectancy by over 10 years and should be replaced within the next four years.

FCAID-040120, FCAID-040121, FCAID-040122, FCAID-040123

**Priority Level:** 2  
**Estimated Cost:** \$160,720  
**Remaining Life:** 4 years

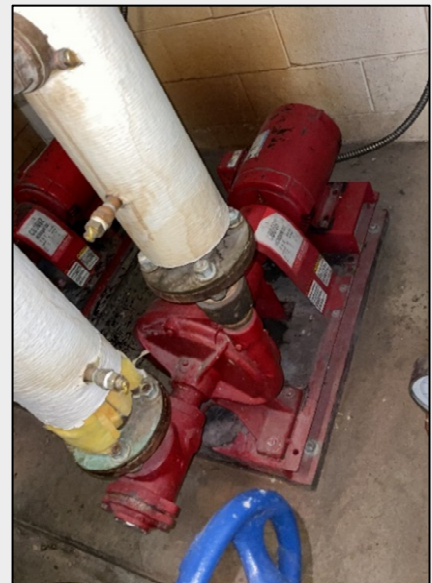
## Replace Hot Water Pumps

The two hot water pumps were installed in 1997 have surpassed their industry life expectancy and should be replaced in three years.

FCAID-040090, FCAID-040091

**Priority Level:** 2  
**Estimated Cost:** \$23,440  
**Remaining Life:** 3 years

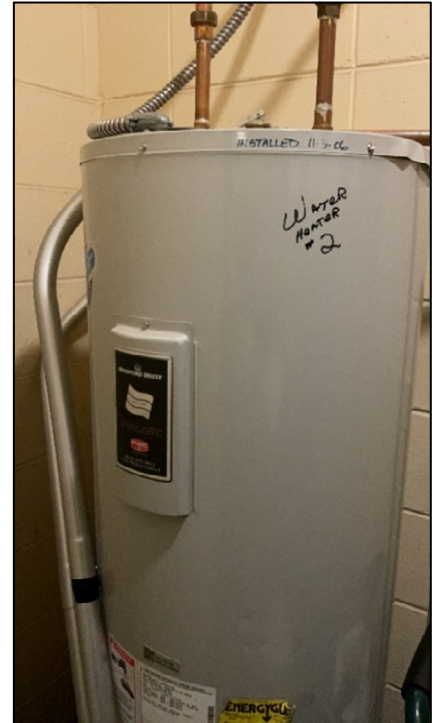
## Replace Water Heaters

The three water heaters installed before 2010 have surpassed their life expectancies and are anticipated to need replacement within the next three years.

FCAID-040056, FCAID-040057, FCAID-040058

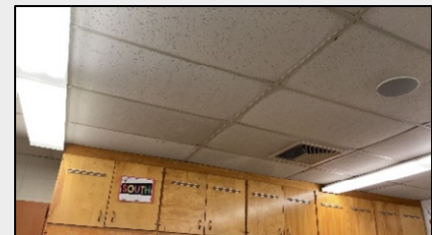
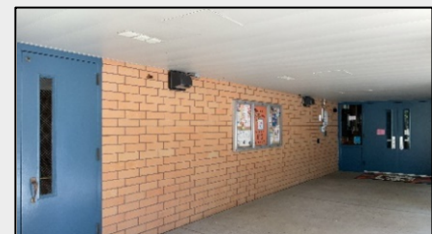
## Replace Lighting Fixtures

FCAID-040107, FCAID-040141, FCAID-040159
