# POUDRE SCHOOL DISTRICT BAUDER ELEMENTARY SCHOOL

## FACILITY CONDITION ASSESSMENT

FORT COLLINS, CO

OCTOBER 2023

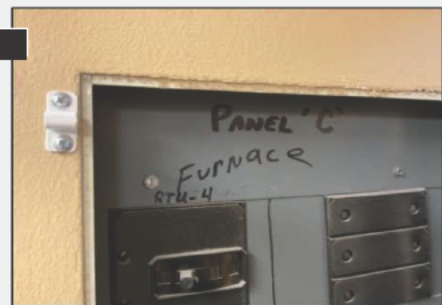
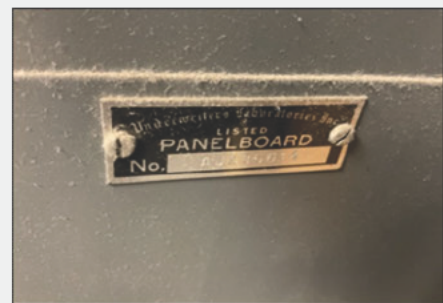
##### Replace Panel C

FCAID-03137

| Priority Level: | 1 |
| Estimated Cost: | \$4,740 |

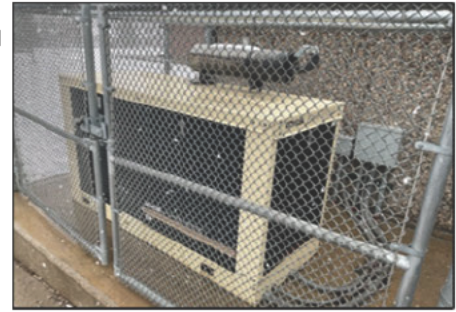
## Replace Emergency Back-Up Generator

The Generator was built in 1992 and is 11 years past expected life. Per PSD, the Total Generator Run Hours = 339.5 . Recommend replacement within three years.

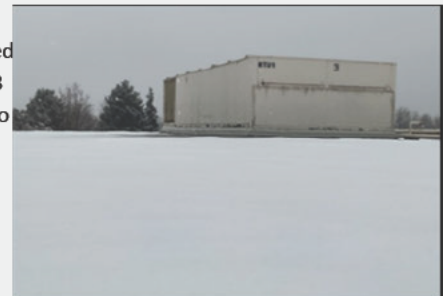
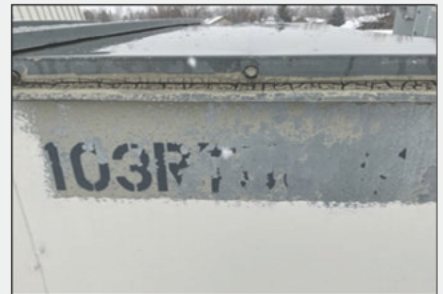
## Replace 1992 Rooftop Units

RTU-3 and RTU-103 (RTU-9) are both 1992-built Temptrol units 6 years past expected life. RTU-3 is [REDACTED], requiring replacement within the year. RTU-103 (RTU-9 in the BAS) [REDACTED] a recommended replacement within two years.

**Priority Level:** 2  
**Estimated Cost:** \$213,300  
**Remaining Life:** 1-2 Years

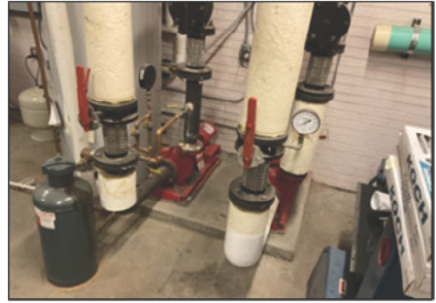
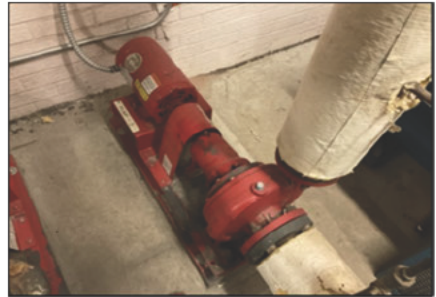
## Replace P-1 & P-2

P-1 and P-2 serve as the HWS circulation pumps. They date to 1992 and are both 11 years past expected life. [REDACTED] Recommend replacement within two years, or in 4 years when Boilers 1 and 2 are expected to require replacement.

**Priority Level:** 2  
**Estimated Cost:** \$16,600  
**Remaining Life:** 2-4 Years

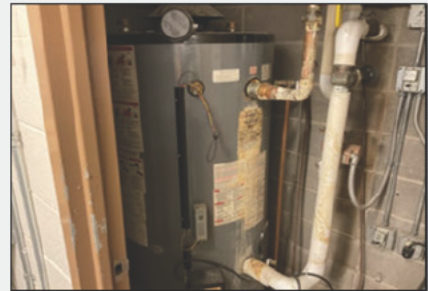
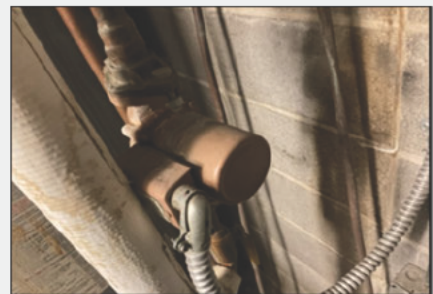
## Replace GWH-1 & DHWCP-1

GWH-1 and associated circulation pump DHWCP-1 were both observed to have leakage and corrosion. Both are recommended to be replaced within two years

**Priority Level:** 2  
**Estimated Cost:** \$15,240  
**Remaining Life:** 2 Years
