# POUDRE SCHOOL DISTRICT BENNETT ELEMENTARY SCHOOL

## FACILITY CONDITION ASSESSMENT

FORT COLLINS, CO

OCTOBER 2023

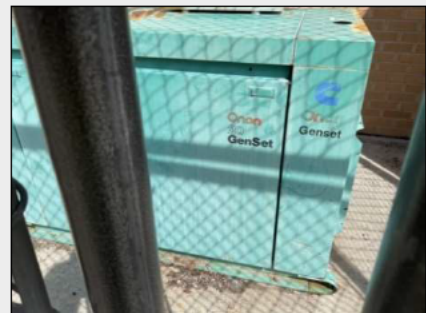
##### 1. Replace Back-Up Generator & ATS-1

The back-up generator dates to 1994 [REDACTED]  
Total Generator Run Hours = 506.5 [REDACTED]. The  
associated ATS-1 (not located) is estimated to be 50A and built in 1994 [REDACTED]  
[REDACTED]

The following assets are included within this measure:

FCAID-060153, FCAID-060184

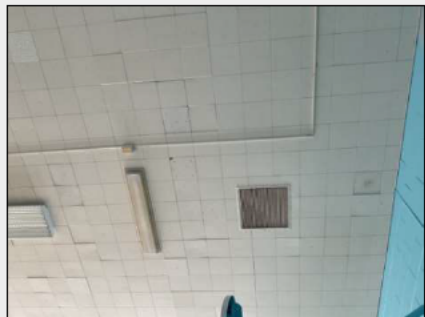
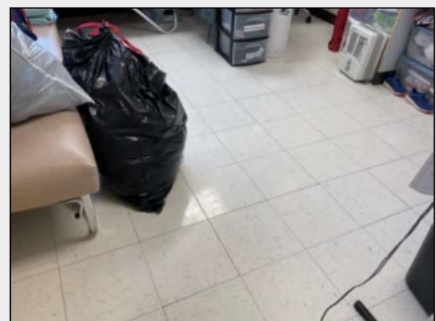
## 5. Replace carpet, acoustic tile, VCT

The building includes section of 1994 and 2002 carpeting, 1994 VCT flooring, and 1996 acoustical tile ceiling in the Gym (37 years past expected life). Recommend replacement of these dated interior finish assets in 1-2 years.

**Priority Level:** 2  
**Estimated Cost:** \$712,580  
**Remaining Life:** 1-2 Years
