# POUDRE SCHOOL DISTRICT BETHKE ELEMENTARY SCHOOL

## FACILITY CONDITION ASSESSMENT

TIMNATH, CO

OCTOBER 2023

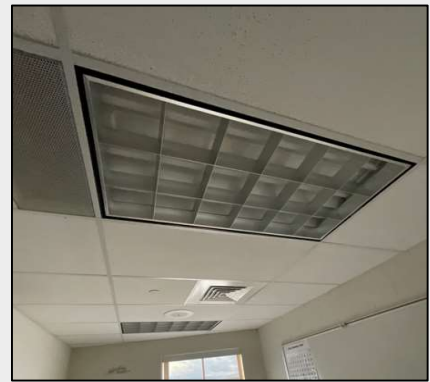
##### 1. Replace outdated Lighting

A portion of the building's interior lighting utilizes fluorescent (T8) technology. This includes the classroom spaces, corridors, and administrative areas. Consider replacing these fixtures with light emitting diode (LED) fixtures to reduce the building's energy costs and maintenance needs.

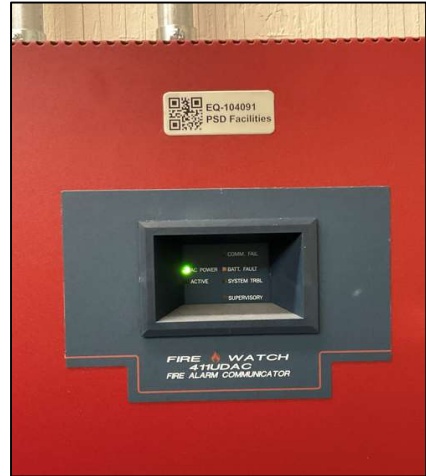
- Fire Alarm System (FCAID-70182)

**Priority Level:** 2  
**Estimated Cost:** \$439,810  
**Remaining Life:** 1 Year

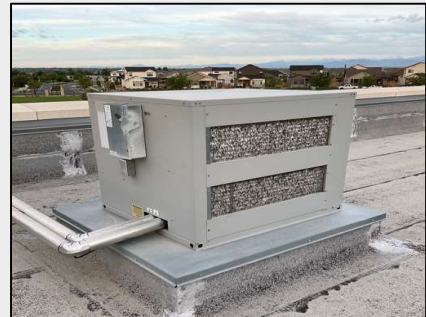
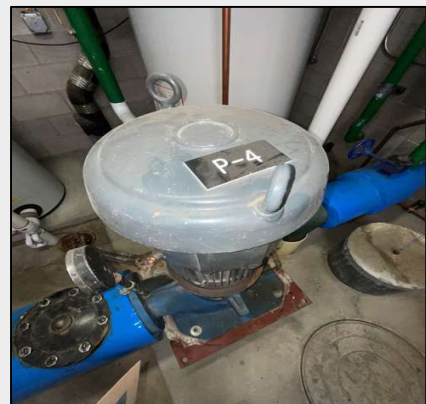
## 3. Replace outdated HVAC Units / Equipment

Multiple HVAC units are in need of replacement such as a Heat Pump, Condensing Unit, and multiple related HVAC Pumps.

- CU-1 (FCAID-70040)
- HP (FCAID-70073)
- P-1 (FCAID-70075)
- P-3 (FCAID-70037)
- P-4 (FCAID-70038)

**Priority Level:** 2  
**Estimated Cost:** \$70,880  
**Remaining Life:** 2 Years

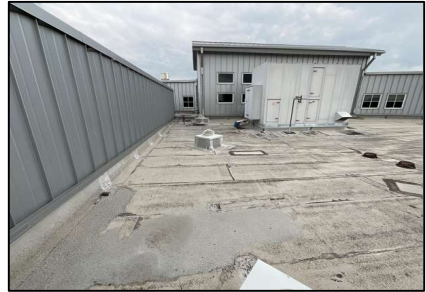
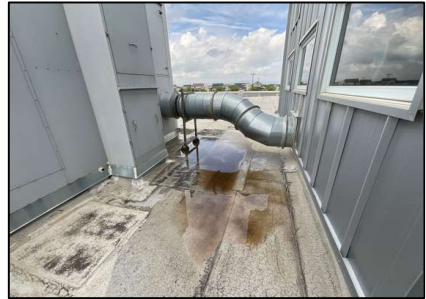
## 4. Granular Rolled Roofing / Asphalt is in poor condition

-ROOFING: ROLLED ASPHALT (FCAID-70013)

Priority Level: 2  
Estimated Cost: \$288,500  
Remaining Life: 2 Years

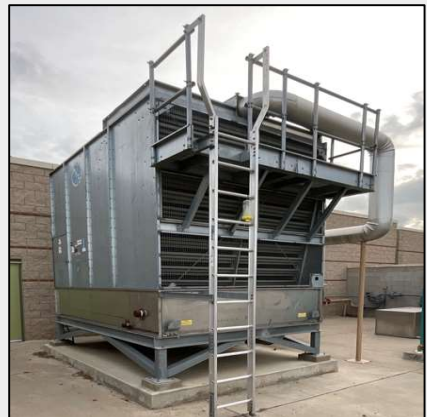
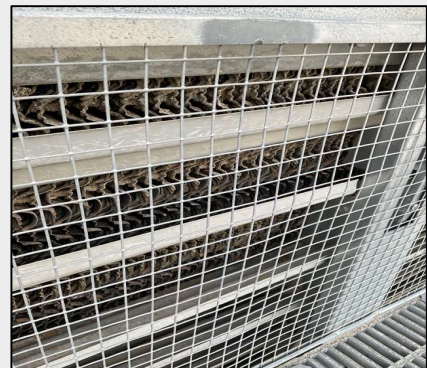
## 5. Replace outdated Cooling Tower

-CT-1 (FCAID-70041)

Priority Level: 3  
Estimated Cost: \$161,090  
Remaining Life: 3 Years
