# POUDRE SCHOOL DISTRICT BAMFORD ELEMENTARY SCHOOL

## FACILITY CONDITION ASSESSMENT

LOVELAND, CO

OCTOBER 2023

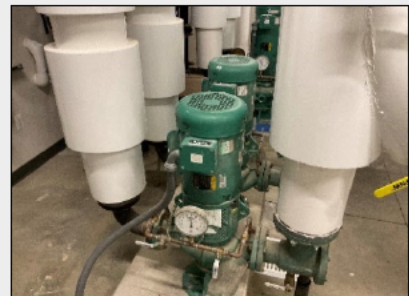
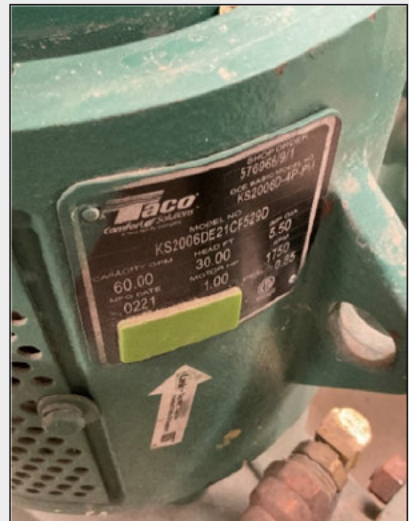
It was observed that several pumps that were installed to serve the ground source loop varied from the sizing originally intended per design and specifications. This is a top issue at Bamford Elementary School as these sizing discrepancies could present issues in the proper functioning of the ground source loop system.

FCAID-020044, FCAID-020045, FCAID-020046, FCAID-020047, FCAID-020051, FCAID-020052, FCAID-020053, FCAID-020054

| Priority Level: | 2 |

| Estimated Cost: | \$104,360 |

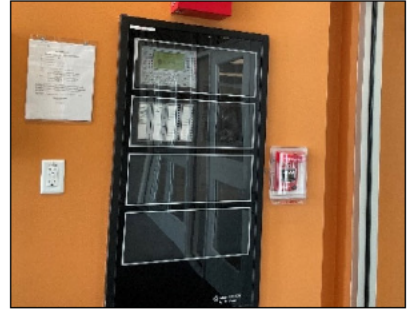
## Replace Fire Alarm System

The fire alarm system was installed when Bamford Elementary School was built in 2022, however, given that it is a high-priority asset with a shorter industry life expectancy it is a top issue that will need to be replaced sooner than other equipment at the school.

FCAID-020190

| <b>Priority Level:</b> | 3 |

| <b>Estimated Cost:</b> | \$584,250 |
