POUDRE SCHOOL  
DISTRICT

CACHE LA POUDRE  
ELEMENTARY  
SCHOOL

FACILITY CONDITION ASSESSMENT

OCTOBER 2023

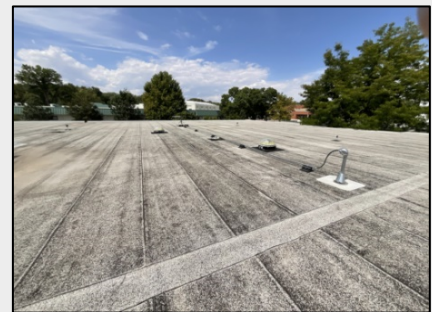
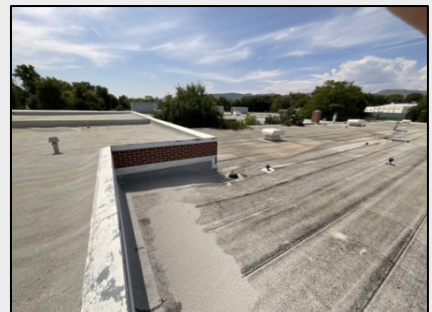
##### Replace Rolled Asphalt Roof

[REDACTED] Recommend replacement within the year.

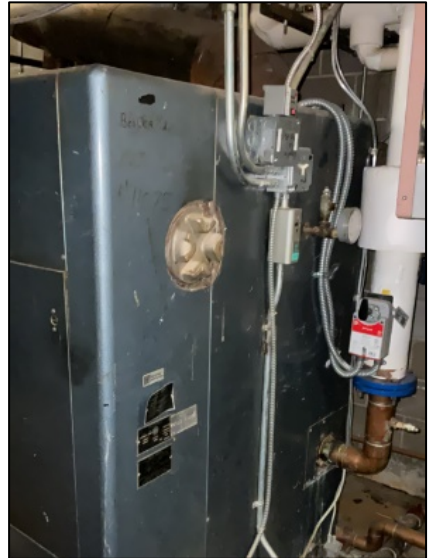
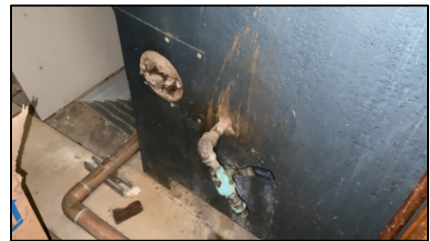
## Replace Boiler-2

Boiler-2, a 1,080 MBH fuel-fired boiler, dates to 1973 install and is 15 years past expected life. Recommend replacement prior to 2024-2025 heating season.

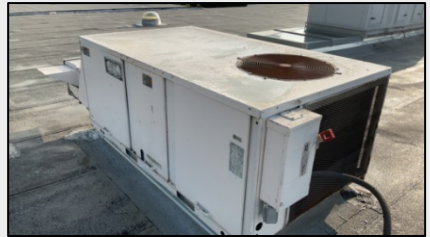
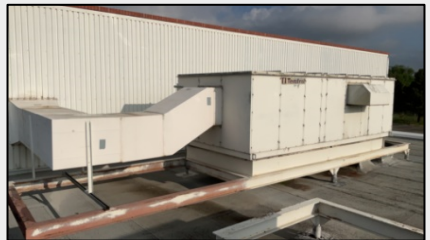
## Replace RTU-6 & RTU-4

Both RTU-6 and RTU-4 were installed in 1993. Recommend that RTU-6 be replaced within the year and RTU-4 be replaced within two years.

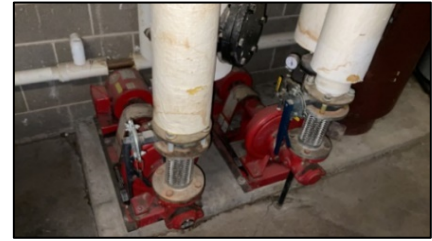
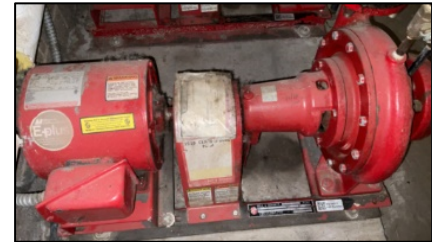
## Replace P-1 & P-2

P-1 and P-2, 3 Hp pumps serving the Heating Water System, [REDACTED] and are estimated to require replacement within two years.

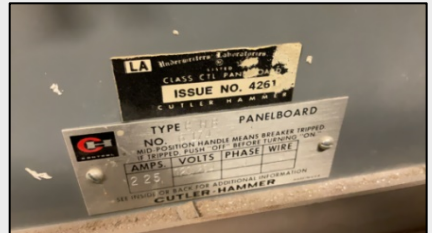
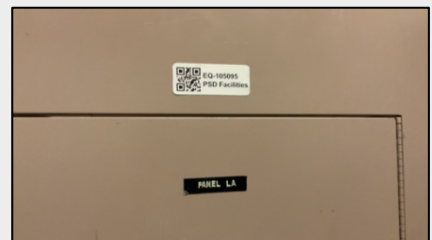
## Replace Panel -LA

[REDACTED] Replace within two years.
