# POUDRE SCHOOL DISTRICT DUNN ELEMENTARY SCHOOL

## FACILITY CONDITION ASSESSMENT

FORT COLLINS, CO

OCTOBER 2023

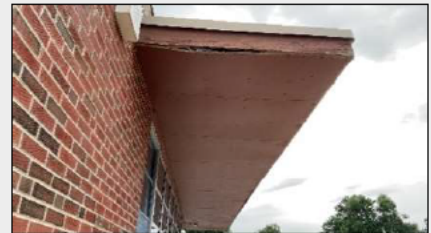
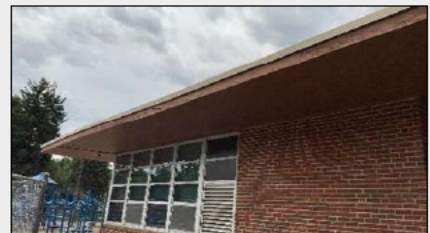
##### Replace Wood Soffit

The wood soffit [REDACTED] should be replaced within the next year.

FCAID-170006

| Priority Level: | 2 |
| Estimated Cost: | \$5,120 |

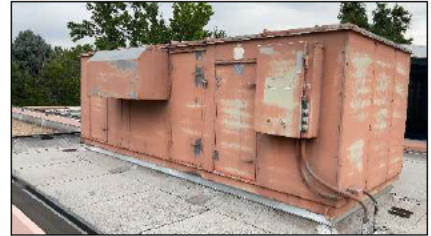
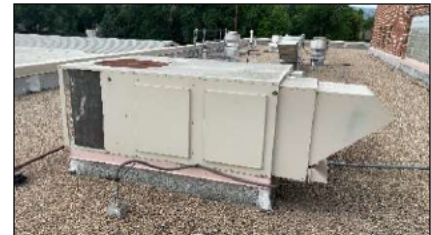
## Replace RTU-1 and RTU-2

RTU-1 and RTU-2, which serve various classrooms and the administration area, have surpassed their life expectancies by over 15 years [REDACTED] should be replaced within the next two years.

FCAID-170122, FCAID-170123

**Priority Level:** 2  
**Estimated Cost:** \$158,380  
**Remaining Life:** 2 years

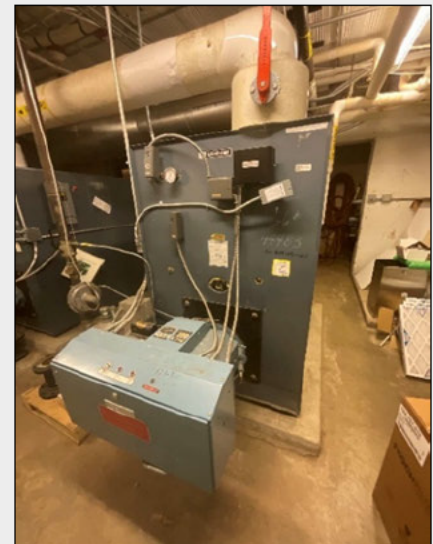
## Replace Boilers

The two boilers in serving the hot water system at Dunn Elementary School, are nearing the end of their life expectancy and are anticipated to need replacement within the next four years.

FCAID-170110, FCAID-170111

**Priority Level:** 2  
**Estimated Cost:** \$231,160  
**Remaining Life:** 4 years

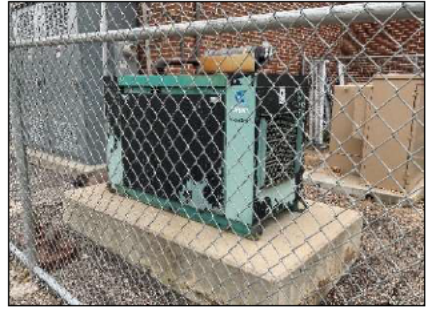
## Replace Emergency Generator

The emergency generator has surpassed its industry life expectancy and [REDACTED] [REDACTED] It is recommended the the generator be replaced within the next three years.

FCAID-170143

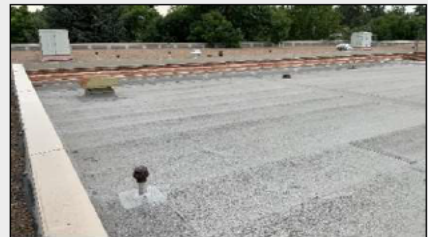
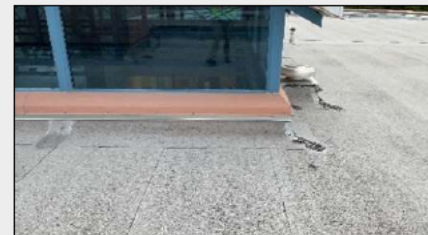
## Replace 2006 Asphalt Roofing

The area of roof with rolled asphalt installed in 2006 is [REDACTED] nearing the end of its life expectancy. This roofing is anticipated to need replacement within the next two years.

FCAID-170029

| Priority Level: | 2 |
| Estimated Cost: | \$26,780 |
