POUDRE SCHOOL  
DISTRICT  
EYESTONE  
ELEMENTARY  
SCHOOL SOUTH

FACILITY CONDITION ASSESSMENT

WELLINGTON, CO

OCTOBER 2023

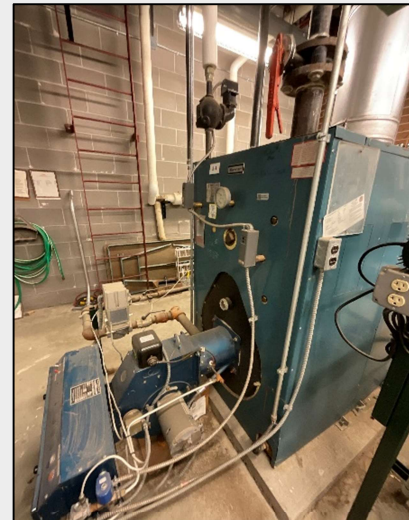
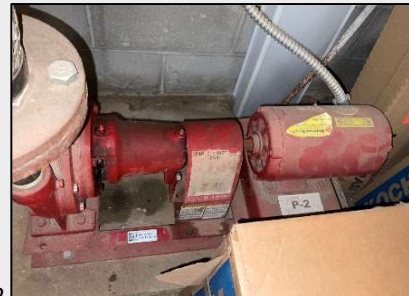
##### Replace Boilers and Hot Water Pumps

[REDACTED]. Additionally, hot water pumps P-1 and P-2 should be replaced within the next year [REDACTED]

Priority Level: 2

Estimated Cost: \$198,630

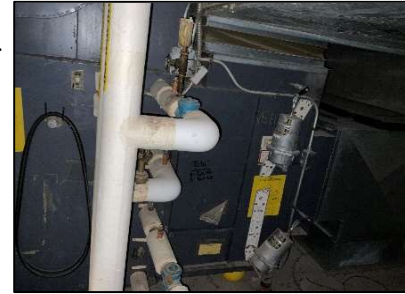
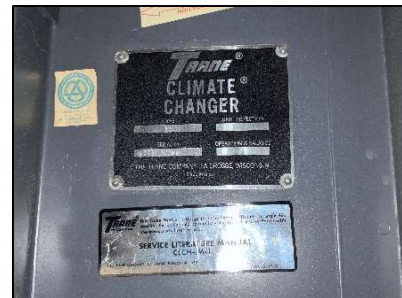
## Replace Air Handling Units

The three air handling units serving the locker rooms and gym [REDACTED]. These units are estimated to have surpassed their industry life expectancies. It is recommended that these three units be replaced within the next two years.

**Priority Level:** 2  
**Estimated Cost:** \$533,260  
**Remaining Life:** 2 years

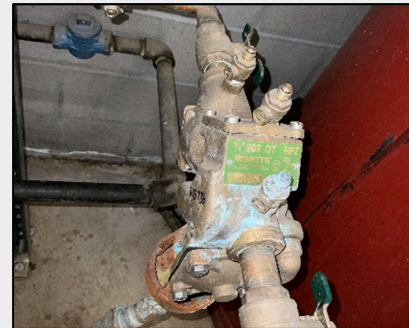
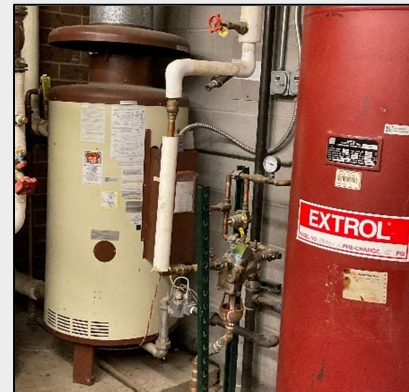
## Replace Plumbing System Components

The gas water heater installed in 1993 has surpassed its life expectancy and is anticipated to need replacement within the next year. The backflow preventer and mixing valve both installed in 1993 [REDACTED] they should both be replaced within the next year.

**Priority Level:** 2  
**Estimated Cost:** \$30,390  
**Remaining Life:** 1 year

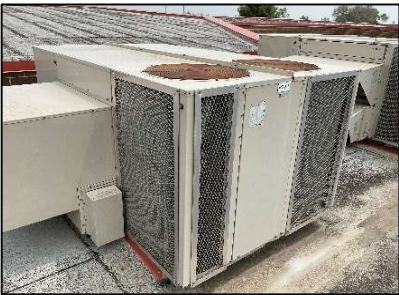
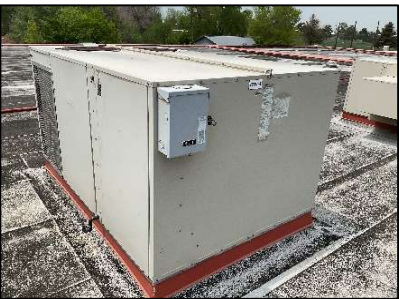
## Replace Rooftop Units

The nine rooftop units installed in 1993, serving various areas including classrooms, labs, media center, and the multipurpose room, [REDACTED] These units have surpassed their industry life expectancies by approximately 15 years [REDACTED] [REDACTED]. It is recommended that these nine units be replaced within the next two years.

Priority Level: 2  
Estimated Cost: \$438,360  
Remaining Life: 2 year
