# POUDRE SCHOOL DISTRICT EYESTONE ELEMENTARY SCHOOL NORTH

## FACILITY CONDITION ASSESSMENT

WELLINGTON, CO

OCTOBER 2023

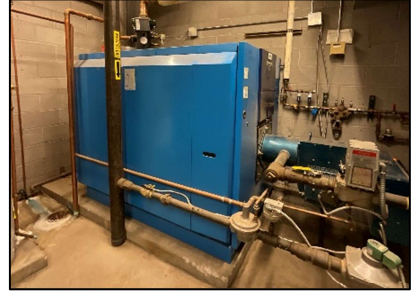
## Replace Boilers

The boilers were installed in 1988 and 1990 [REDACTED]. They are anticipated to need replacement within the next two years.

**Priority Level:** 2  
**Estimated Cost:** \$197,380  
**Remaining Life:** 2 years

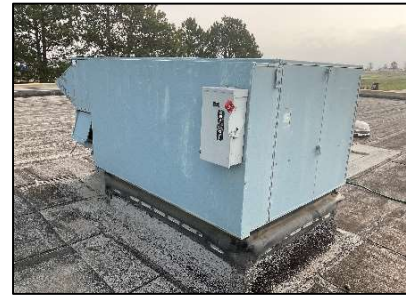
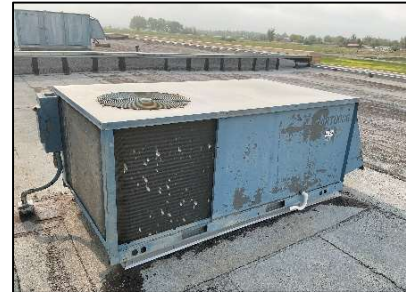
## Replace Rooftop Units

Five of the rooftop units, serving various classrooms and the gym, [REDACTED]  
[REDACTED] These units have surpassed their industry life expectancies. It is recommended that these five units be replaced within the next two years.

**Priority Level:** 2  
**Estimated Cost:** \$258,640  
**Remaining Life:** 2 years

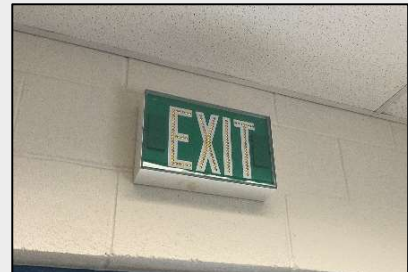
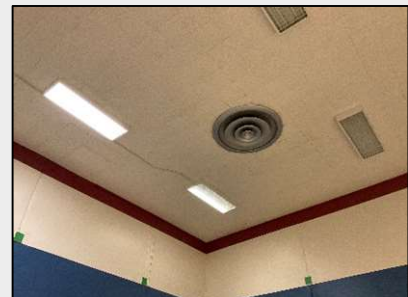
## Replace Various Lighting Fixtures

[REDACTED]  
[REDACTED] Interior lighting consists of fluorescent fixtures. Exterior lighting is made up of a mixture of fluorescent and LED lights. Consider upgrading the fluorescent interior and exterior lighting to light emitting diode (LED) fixtures to reduce energy costs and maintenance needs.

**Priority Level:** 2  
**Estimated Cost:** \$1,241,990  
**Remaining Life:** 2 years
