# POUDRE SCHOOL DISTRICT HARRIS BILINGUAL ES

## FACILITY CONDITION ASSESSMENT

FORT COLLINS, CO

MARCH 2023

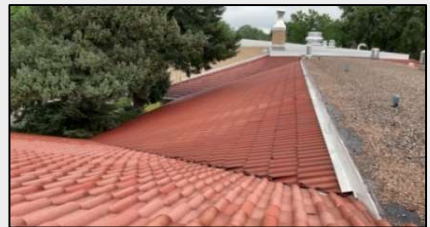
##### Red Clay Tile Roofing

3,500 SF of red clay tile roofing was replaced in 2002. This type of roofing has a 50 year expected useful life per BOMA. This roof has approximately 29 years of remaining life at present. No deficiencies or repairs were noted during the FCA inspection. This is not a "Top Deficiency Issue", it is listed at #1 due to PSD's request to determine whether additional assessment is required. In McKinstry's opinion an additional assessment of this roof is not required at present.

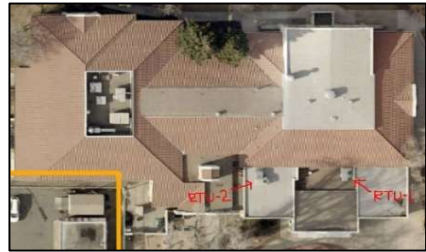
## Replace RTU-1 and RTU-2

RTUs 1 (served Administration Area) & 2 (serves Admin & Classrooms) are seven years and ten years past expected useful life respectively. They are both expected to require replacement within the next two years. [REDACTED]

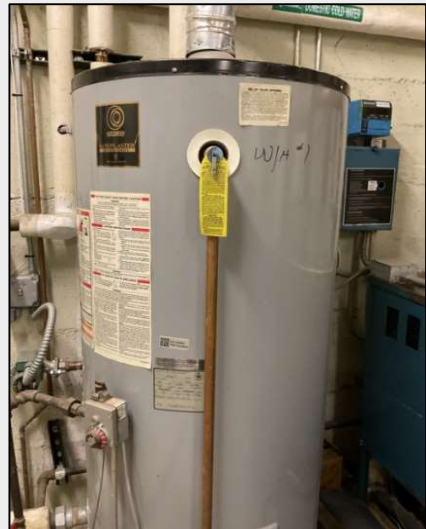
## Replace WH-1

WH-1 (75 Gal, 75MBH) was installed in 2001, and is therefore 12 years past expected useful life. Anticipate replacement within the next two years.

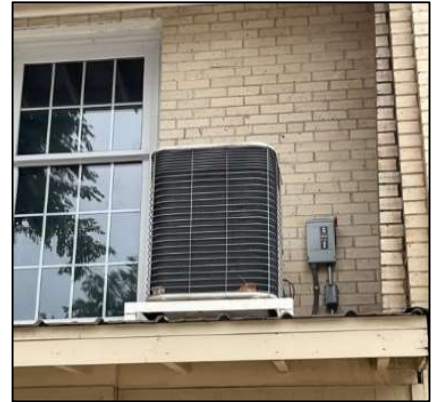
CU-1 (serving F-1), and CU-Walk-in Cooler/Freezer (serving the kitchen walk-in cooler and freezer) were installed 2001-2002. Therefore, they are 7 and 6 years past expected useful life at present. Expect to replace these condensing units within two years.

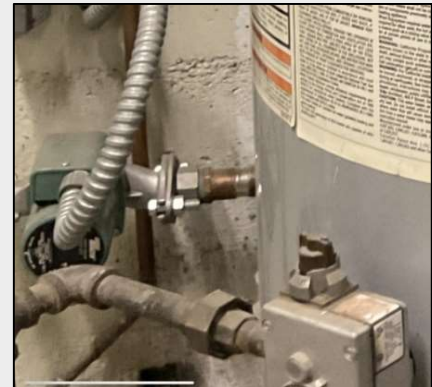
## Replace CP-1

CP-1 (1/25 Hp) serves WH-1 and is two years past expected useful life. Recommend replacing this pump at the same time that WH-1 is replaced in two years.
