# POUDRE SCHOOL DISTRICT LIVERMORE ELEMENTARY SCHOOL

## FACILITY CONDITION ASSESSMENT

LIVERMORE, CO

OCTOBER 2023

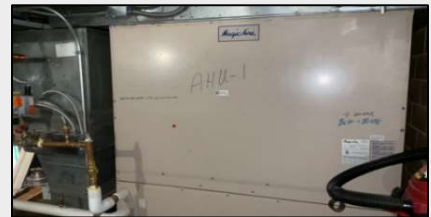
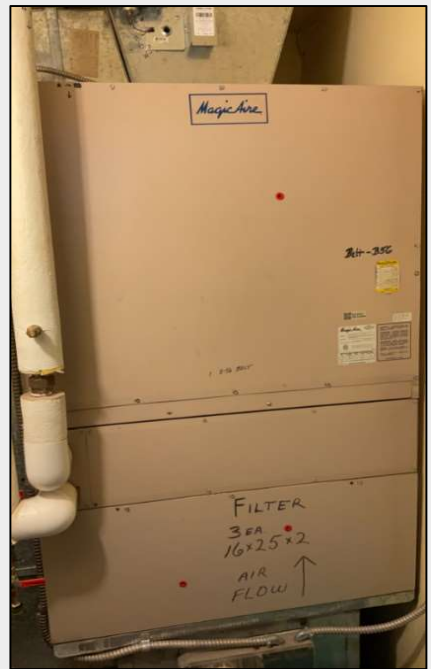
##### Replace AHU-1, AHU-2, & AHU-3

AHU-1, AHU-2, and AHU-3 are 1993-built AHUs in poor condition. These are Magic Aire Fan Coil Units labeled as AHUs. These include pneumatic valves and dampers and are 5 years past expected life. [REDACTED]

FCAID-350044 through FCAID-350046

| Priority Level: | 2 |
| Estimated Cost: | \$117,320 |

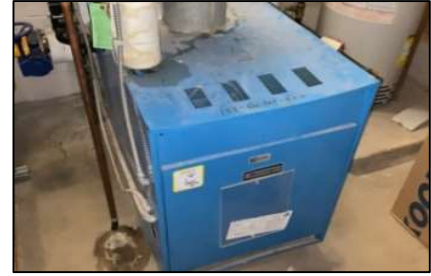
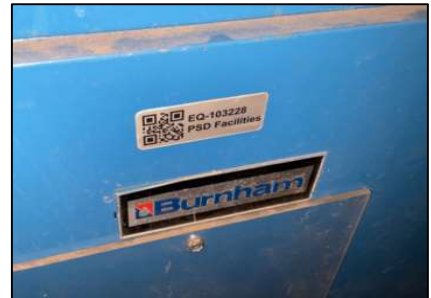
## Replace Boiler-2

Though Boiler-1 was replaced in 2015, Boiler-2 dates to 1983 and is 5 years past expected life. [REDACTED]

FCAID-350055

**Priority Level:** 2  
**Estimated Cost:** \$37,000  
**Remaining Life:** 2 years

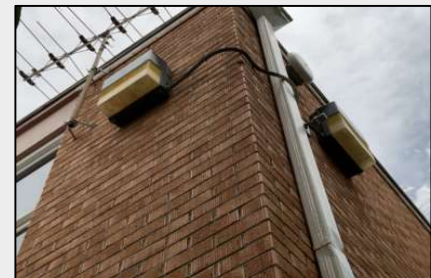
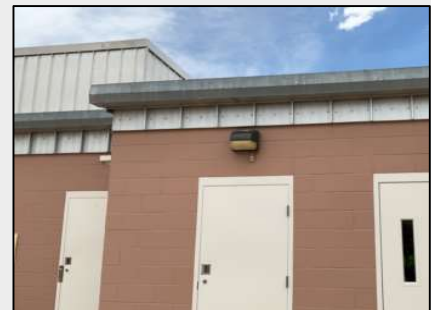
## Replace (6) Incandescent Exterior Wall Packs

Six exterior incandescent wall packs date to 1993 and are 10 years past expected life. Recommend upgrading to LED fixtures within two years.

FCAID-350064

**Priority Level:** 2  
**Estimated Cost:** \$3,640  
**Remaining Life:** 1 year
