# POUDRE SCHOOL DISTRICT LINTON ELEMENTARY SCHOOL

## FACILITY CONDITION ASSESSMENT

FORT COLLINS, CO

OCTOBER 2023

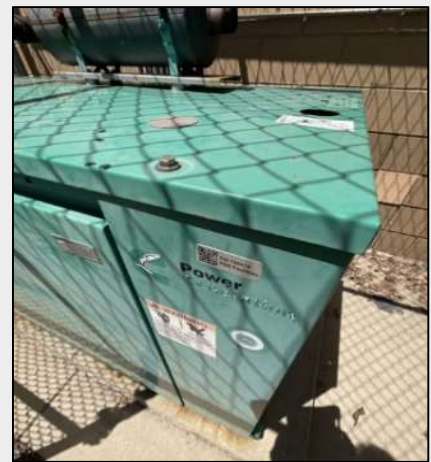
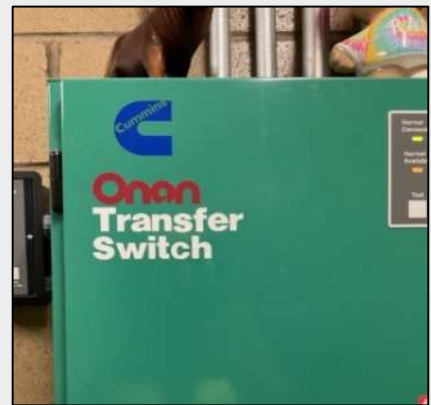
##### Replace Back-Up Generator & ATS-1

FCAID-340111, FCAID-340110

[REDACTED] Recommend replacement of both assets at the same time.

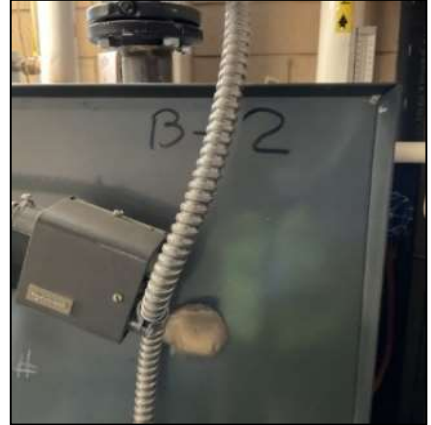
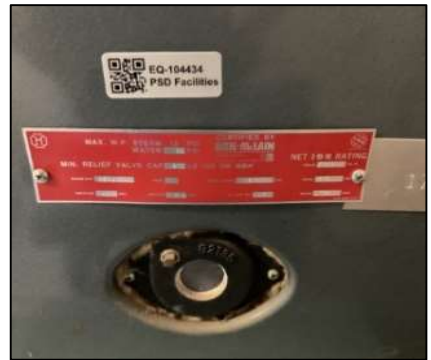
## Replace Boiler-2

Though Boiler-1 was replaced in 2020 and is in good condition, [REDACTED] Recommend replacement prior to 2024-2025 heating season.

FCAID-340074

Priority Level: 2  
Estimated Cost: \$78,630  
Remaining Life: 1 year

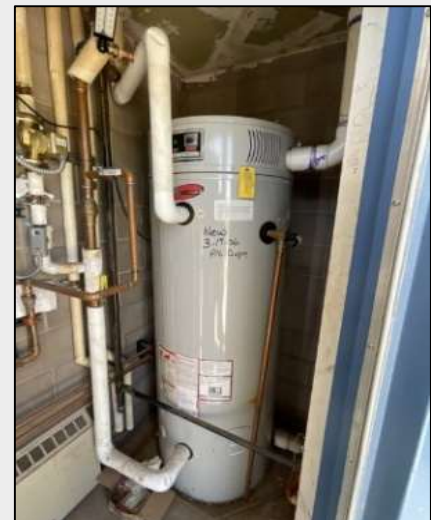
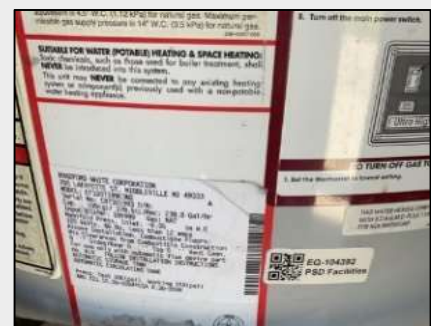
## Replace (3) GWHs

GWH-1, GWH-2, and GWH-3 date to between 2003 and 2005 and are expected to require replacement in approximately 2 years.

FCAID-340028, FCAID-340029, FCAID-340030

Priority Level: 2  
Estimated Cost: \$28,950  
Remaining Life: 2 years

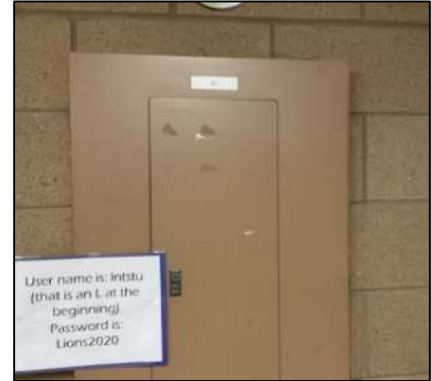
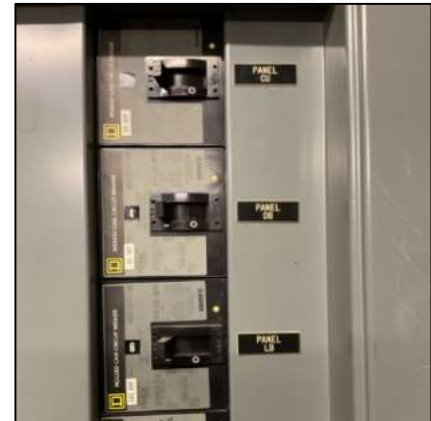
## Replace 1988 Electrical Assets

Though not an immediate concern, there exist (12) panelboards, a switchboard, and the pad transformer that date to 1988. These assets are expected to require replacement in approximately 5 years and will represent a substantial Replacement Cost at that time. Item added for Capital Planning.

FCAID-340130, FCAID-340134, FCAID-340117 through FCAID-340128,

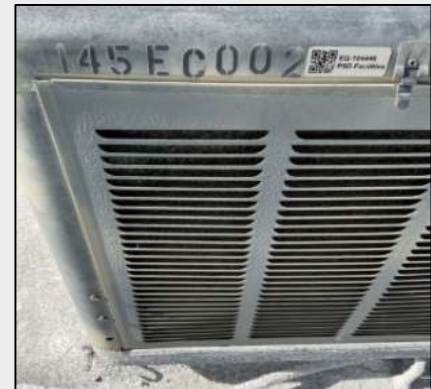
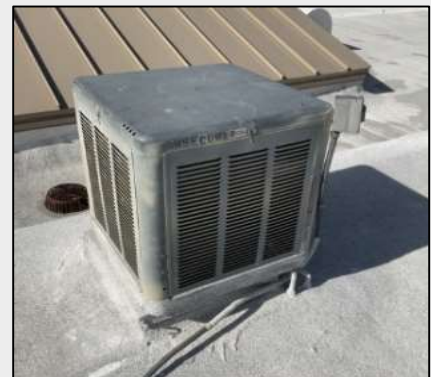
## Replace EC-1

EC-1 (145EC002 Evap Cooler) is 10 years past expected useful life [REDACTED]. Recommend replacement in 1-2 years.

FCAID-340043
