POUDRE SCHOOL  
DISTRICT  
JOHNSON  
ELEMENTARY  
SCHOOL

**FACILITY CONDITION ASSESSMENT**

FORT COLLINS, CO

OCTOBER 2023

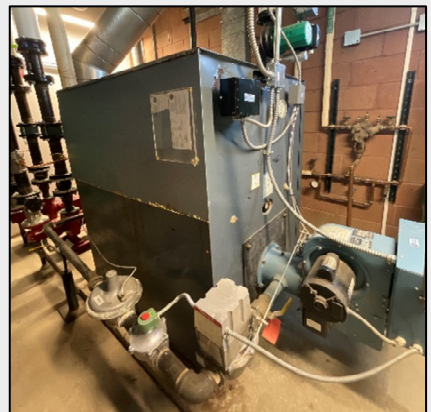
##### Replace Boilers

The two boilers serving the school's hot water system have reached the end of their life expectancy. They are [REDACTED] anticipated to need replacement within the next five years.

FCAID-270078, FCAID-270079

| Priority Level: | 2 |
| Estimated Cost: | \$182,030 |

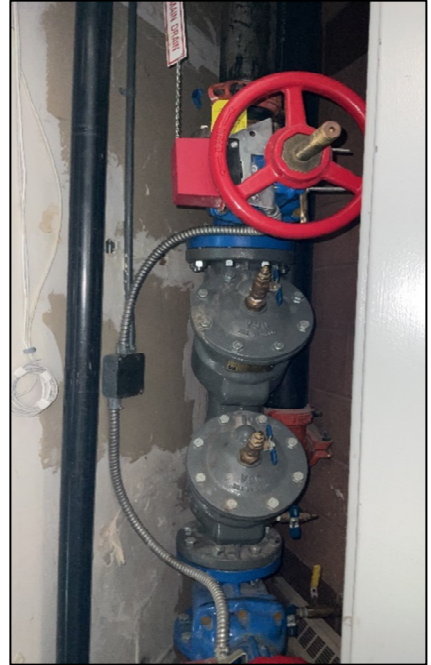
## Replace Wet Sprinkler System

FCAID-270132

**Priority Level:** 1  
**Estimated Cost:** \$977,910  
**Remaining Life:** 4

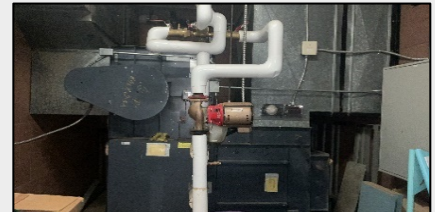
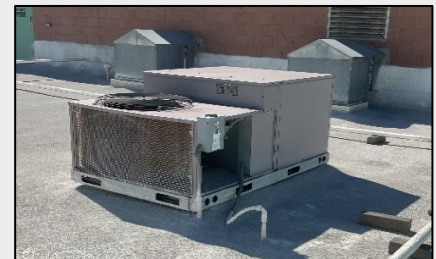
## Replace Air Handling and Rooftop Units

The two air handling units in the mezzanine, along with RTU-3, have surpassed their industry life expectancies [REDACTED]. These three units should be replaced within the next 2-3 years.

FCAID-270037, FCAID-270038, FCAID-270126

**Priority Level:** 2  
**Estimated Cost:** \$228,420  
**Remaining Life:** 2-3 years

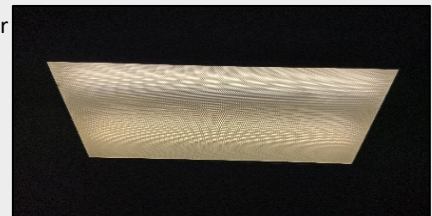
## Replace Fluorescent Lighting Fixtures

Interior lighting consists of mostly fluorescent fixtures. Consider upgrading the interior and exterior lighting to light emitting diode (LED) fixtures to reduce energy costs and maintenance needs.

FCAID-270138
