# POUDRE SCHOOL DISTRICT KRUSE ELEMENTARY SCHOOL

## FACILITY CONDITION ASSESSMENT

FORT COLLINS, CO

OCTOBER 2023

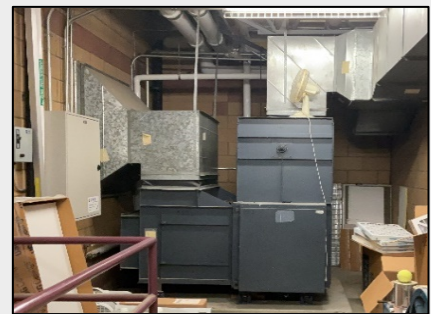
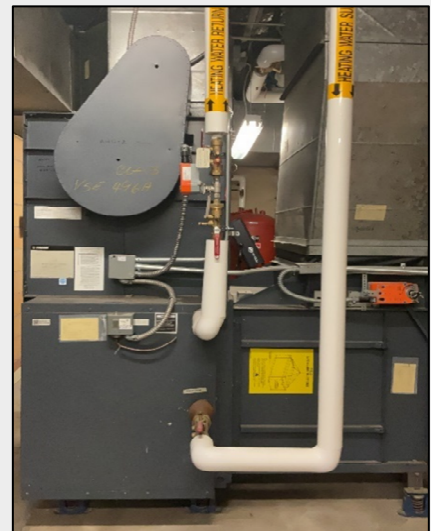
##### Replace Air Handling Units

The two air handling units in the mezzanine have surpassed their industry life expectancies [REDACTED]. These three units should be replaced within the next three years.

FCAID-290035, FCAID-290036

| Priority Level: | 2 |
| Estimated Cost: | \$193,040 |

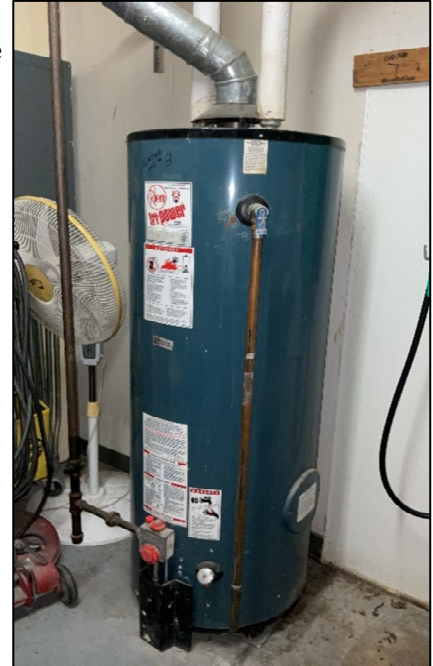
## Replace Water Heaters

The three water heaters installed in 1992 and 2002 have surpassed their life expectancy, [REDACTED], and are anticipated to need replacement within the next two years.

FCAID-290031, FCAID-290033, FCAID-290034

**Priority Level:** 2  
**Estimated Cost:** \$28,950  
**Remaining Life:** 2 years

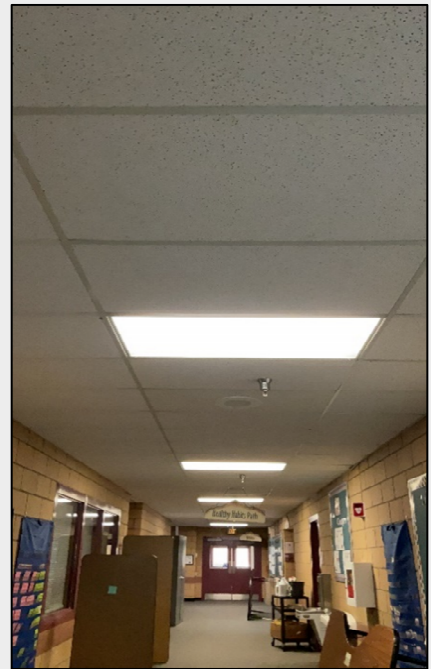
## Replace Fluorescent Lighting Fixtures

FCAID-290130

**Priority Level:** 2  
**Estimated Cost:** \$786,690  
**Remaining Life:** 4 years

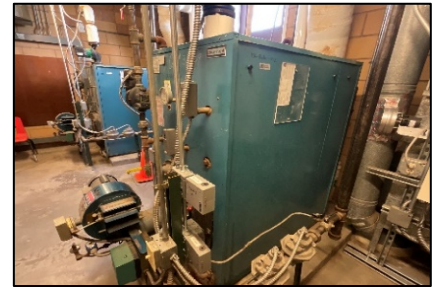
## Replace Boilers

The two boilers serving the school's hot water system are nearing the end of their life expectancy. They are [REDACTED] anticipated to need replacement within the next five years.

FCAID-290087, FCAID-290088
