# POUDRE SCHOOL DISTRICT LAUREL ELEMENTARY SCHOOL

## FACILITY CONDITION ASSESSMENT

FORT COLLINS, CO

OCTOBER 2023

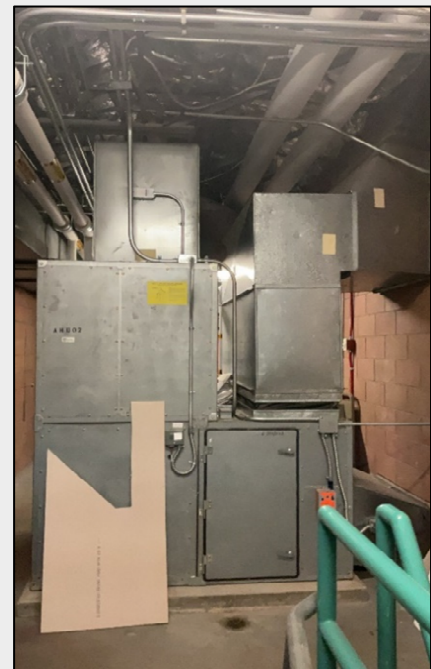
### Replace Air Handling Units

The two air handling units in the mezzanine have surpassed their industry life expectancies [REDACTED]. These three units should be replaced within the next five years.

FCAID-310034, FCAID-310035

| Priority Level: | 2 |
| Estimated Cost: | \$193,040 |

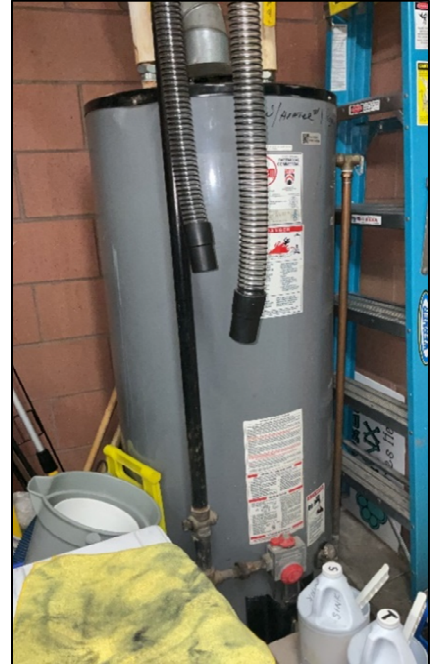
## Replace Water Heaters

The two water heaters installed during original construction in 1993 have surpassed their life expectancy, are in poor condition, and are anticipated to need replacement within the next two years.

FCAID-310030, FCAID-310032

| <b>Priority Level:</b> | 2 |
| <b>Estimated Cost:</b> | \$19,300 |

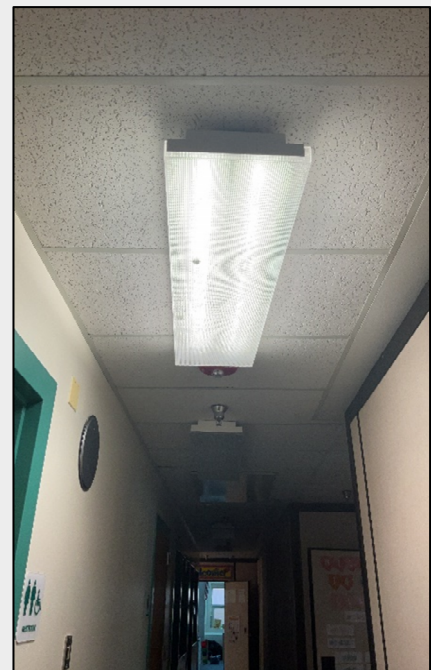
## Replace Fluorescent Lighting Fixtures

FCAID-310136

| <b>Priority Level:</b> | 2 |
| <b>Estimated Cost:</b> | \$786,690 |

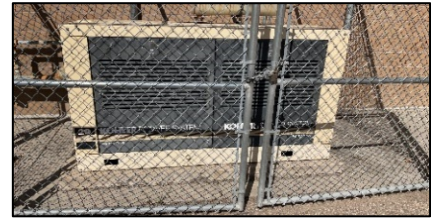
## Replace Emergency Generator

The emergency generator is [REDACTED]  
[REDACTED] anticipated to need replacement within the next four years.

FCAID-310135
