# POUDRE SCHOOL DISTRICT

## IRISH ELEMENTARY SCHOOL

### FACILITY CONDITION ASSESSMENT

FORT COLLINS, CO

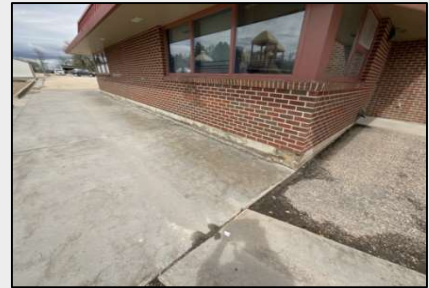
##### Slab Foundation Repair

Out of scope item (Foundation). The West Central 1989 exterior was observed to have [REDACTED] concrete slab spalling. Recommend immediate repair to this 25' section to prevent further water/weather damage.

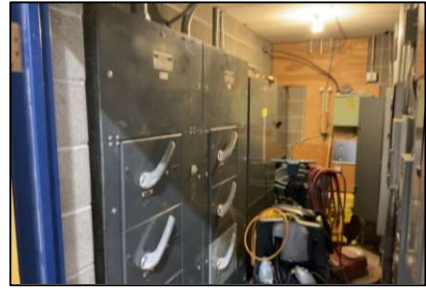
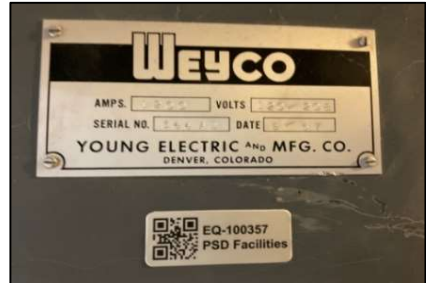
## Replace 1968 Switchboard & Panelboards

[REDACTED]  
[REDACTED]  
[REDACTED]

**Priority Level:** 1  
**Estimated Cost:** \$131,820  
**Remaining Life:** 1 Year

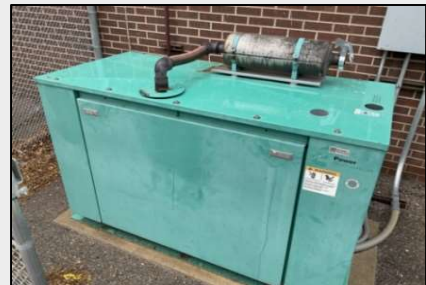
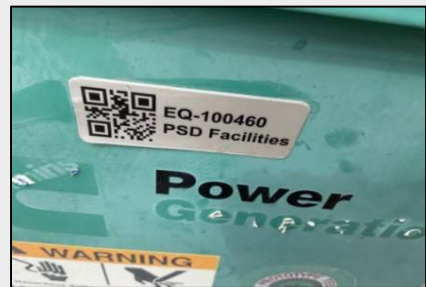
## Replace Back-Up Generator

[REDACTED]  
[REDACTED] The associated

ATS was replaced in 2014 and does not require replacement.

**Priority Level:** 1  
**Estimated Cost:** \$51,270  
**Remaining Life:** 2 Years

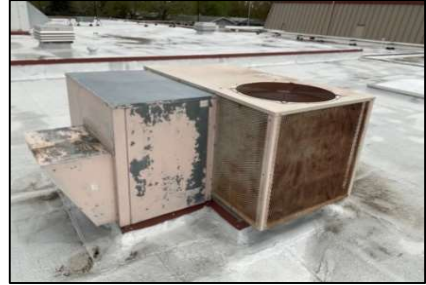
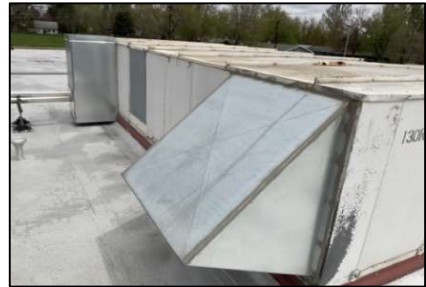
## Replace (6) Rooftop Units

Of the total eleven RTUs, five were replaced in 2014 but two (RTU-8 and RTU-9) date to 1989 and four (RTUs 2,3,4,5,) date to 1992.

**Priority Level:** 2  
**Estimated Cost:** \$253,480  
**Remaining Life:** 1-2 Years

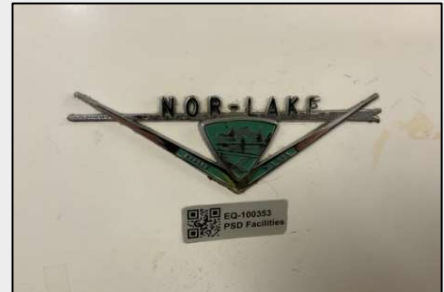
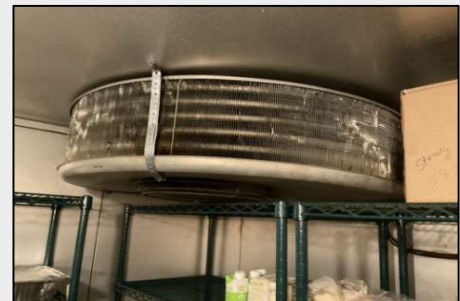
## Replace Walk-In Cooler

The Walk-In Cooler is original 1968 construction and is 35 years past expected life. Expect to replace the Walk-In Cooler within the year.

**Priority Level:** 2  
**Estimated Cost:** \$12,060  
**Remaining Life:** 1 Year
