# POUDRE SCHOOL DISTRICT RICE ELEMENTARY SCHOOL

## FACILITY CONDITION ASSESSMENT

WELLINGTON, CO

OCTOBER 2023

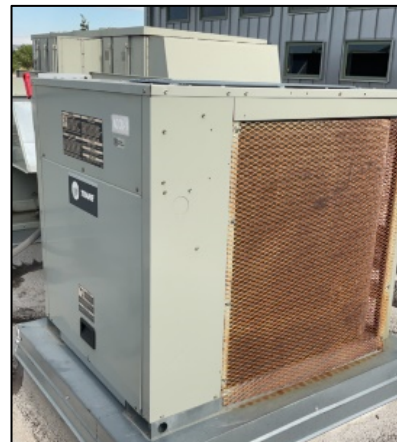
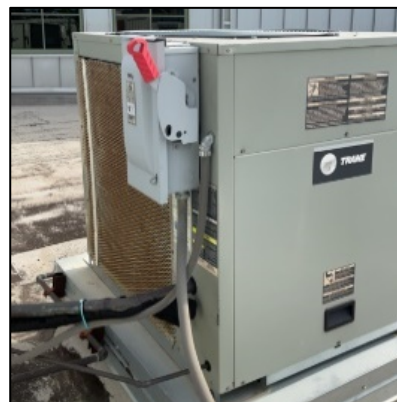
FCAID-490054

## Replace ACCU-1

ACCU-1 is past expected life [REDACTED] Recommend replacement within two years.

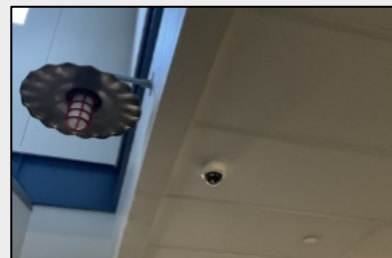
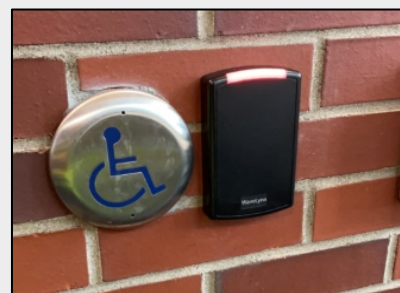
FCAID-490166

## Update Security System

[REDACTED]  
Recommend replacement within the next year. [REDACTED]

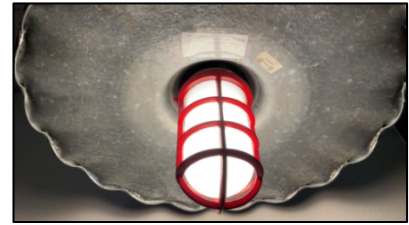
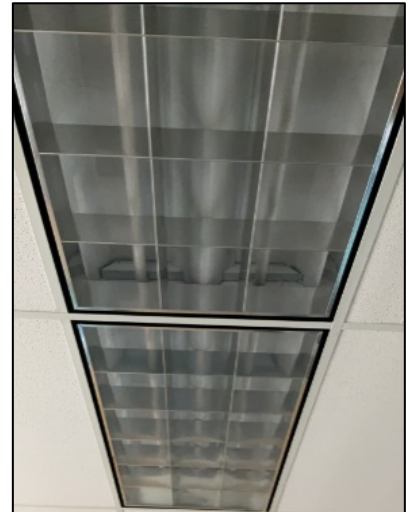
FCAID-490143, FCAID-490142

## Replace Interior Incandescent & Fluorescent Lighting

Recommend replacement of the remaining fluorescent and incandescent lighting fixtures with LED lighting fixtures within 4 years.

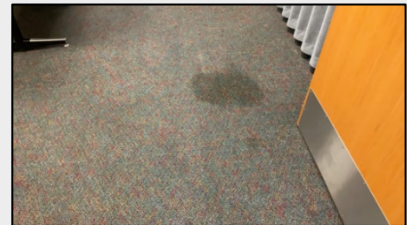
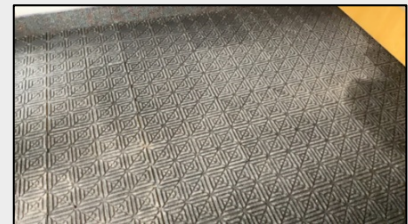
FCAID-490023

## Replace Carpeting

Carpeting is 6 years past expected life. REDACTED Replace within 2 years.
